## Case Study #4

Install Date – 10/25/2024

Rheem – Type: Vertical System / Location: Office closet / Condensate Pump / AC Power Adapter Used / Dispense Interval set to every seven days

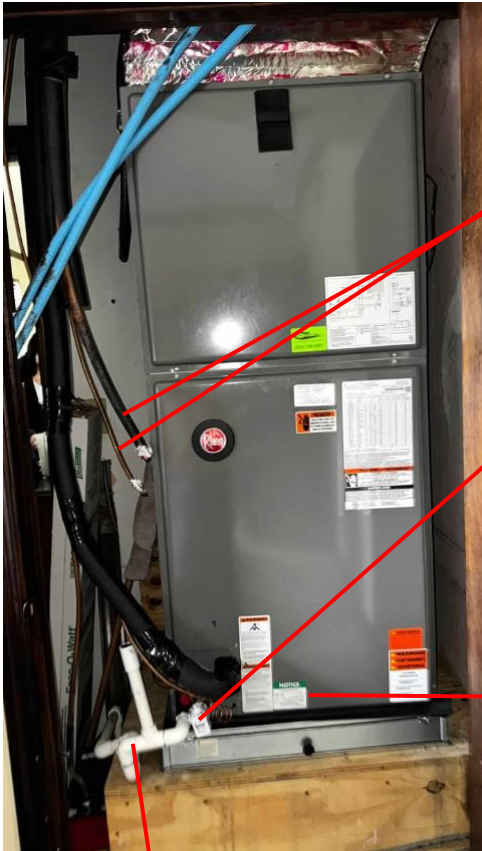
This system is in an office “closet”.

Previous system copper tubes were left hanging (why?)  
(these were cut off above and taped closed)

Cutoff switch directly in a drain outlet.

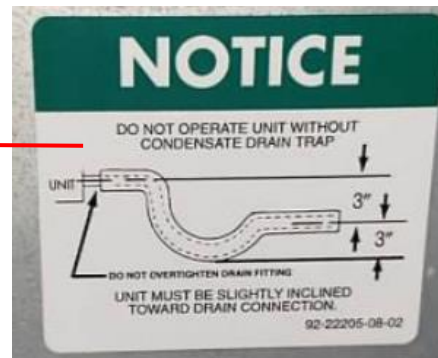
There is no trap, even though there is a label on the unit stating not to run the system without a trap.

The condensate line feeds directly into a condensate pump, however, even with just two feet of total length of pipe the line was susceptible to clogging.

The drain line was rebuilt using the classic “Cleanout, P-Trap, Vent” combo.

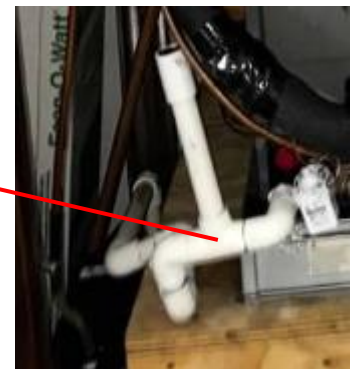
**FYI:** the AC fan/blower switch was in the “On” position instead of the “Auto” position, so the fan was running 24/7 – for who knows how long?

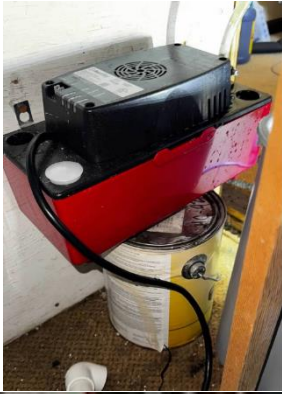
The condensate pump was sitting on a paint can – with no secondary pan in case the pump fails.

There was a mounting screw on the plywood for the pump hanger but for some reason the pump was off one of the screws – and sitting on the paint can...?

A plastic container was used to house the pump, so if there is a future pump failure water will be held in the container.

A second safety cutoff switch was added to shut down the AC system on a pump failure.

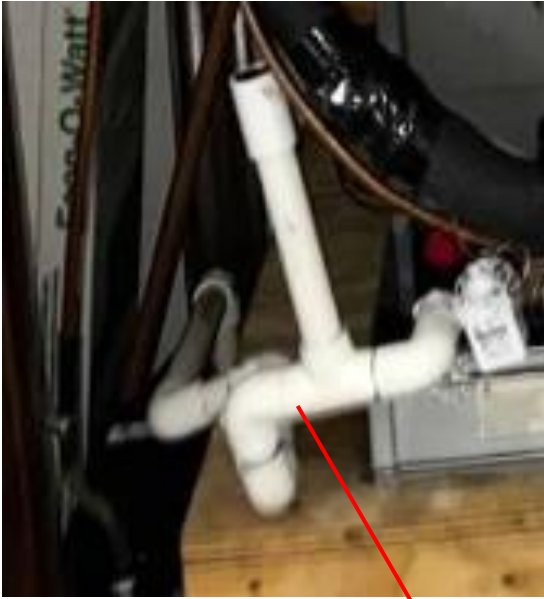
The reason for the clogging – **a terrible drain line design.**

Looking at the left picture, this one drain line has **six** 90-degree couplings! There is nothing worse in a drain line than a right-angle turn to slow the condensate flow and provide a spot for bacteria to take hold and grow.

The slope of the pipe that is sitting on the plywood is basically zero (flat), so water will sit inside this section of pipe providing an environment for bacterial growth. Adequate slope of the drainpipe(s) is critical to the flow of condensate. *Ideally, as fast as condensate is generated inside the cabinet, the condensate should exit the cabinet and flow expediently to the exit location, which in this case is the pump. A trap/vent combined with adequate slope should always be used if possible.*

Combining six 90-degree couplings with little slope is a perfect recipe for clogs.

Minimizing the number of 90-degree fittings or eliminating them completely should be a priority in a drain line design.

Only two 45-degree elbows were used instead of 90-degree fittings.

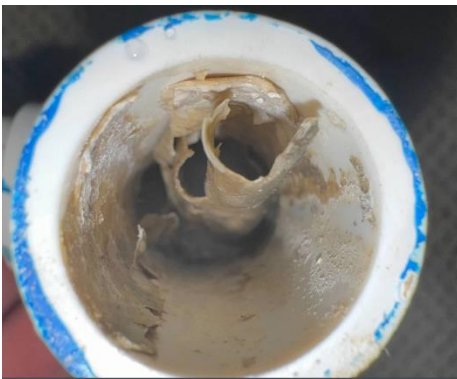
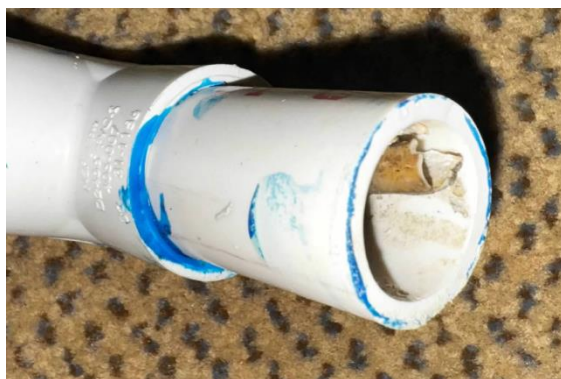
Examining the pipe showed bacteria that would have caused the clogging:

This is that “flat” section of pipe:

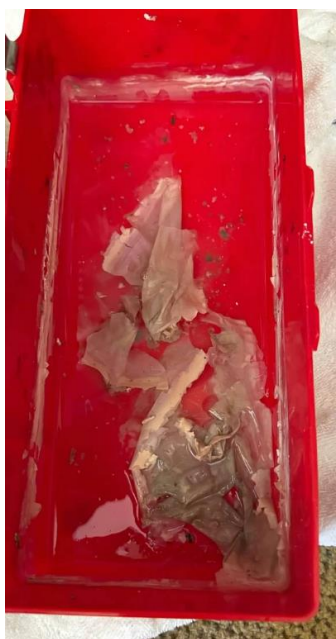
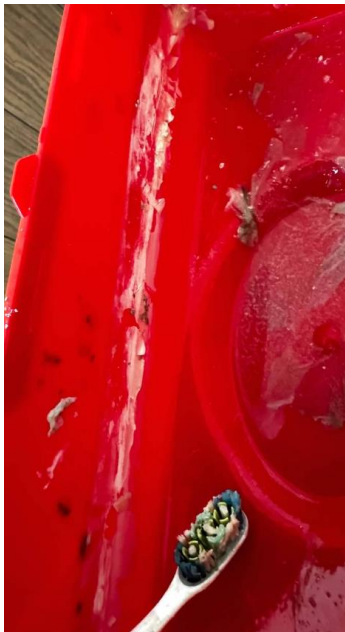
### What's the inside of the pump look like?

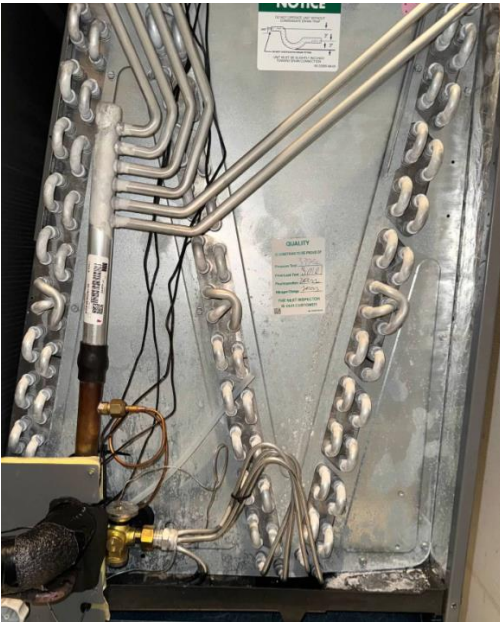
This system is an "N" configuration with one coil on the left side which deposits condensate into the left drain trough, and the other two coils forming a "V" and share a second common drain trough.
