# Town of Carolina Beach Canal Drive Flooding & Vulnerability Assessment Study

Submitted to:  
**Town of Carolina Beach**

Submitted by:  
**Aptim Coastal Planning & Engineering of North Carolina, Inc.**

Project No. 636236194  
February 2019

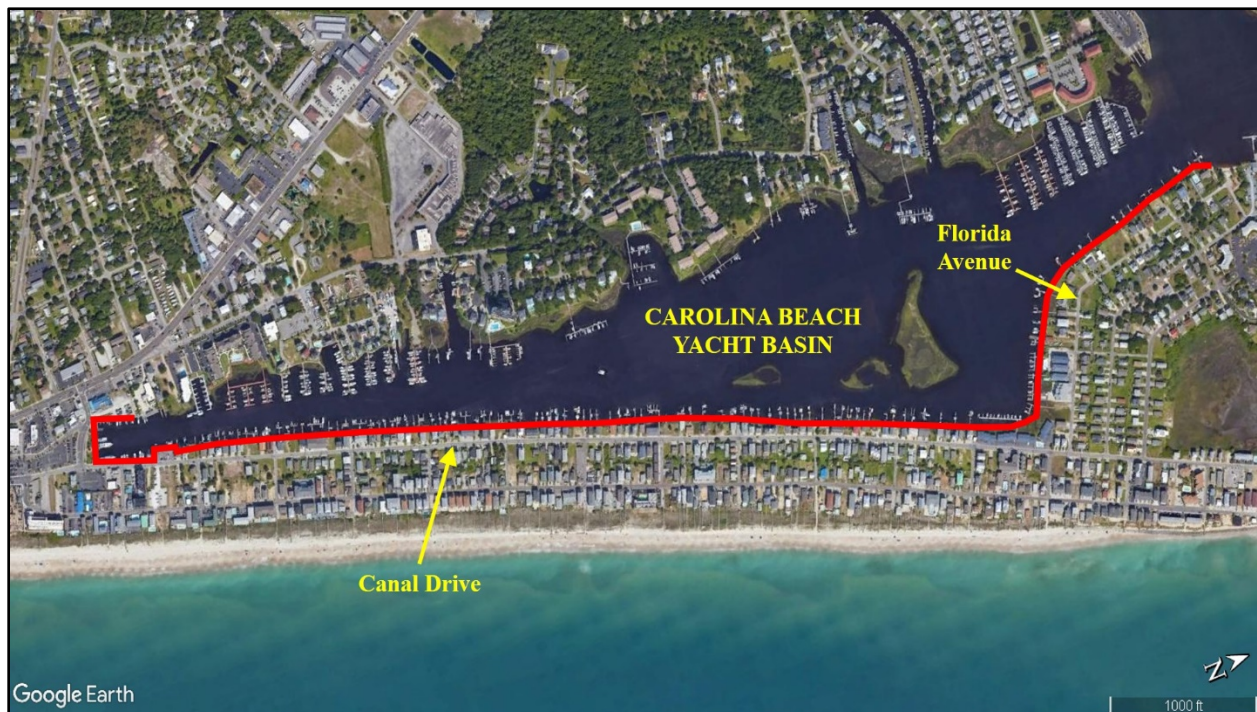
**Figure 1. Study Area Map.**

In support of the Town's goals for this study, Aptim Coastal Planning & Engineering of North Carolina, Inc. (APTIM) was retained to review available water level data, climate data, sea level rise modeling performed by NOAA, the USACE, and the Intergovernmental Panel on Climate Change (IPCC), and analyze return periods of extreme events to develop a recommendation for a minimum bulkhead height for the next 30-year horizon. APTIM also conducted field investigations to catalogue existing conditions of bulkheads, stormwater outfalls and inlets, and backflow prevention devices along approximately 1.75 miles of the tidally influenced shoreline along Canal Drive and Florida Avenue within the study area in October/November 2018. APTIM was also hired to coordinate the installation of a remote monitoring station designed to record water levels and weather data affecting the basin shorelines. The extents of this study area are identified by the red line shown in Figure 1.

The Town of Carolina Beach (Town) has experienced more frequent and increased flooding events of the public and private infrastructure located along Canal Drive and Florida Avenue that border the Carolina Beach Yacht Basin in recent years (Figure 1). These flooding events have been primarily caused by inundation from the Carolina Beach Yacht Basin during elevated water levels and during significant rainfall events. Though it is understood that these two factors are the primary factors contributing to flooding along Canal Drive and Florida Avenue, the amount of influence either factor has on specific flooding events is poorly understood. The Town commissioned this study in order to 1) determine a recommended bulkhead elevation to mitigate overtopping over a 30-year time horizon; 2) evaluate the elevation and conditions of the bulkheads along Canal Drive and Florida Avenue; and 3) to implement a long-term monitoring program aimed at better understanding tidal fluctuations and rainfall totals driving flooding events.

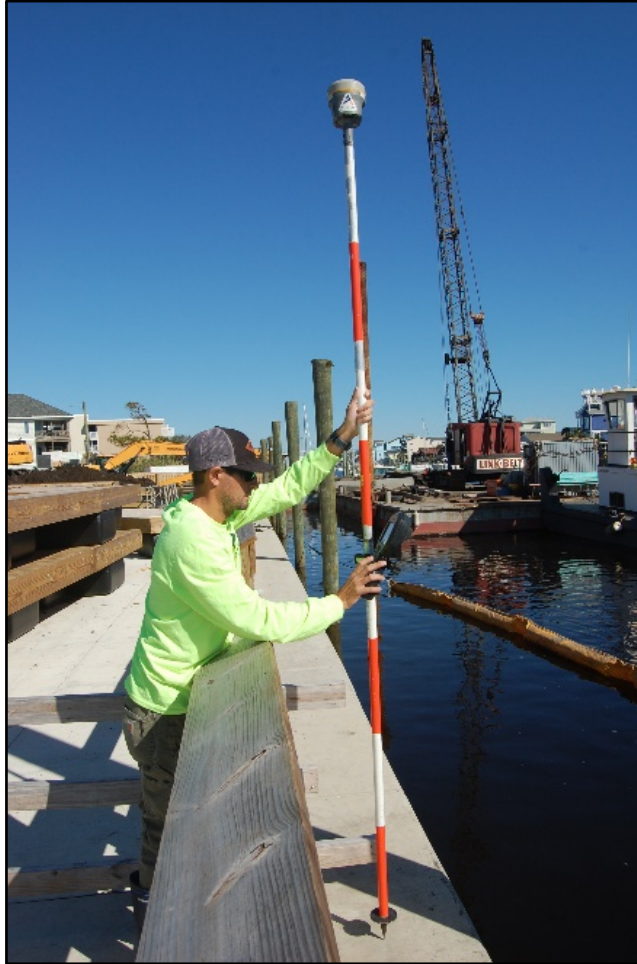
**Figure 13. APTIM Conducting Survey of the Bulkheads along the Carolina Beach Yacht Basin.**

shoreline surveyed within the study site are provided in Appendix A. All survey data was provided as part of the GIS geodatabase digital deliverable.

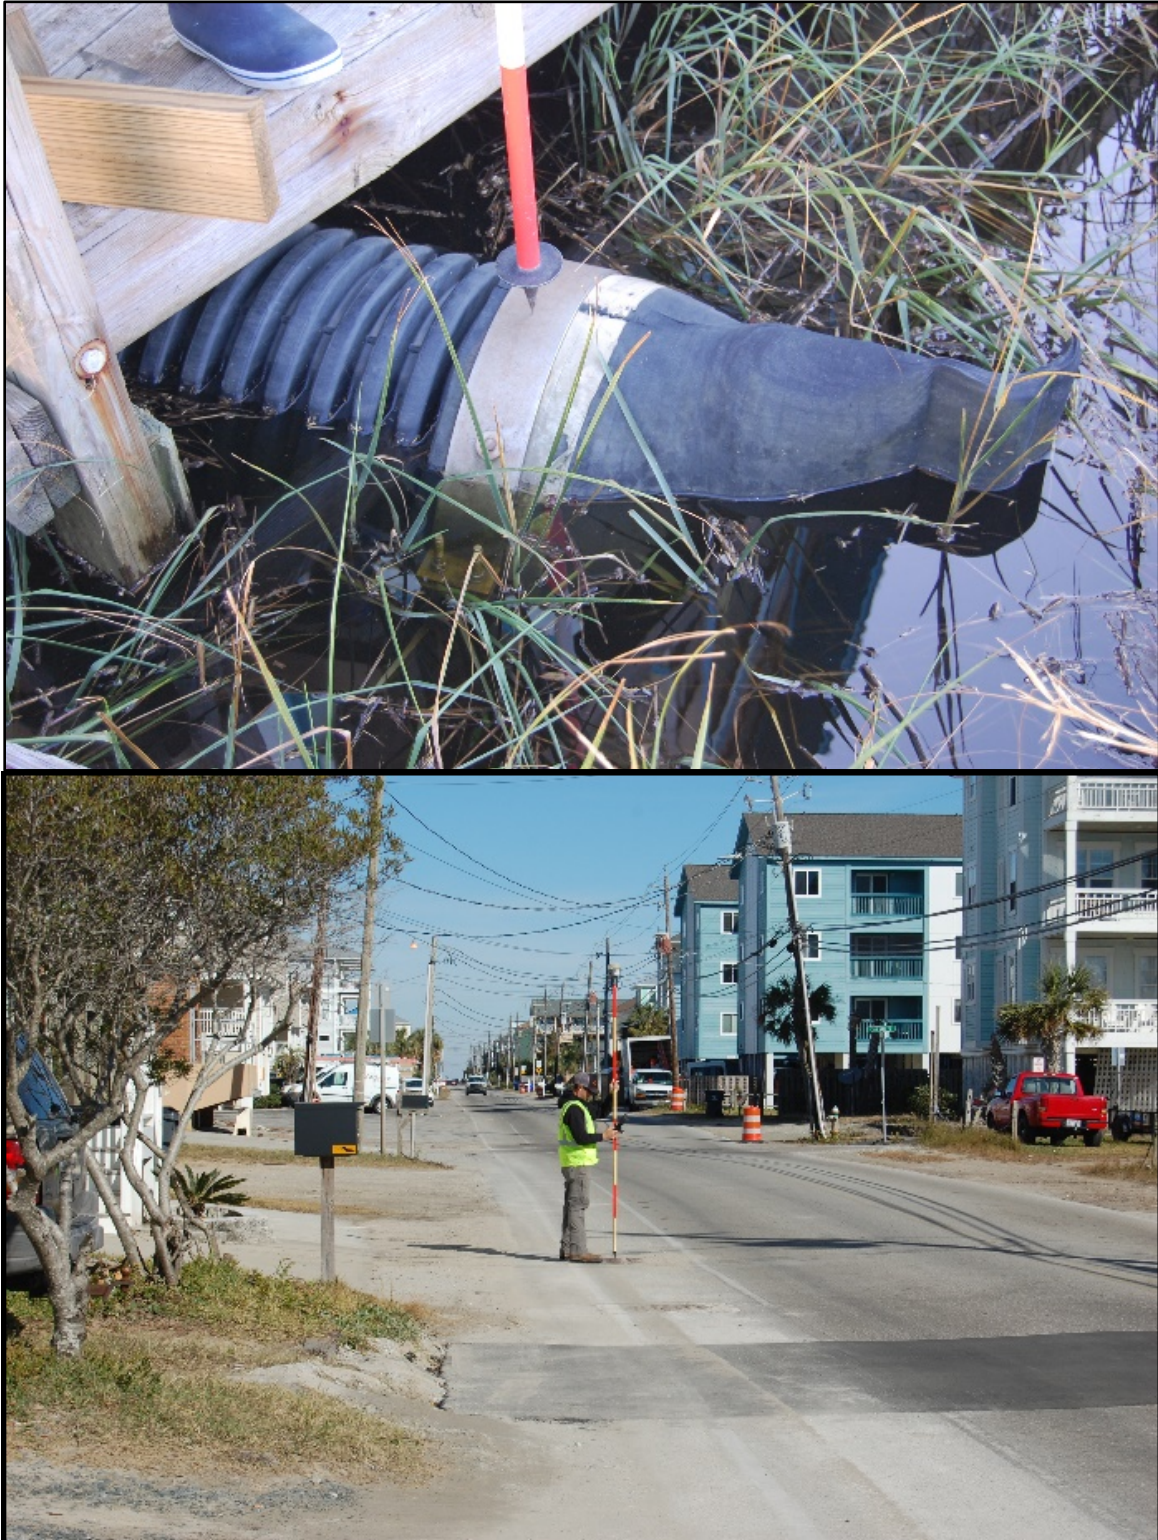
**Figure 14. Surveying an Outfall Pipe Located at 909 Canal Drive (upper). Surveying Stormwater Inlets Along Canal Drive (lower).**

In addition to the bulkheads, APTIM located, observed, and surveyed 17 stormwater outfalls and 110 stormwater inlets along Canal Drive and Florida Avenue. The stormwater outfalls flow directly to the Carolina Beach Yacht Basin. Stormwater outfall elevations were collected at the top of the outfall pipe as close to the waterward edge of the pipe as possible. If the outfall had a duckbill, an elevation was taken on the top of the pipe where the pipe met the duckbill as shown in Figure 14. Stormwater inlet elevations were taken at the center of each inlet grate as shown in Figure 14. Plan view maps showing the location and representative elevation of the stormwater outfalls and inlets surveyed within the study site are provided in Appendix A. All survey data was provided as part of the GIS geodatabase digital deliverable.

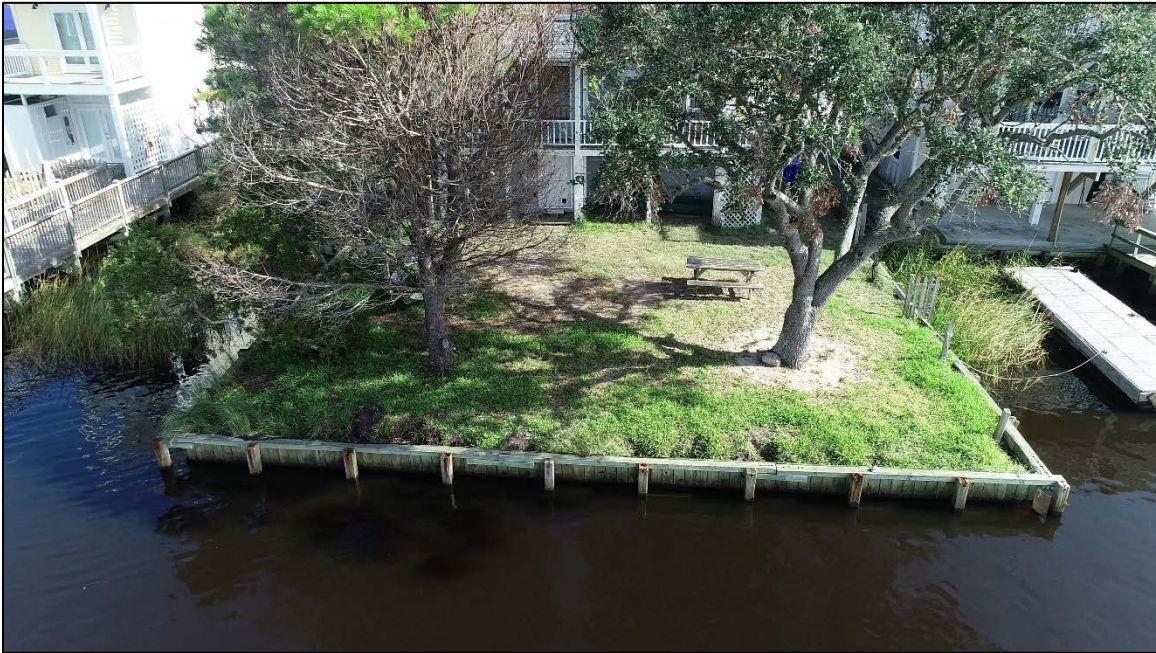
In addition to the bulkhead surveys, a video record was collected. The video was captured using a small Un-manned Aerial System (sUAS) or drone to further document the conditions along the study area's shoreline. The video provided a visual record of the study site shoreline and facilitated quality control of the assessment observations. All videos were provided as part of the digital deliverable. An example screenshot is displayed in Figure 15.

**Figure 15. Screenshots from the Drone Video showing a portion of the marina bulkhead along Canal Drive and the bulkhead at 1313 Canal Drive.**

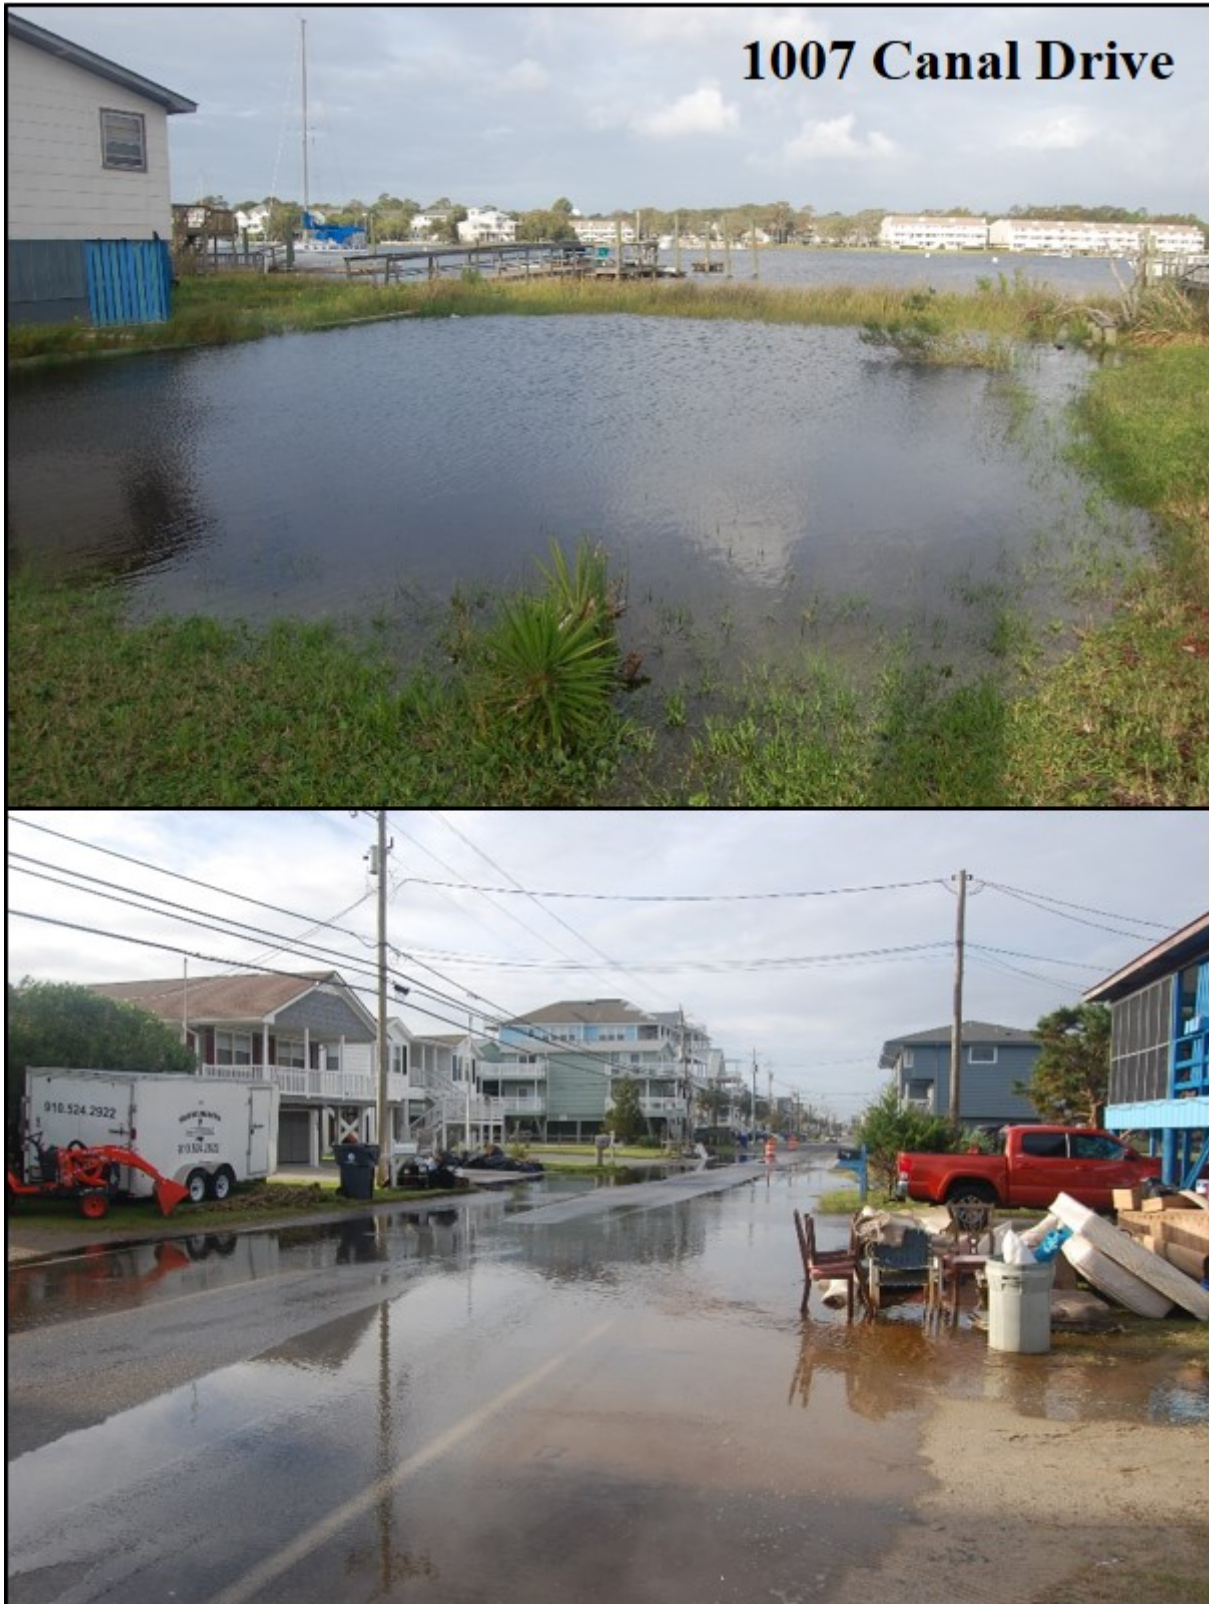
Examples of flooding of Canal Drive directly attributed to overtopping of bulkheads or inundation of low-lying parcels with no bulkhead are shown in Figure 18 and Figure 19. The property at 1007 Canal Drive shown in Figure 18 does not have a bulkhead and has an average elevation of 1.94 ft. NAVD, the lowest elevation along the Canal Drive shoreline. The photographs were taken shortly after high tide on October 9, 2018, water was observed flowing onto Canal Drive from the property as shown in the lower image of Figure 18. The photographs in Figure 19 show a similar situation on the property at 1013 Canal Drive with the exception that the water came around the timber bulkhead (average elevation 4.3 ft. NAVD) and entered from the neighboring property to the north that has an average shoreline elevation of 2.8 ft. NAVD and does not have a bulkhead. The lower image shows the water from the property flowing onto and ponding on Canal Drive.

**Figure 18. View of the property at 1007 Canal Drive at high tide (upper); water flooding onto Canal Drive looking south from 1007 Canal Drive (lower).**

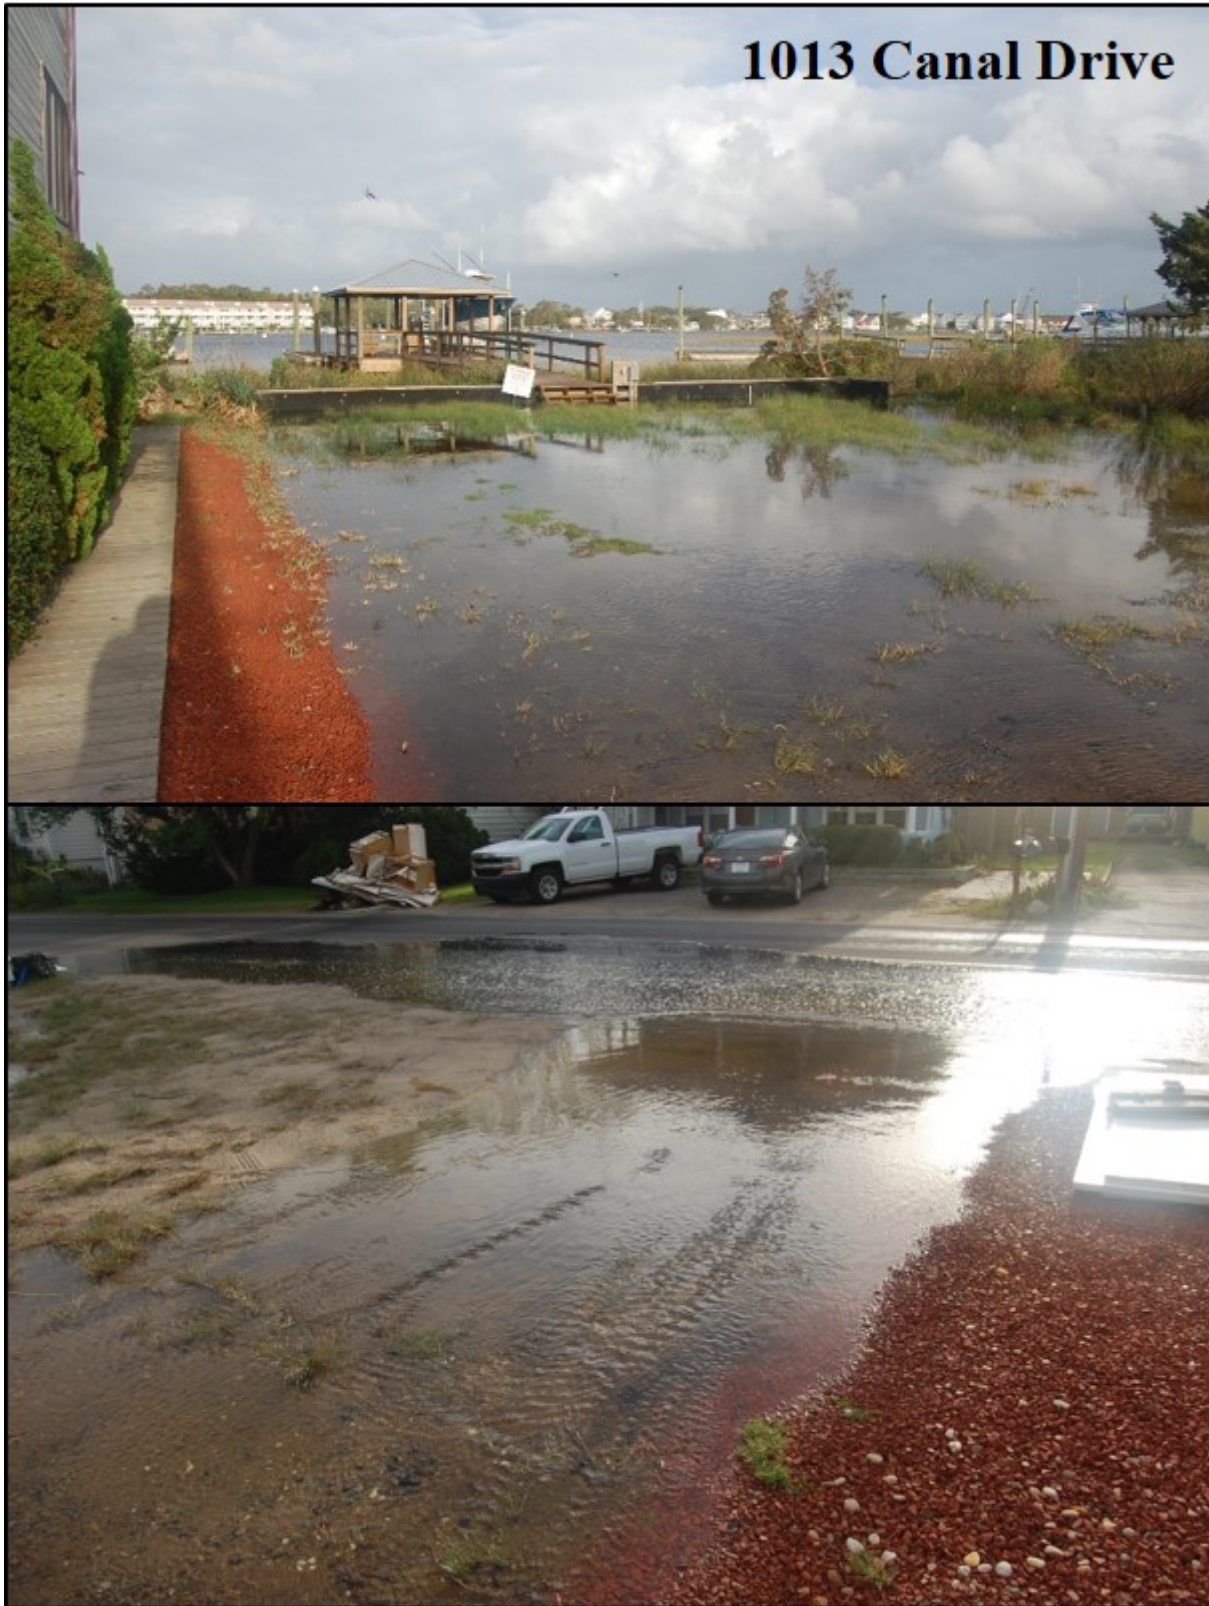
**Figure 19. View of high tide flooding around bulkhead at 1013 Canal Drive (upper) and water flowing from the property onto Canal Drive (lower).**

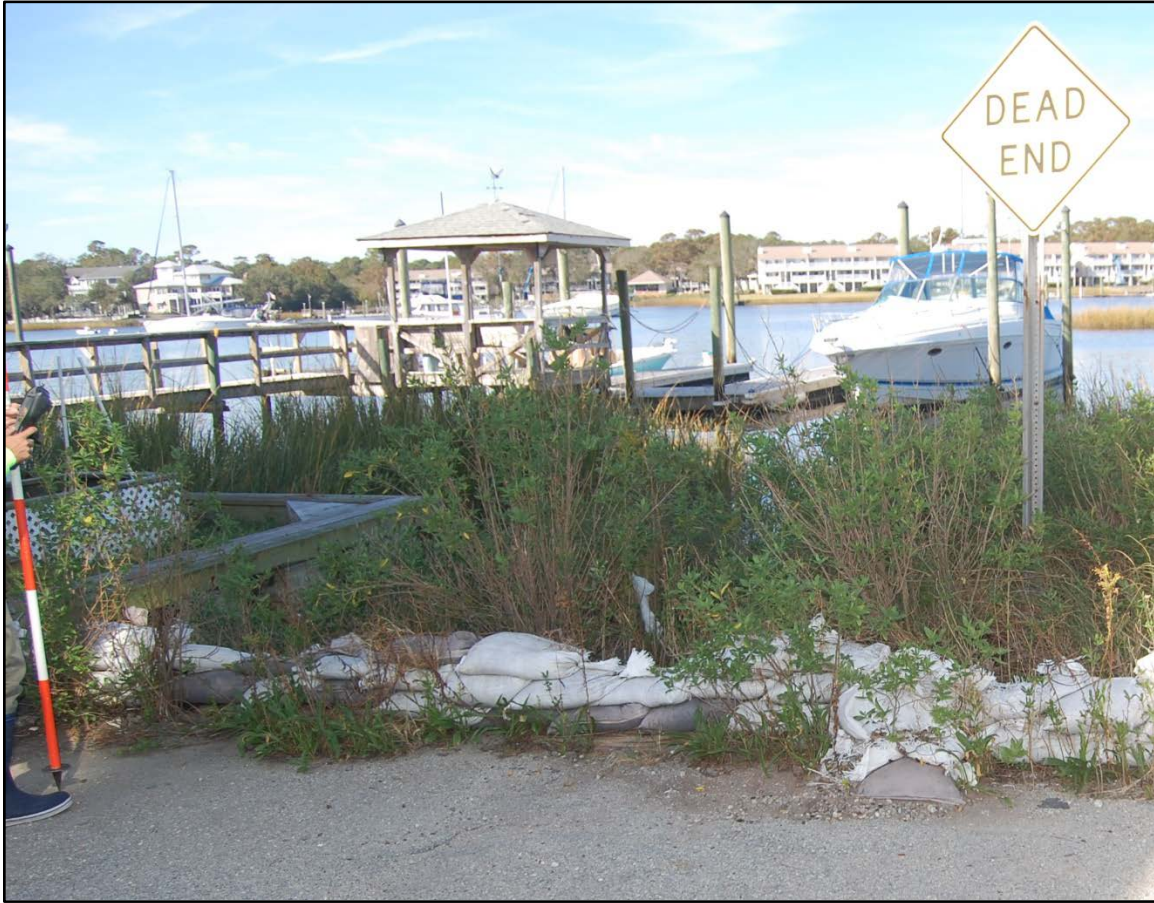
**Figure 20. View of the west end of Scotch Bonnet Lane.**

While the Town can improve publically owned bulkheads and install new bulkheads to mitigate overtopping and flooding, this effort alone will have limited impact without private owner improvements. For example, consider the structure at Scotch Bonnet Lane and Canal Drive (Figure 20). The existing average elevation of the publically owned sandbagged shoreline is 2.8 feet NAVD. The Town can install a bulkhead to the adopted future design elevation, but flooding will not be prevented until the adjoining bulkheads on either side with existing elevations of 3.6 ft. and 3.7 f.t NAVD are also raised to the adopted future design elevation.

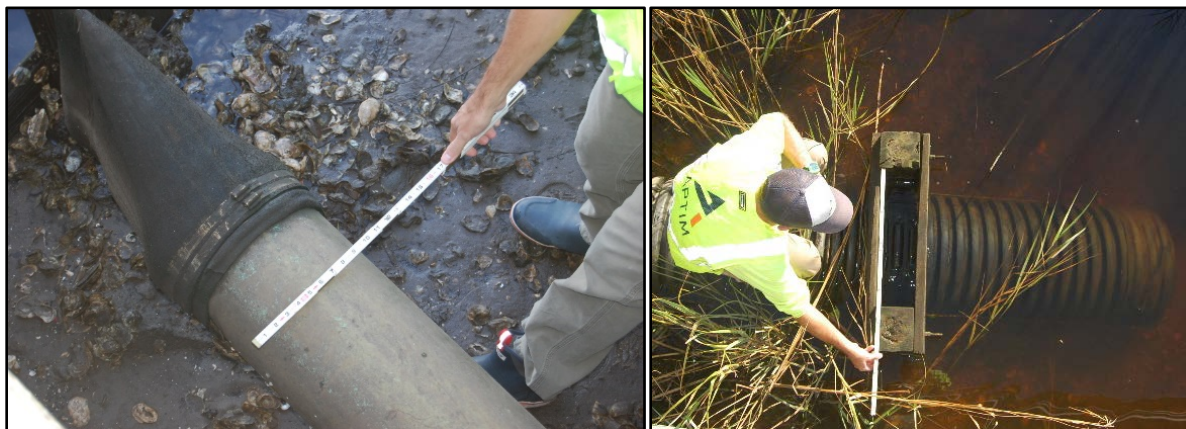
**Figure 21. APTIM Conducting Stormwater Outfall Observations.**

APTIM conducted observations of the stormwater outfalls, backflow prevention devices and stormwater inlets throughout the study area. During these observations, an APTIM engineer noted the dimensions and material of the outfall and the type of backflow prevention device. A total of 17 stormwater outfalls were observed during the site investigations and 110 stormwater inlets located along Canal Drive and Florida Avenue. All of the stormwater outfalls observed were fitted with backflow prevention devices. Results of these investigations are presented visually on the assessment maps in Appendix A and Appendix C. The information is also included in the GIS geodatabase digital deliverable.

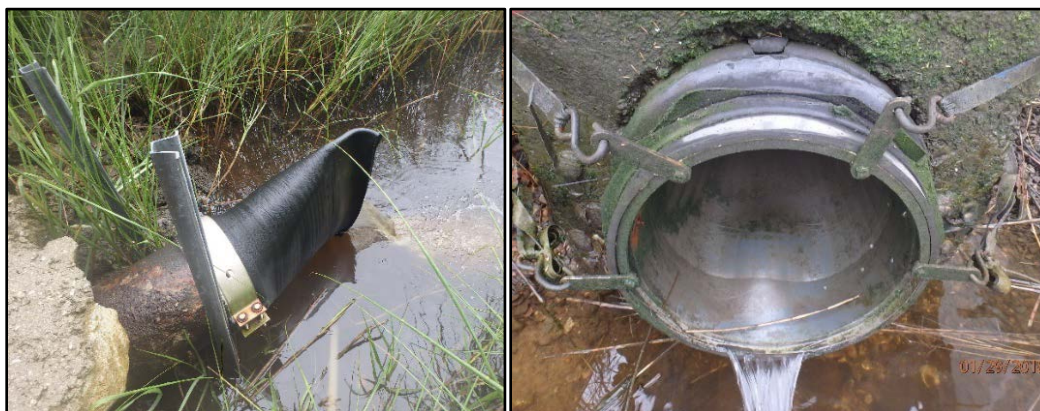
Currently, there are two types of backflow prevention devices installed throughout the study area including: duckbills (recurved) and WaStop® inline check valves. APTIM inventoried 17 backflow prevention devices. Town GIS records indicate that eight (8) additional outfalls are present, primarily along the marina at the south end of the project area. However, due to the elevations of these outfalls and conditions at the time of the site visit, these outfalls were not observed and it is unknown what type of backflow prevention is installed at those locations. Of the 17 stormwater outfalls observed within the study area, 6 were fitted with the WaStop® inline check valves and the remaining 11 had duckbill type backflow prevention devices installed, both of which are shown in Figure 22.

**Figure 22. Examples of Functioning Backflow Prevention Devices Currently Installed.  
(left: recurved duckbill valve, right: WaStop® Inline Check Valve)**

2. All existing external backflow prevention devices should be inspected and cleaned twice per year for oysters, barnacles, and any other blockages. It is recommended that inspections are scheduled around April and September of each year prior to rainy season, and seasonal high tides. Once the rate of oyster and barnacle growth is known, the cleaning frequency may need to be adjusted.

3. All existing internal backflow prevention devices should be inspected and cleaned twice per year for blockages. Similarly, to the external maintenance, it is recommended that internal inspections are scheduled around April and September of each year prior to rainy season, and seasonal high tides.

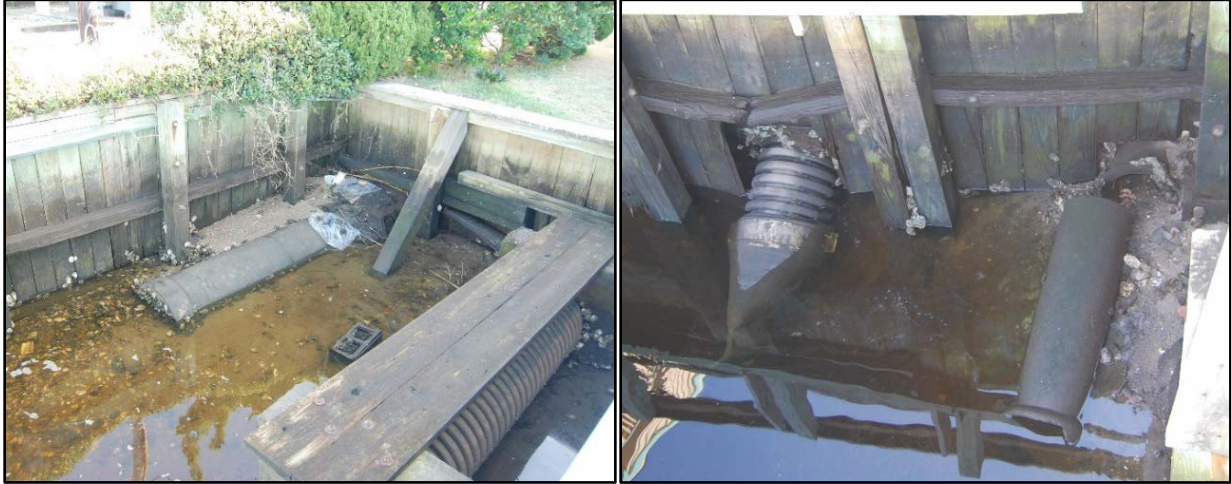
During the site investigations, what appeared to be old stormwater outfalls made out of clay or concrete pipes were observed at the Seagull Lane street end, Seahorse Lane street end, and at 909 Canal Drive. The old outfalls were located within several feet of more recently installed stormwater outfalls with backflow prevention devices. Although the old outfalls appeared to be abandoned if not properly sealed or disconnected from the system they could provide a means for water to backflow into the stormwater system. It is not known whether these old outfalls are still connected to the system, this information is only provided to inform the Town of their existence. The photographs in Figure 23 show the relic outfall pipes adjacent to the more recently installed stormwater outfalls.

**Figure 23. Abandoned Stormwater Outfall Pipes.**  
(left: 909 Canal Drive, right: Street End at Seagull Lane and Canal Drive)

1. It is recommended that all abandoned stormwater outfalls along the Carolina Beach Yacht Basin that have not been removed be inspected to ensure that they are no longer connected to the system. Abandoned stormwater outfalls that have not been removed, filled, or properly disconnected from the stormwater system could circumvent the Town's effort of backflow prevention.

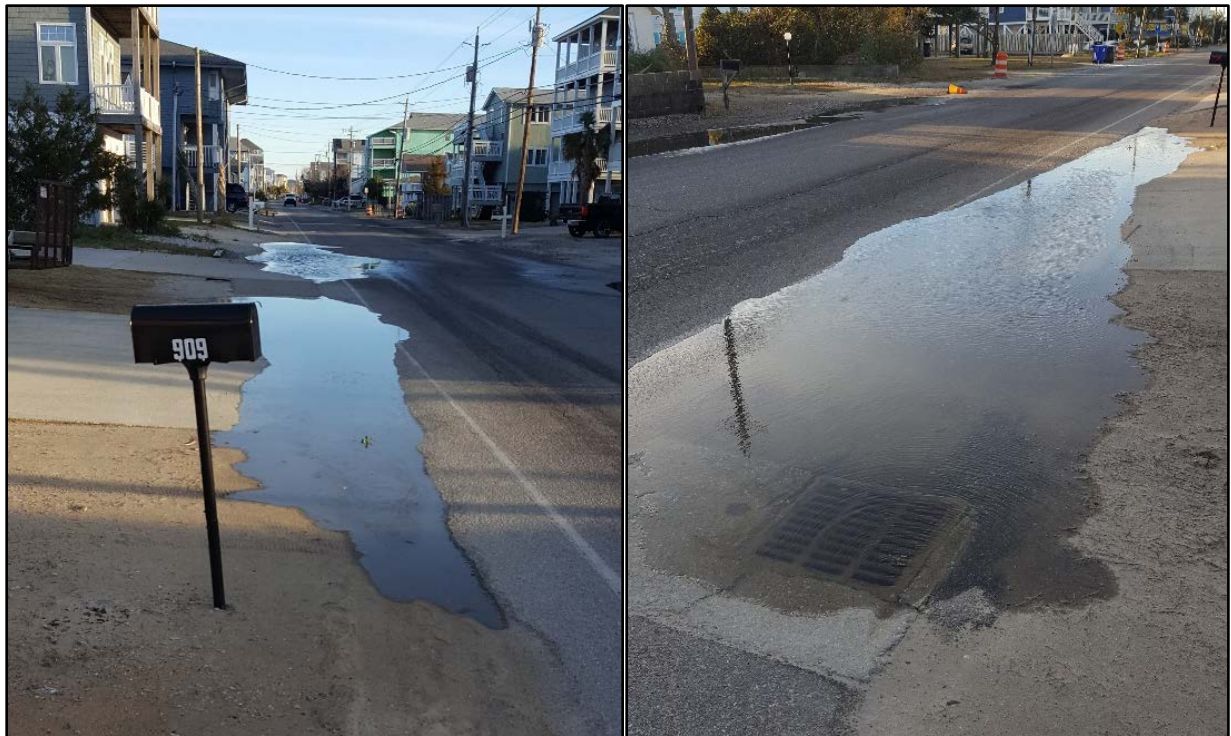
**Figure 24. Water Coming Up Through Street Inlets During High Tide at 909 and 911 Canal Drive.**

The photographs in Figure 24 show water coming up through the street inlets in front of 909 and 911 Canal Drive during a high tide on the morning of January 22, 2019. There is a WaStop® backflow prevention device installed on the outfall at this location; however, there is also an abandoned outfall as this location as shown in Figure 23.
