Roof Inspection Form

Address Inspected: **** Meadow Spring Way, Oceanside, CA.	Date of Inspection: August 24, 2022	Contractor and License Number: Juan Colin (License #CA 909525)
Condition of Roof: <ul style="list-style-type: none">• ~ 6 broken tiles must be replaced with new tiles that match roof color & style• A few sliding tiles must be nailed down with galvanized nails to prevent tiles from falling from edges of roof• Ridge Cap intersections have weather damage and mortar need to be repaired.• Pipes and vents need roof sealant to prevent future leakage and roof damage.• Underlayment paper is reaching end of lifespan. Paper lasts ~20 years. Home was built in 2003. Once leaks begin to occur, the paper will need to be replaced.		
Contractor Notes: <p>Colin Roofing recommends 2 repair options.</p> <p>1. Immediate Repair: Tile roof maintenance (~\$1580.00)</p> <ul style="list-style-type: none">• Sealing and painting all pipes and vents.• Replacing all broken tiles (~6). Resetting all sliding tiles into place w/ galvanized nails.• Repairing the mortar on ridge cap intersections where chipped or cracked. <p>2. Future Repair: Underlayment Replacement (~\$13,500.00)</p> <ul style="list-

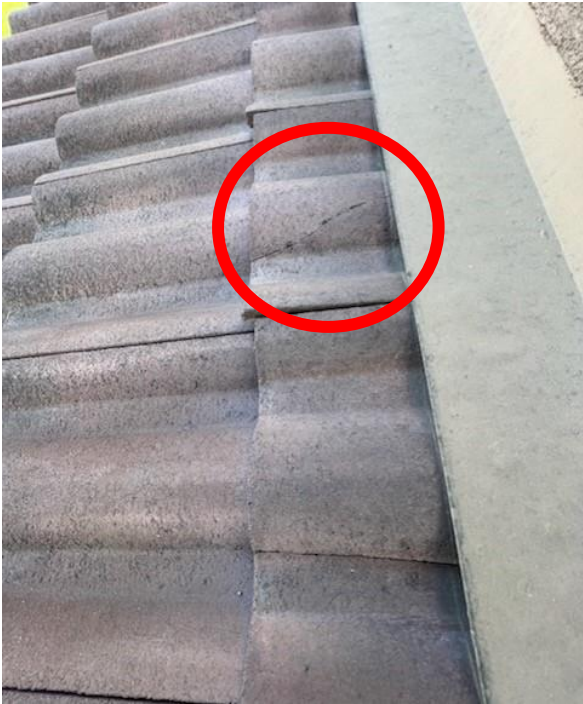
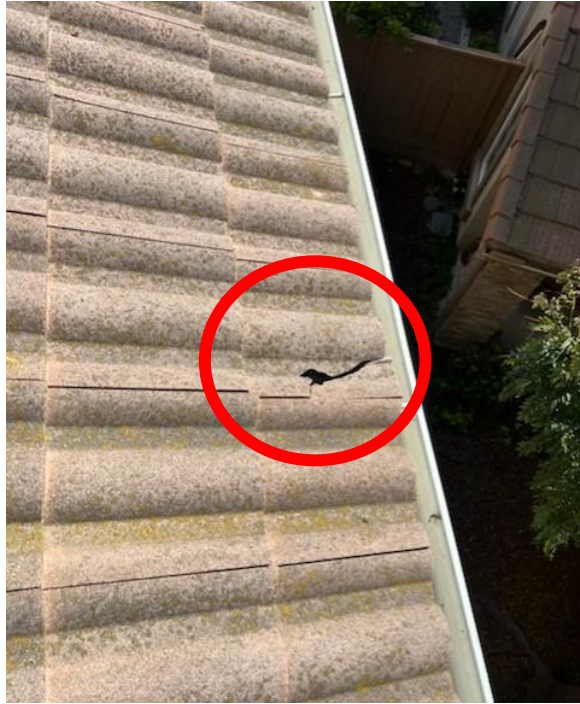
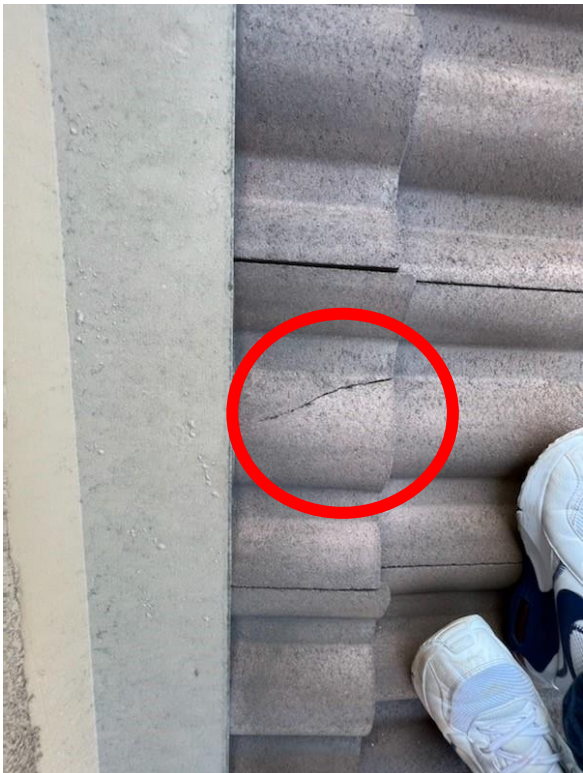
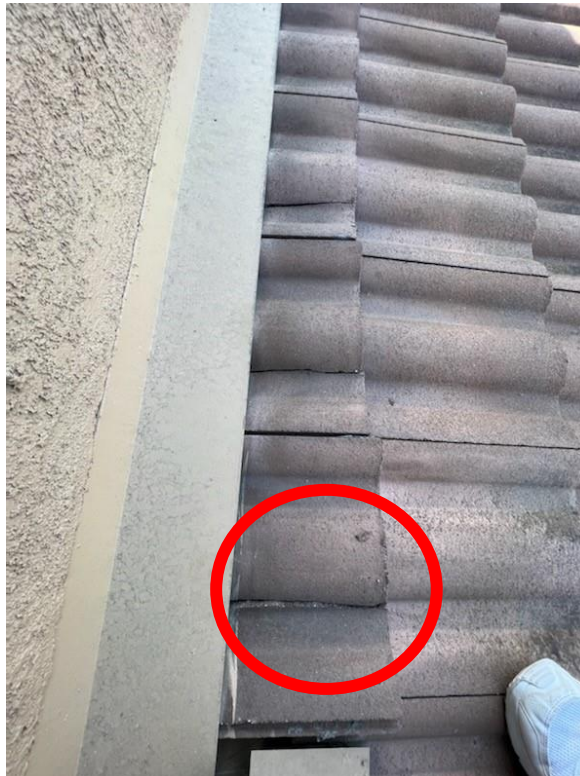
At least 6 broken tiles were spotted on roof. They must be replaced to protect the underlayment paper.

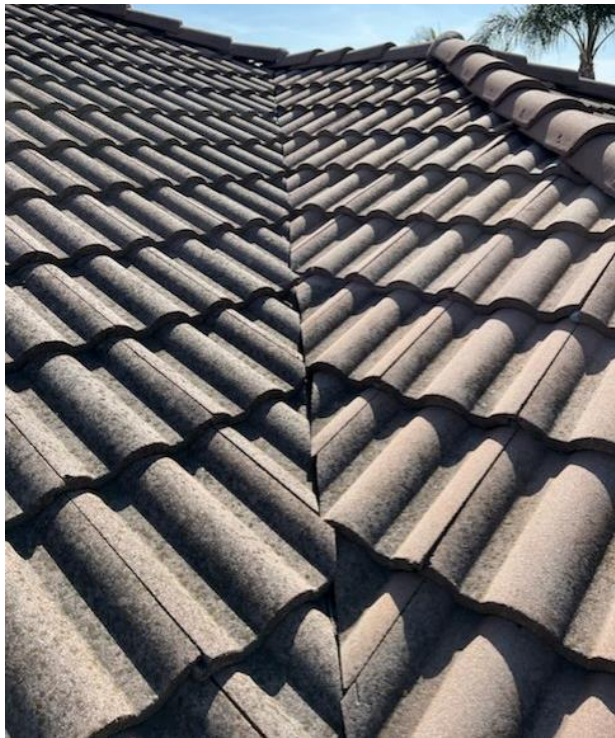
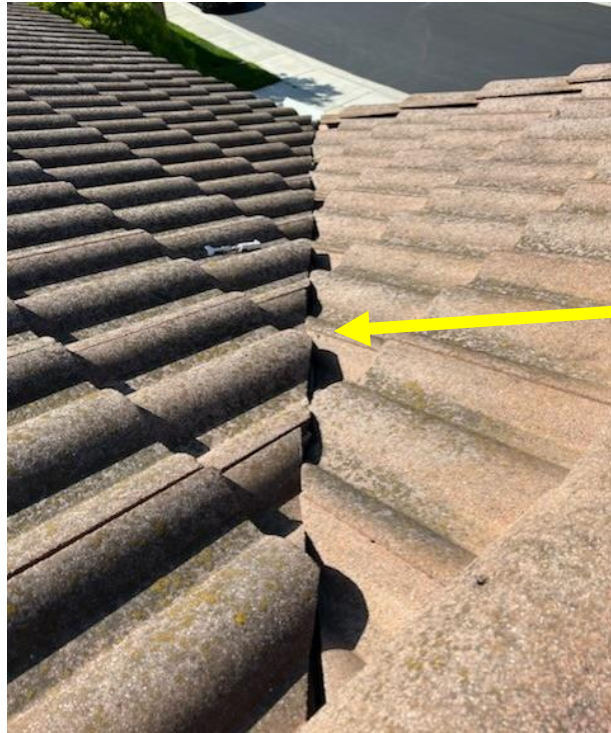
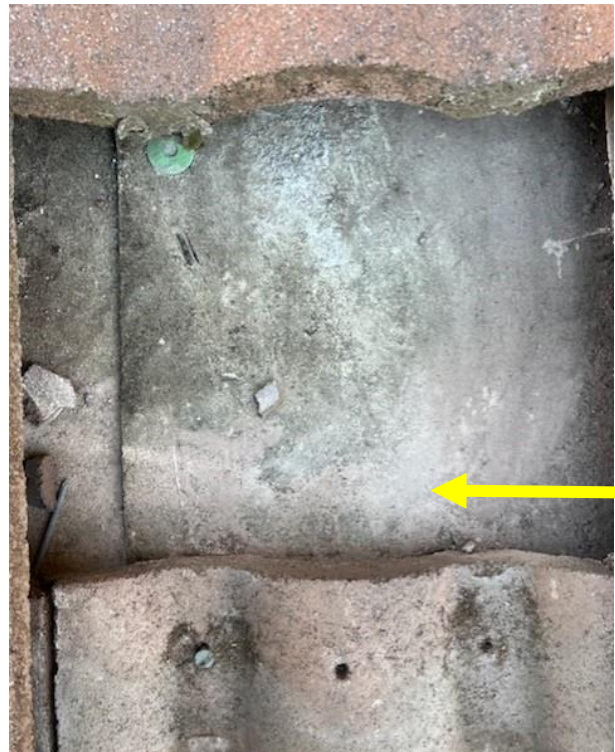
Tile Valleys are closed in nature. This encourages debris build up. When roof paper is replaced in the future, Colin Roofing recommends opening the valley channels.

Some sliding tiles were spotted. They need to be reset into place w/ galvanized nails.

Underlayment paper was assessed. It is nearing the end of lifespan. Paper lasts ~20 years. Home was built in 2003. Replace paper when leaks occur.

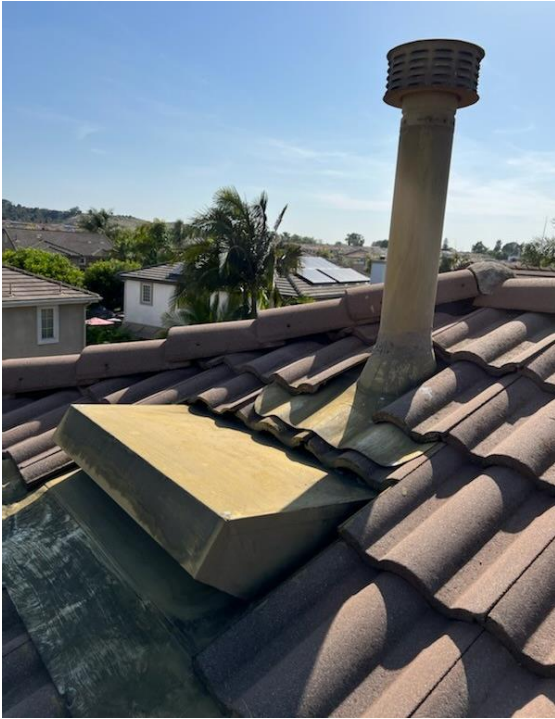
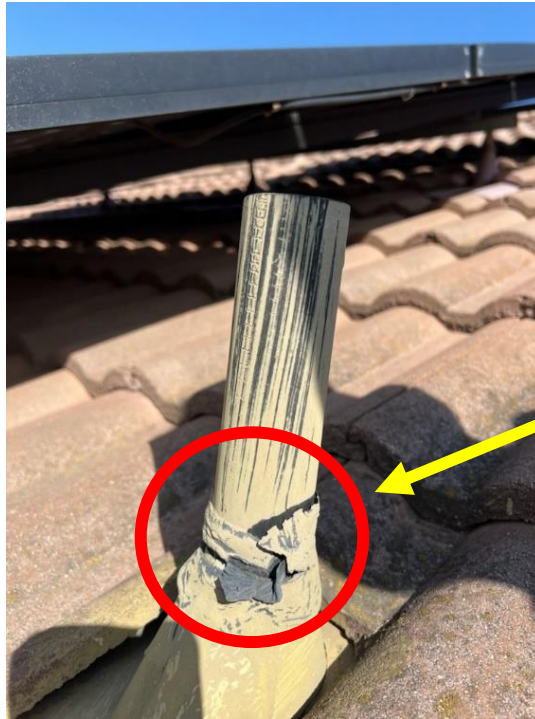
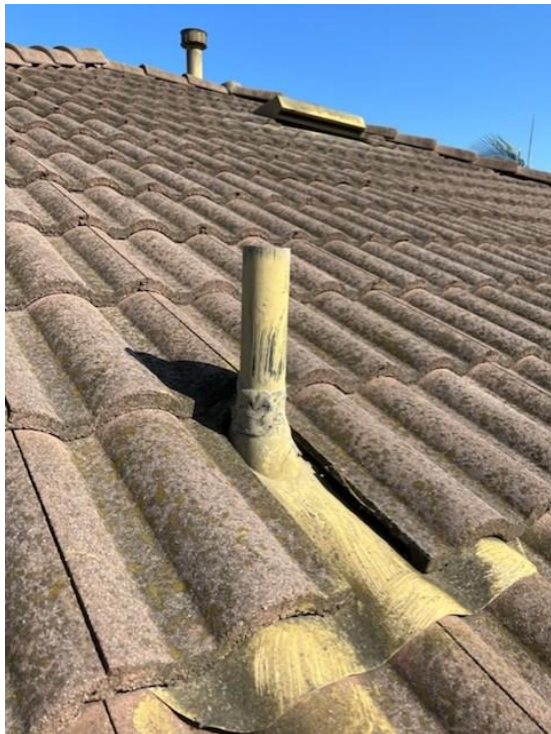
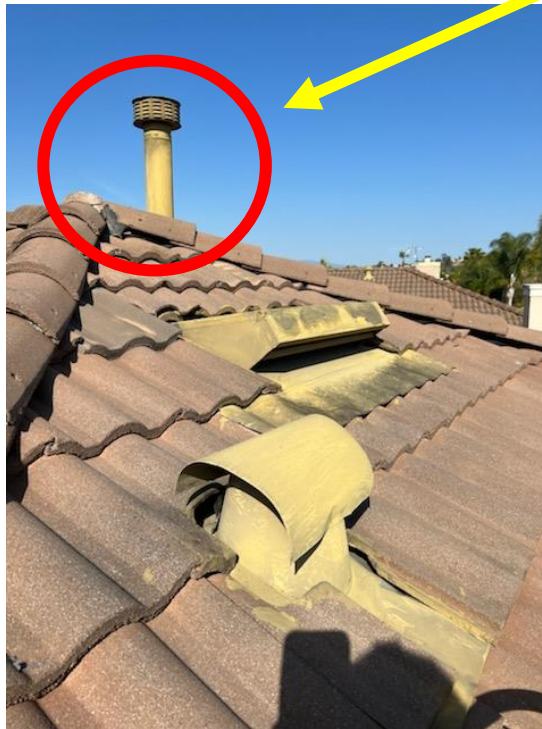
Pipes and Vents:
All pipes and vents need to be sealed with roof sealant to ensure no water leaks in these critical areas. Sealant is cracking.

Ridge Caps:
Mortar needs to be reapplied on some ridge cap ends. It is chipped in certain areas. Cracks in mortar invite water and diminish the lifespan of the roof.
