THE **PRETTY GOOD** HOUSE RENOVATION

PRETTY GOOD RENOVATIONS

CASE STUDY 3d

1874 Eastlake Victorian Style balloon-framed house
Full renovation in 2021

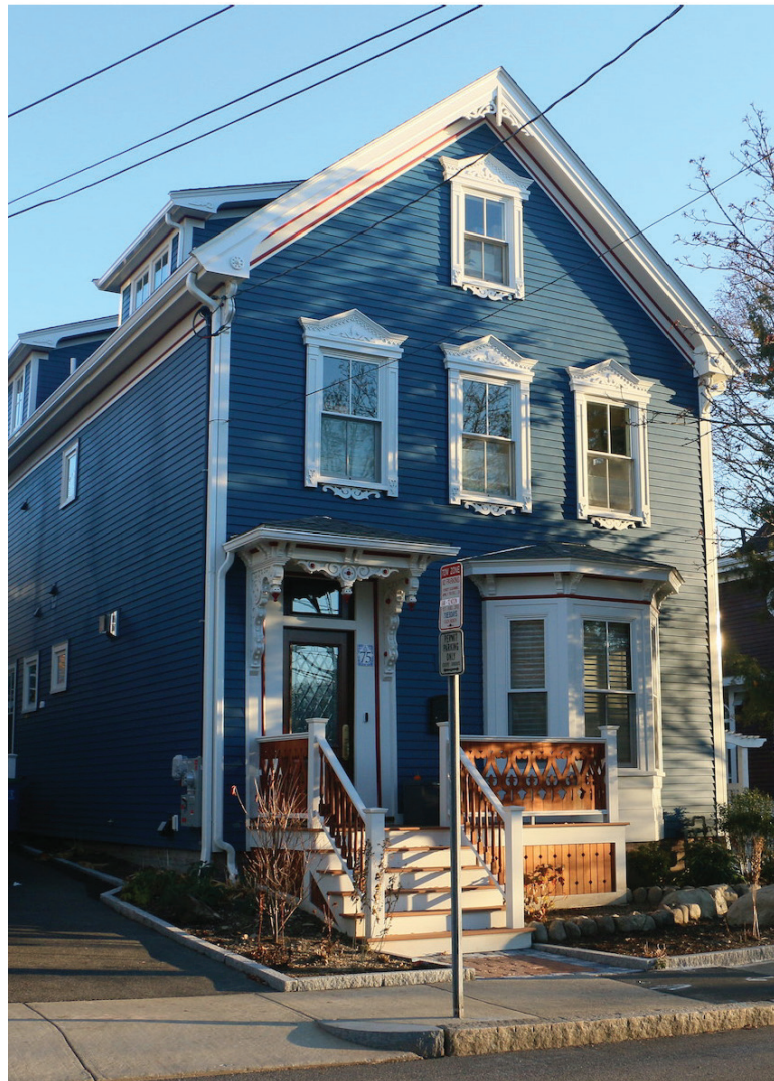
AFTER | FRONT VIEW

The house is a three-story single family with a finished basement. While built in the 1874, it was gut-renovated in 2021.

A small expansion was made on the South side to add space and sunlight to the Kitchen and Primary Bedroom.

Details that were inspired by the Owner's European ancestry and American Victorian architecture were added to the exterior and interior.

Closed cell foam insulation was sprayed into the walls and roofs. Exterior insulation was applied to parts of the house. New Andersen A-Series windows were installed.
