Stauffer Creek Project

DEQ NPS Sub-Grant S528

Final Report

December 2017

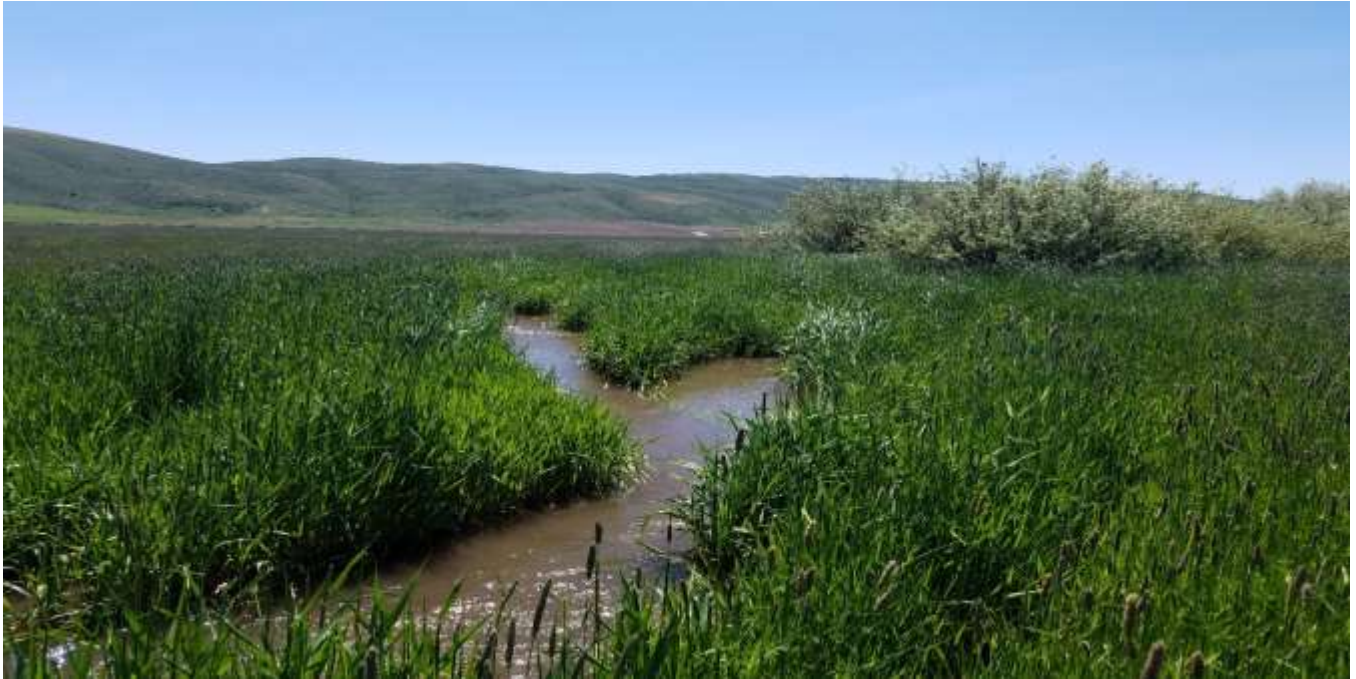
Lower end of Stauffer Creek just upstream from new crossing

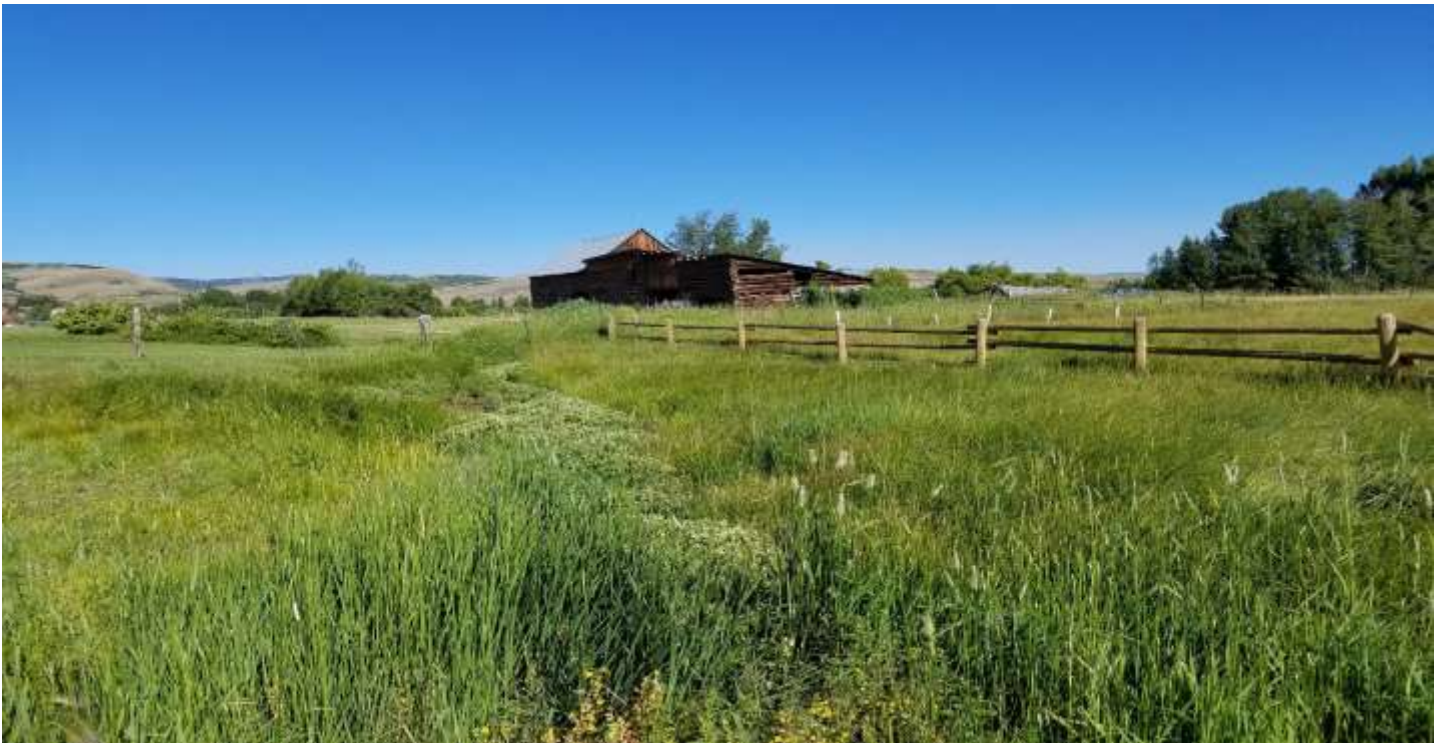
Photo 1. This Photo shows an unnamed spring creek, east of St. Charles, Idaho (tributary to St. Charles Creek) with newly installed riparian fencing directly below an animal feeding operation, SC Photos.

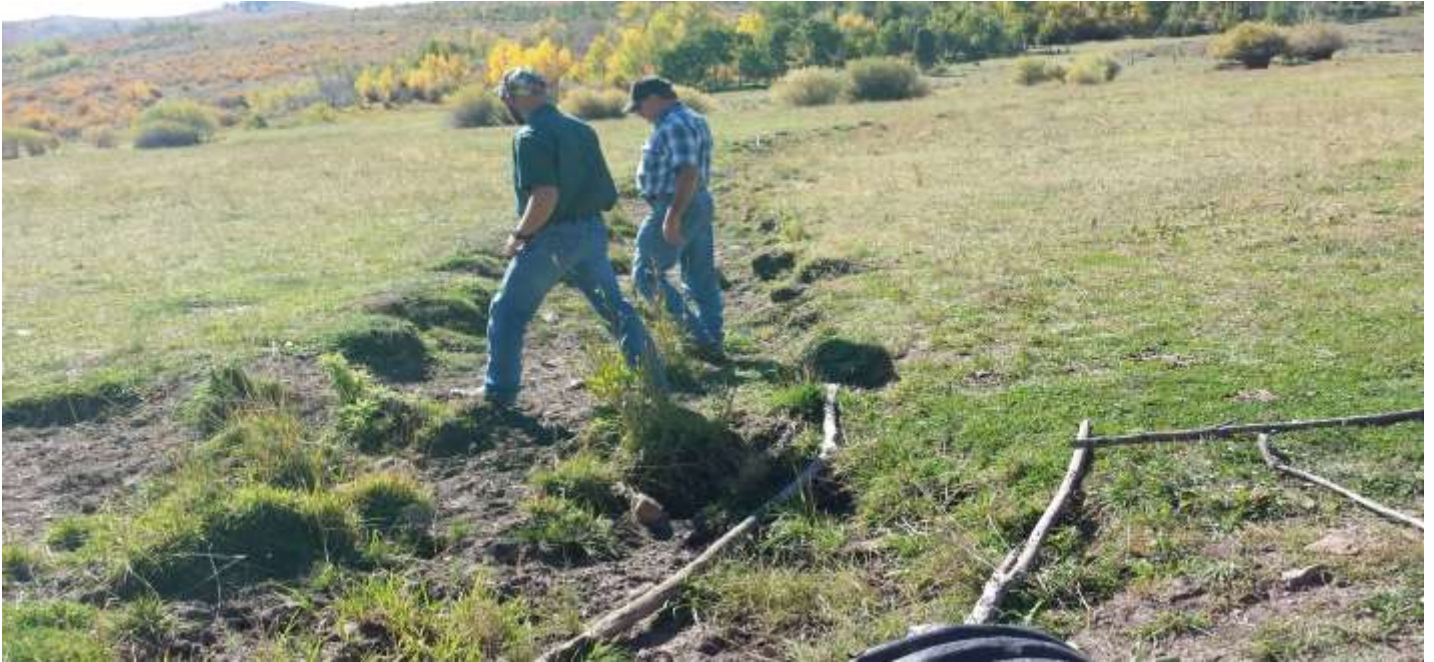
Photo 2. Allan Johnson, ISWCC, and Brett Oxborrow (Landowner) walk across a flood irrigated meadow, SC Photos.

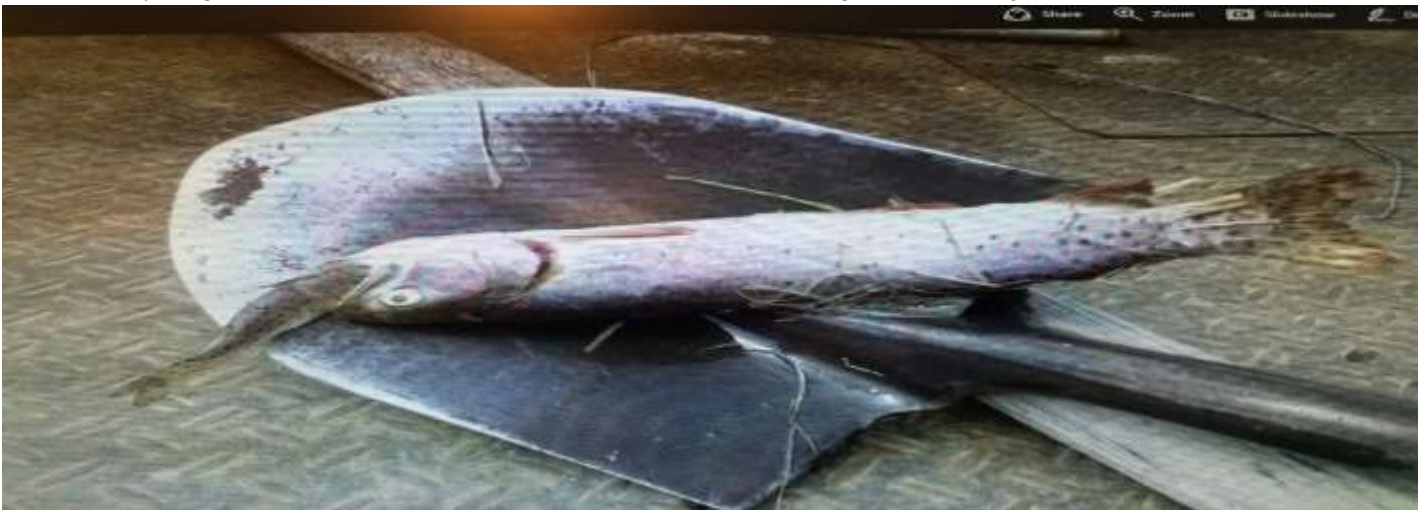
Photo 3. A young Bonneville Cutthroat Trout found Stranded in an irrigation ditch adjacent to Stauffer Creek, SC Photos.

The Stauffer Creek Project worked to reduce the chance of Bonneville Cutthroat Trout (BCT) being stranded in irrigation ditches like the ones pictured above. The project also worked to remove barriers for BCT trying to move upstream to spawn. The Photo below shows a Bonneville Cutthroat Trout which the landowner found stranded in his meadow.

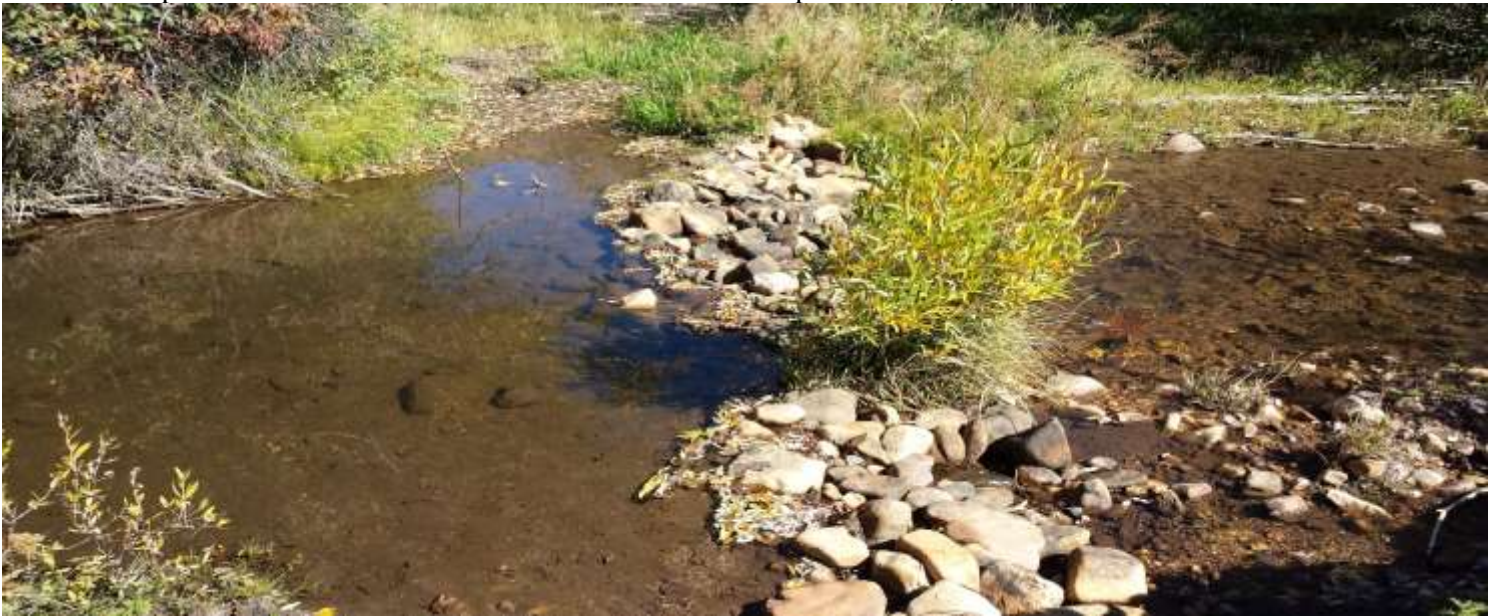
Photo 3-This photo shows an old rock diversion structure before implementation, SC Photos.

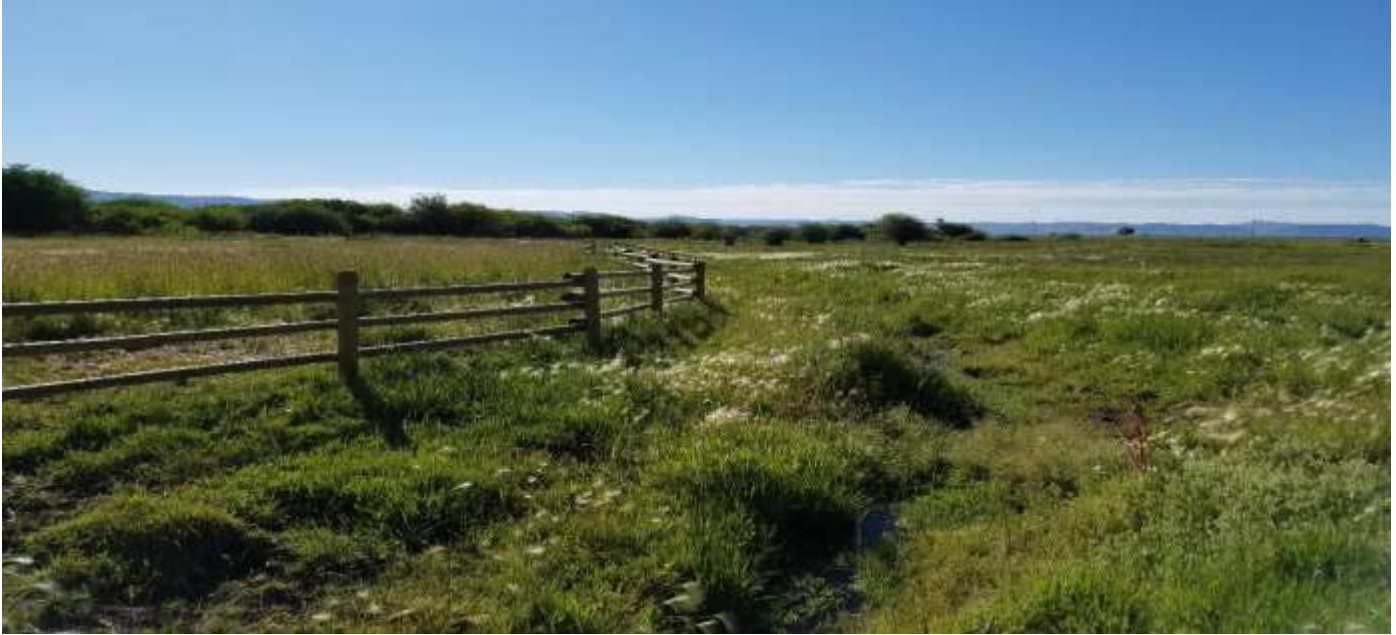
Photo 4. This Photo shows a newly installed riparian fence on an unnamed tributary to St. Charles Creek, SC Photos.

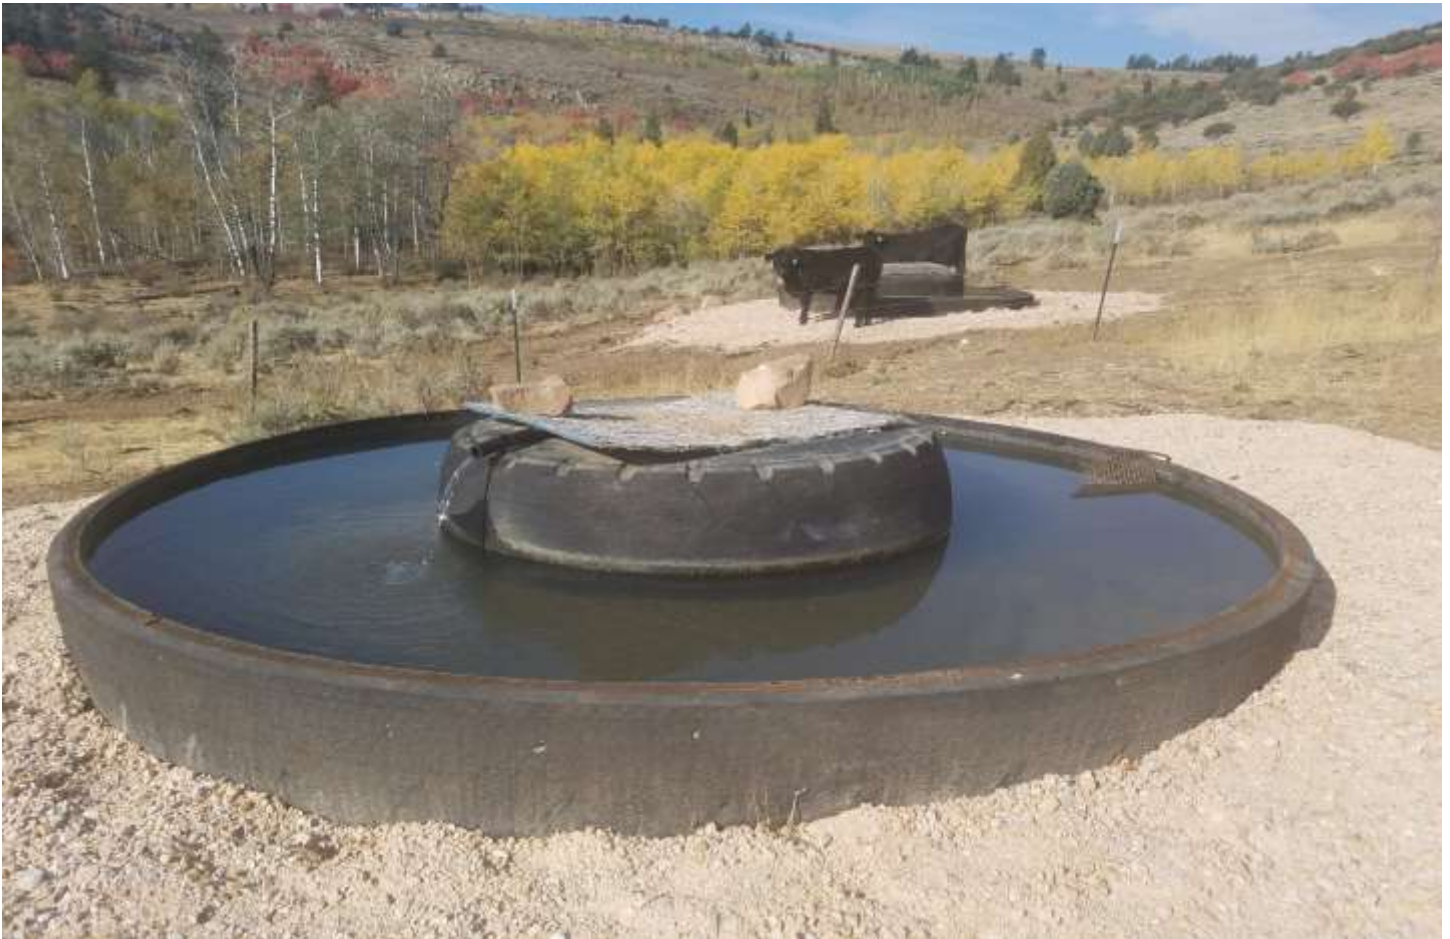
Photo 5. Two troughs installed to reduce livestock impacts to sensitive riparian area, SC Photos.

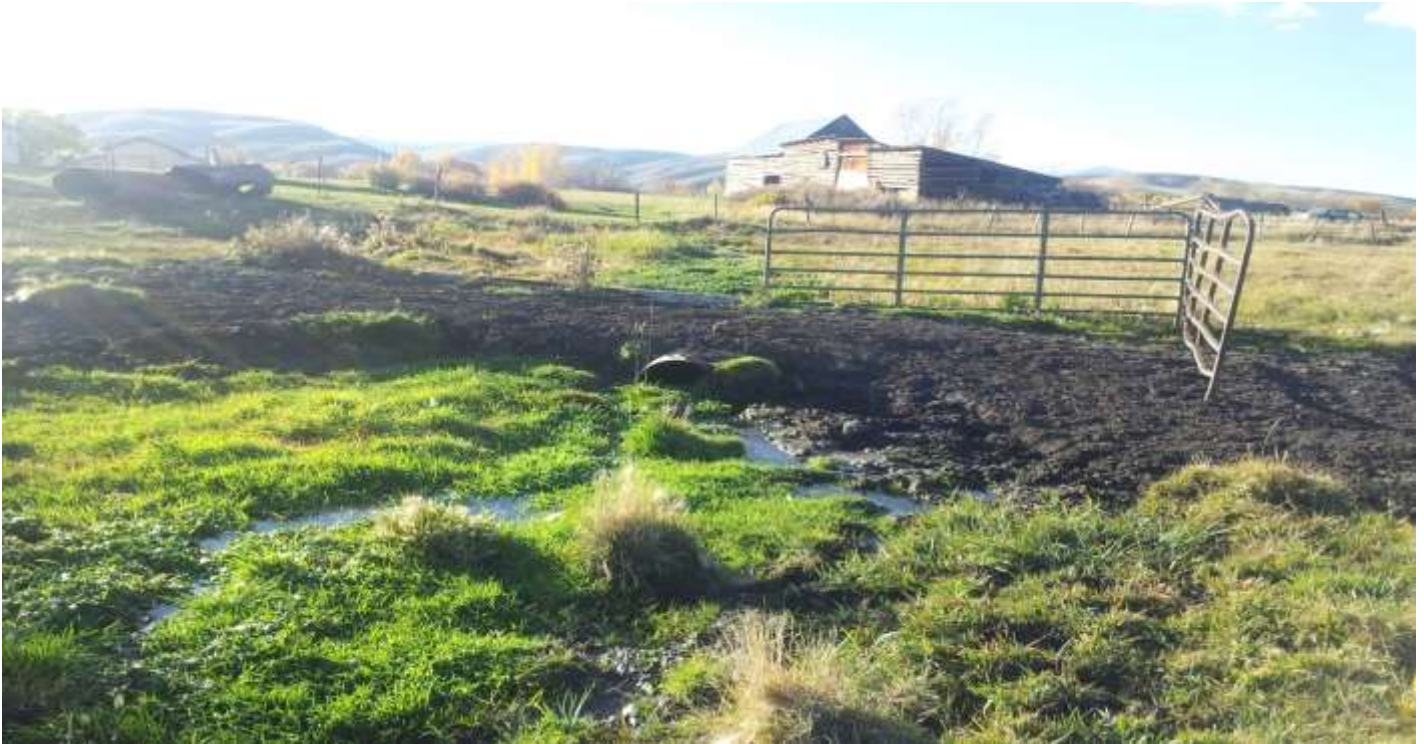
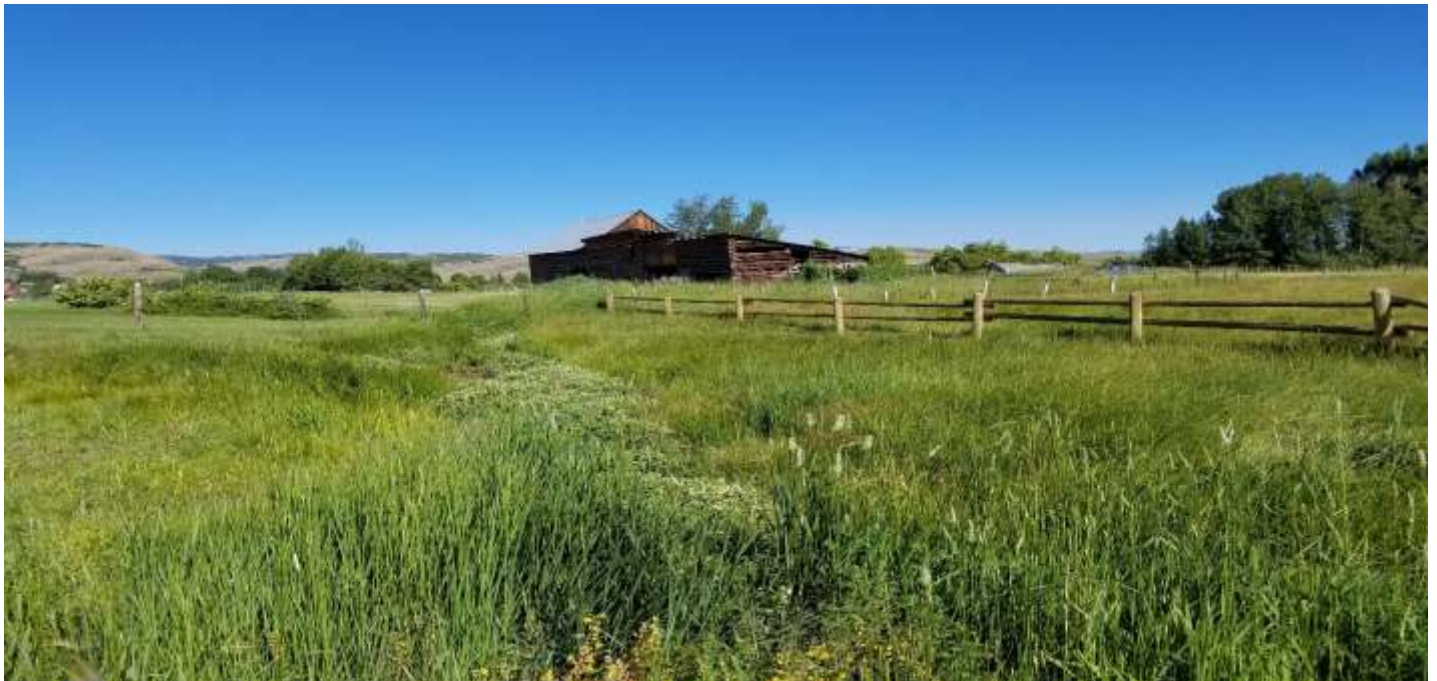
These photos show a the before and after of an unnamed tributary which was fenced to protect the sensitive riparian area. Above, is the stream before fence was installed and below is after the fence had been installed, SC Photos.

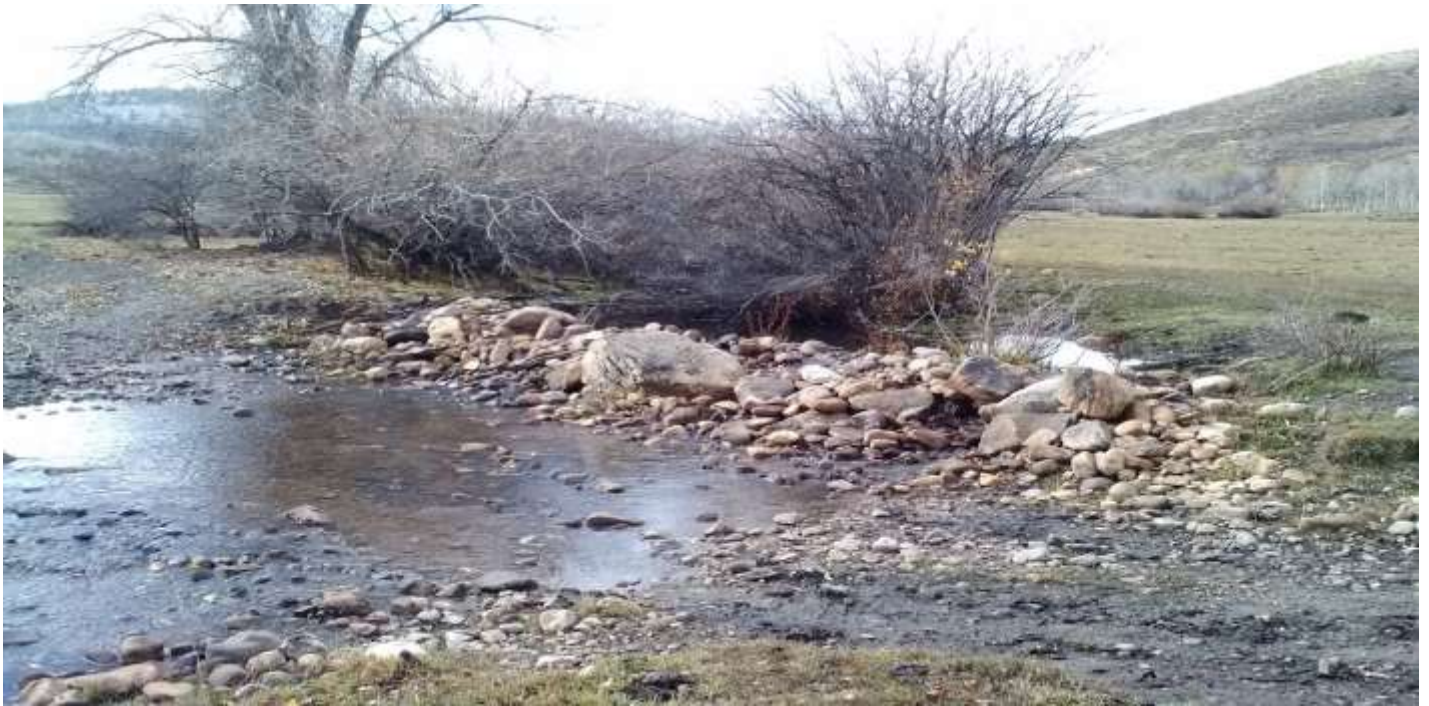
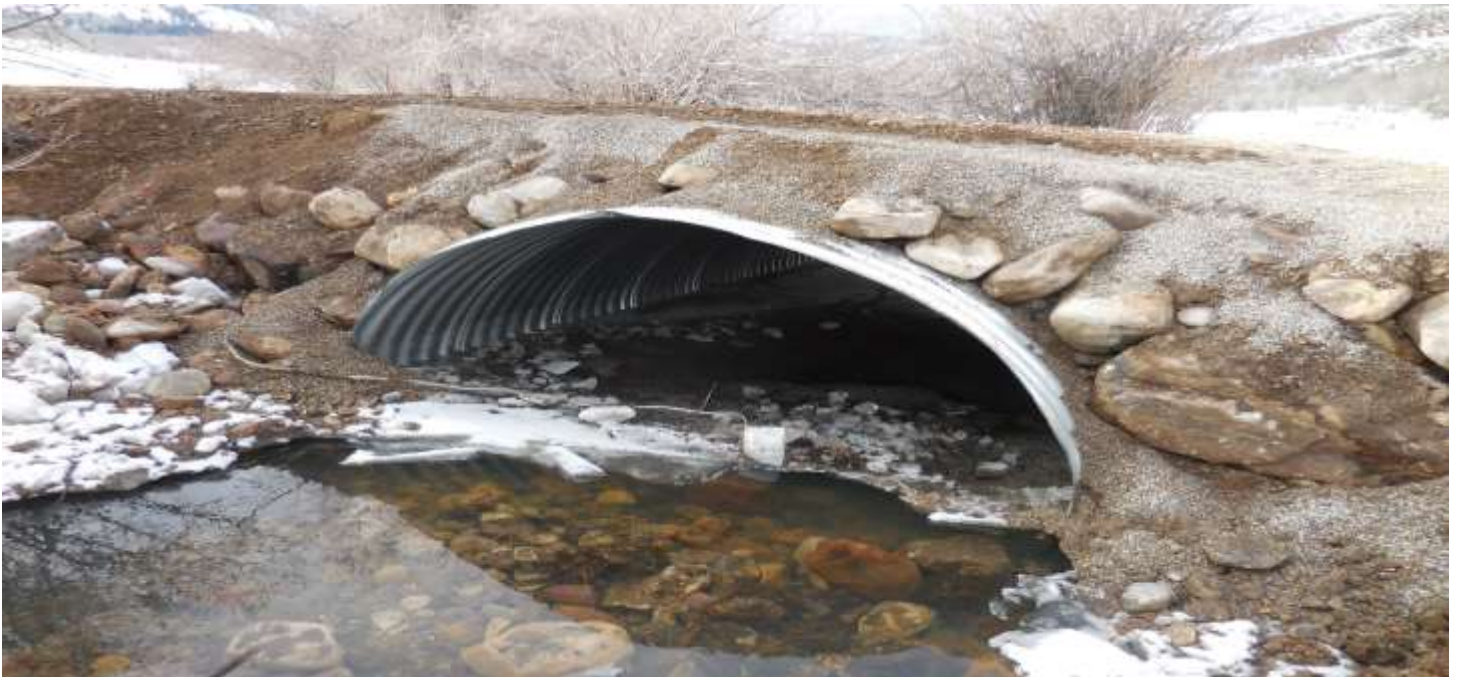
The above photo shows a crossing before implementation on Stauffer Creek. A rock diversion was made to allow vehicles to cross the creek. The photo below shows an oversized culvert installed to remove the rock barrier, and to provide a way to cross the stream without having to be in it, SC Photos.

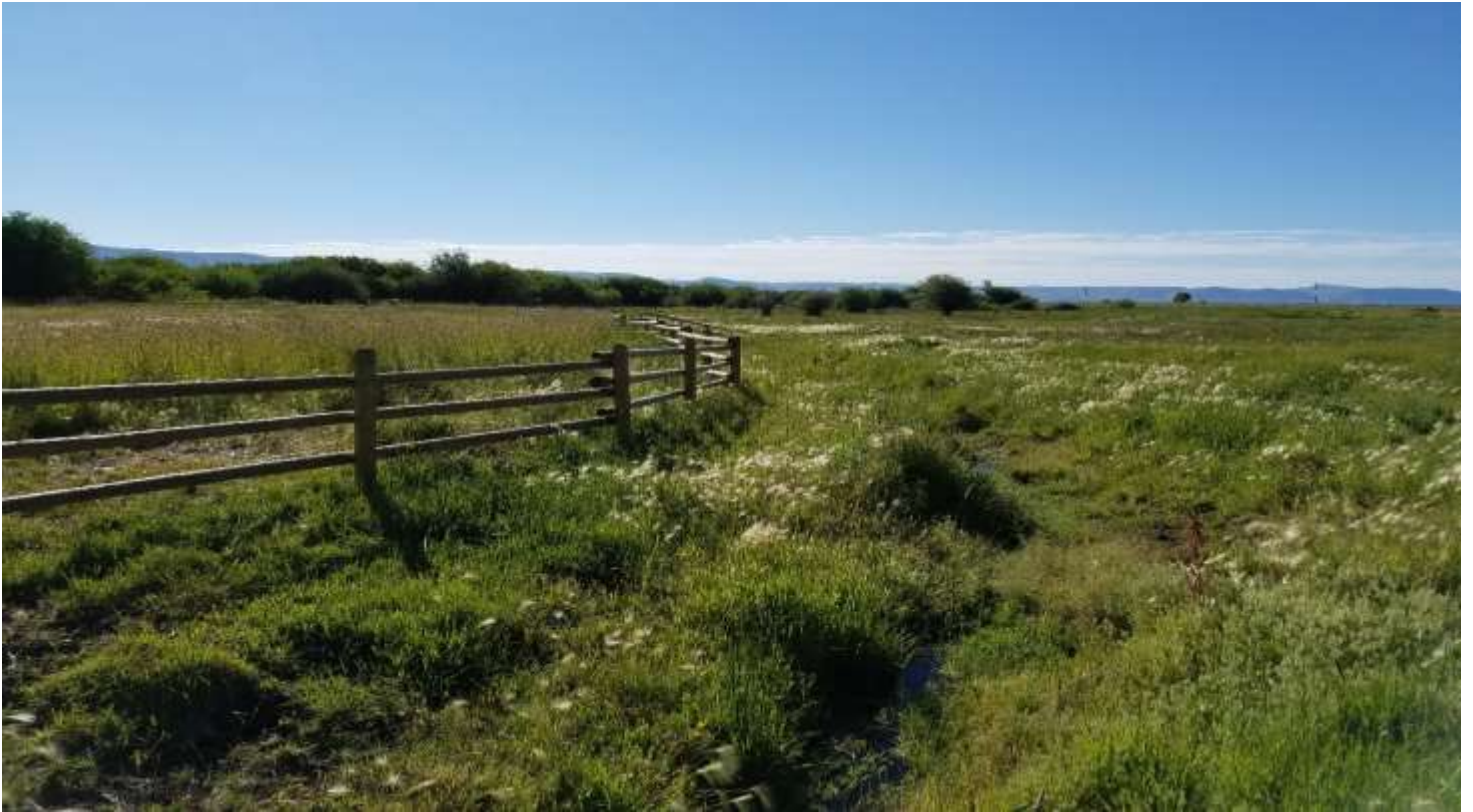
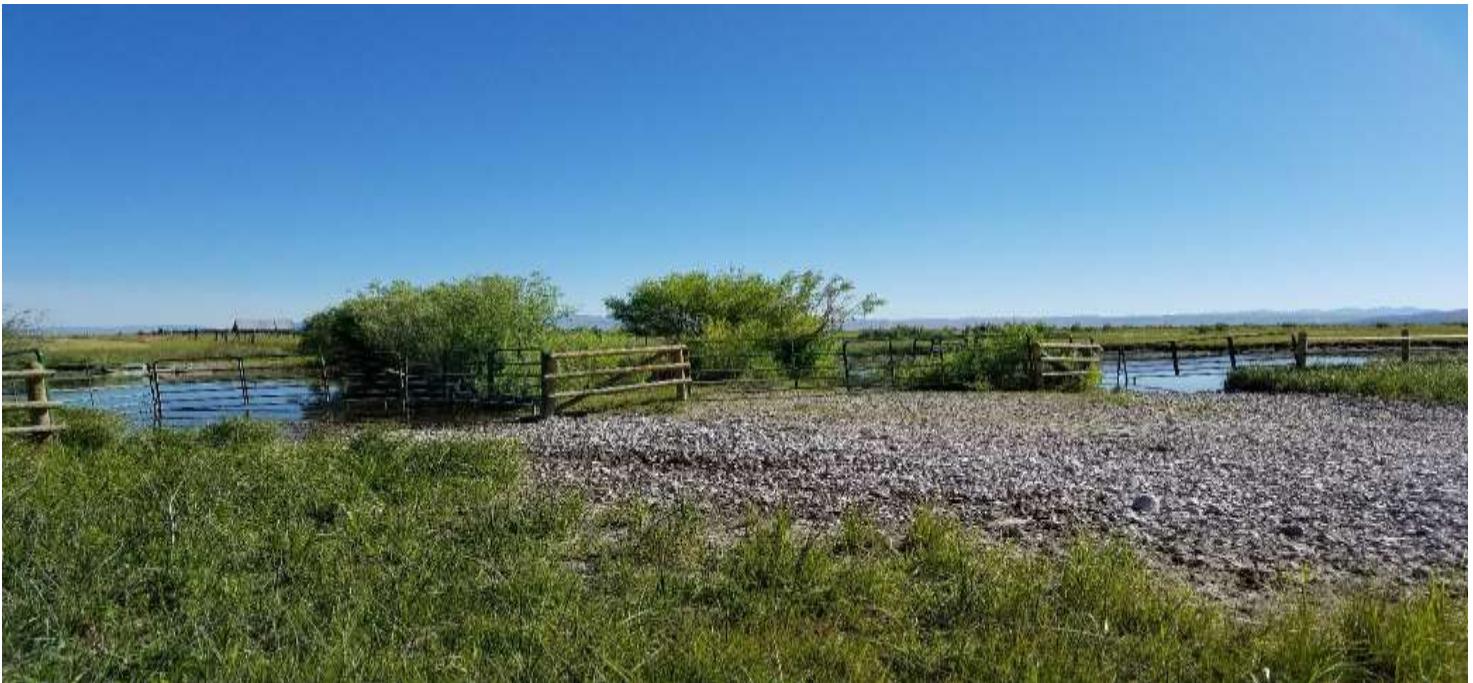
Both of these photos show riparian exclusion fences which were installed to reduce livestock impacts and protect streambank stability. The above photo shows an unnamed tributary to St. Charles Creek. The Lower photo shows the “big arm” of St. Charles Creek, SC Photos.

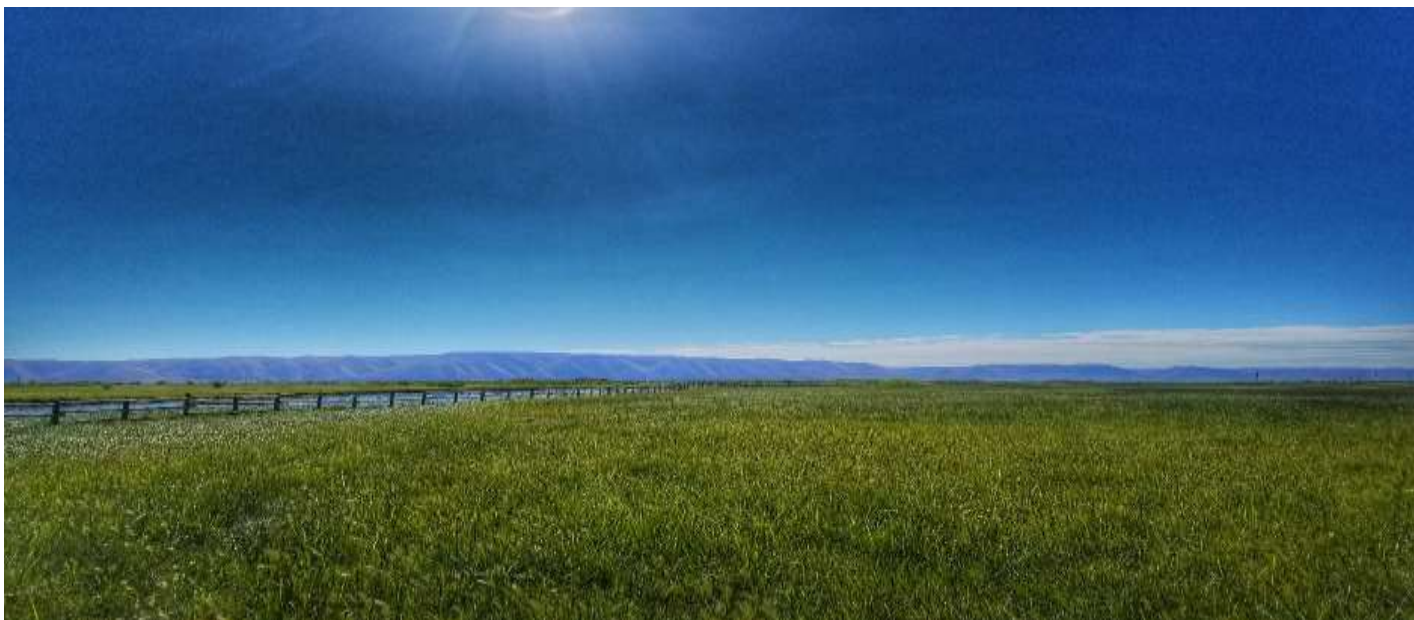
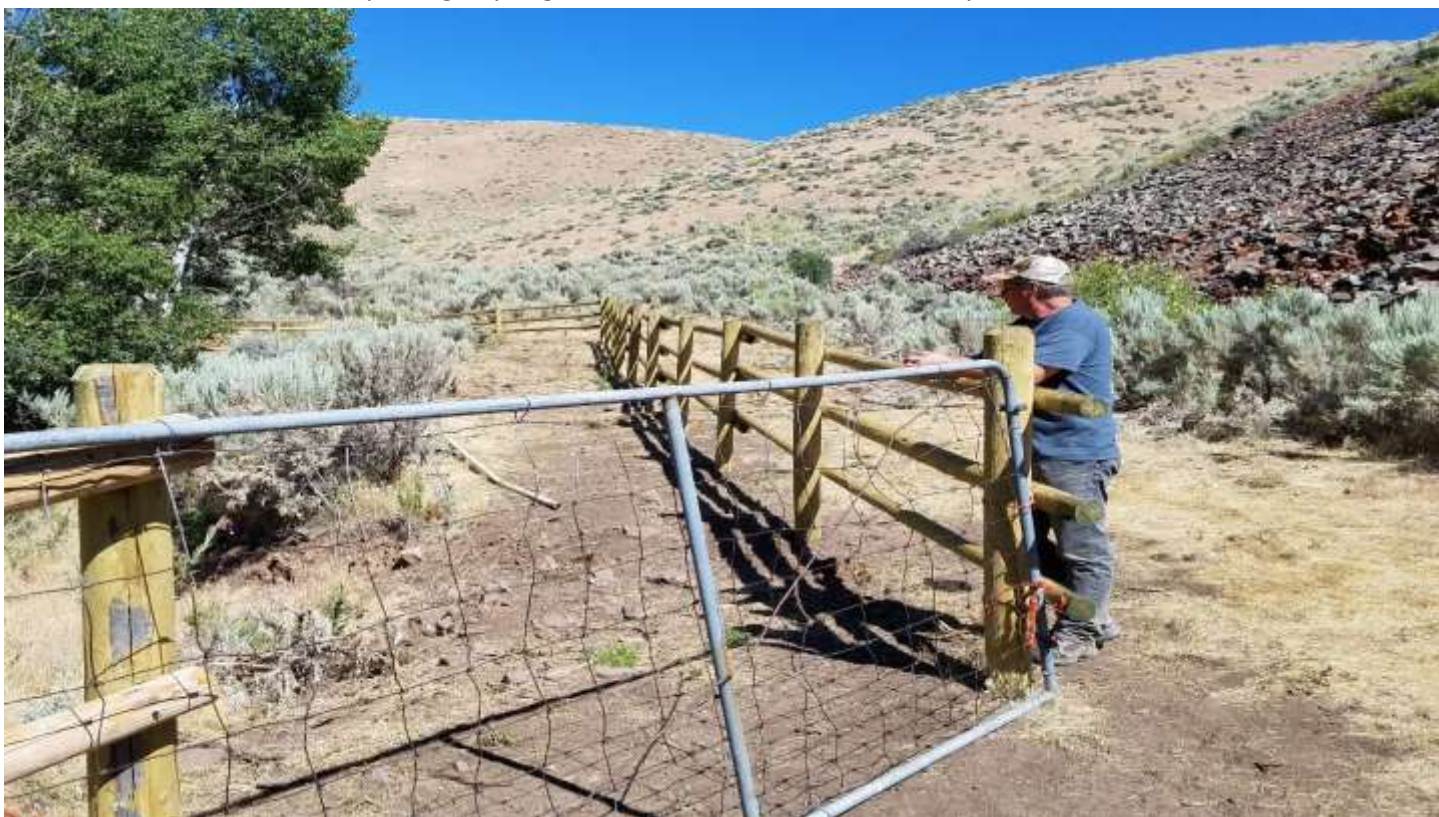
The above photo shows more of the installed riparian fence along the “big arm” of St. Charles Creek. The lower photo shows Steven Smith (IDEQ) inspecting a spring exclusion on an unnamed tributary to the Bear River, SC Photos.

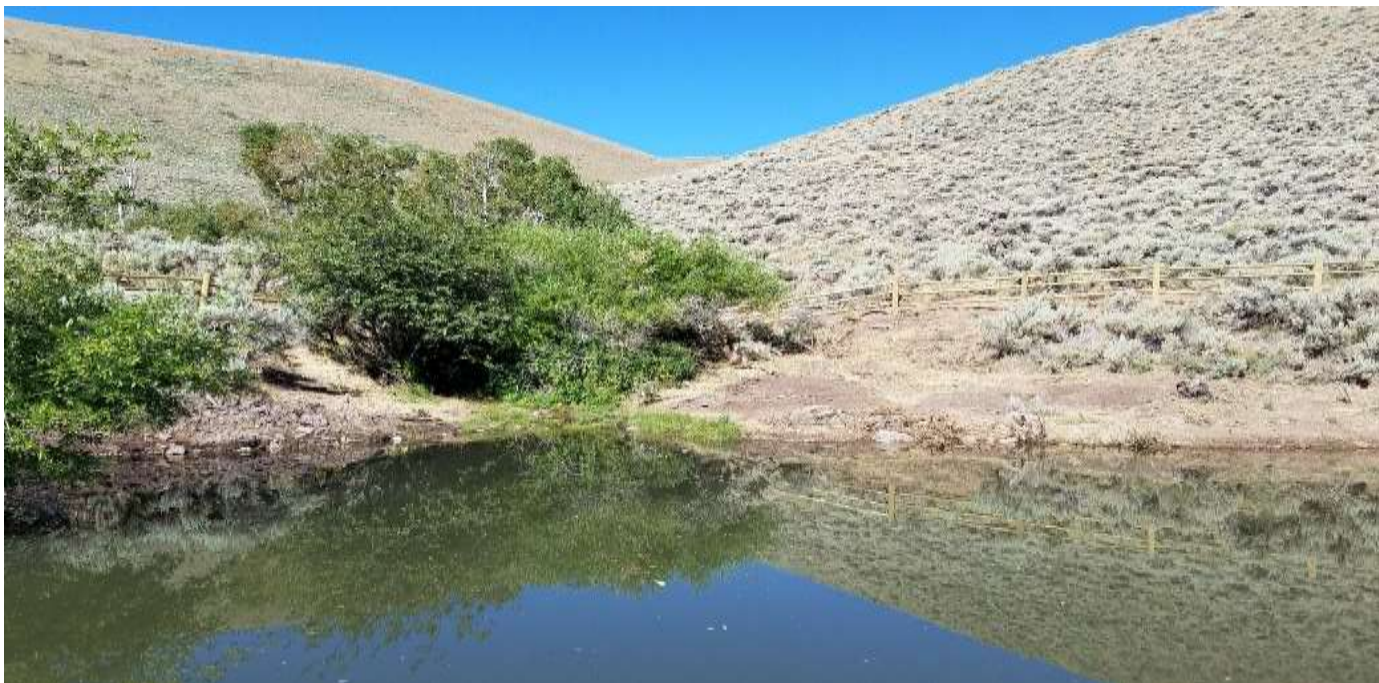
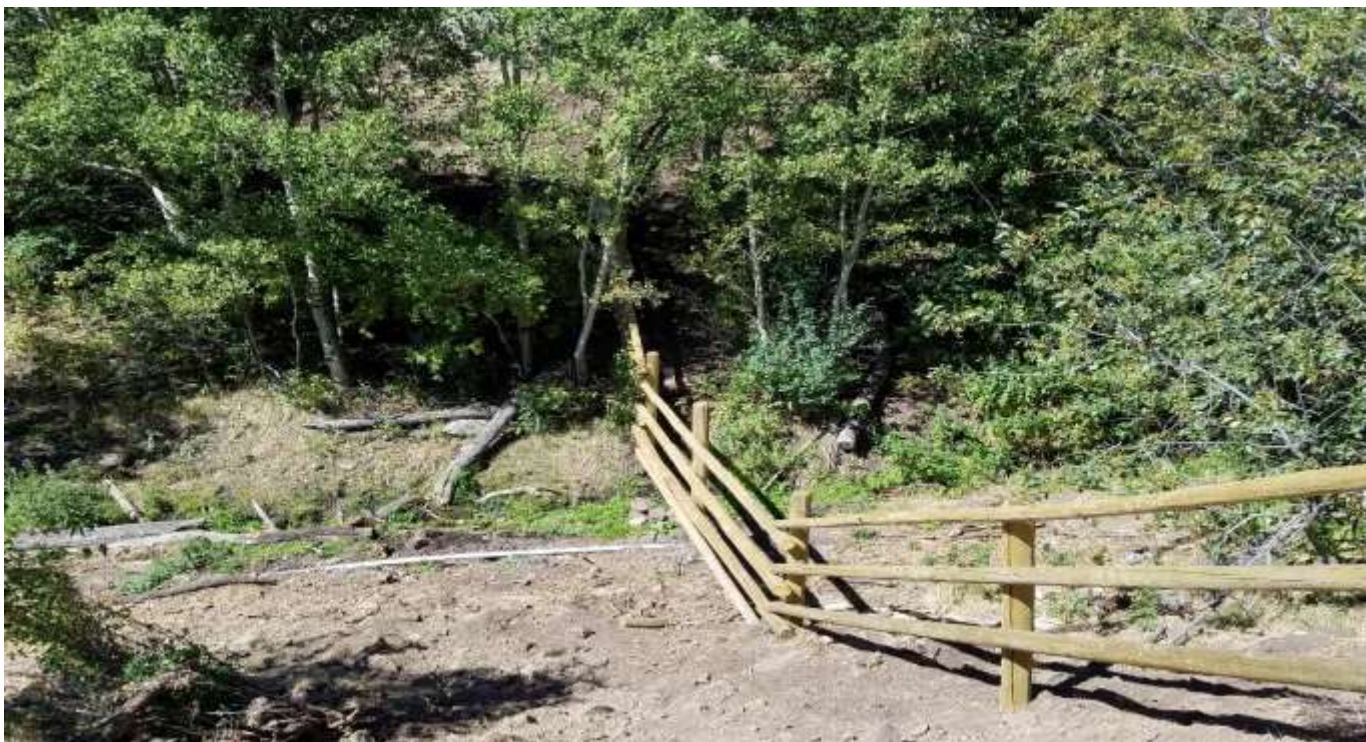
Both photos on this page show a large spring which was fenced and excluded to reduce livestock impacts. This spring is located in Peagram, and feeds an unnamed tributary to the Bear River, SC Photos.

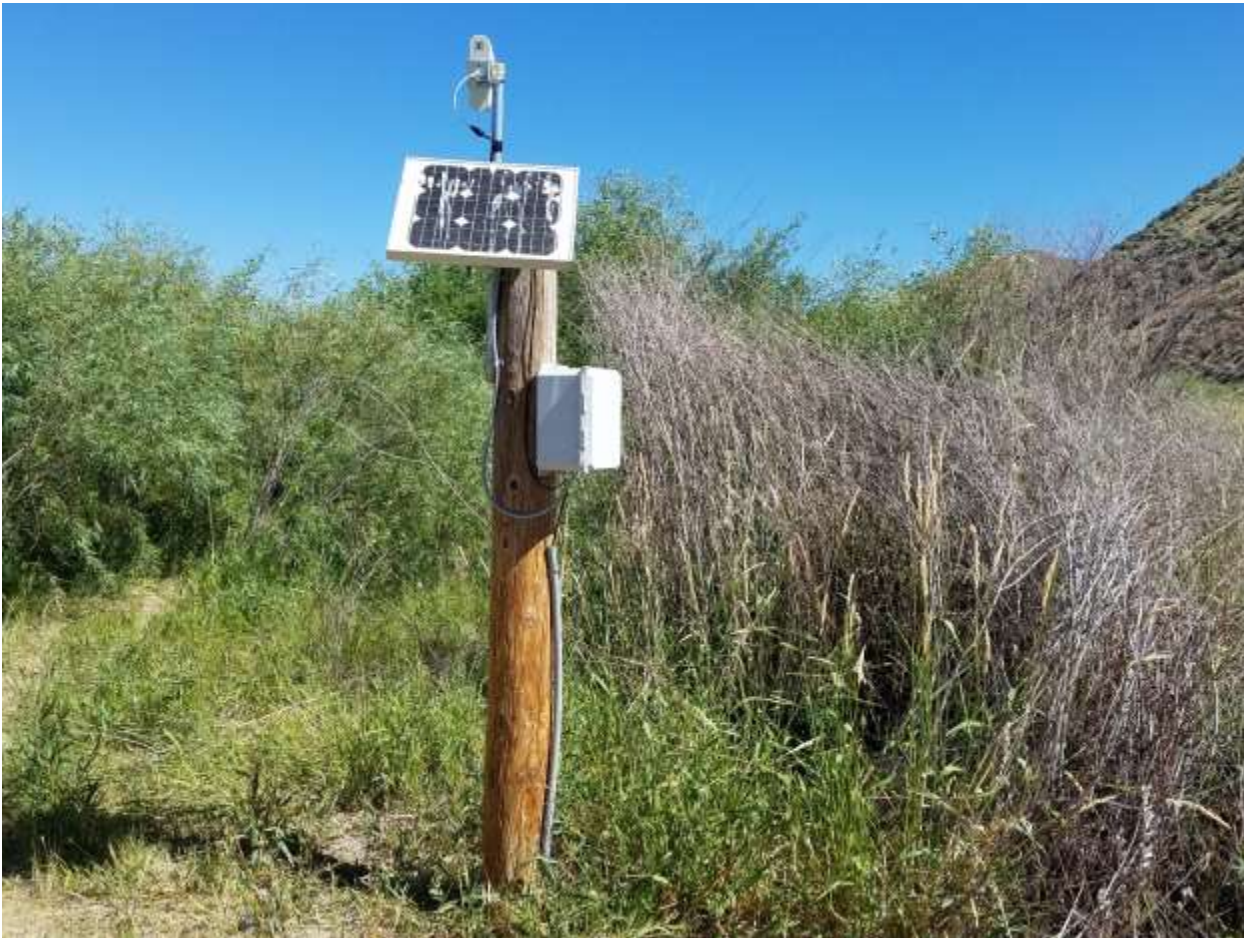
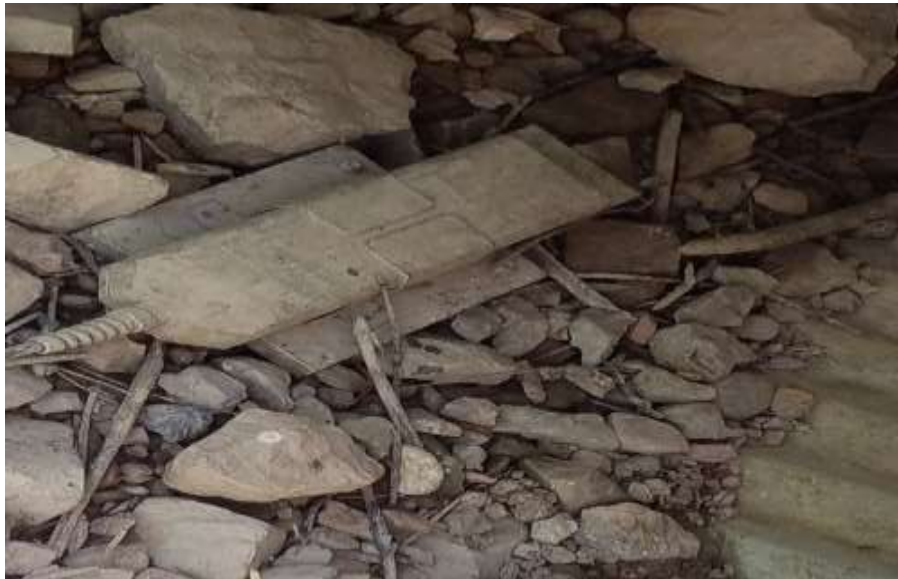
The photos on this page show the telemetry station which was installed in Pegram. This telemetry station is solar powered and provides up to the minute flow data to the landowner, helping to also ensure that the proper amount of water is being used in the irrigation canal. The lower photo shows the probe that sits in the bottom of the stream and sends information back to the computer mounted on the pole, SC Photos.

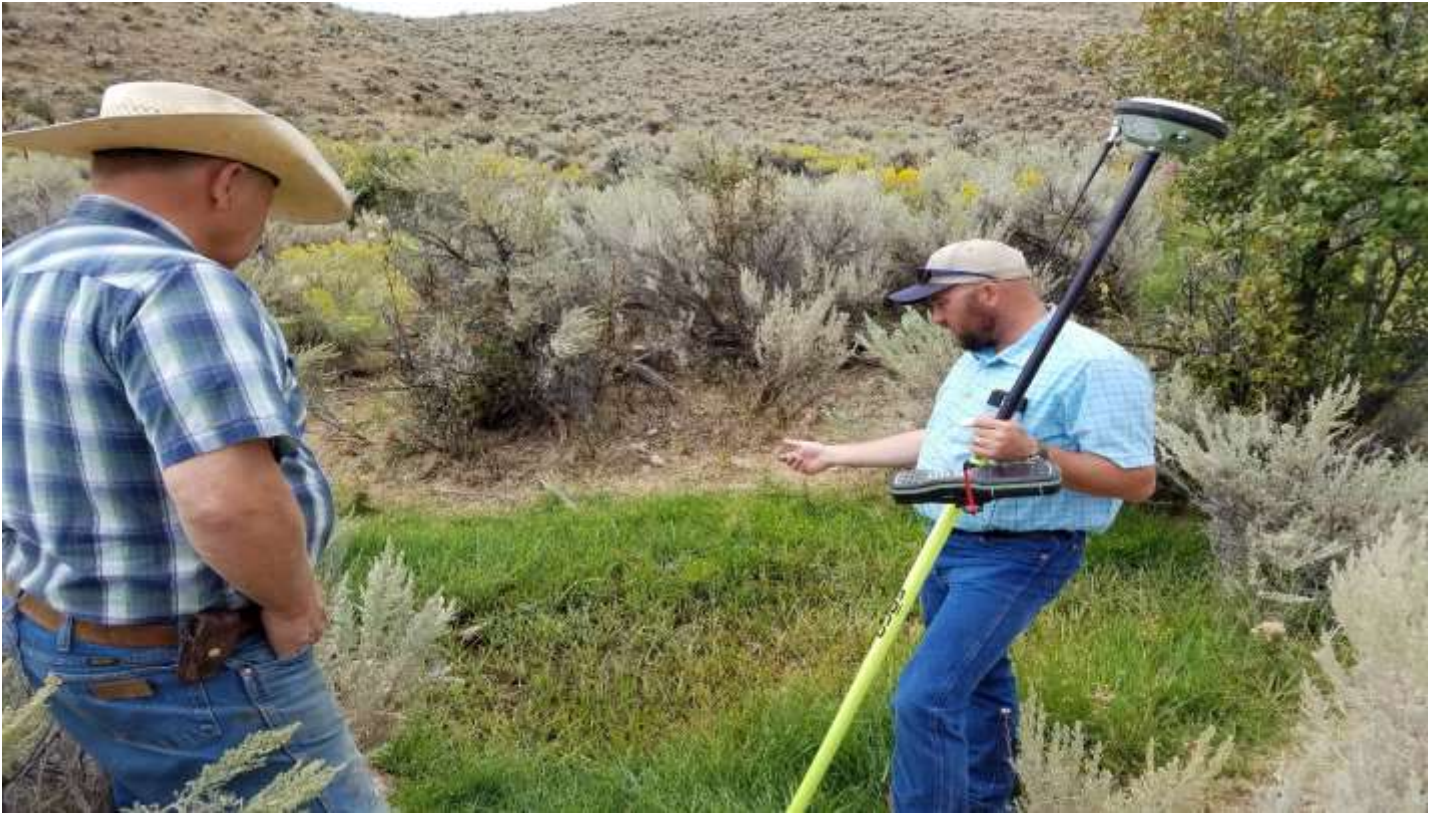
This photos shows ISWCC Engineer Allan Johnson discussing the route of a stockwater system, as we surveyed the elevations and topography to ensure the system would work properly after installation, SC Photos.

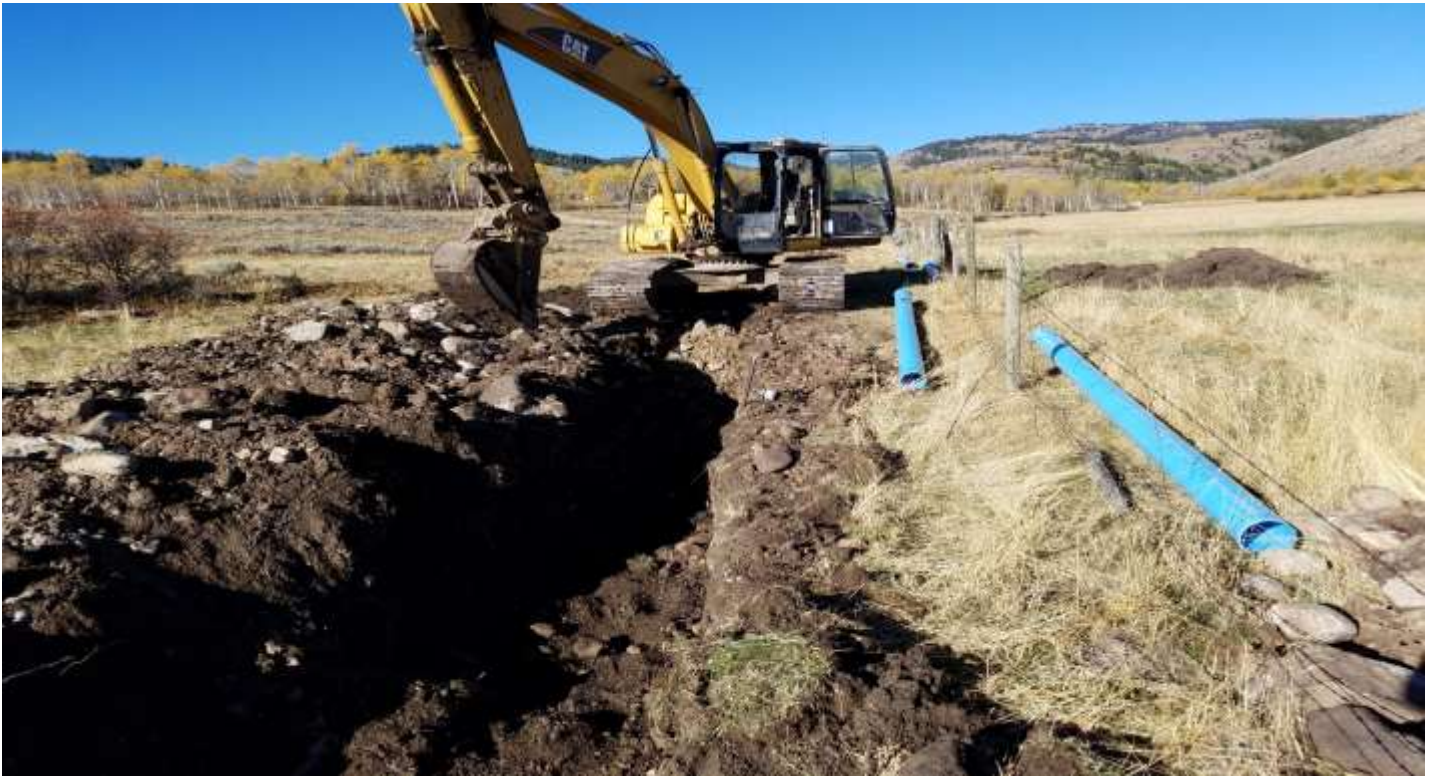
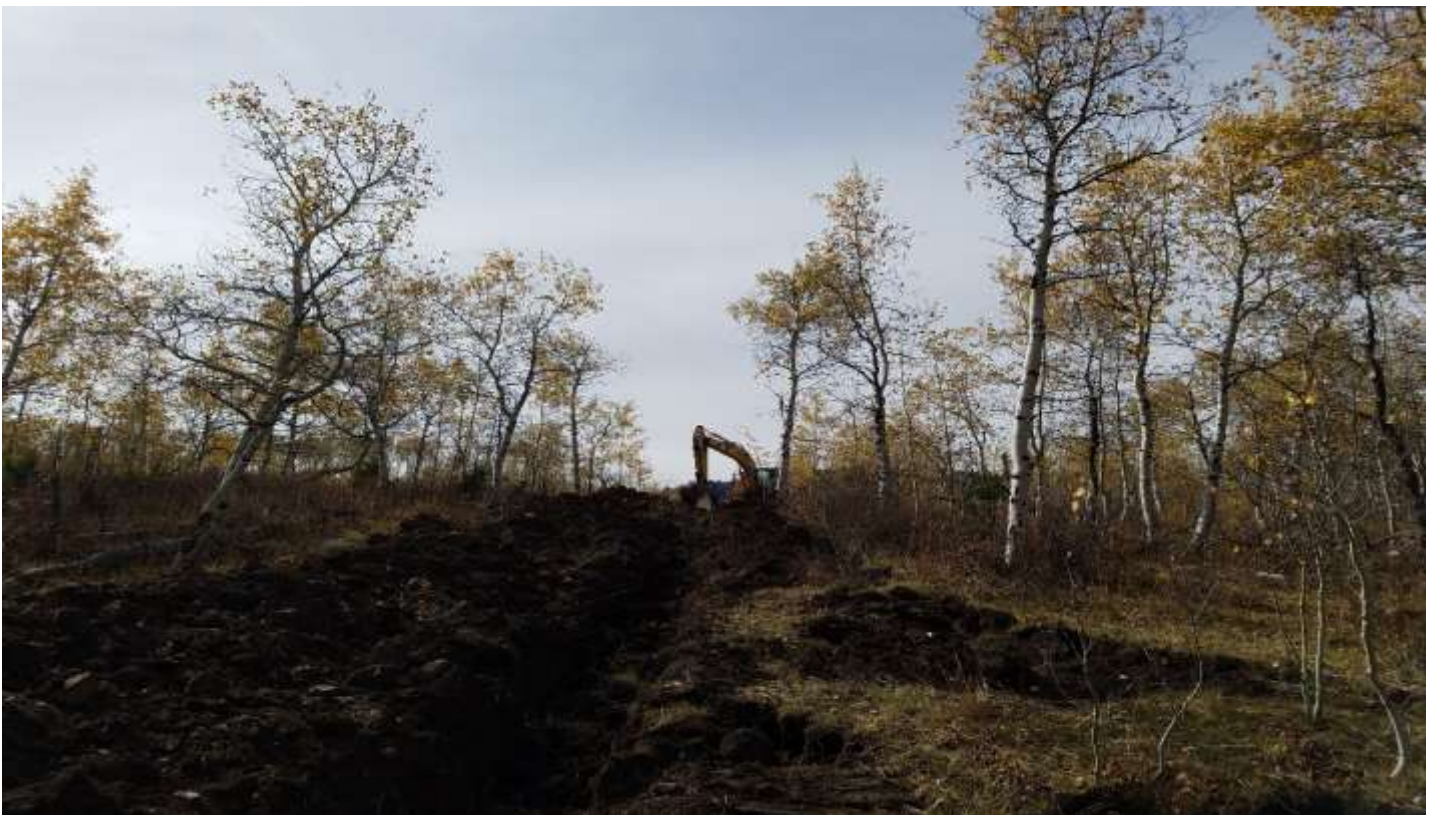
These photos show the installation of irrigation mainline which was installed adjacent to Stauffer Creek. This irrigation system upgrade was installed to reduce the need for flood irrigation and to prevent standing of migrating BCT, SC Photos.
