Stauffer Creek Project

DEQ NPS Sub-Grant S528

Final Report

December 2017

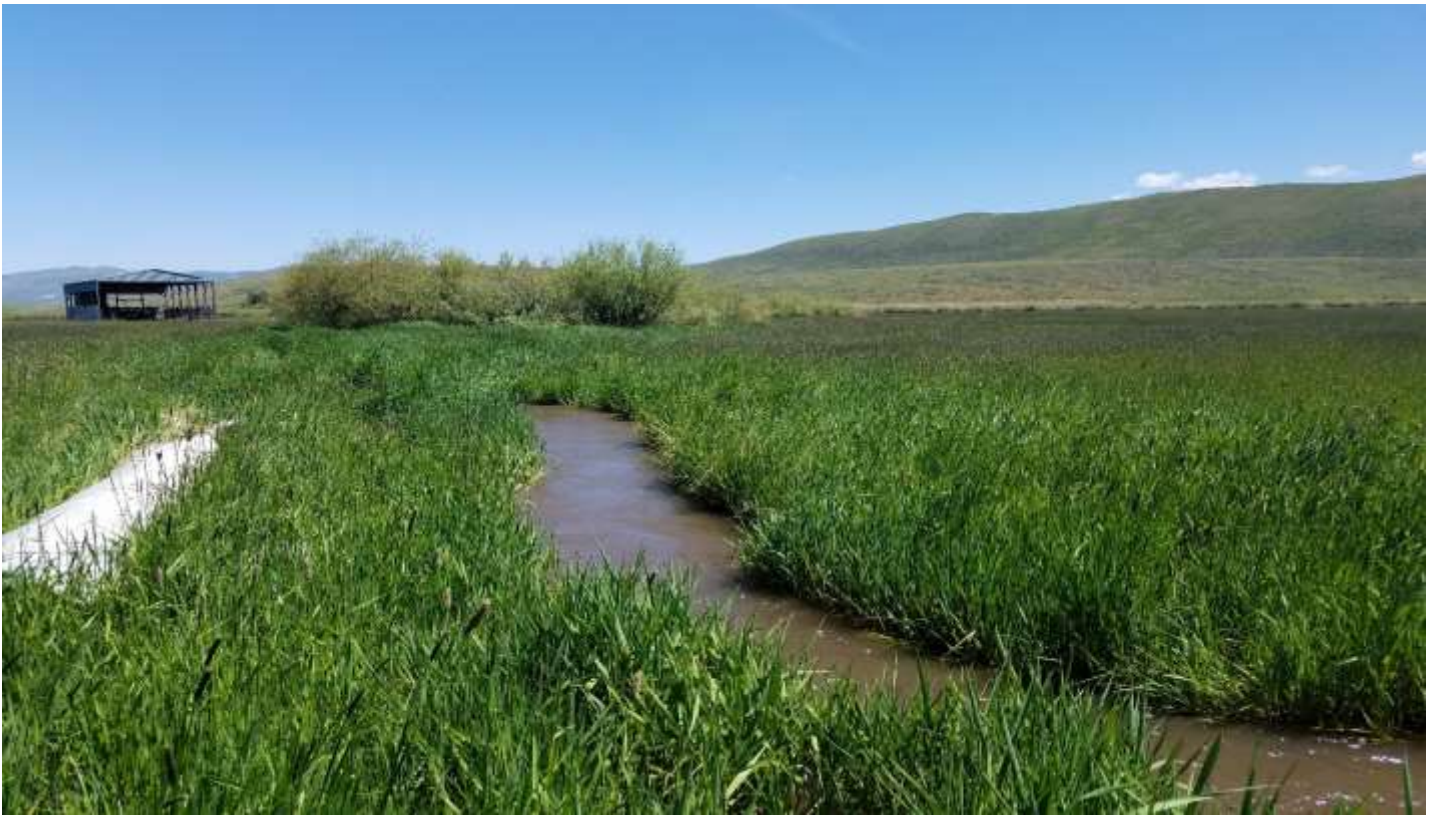
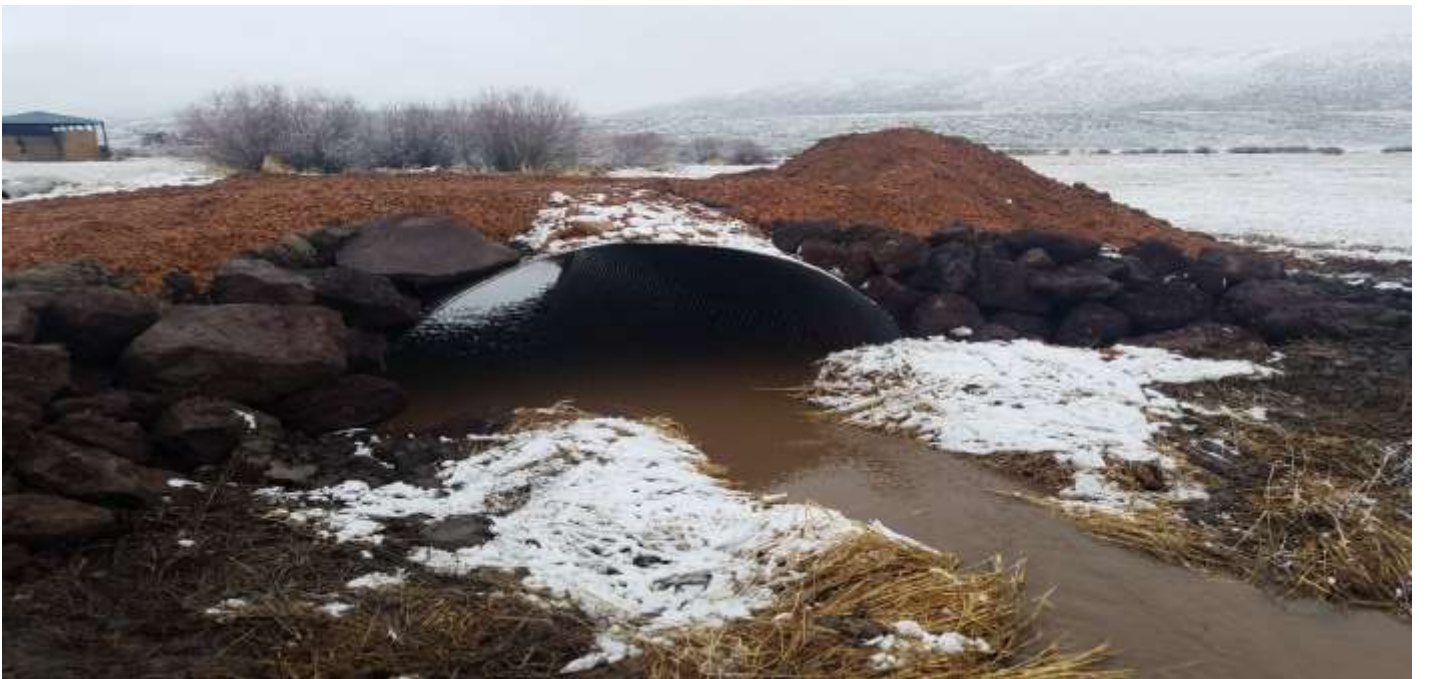
These two photos are the before and after of another stream crossing on Stauffer Creek. The historic culverts had washed out (one of two still pictured) and made it difficult for the landowner and for livestock to cross the stream. The lower photos shows the newly installed oversized culvert, which will provide access to the other side of the stream, and eliminate barriers to migrating BCT, SC Photos.

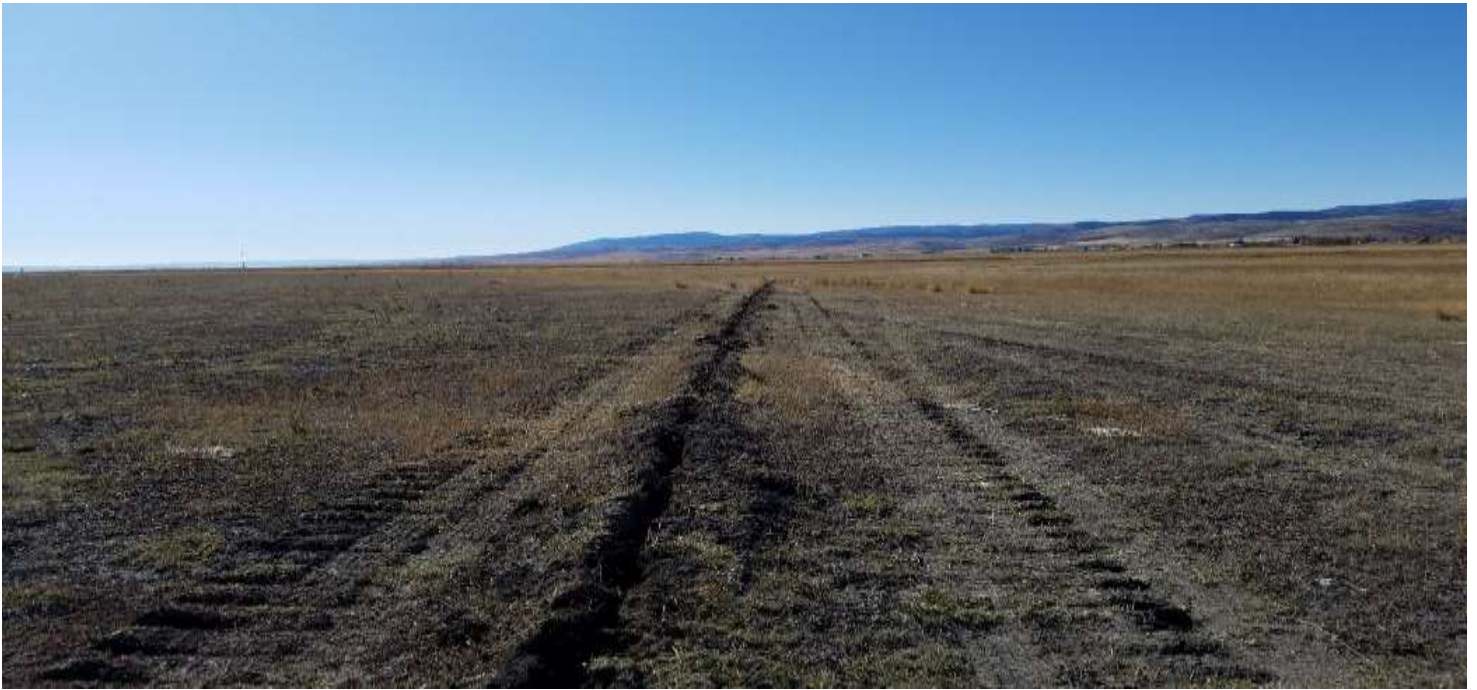
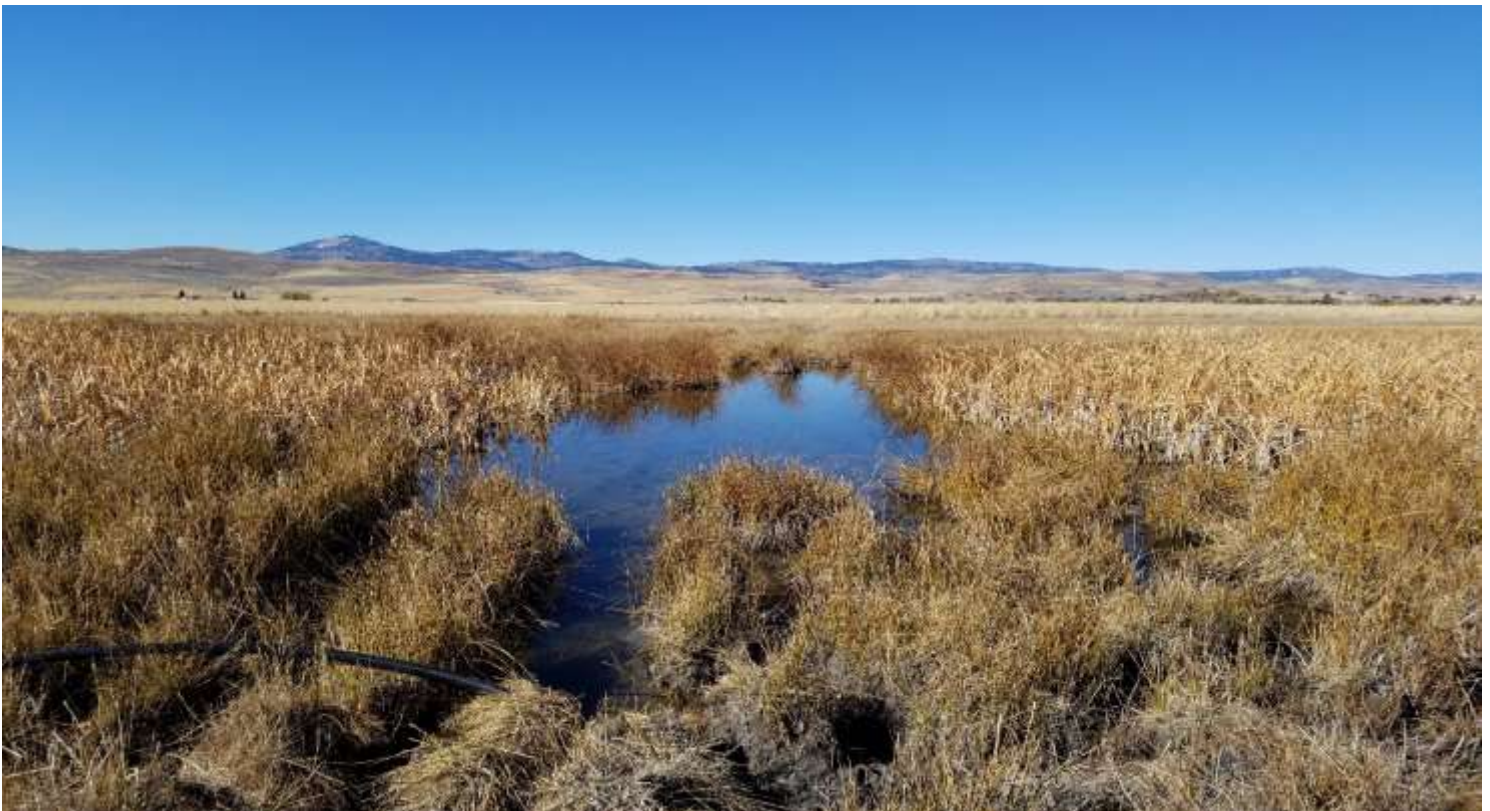
The above photos shows an installed stockwater line which was ripped in by a large bulldozer to provide water for livestock from a sump well installed near the Paris Slough pictured below, SC Photos.

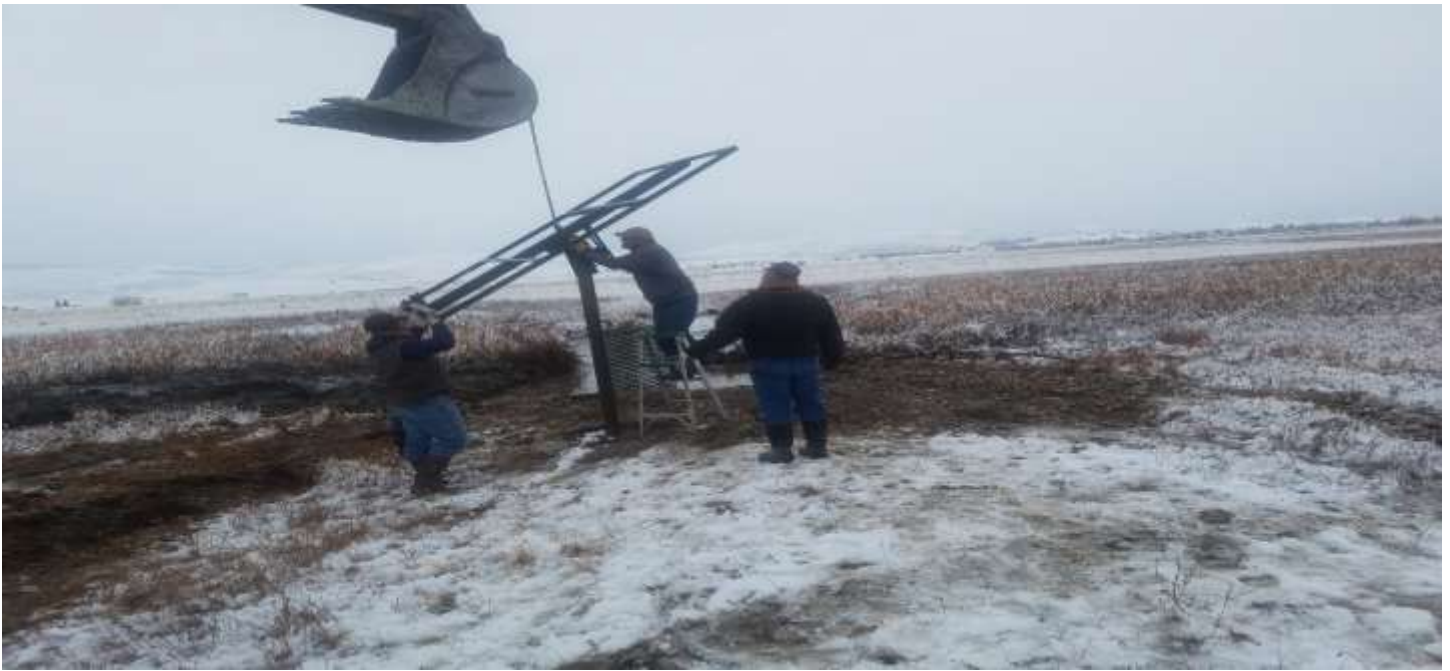
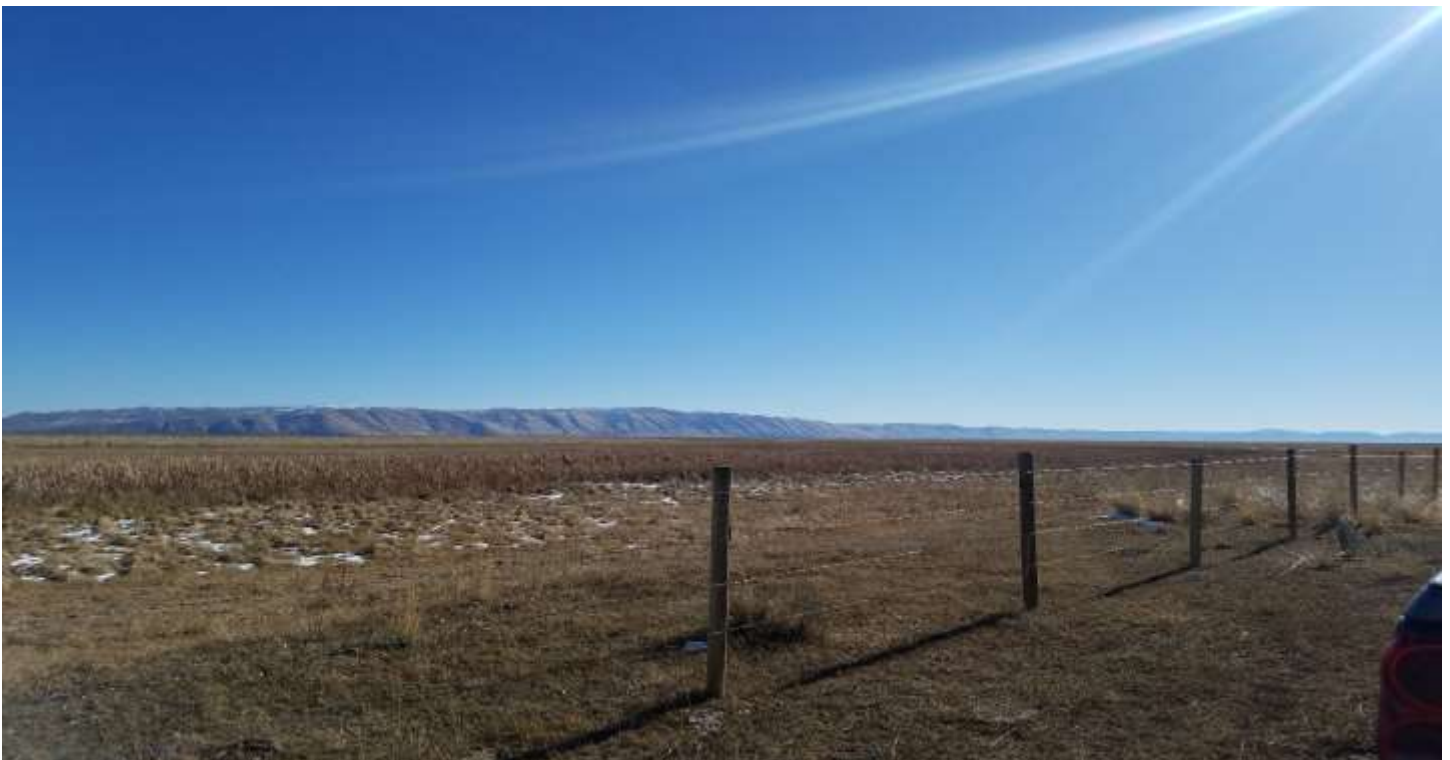
The above photos show the installation of the solar array, which will power the pump providing water to livestock. This arm of Paris Creek was completely fenced off, and a grazing management plan will be followed to improve riparian habitat and reduce livestock impacts. Three water troughs were installed as part of this project to provide off-stream water for livestock. The lower photo shows a portion of the newly installed barbed wire exclosure fence, SC Photos.

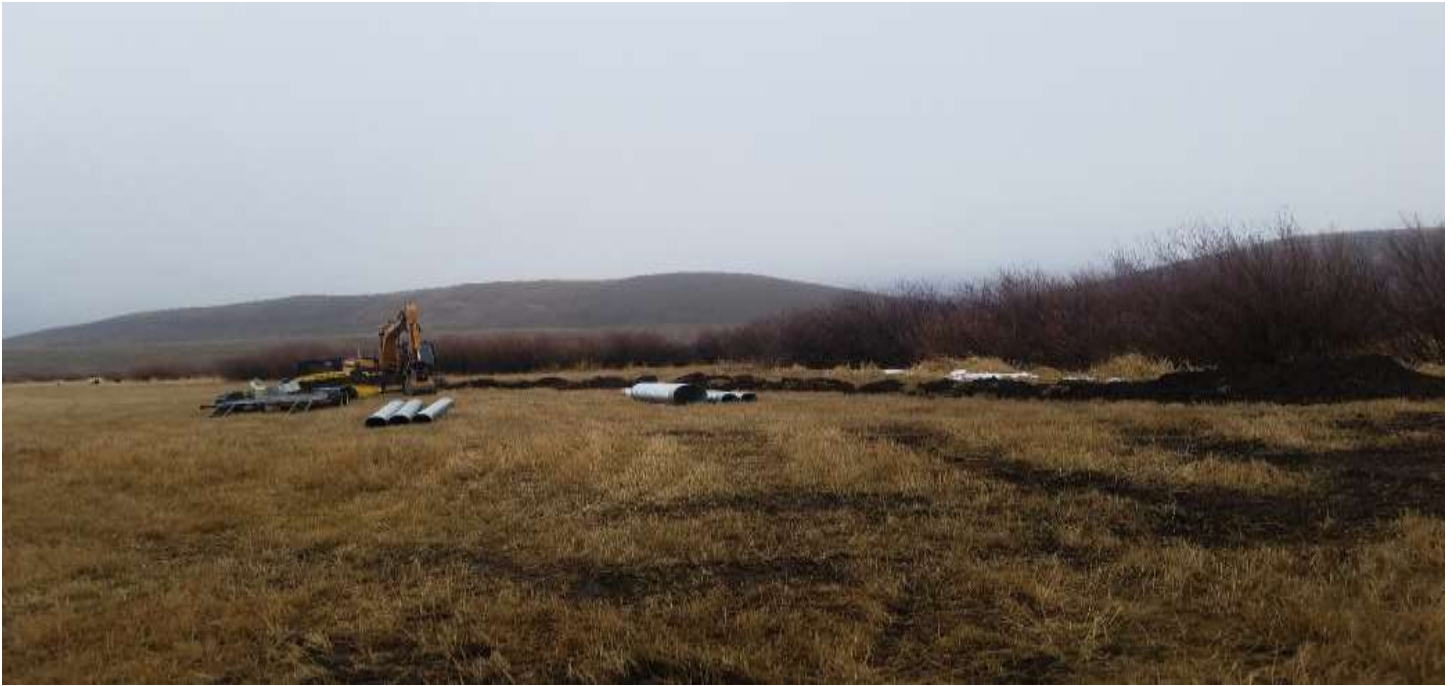
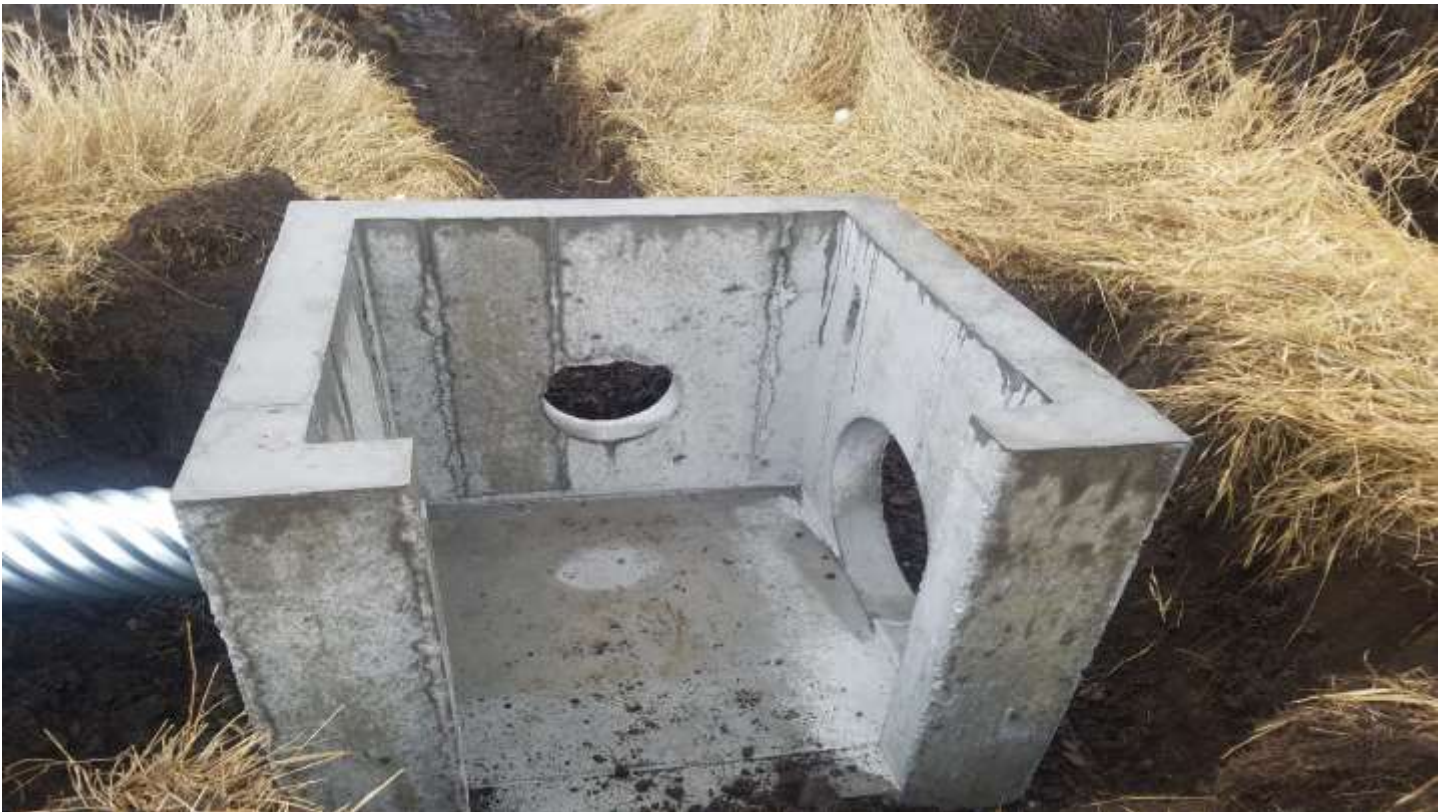
The Above photo shows the installation of the diversion box next to Stauffer Creek. The below photo shows the actual box structure which was installed. There are three holes in the box two, 12 inch holes for the irrigation water and one 21 inch whole which is the stream return and allows fish to passthrough the box as they travel up and down stream, SC Photos.

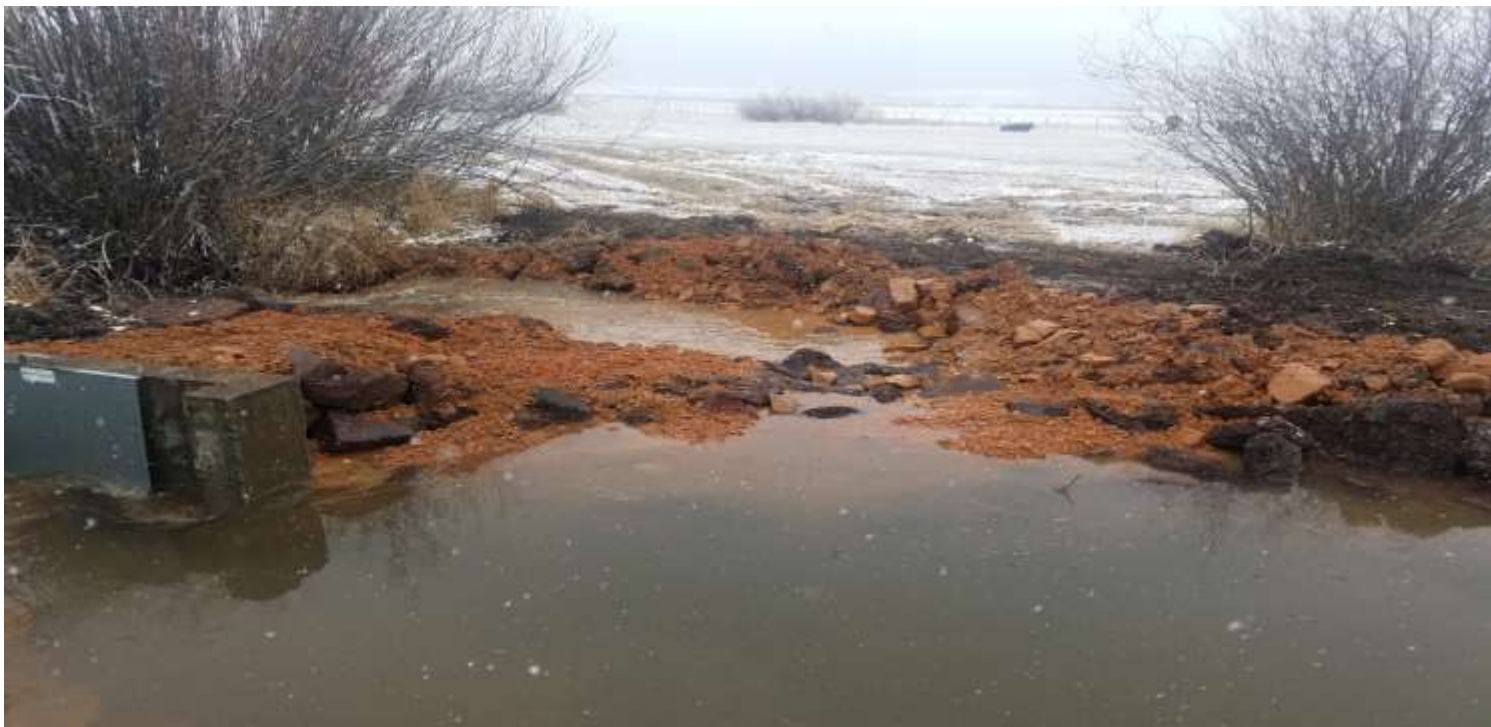
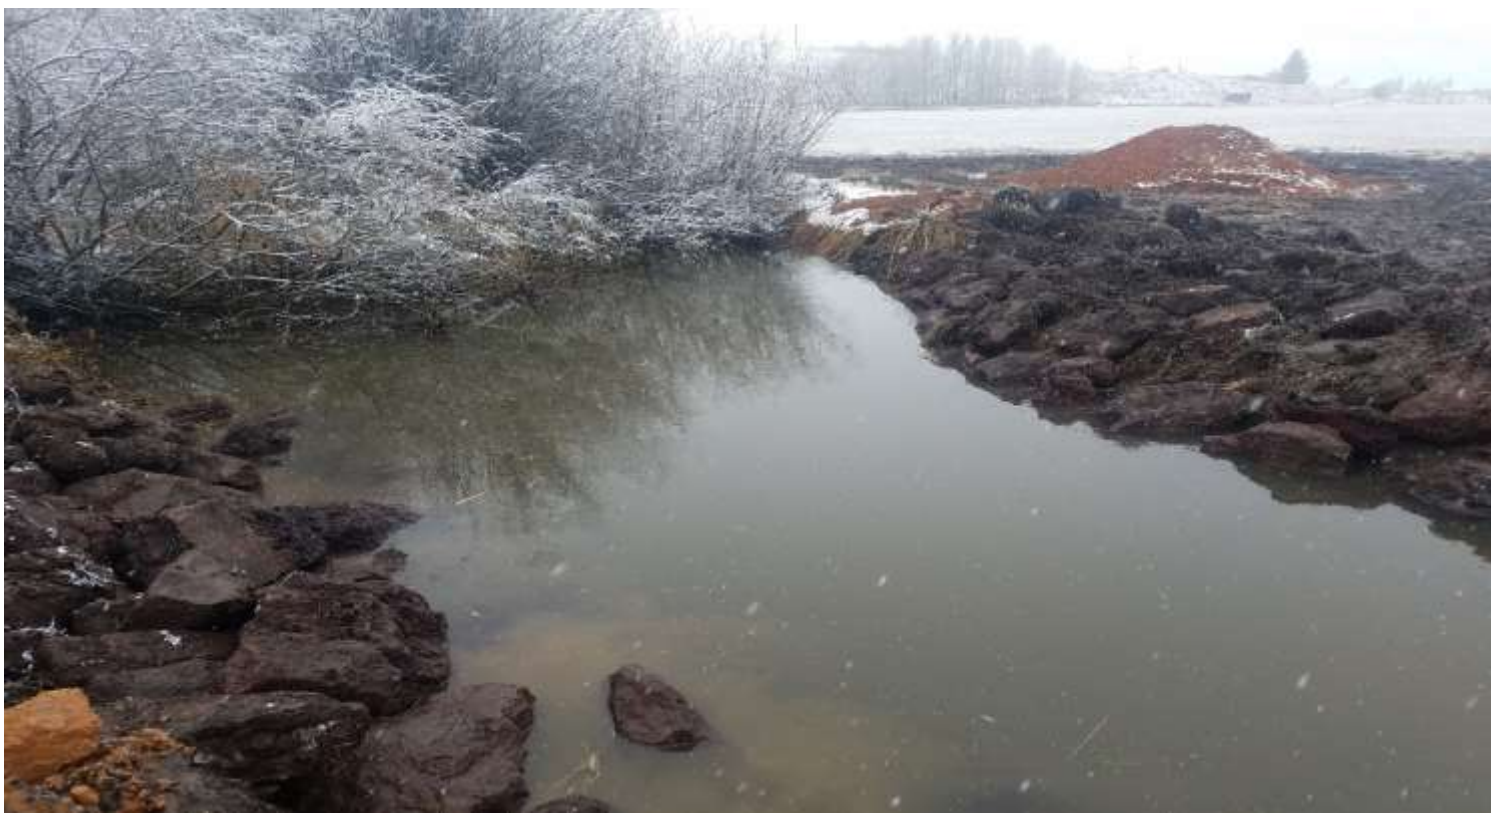
These two photos show how smaller gravels were filtered into the larger rocks for stability and for bank protection. Also, the smaller gravels provide excellent spawning beds for Bonneville Cutthroat Trout, SC Photos.

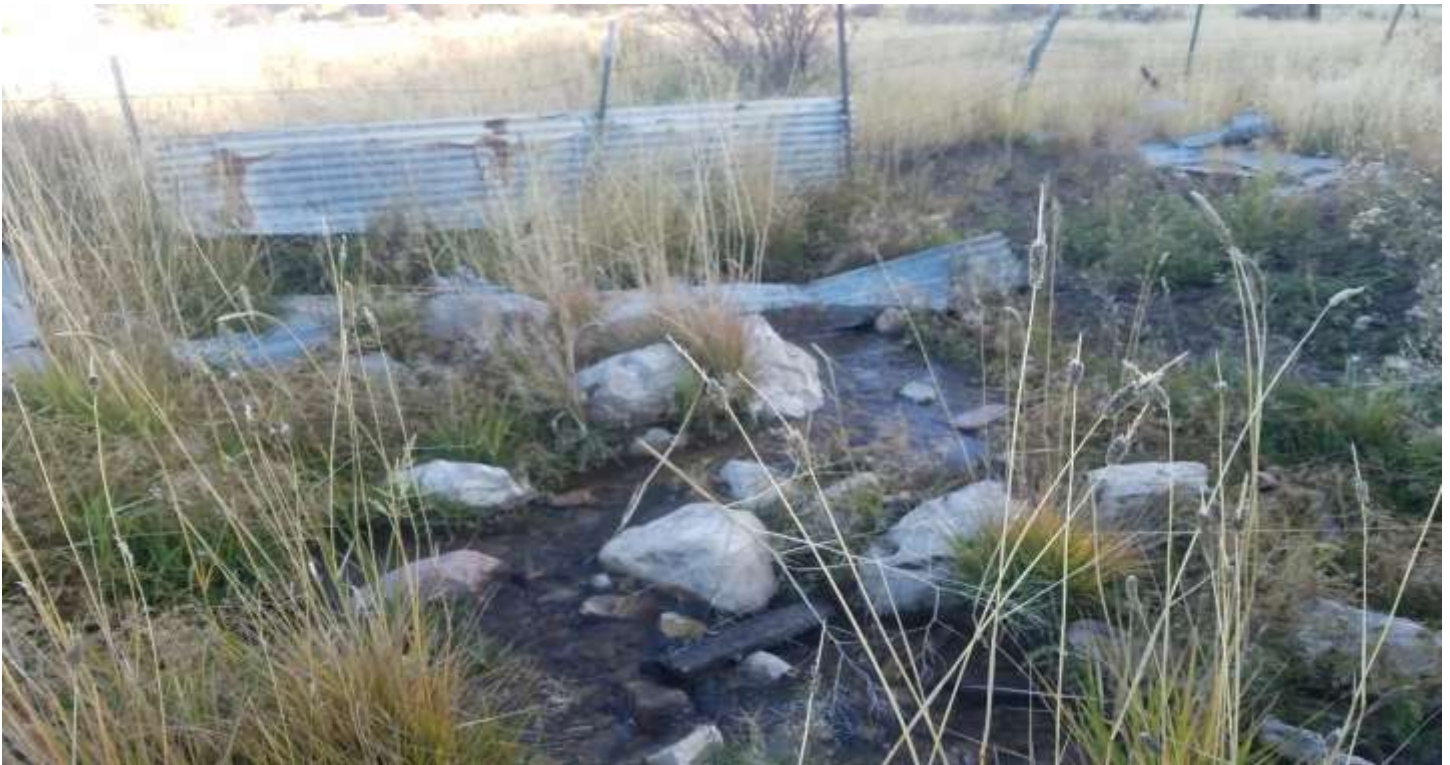
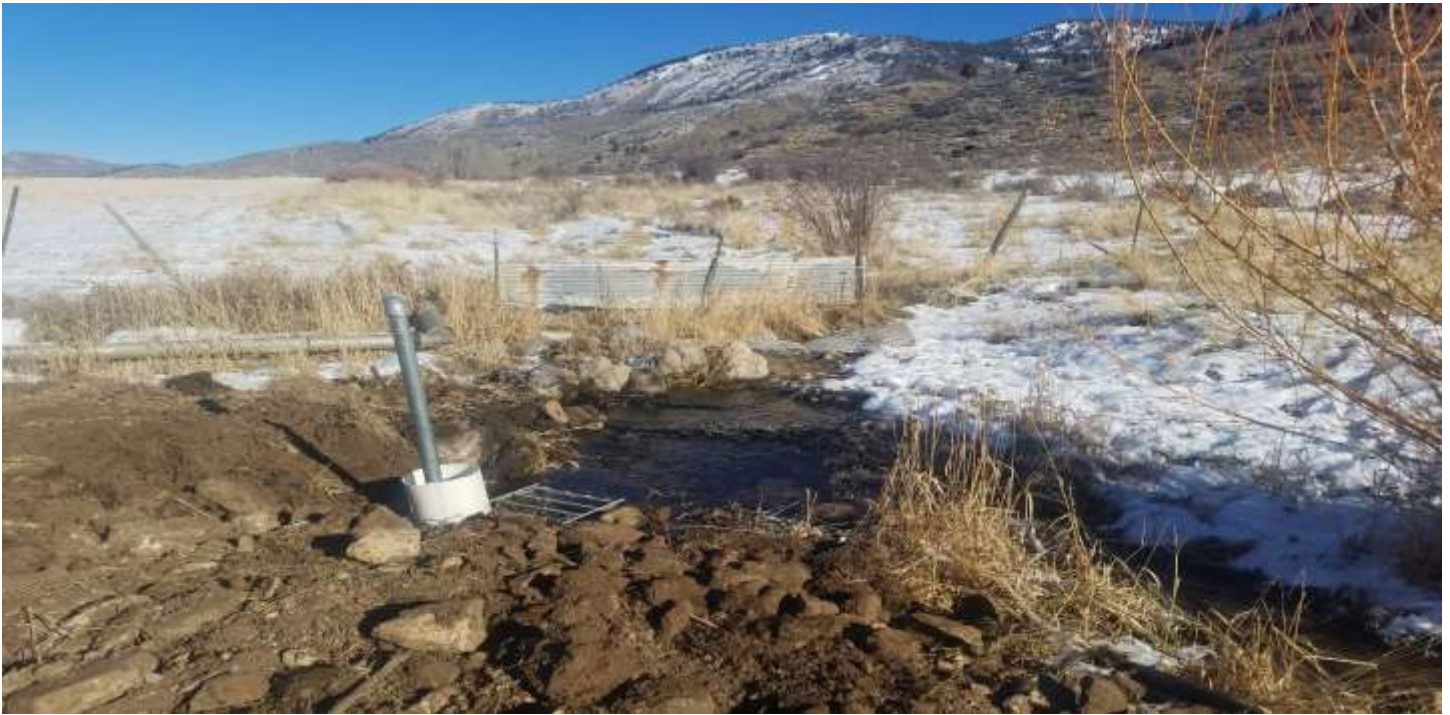
Above, is the area where a sump well was going to be installed. Below is after the sump well was installed, SC Photos.

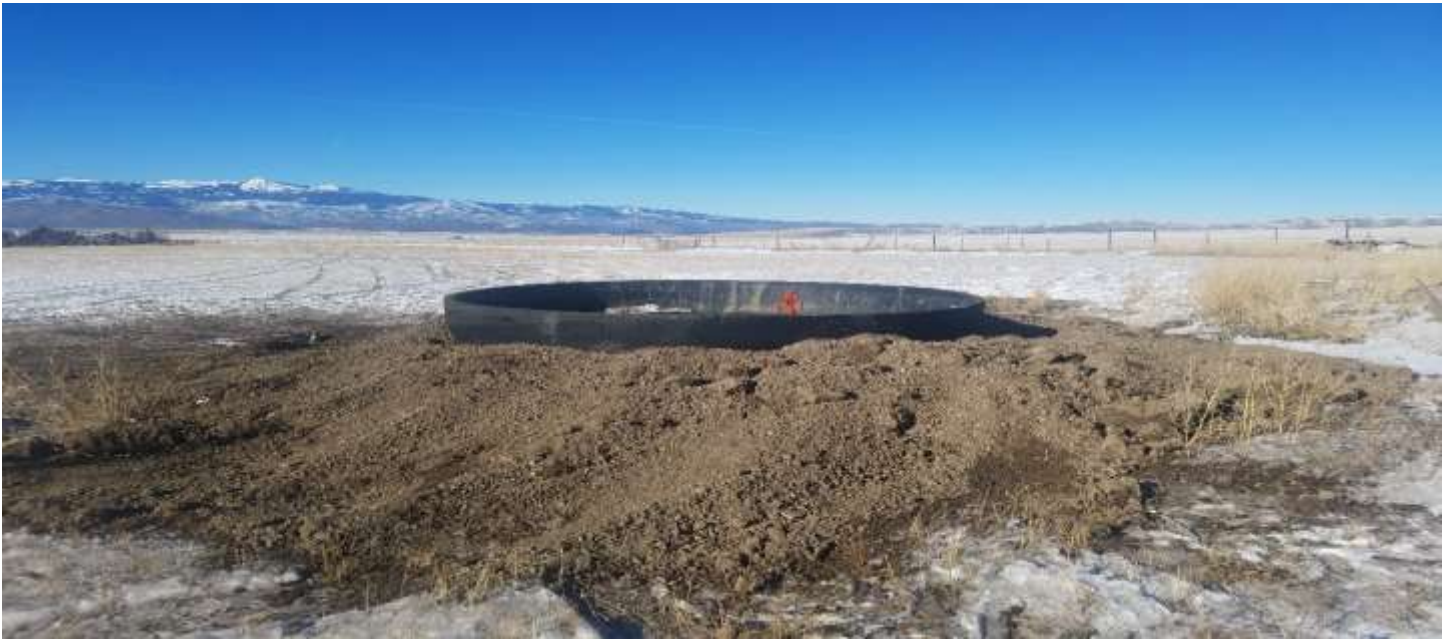
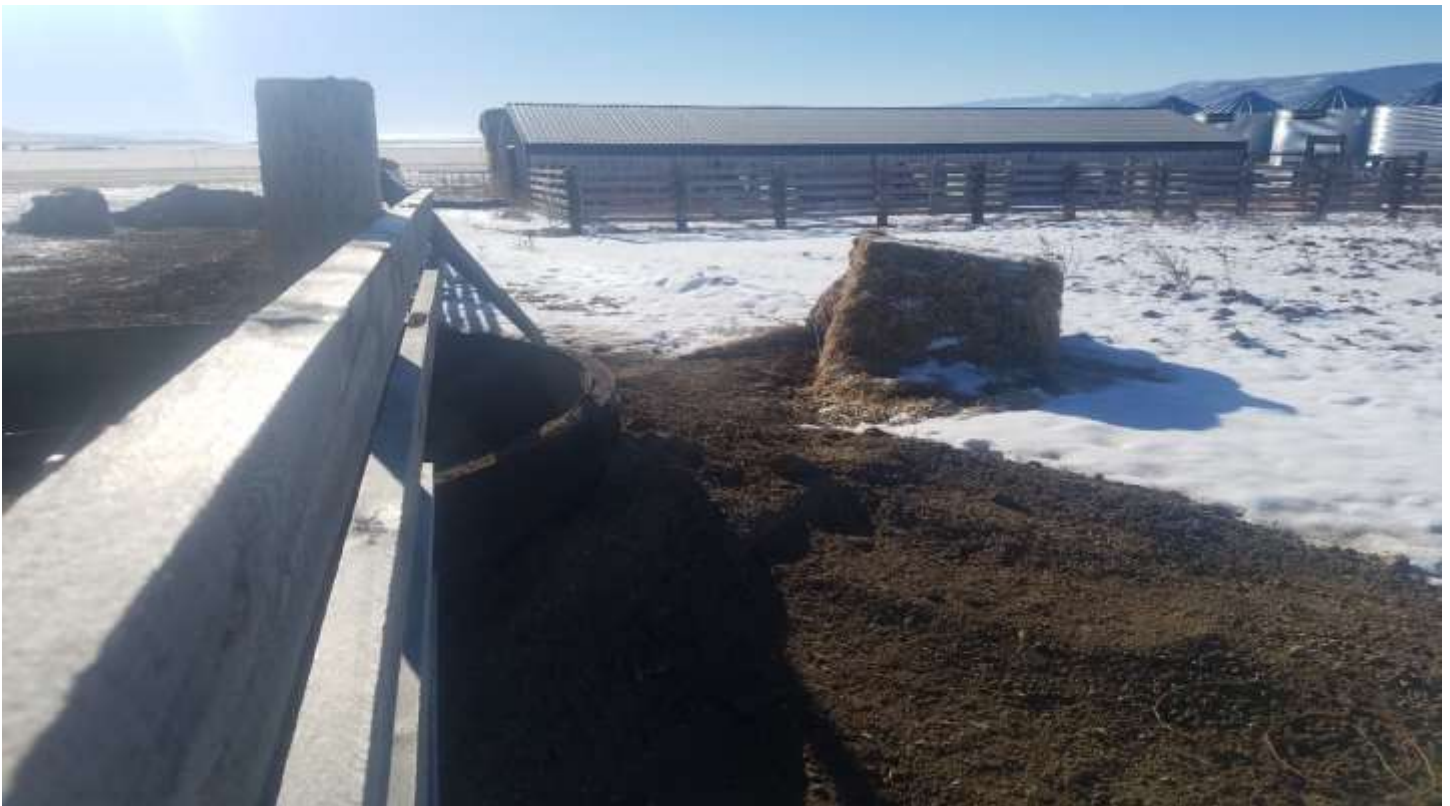
Above photo shows one of the large tires which was installed. These tires are 12 foot tires and are estimated to hold ~1400 gallons of water. Below shows a tire trough installed in the fence line so it can be used on both sides of the fence. This system was installed to draw livestock away from sensitive riparian areas and reduce livestock impacts on a small unnamed tributary, SC Photos.

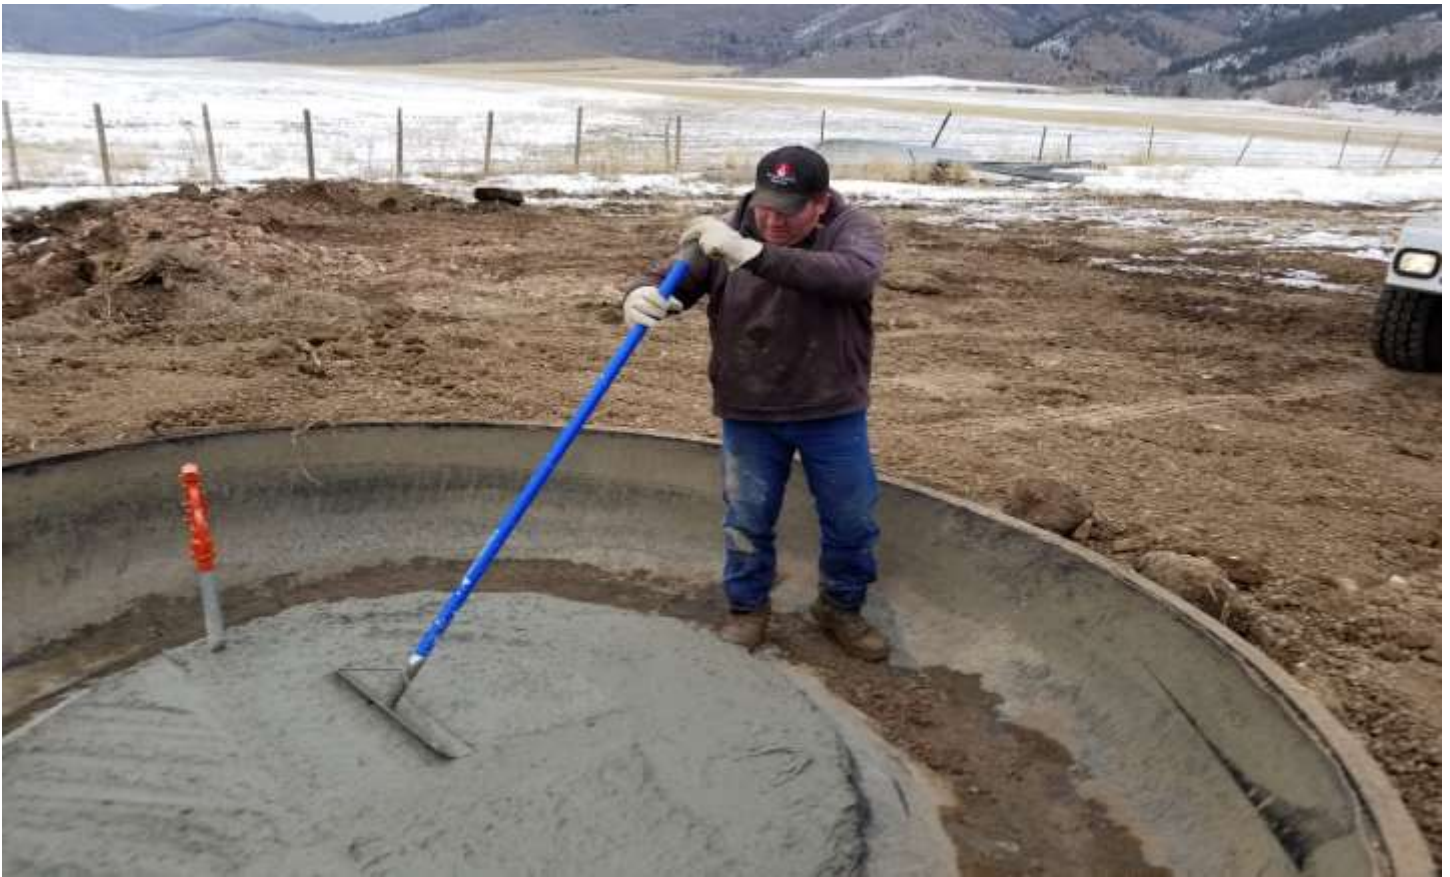
(Above) This photo shows the contractor putting the finish on the cement inside one of the troughs, SC Photos.
