Rosebud Power Plant Annual Engineer's Inspection Report

Prepared for Rosebud Operating Services, Inc.
by Allied Engineering Services, Inc.
2018 Report
Posted: January 18, 2019

**ROSEBUD ACTIVE LANDFILL
 PHASE 1 LANDFILL SLOPES
 ROSEBUD COUNTY, MT**

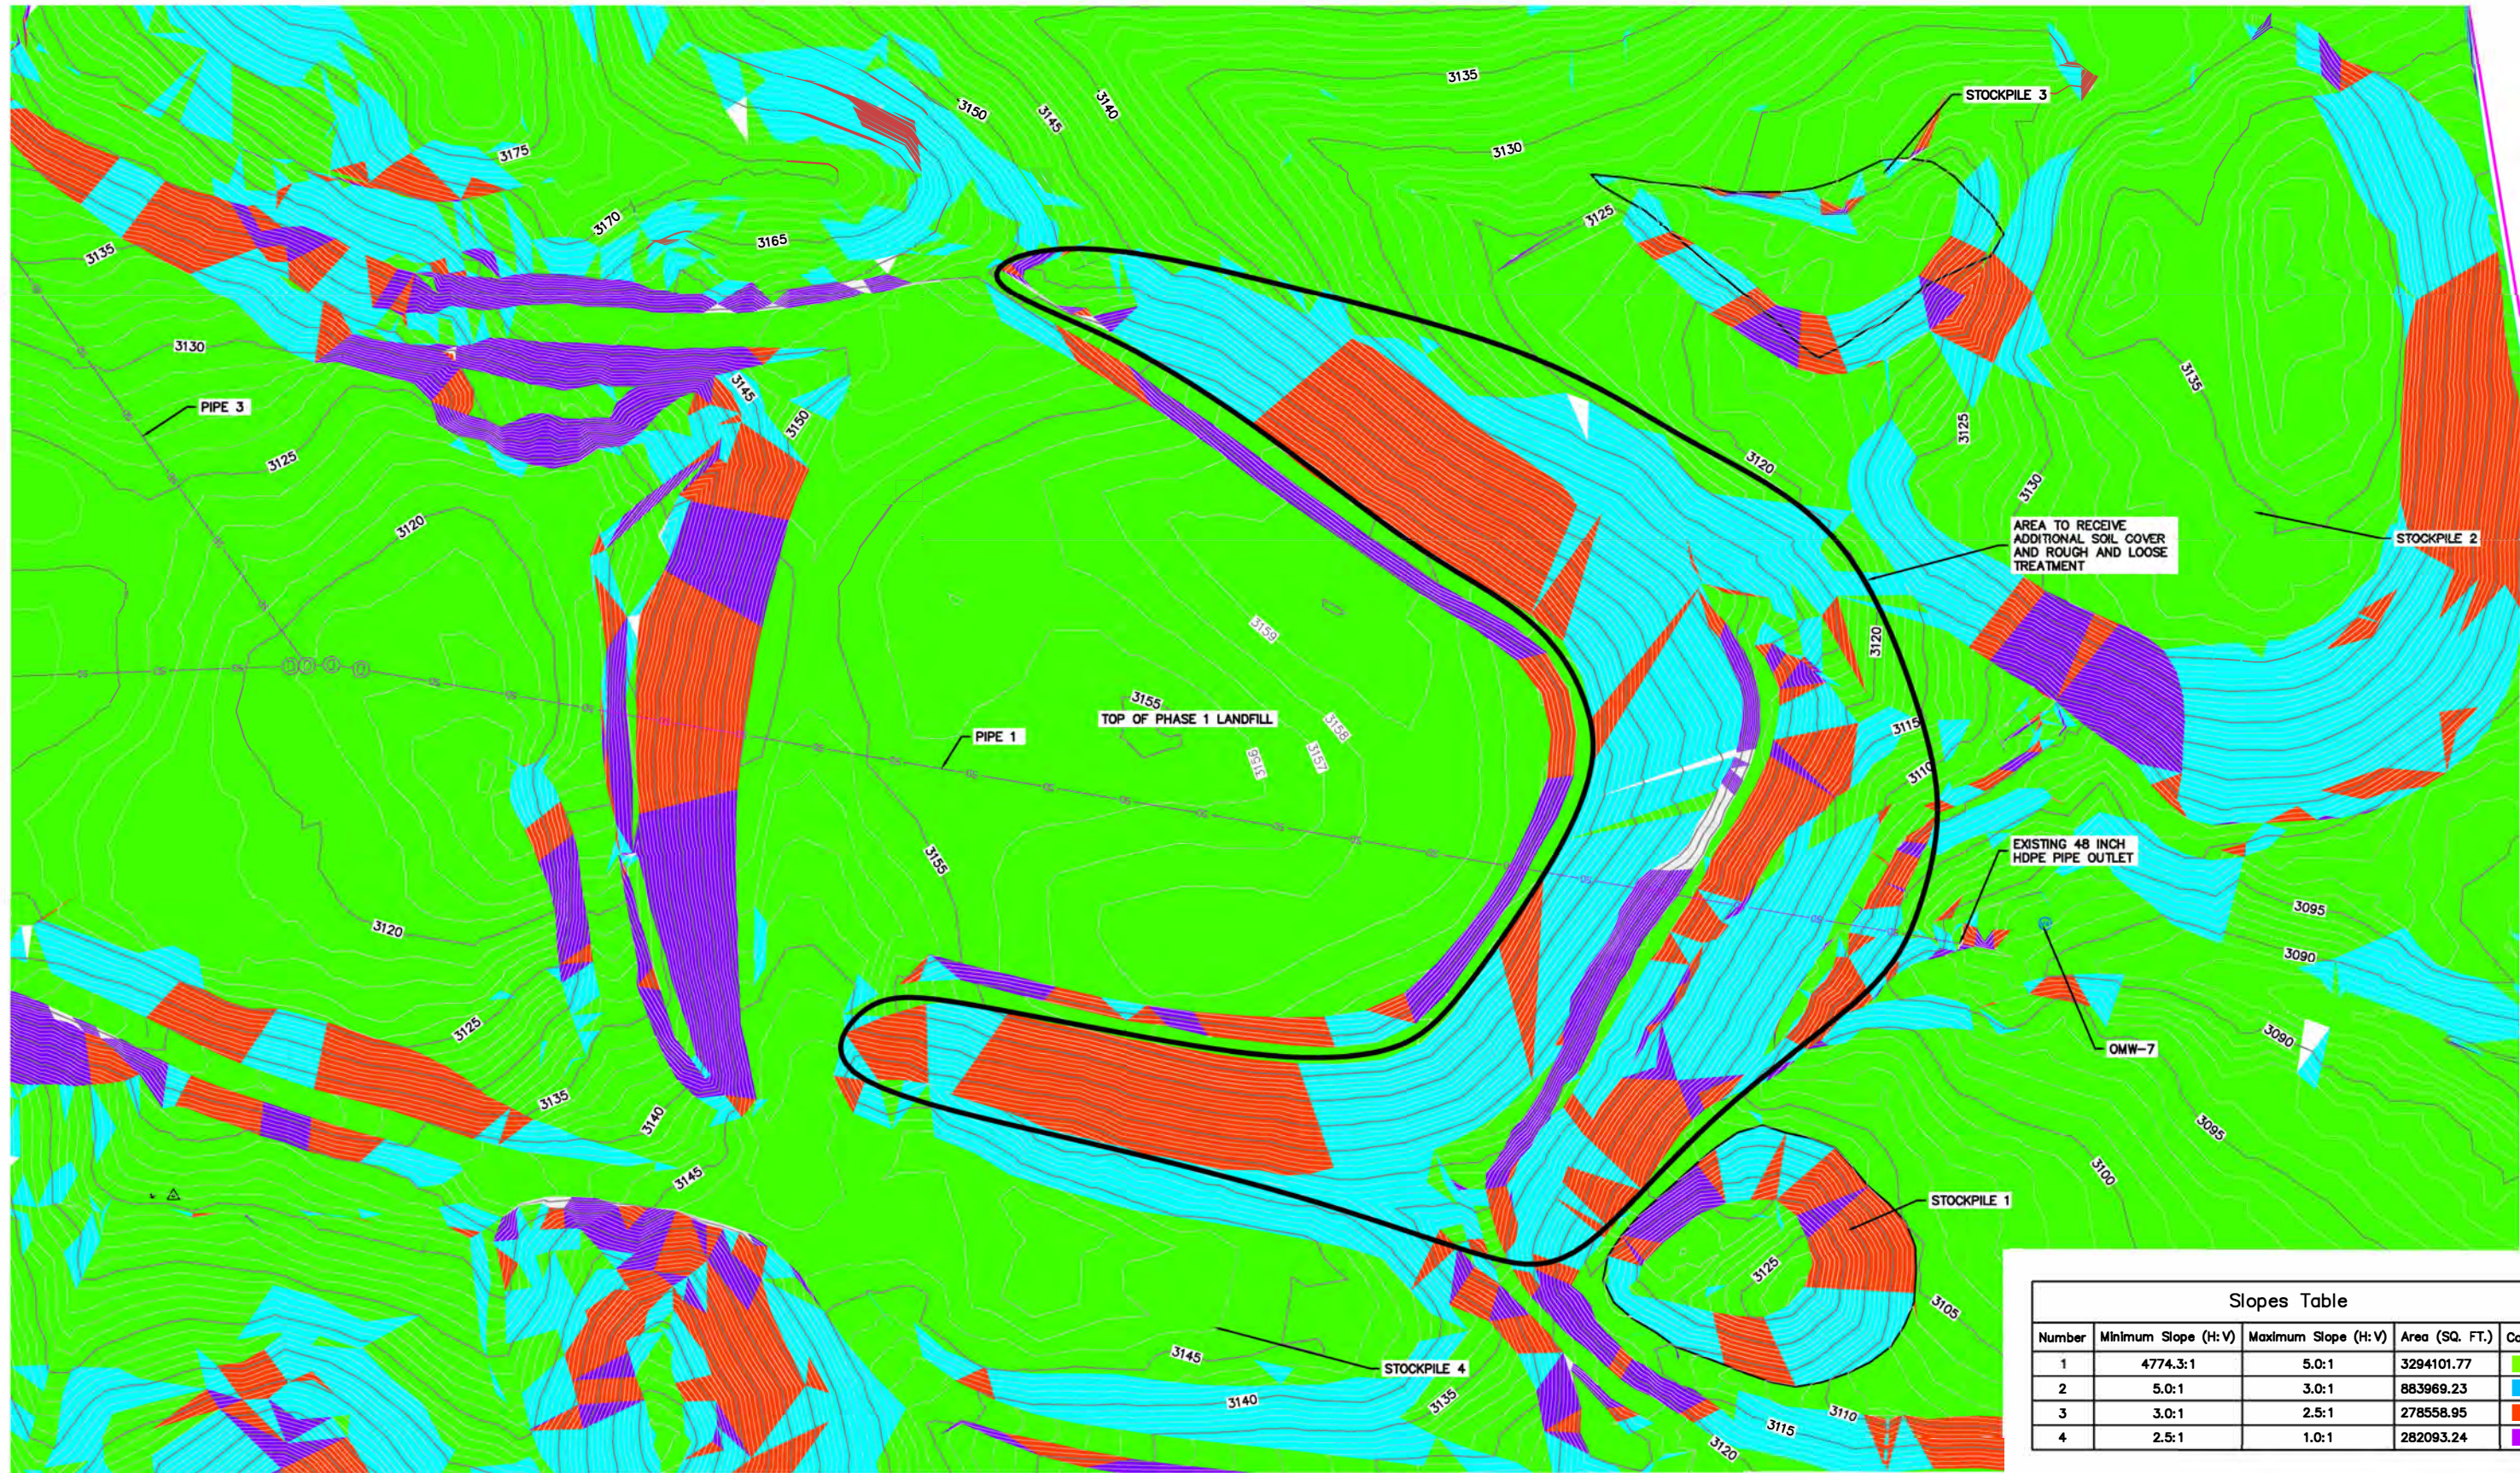
SHEET
S-1

An effort was made to complete the design and planning for the Reclamation of some problem areas on the Phase 1 Landfill Slope (see Appendix A). This project was not constructed in 2018.

Slopes Table				
Number	Minimum Slope (H:V)	Maximum Slope (H:V)	Area (SQ. FT.)	Color
1	4774.3:1	5.0:1	3294101.77	Green
2	5.0:1	3.0:1	883969.23	Cyan
3	3.0:1	2.5:1	278558.95	Orange
4	2.5:1	1.0:1	282093.24	Purple

The landfill inspection at the Rosebud Power Plant revealed that there is currently no significant or damaging active settlement or significant stability issues related to landfilling of CCR. All existing piping is functioning as designed, and all disturbed areas have been hydro-seeded. As stated above, the reclamation plans for the Phase 1 slopes have been completed but never constructed.

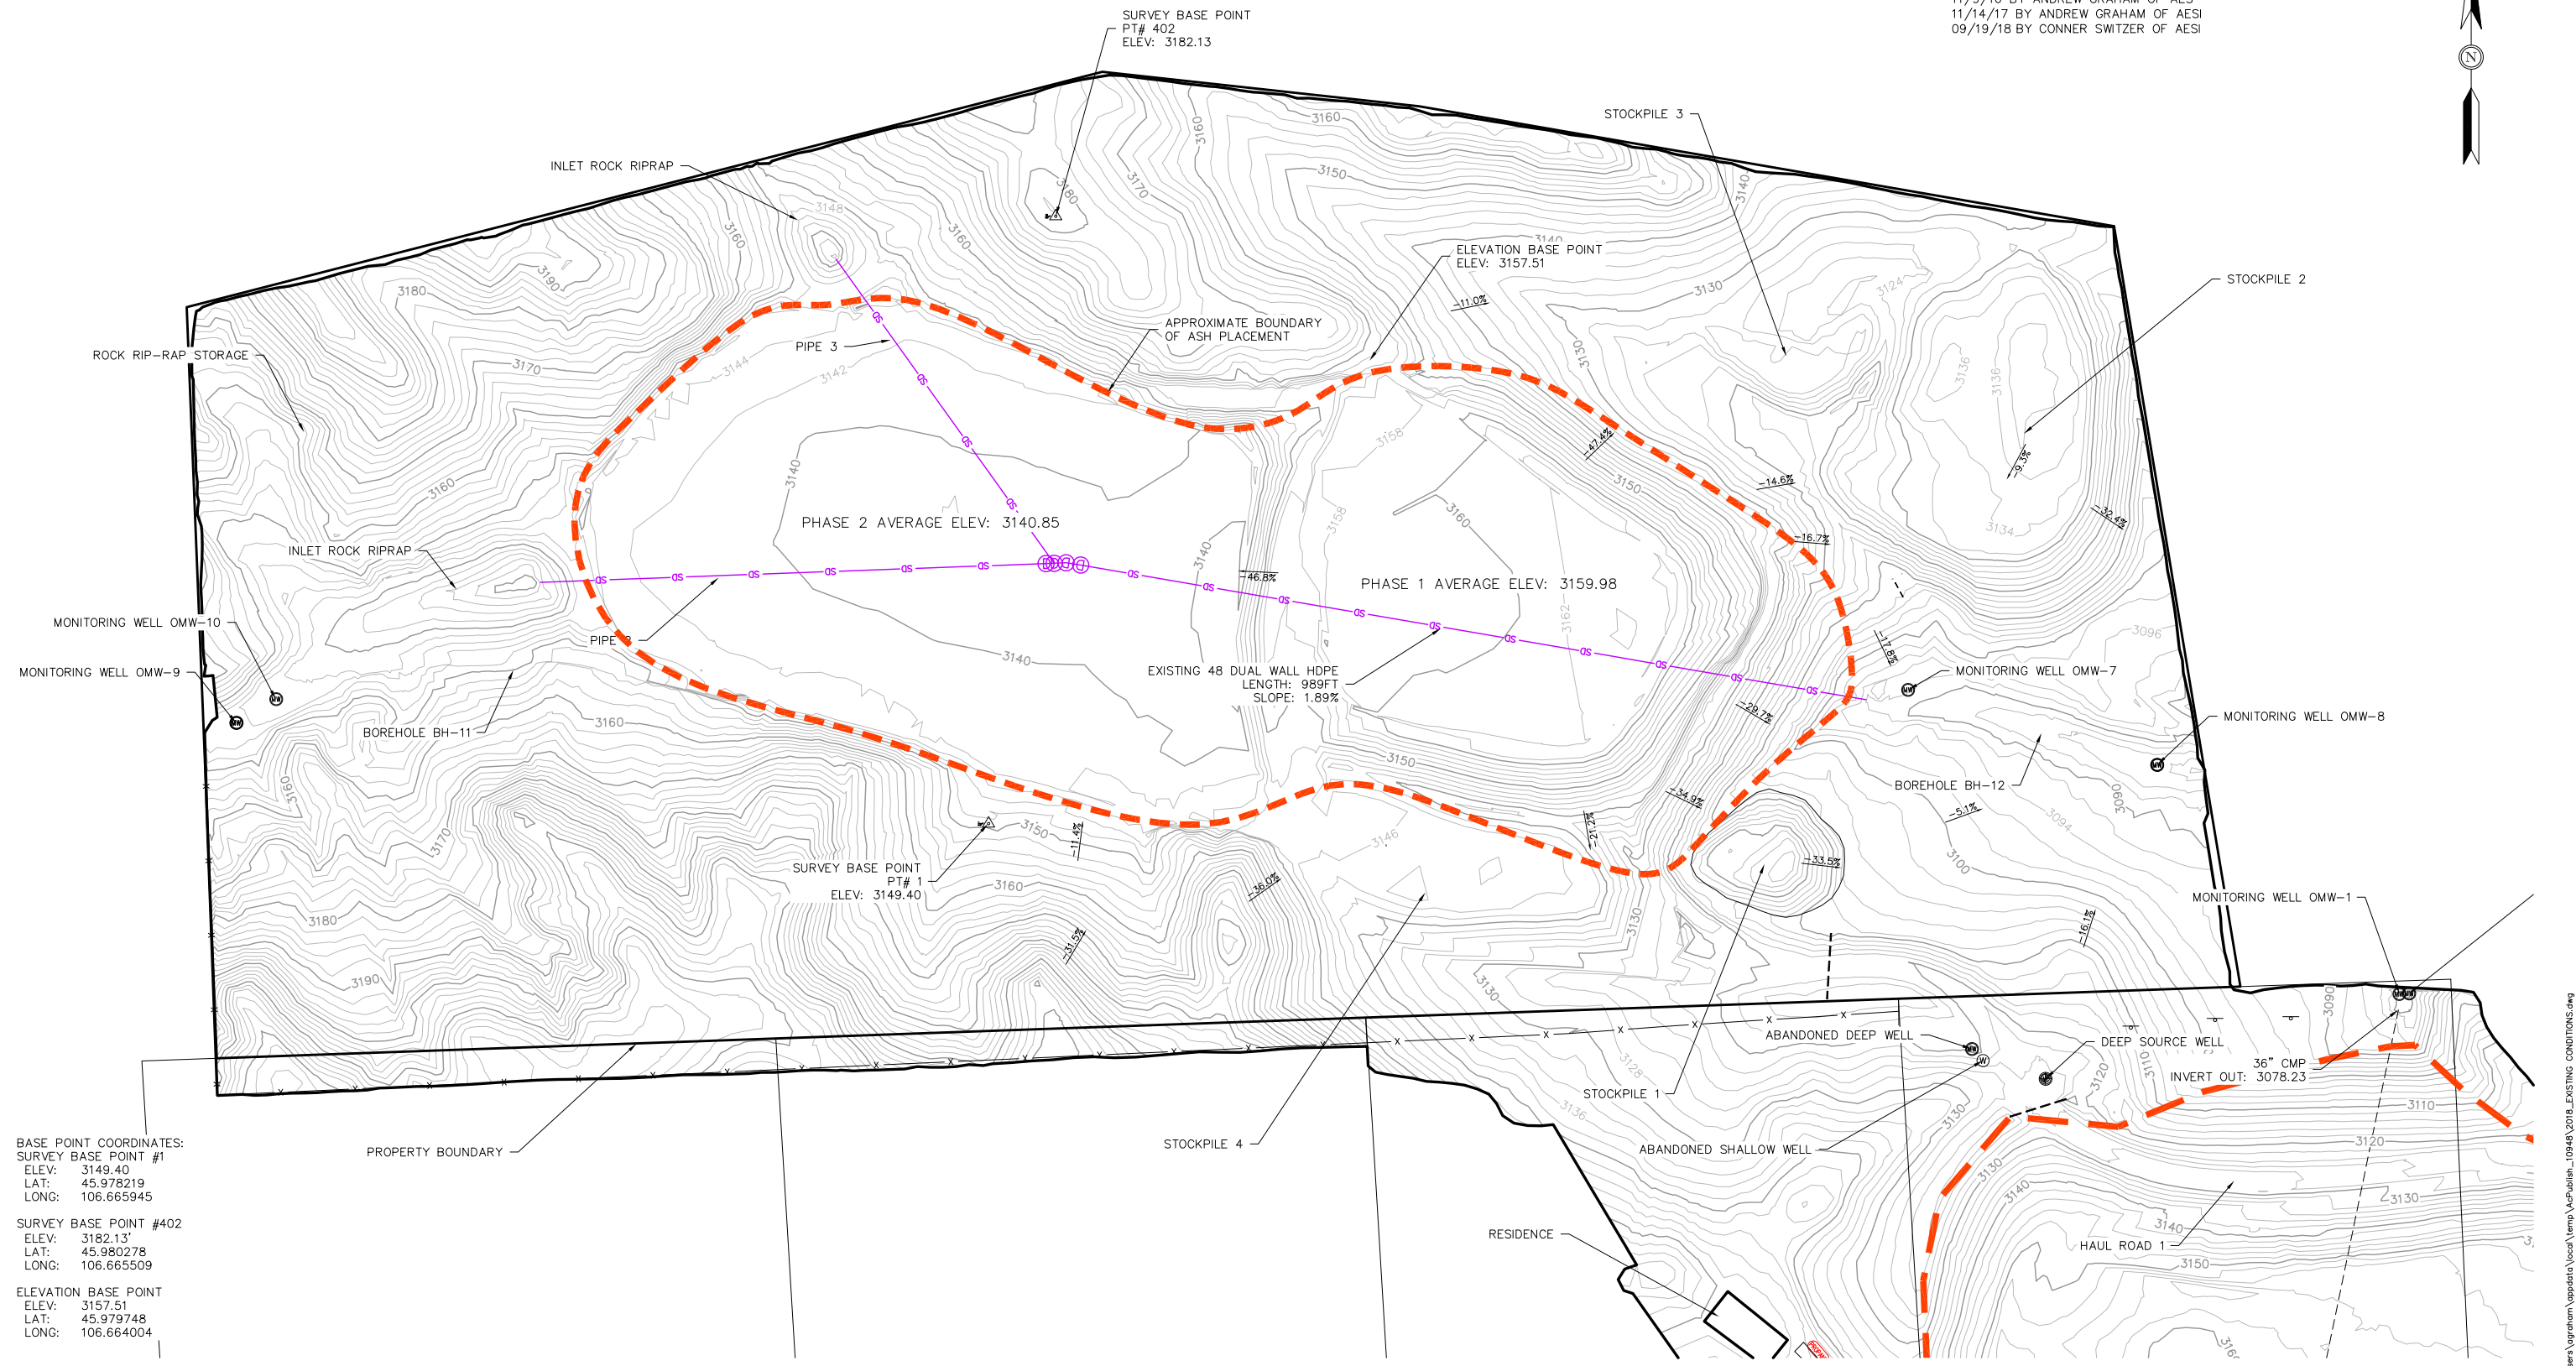
**ROSEBUD SURVEY FIGURE
 2018 ACTIVE LANDFILL (AS-BUILT)
 ROSEBUD COUNTY, MT**

The geometry of the landfill is actively changing as CCR is placed in lifts and hydrated. The attached as-built survey sheets depict the topography of the ash surface as of September 19, 2018. The elevation of the ash placed in Phase 2 has risen an average of 3.7-ft since the last as-built survey on November 14, 2017. The general shape of Phase 2 is concave which captures precipitation within the ash footprint. The average elevation of Phase 1 and 2 is now 3160-FT and 3140.7-FT respectively. A total of 52,701 CY of ash was placed in both Phases 1 & 2 during the time between as-built surveys. During this same time-frame, approximately 6,439 CY of ash was sold and not placed in the landfill area.

SURVEY OF PHASE 1 & 2 LANDFILL AND SURROUNDING AREA BASED ON TOPOGRAPHIC SURVEYS COMPLETED ON:
 9/14/15 BY GREG FINCK OF AESI
 1/27/16 BY GREG FINCK AND KYLE THOMPSON OF AESI
 11/9/16 BY ANDREW GRAHAM OF AESI
 11/14/17 BY ANDREW GRAHAM OF AESI
 09/19/18 BY CONNER SWITZER OF AESI

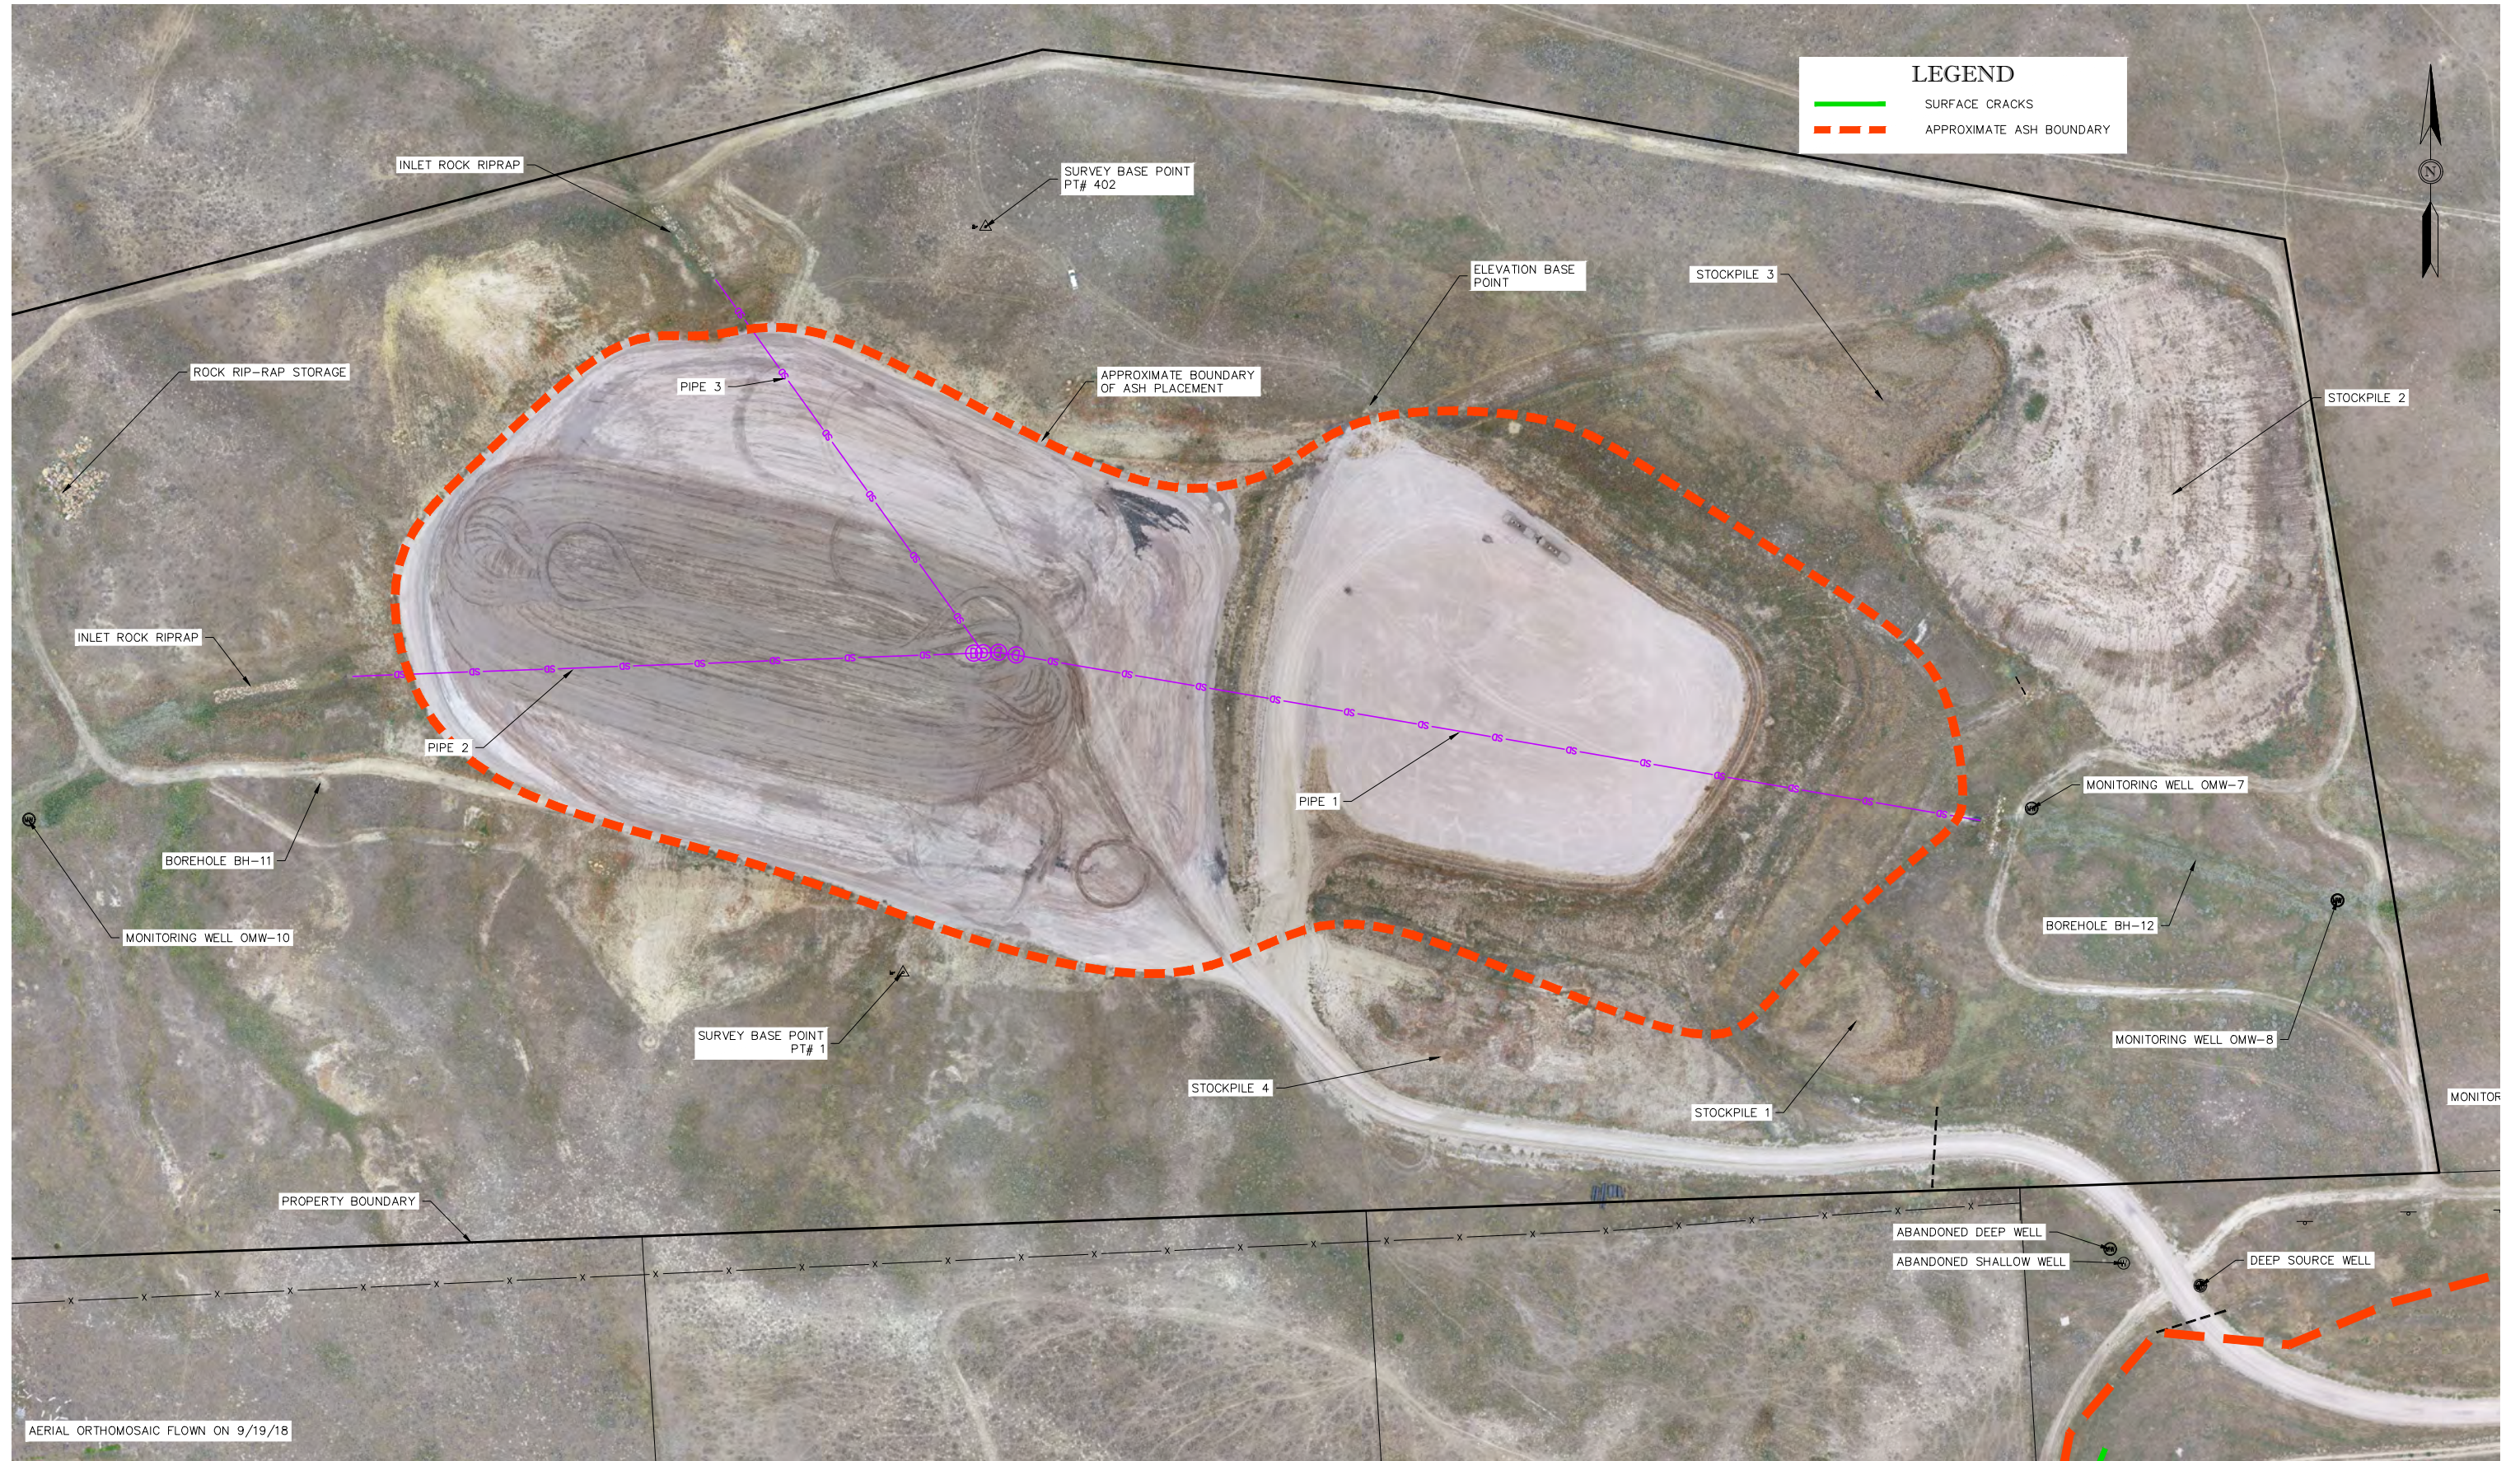
ROSEBUD SURVEY FIGURE
2018 ACTIVE LANDFILL ORTHOMOSAIC
ROSEBUD COUNTY, MT

During the primary inspection, traditional survey and aerial mapping was performed across the site. The 2018 survey information is summarized in Appendix B.
