Rosebud Power Plant

2025 Annual Engineer's

Inspection Report

Prepared for Rosebud Operating Services, Inc.
by Allied Engineering Services, Inc.
2025 Report
Posted: January 15, 2026
Project #: 15-125

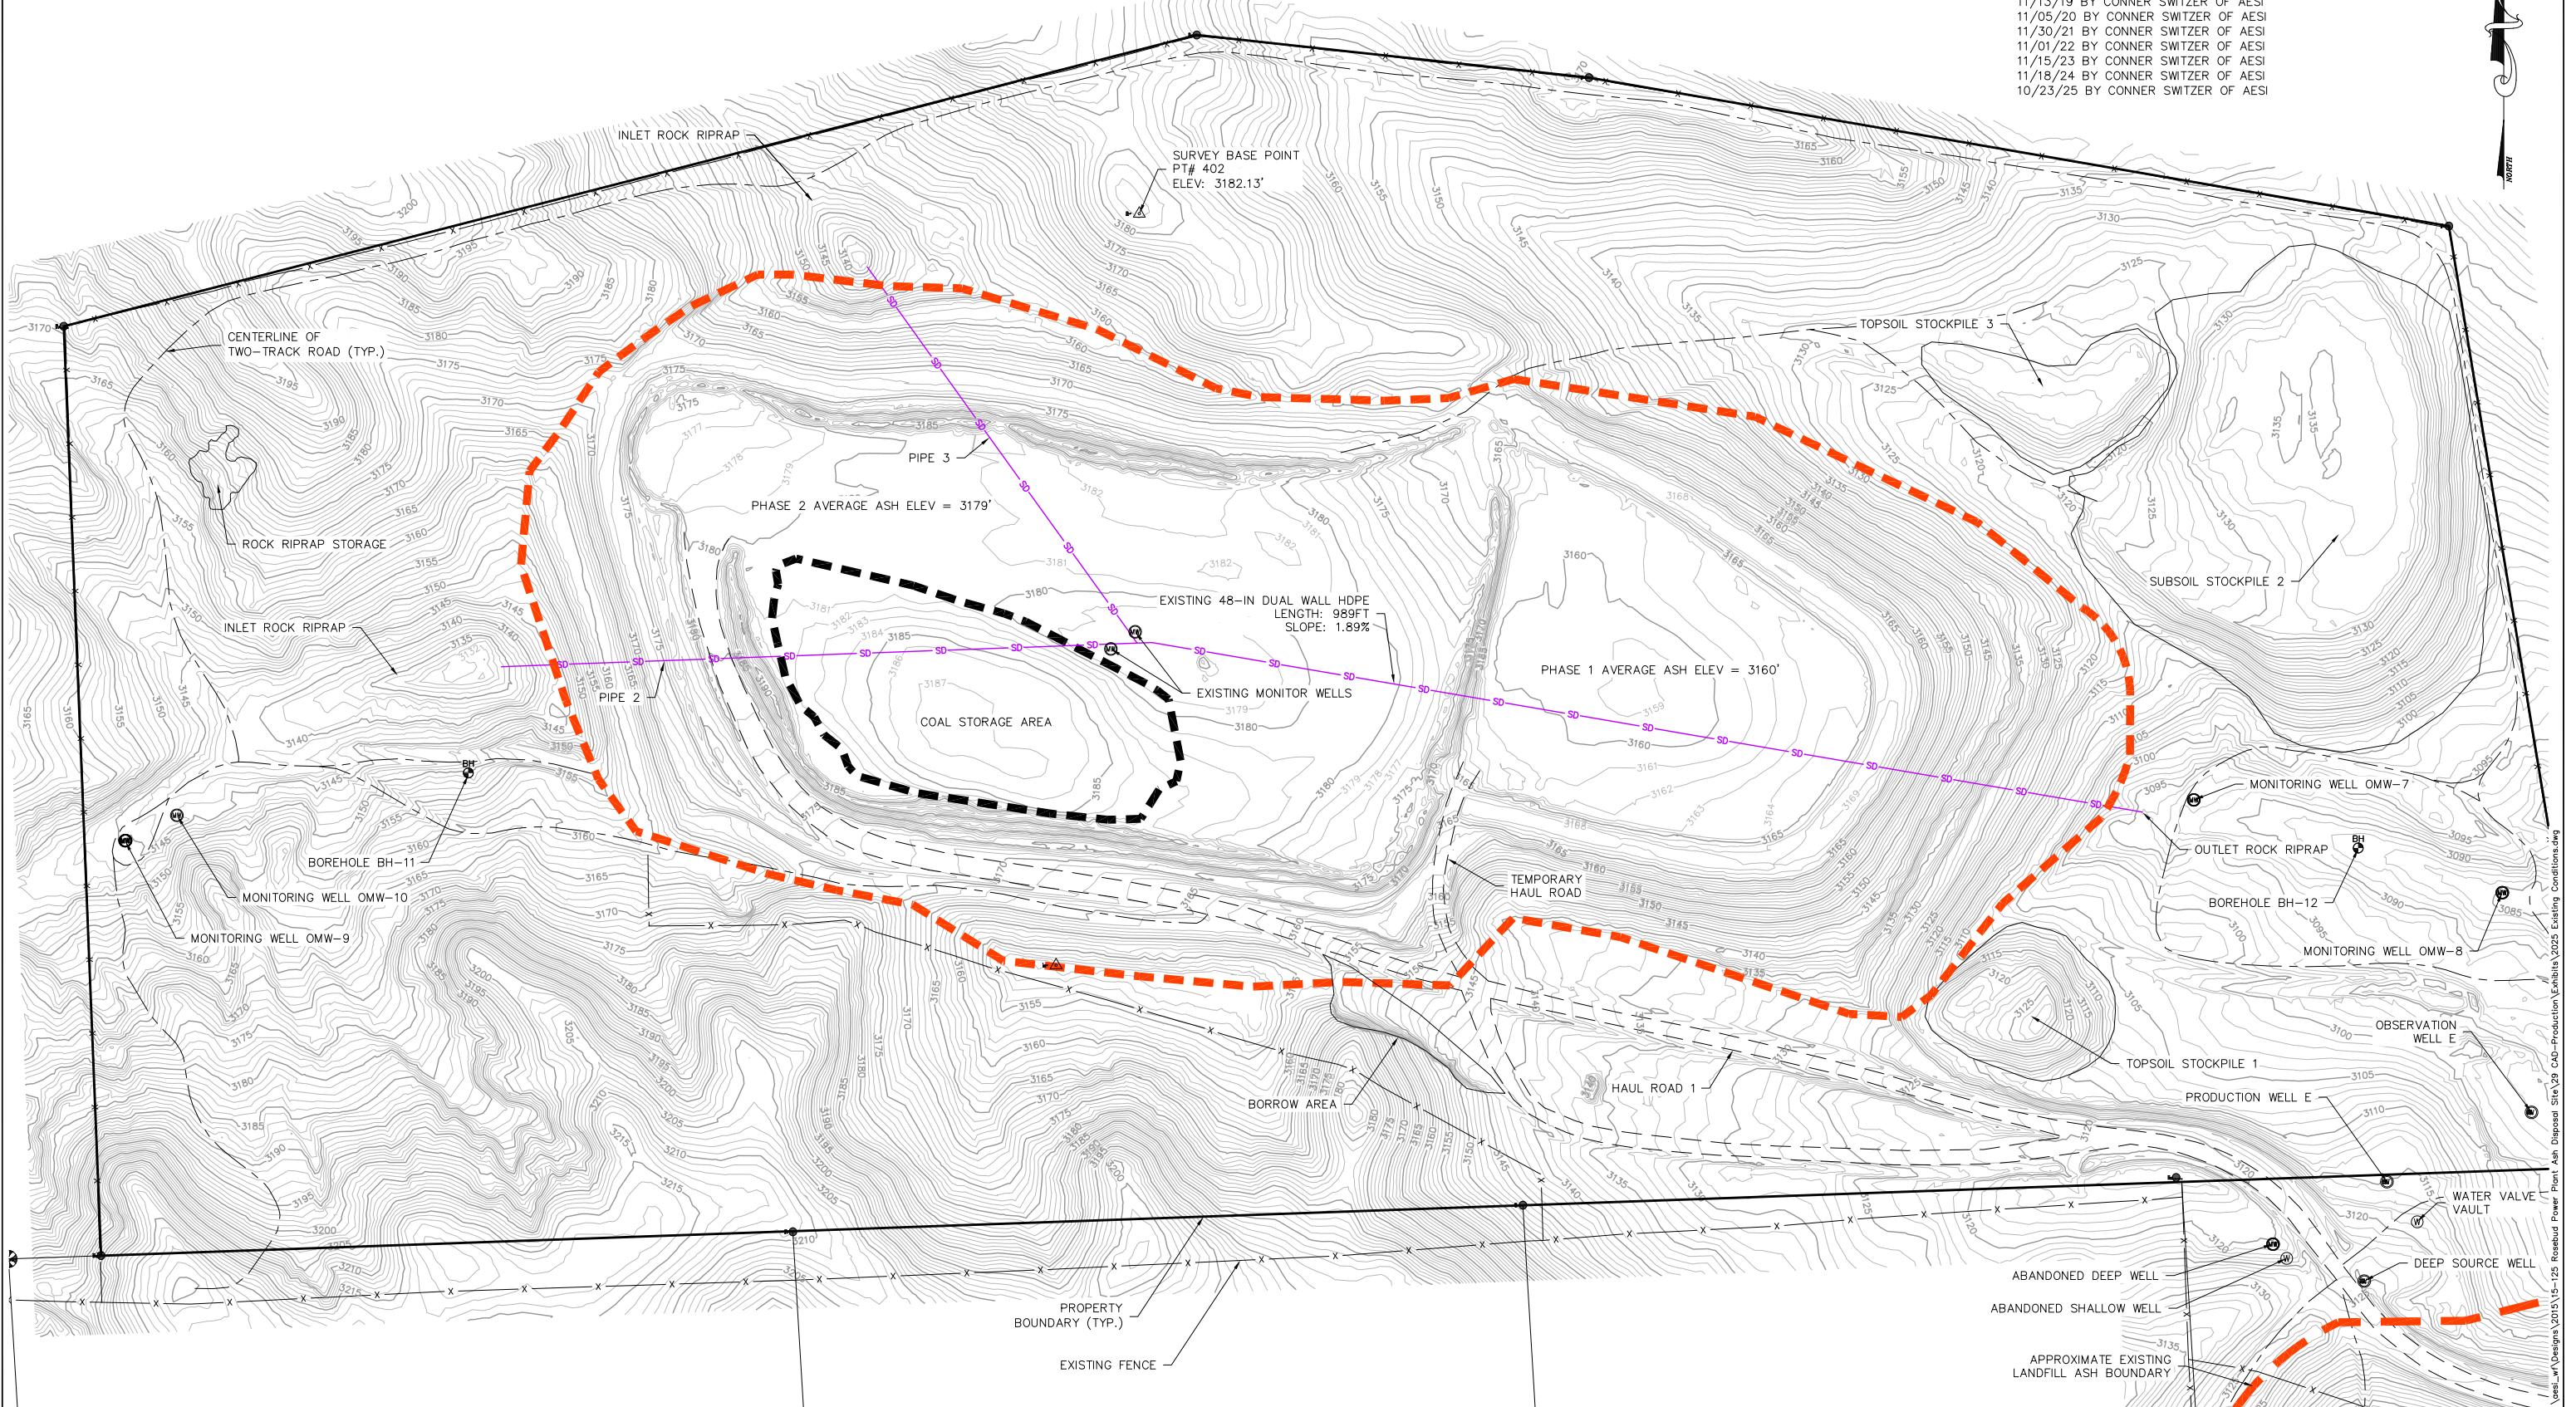
ROSEBUD SURVEY FIGURE
2025 ACTIVE LANDFILL (AS-BUILT)
ROSEBUD COUNTY, MT

The attached as-built survey sheets depict the topography of the ash surface as of October 23, 2025. The elevation of the ash placed in Phase 2 has risen an average of 5.6-ft since the last as-built survey on November 18, 2024. The general shape of Phase 2 is a depression which captures precipitation within the ash footprint. The average ash elevation of Phase 1 remains the same as the previous years (2018-2024) at 3160-FT. Phase 2 has an average ash elevation of 3179-FT. A total of 74,482 CY of ash was placed in Phase 2 between as-built surveys (11/18/2024 – 10/23/2025). During this same timeframe, approximately 149 CY of ash was sold and not placed in the landfill area.

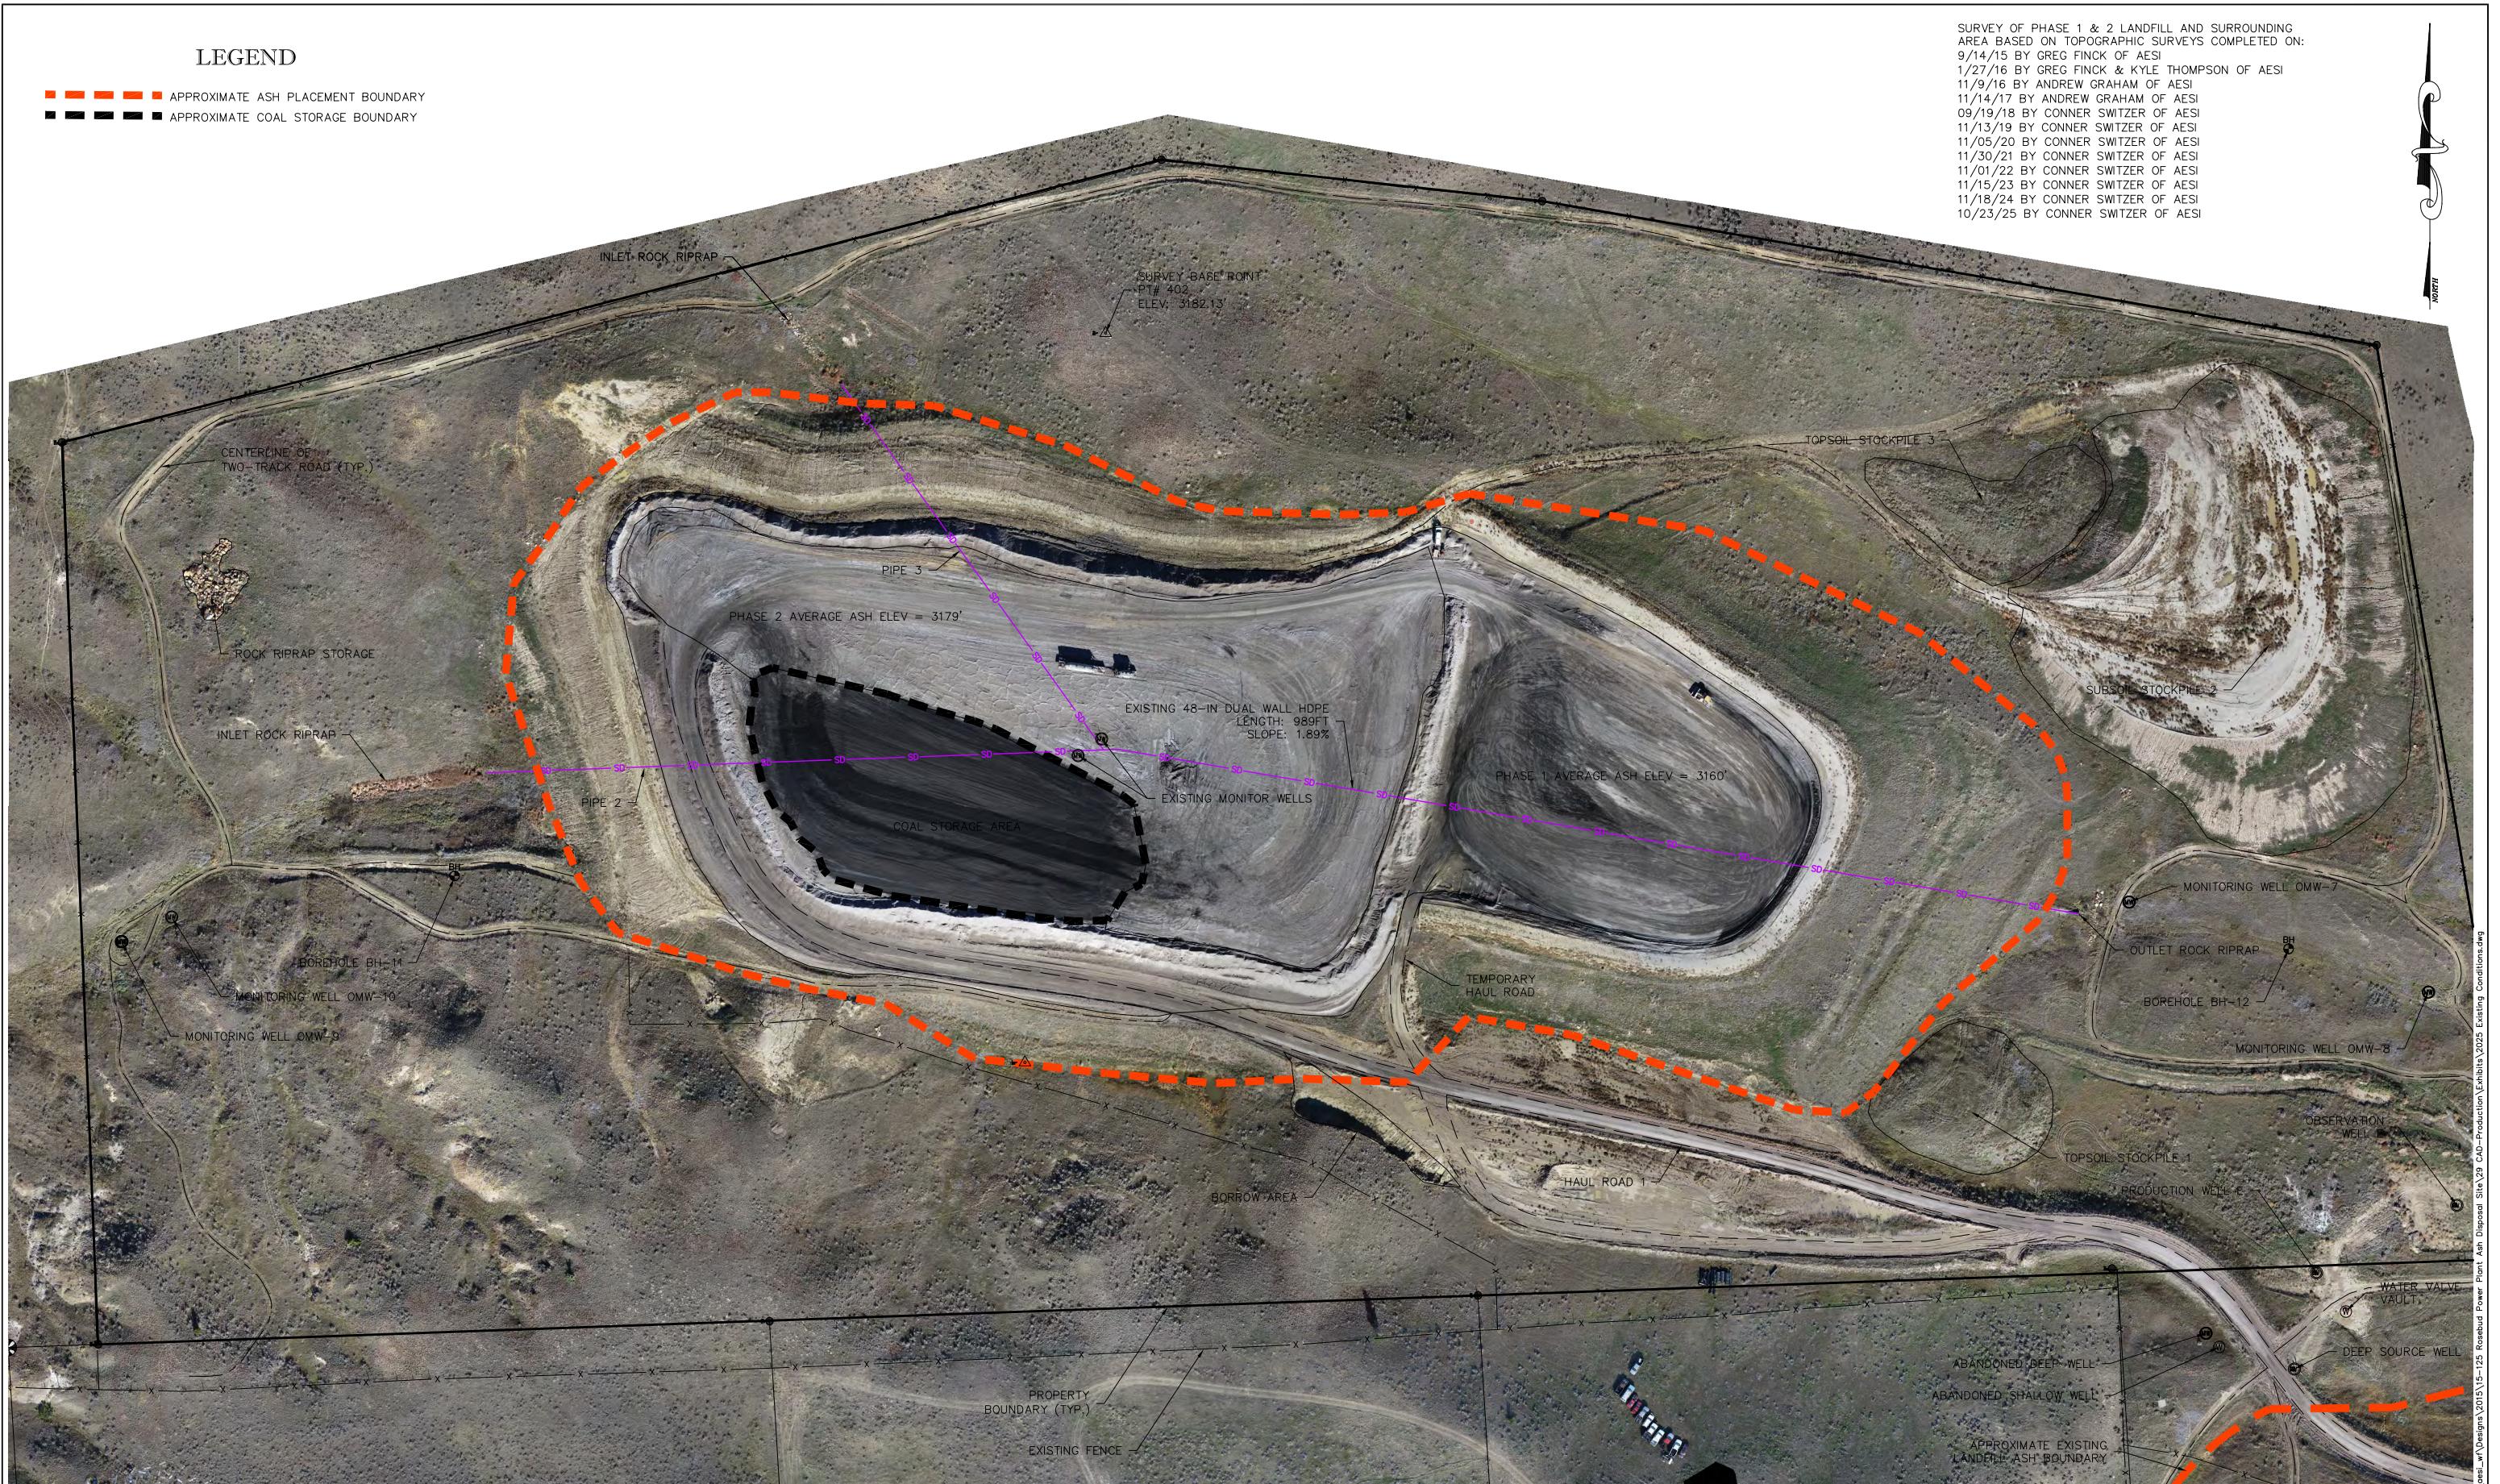
ROSEBUD SURVEY FIGURE
2025 ACTIVE LANDFILL (ORTHOMOSAIC)
ROSEBUD COUNTY, MT

Personnel from Allied Engineering Services, Inc. visited the site on October 23, 2025 for the Annual Engineers Inspection. During the inspection, traditional survey and aerial drone mapping was performed across the site. The 2025 survey information is summarized in Appendix A.

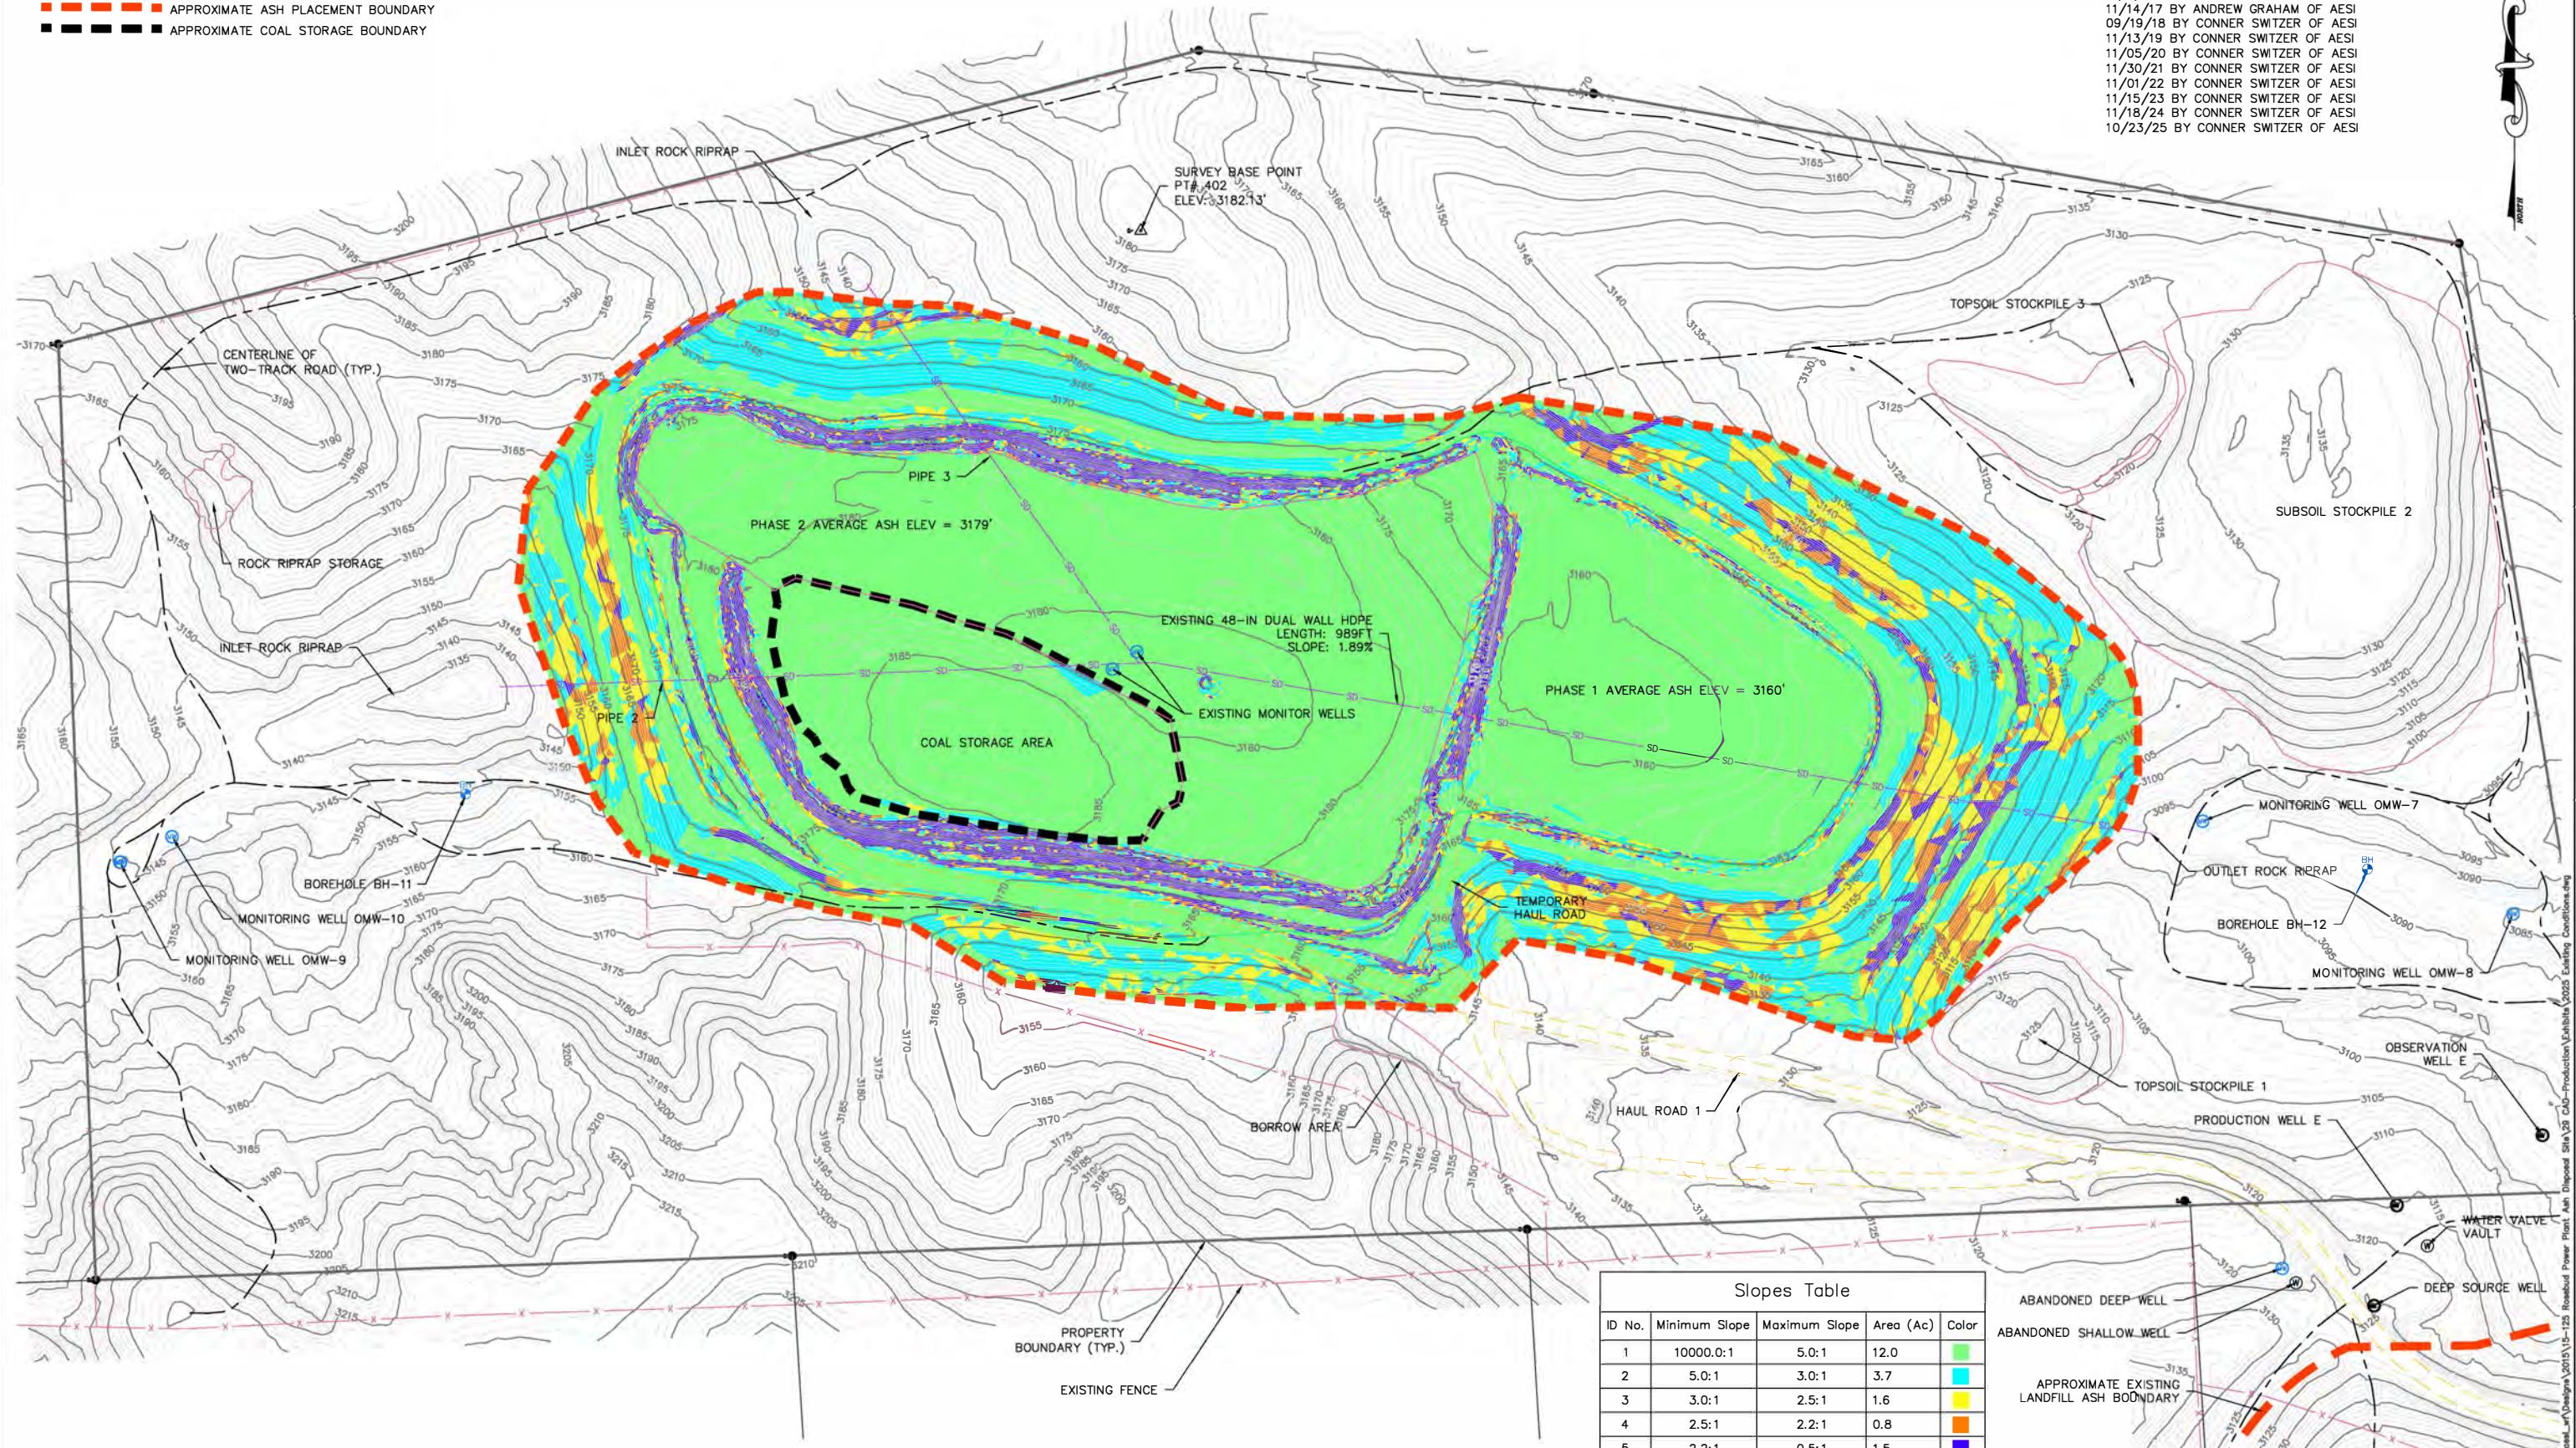
ROSEBUD SURVEY FIGURE
2025 ACTIVE LANDFILL (SLOPES)
ROSEBUD COUNTY, MT

The geometry of the landfill is actively changing as CCR is placed in lifts and hydrated. As the CCR surface continues to rise, a minimum of 3H:1V side slope should be maintained. Maintaining 3H:1V side slopes during placement of CCR lifts and construction of perimeter berms will ensure final configuration and reclamation geometry can be achieved. No significant structural weaknesses or stability issues were observed during the annual inspection.

Slopes Table				
ID No.	Minimum Slope	Maximum Slope	Area (Ac)	Color
1	10000:0:1	5.0:1	12.0	Green
2	5.0:1	3.0:1	3.7	Cyan
3	3.0:1	2.5:1	1.6	Yellow
4	2.5:1	2.2:1	0.8	Orange
5	2.2:1	0.5:1	1.5	Blue

1. Continue grading outward facing slopes for berm construction (2025 and future) to ensure a 3H:1V side slope or flatter geometry. Any existing (2025 or earlier) or future finished slopes steeper than 3H:1V will require flattening from the bottom (i.e., additional fill placement) during final closure. See the attached Slope Figure for existing slopes. Note, areas that are orange and purple represent slopes steeper than 3H:1V.
