**Geotechnical Report of Post Grading,
PA-6, N4B Backbone Street
Improvements on Pearlblossom and
Tomato Springs, Portions of VTTM
16814 and VTTM 17769, Irvine,
California.**

**PN 16045-00
September 17, 2018**

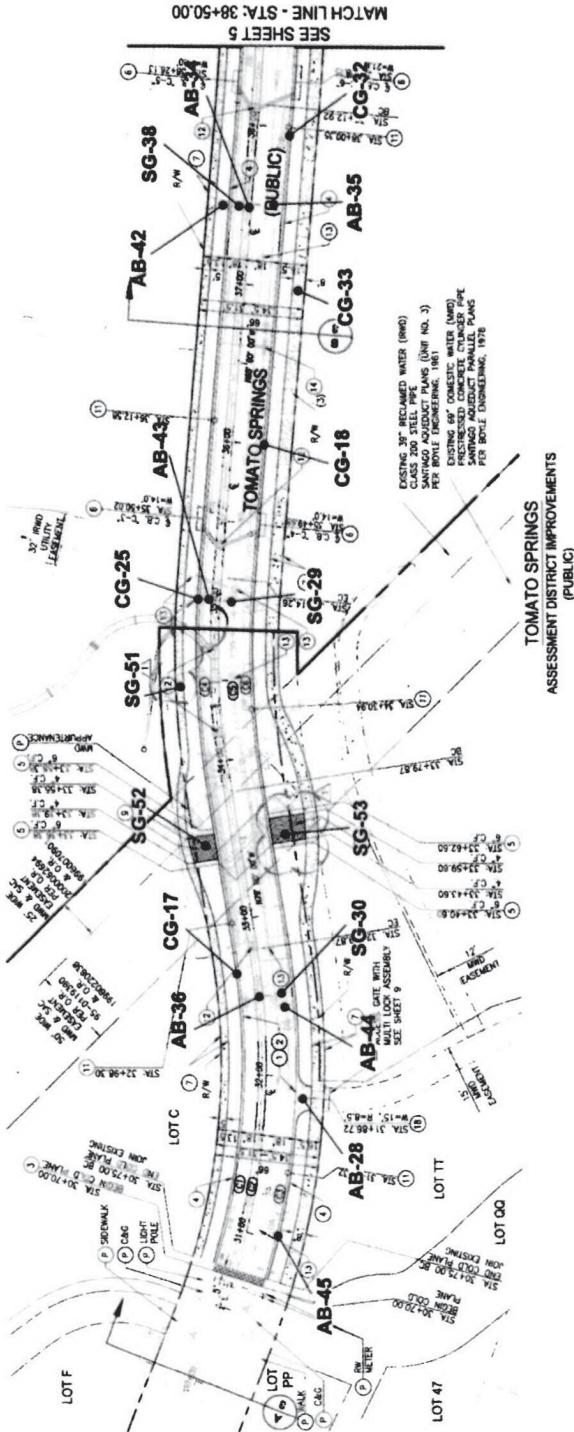
TOMATO SPRINGS
ASSESSMENT DISTRICT IMPROVEMENTS
(PUBLIC)

AB-45	● Approximate Density Test Location of Aggregate Base
CG-32	● Approximate Density Test Location of Curb & Gutter
SG-54	● Approximate Density Test Location of Subgrade

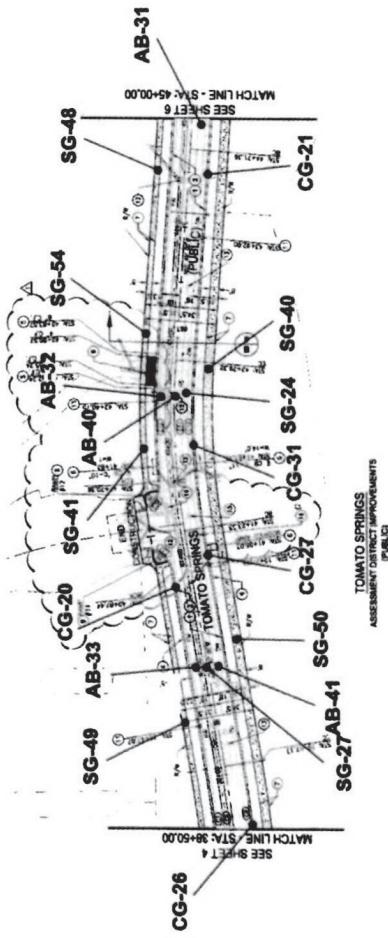
TOMATO SPRINGS
ASSESSMENT DISTRICT IMPROVEMENTS
[P.M.G.]

Reference: Shantec Improvement Plans, Plan & Profile - Sta. 30+50 - Sta. 38+50, Portion of VTTM 16814 & VTTM 17769, Irvine, California, Sheet 4&5/13, 4-21-2016

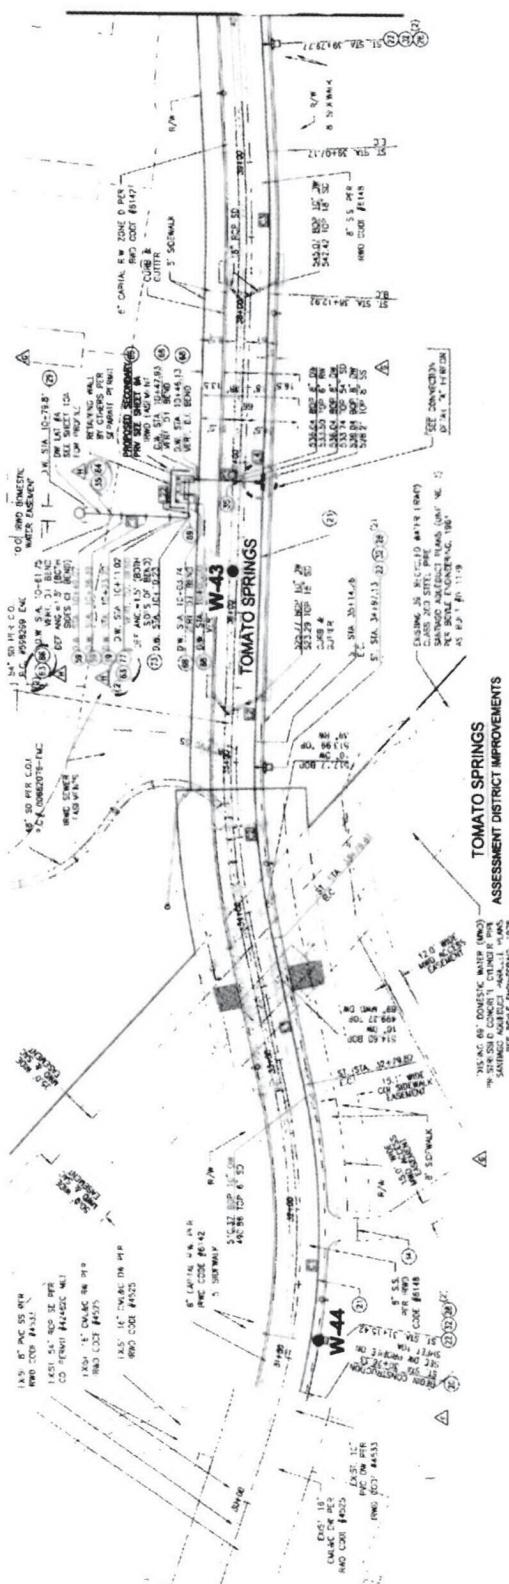
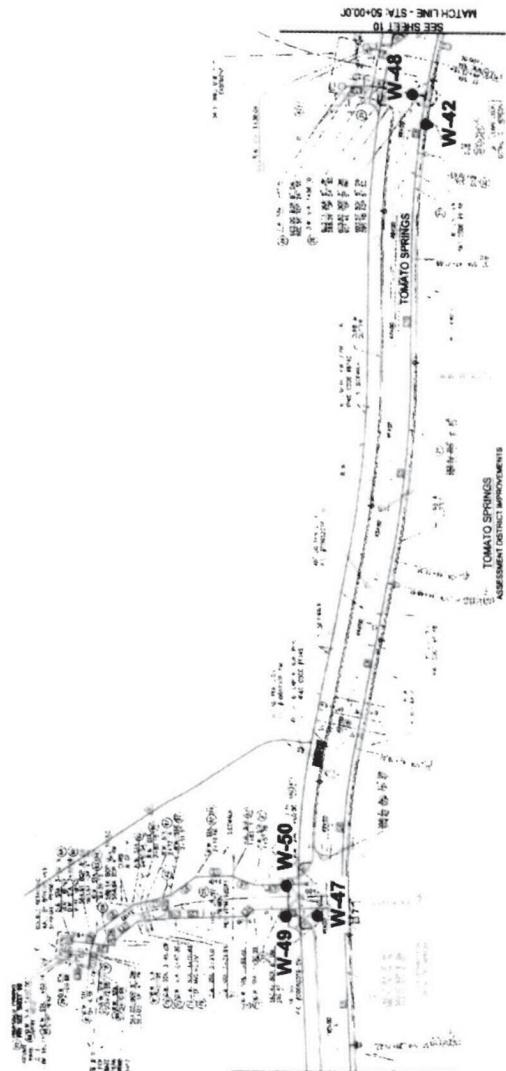
111
16045-00
Sept 17, 2018

- Approximate Density Test
- Location of Water

Reference: Stantec, Improvement Plans, Plan & Profile - Sta. 30+50 - Sta. 38+50, Portion of VTTM 16814 & VTTM 17769, Irvine, California, Sheet 9/13 4-21-2016

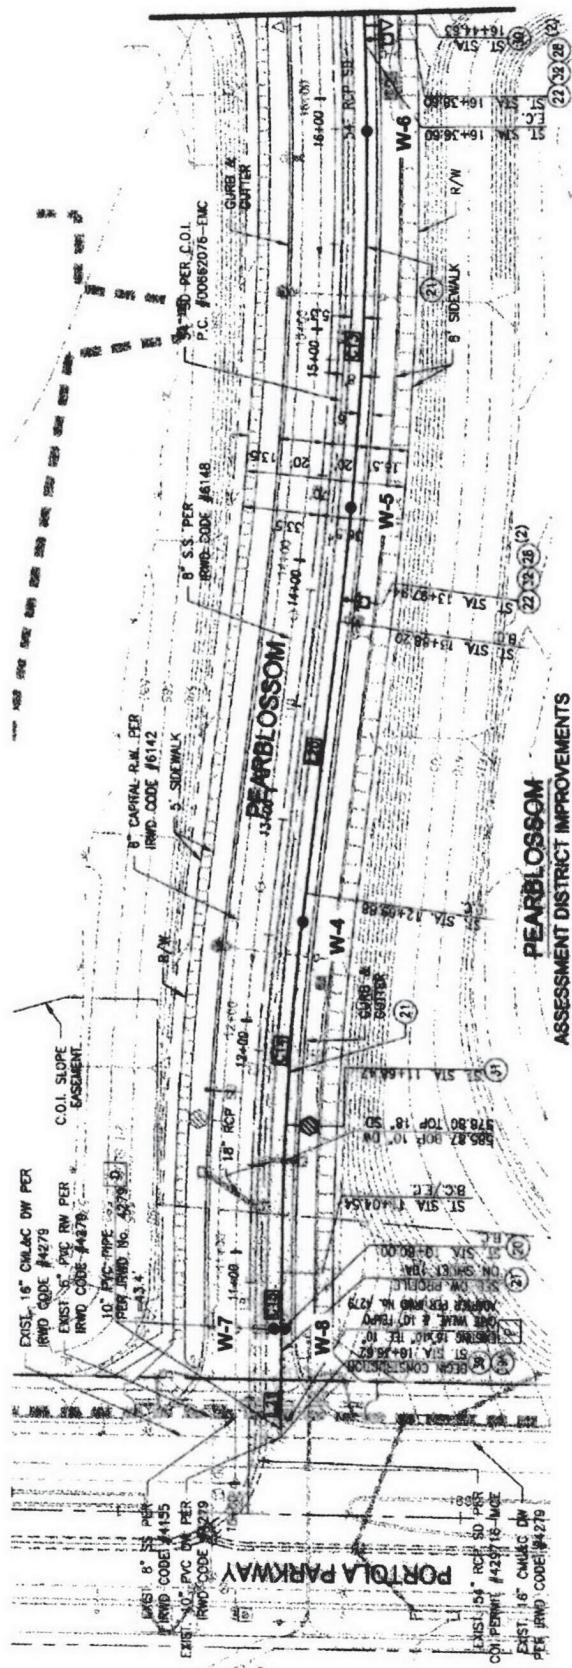
KCG KLING Consulting Group, Inc.	Density Test Location Map	Pearblossom Planning Area 6 - N4B, Irvine, California	Plate: PN: Date:
			16045-00 IV Sept 17, 2018

PEARBLOSSOM ASSESSMENT DISTRICT IMPROVEMENTS

Reference: Stantec, Improvement Plans, Plan & Profile - Sta. 30+50 - Sta. 38+50,
Portion of VTTM 16814 & VTTM 17789, Irvine, California, Sheet 1013, 4-21-2016

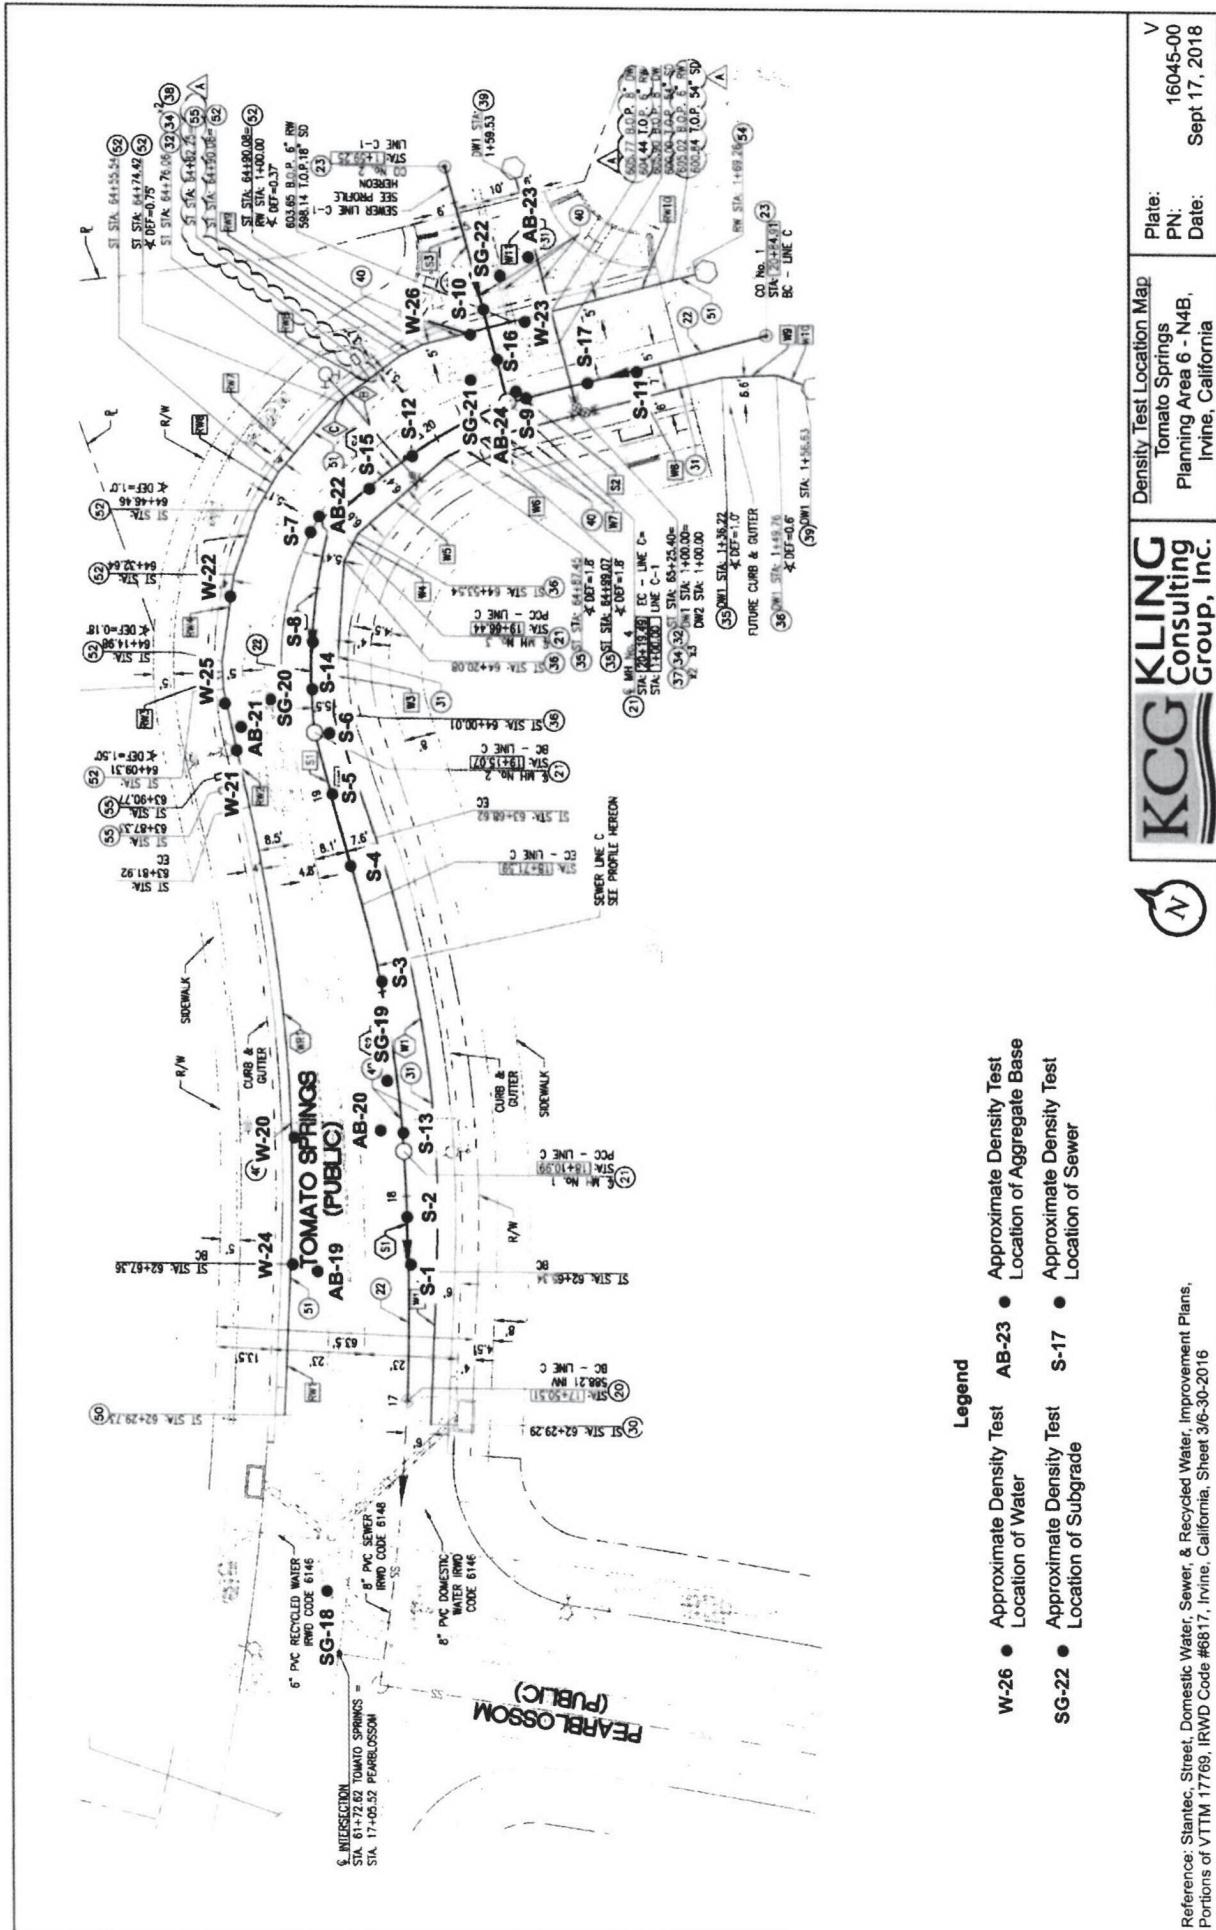
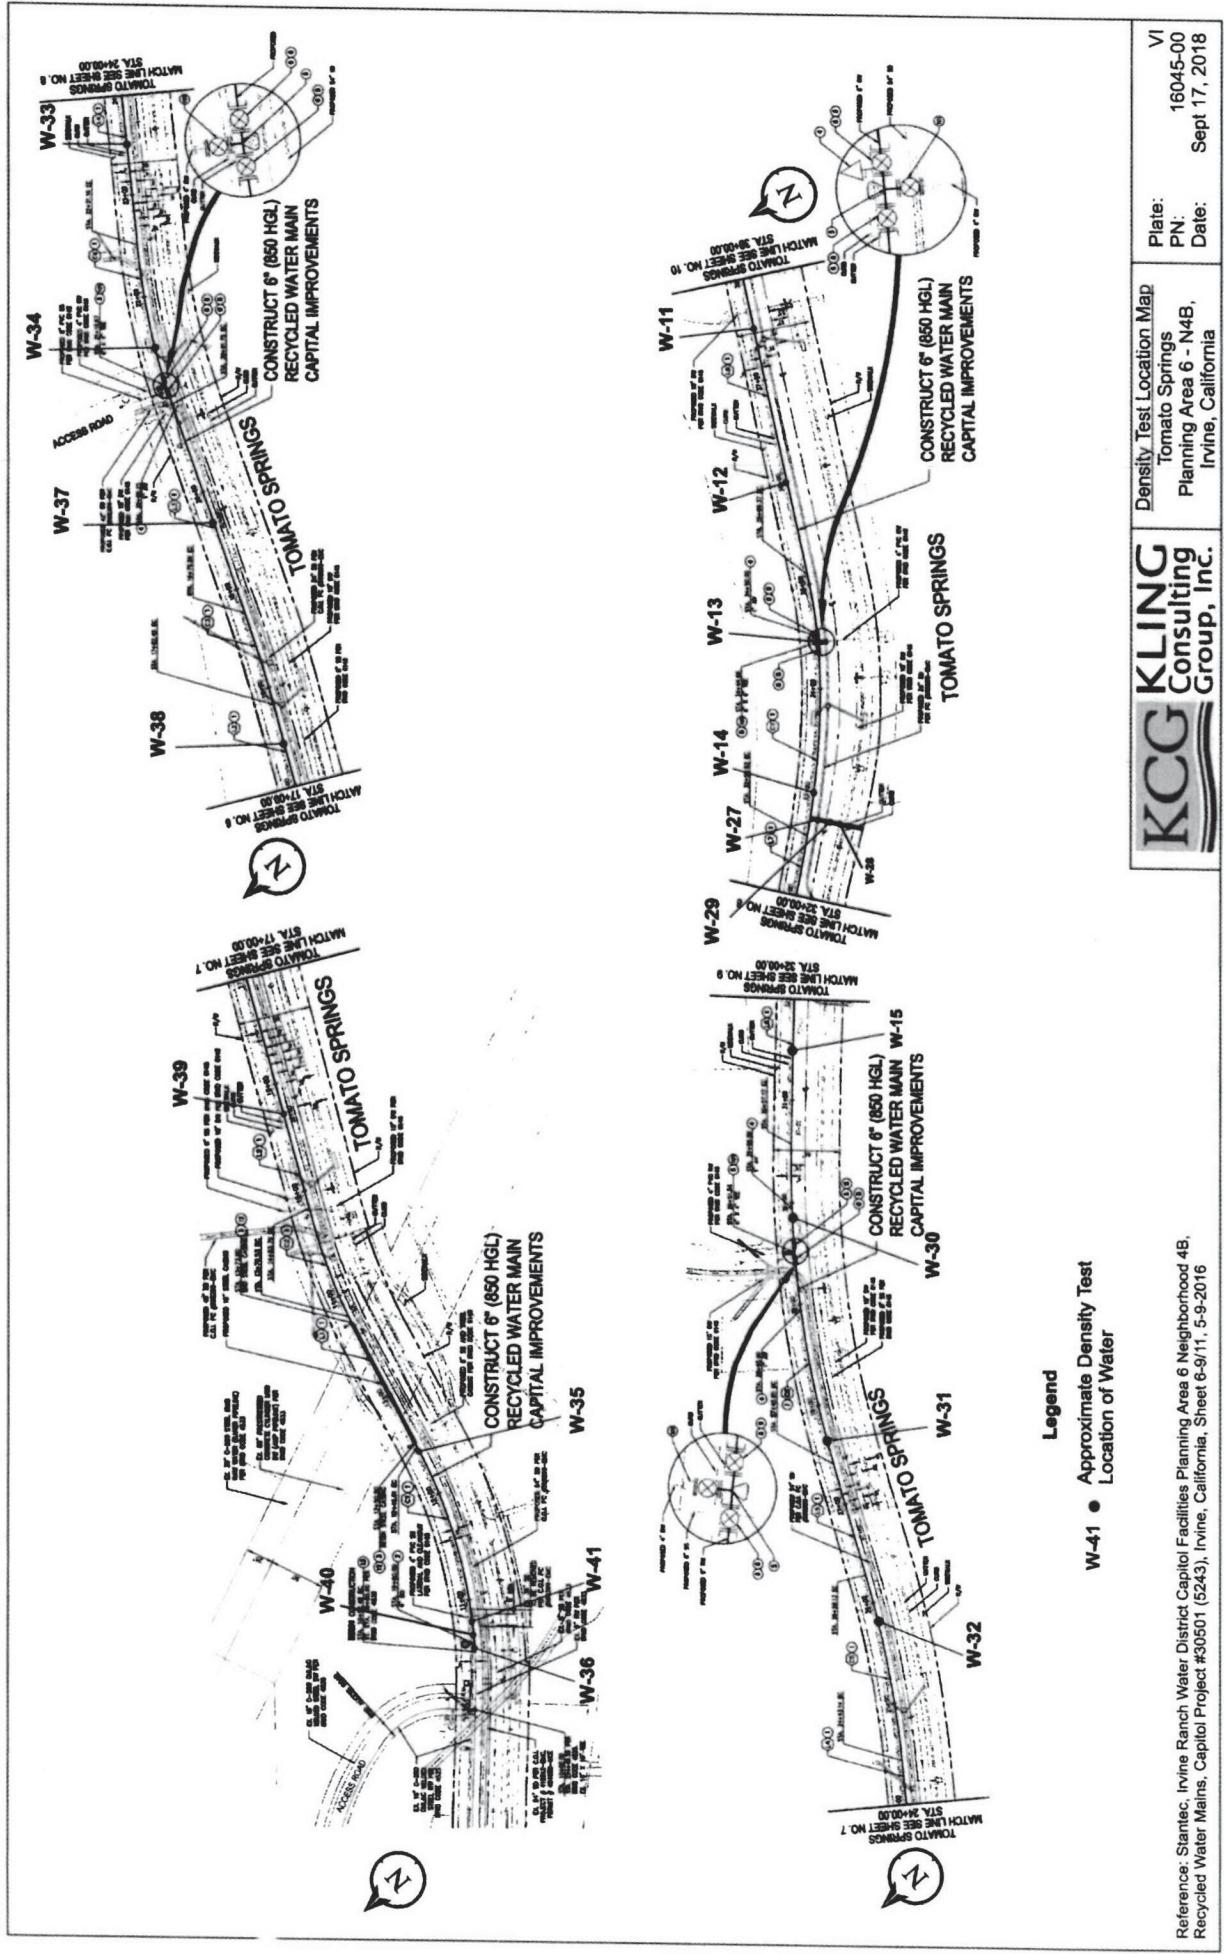
The street subgrade was compacted to at least 90 percent of the laboratory maximum dry density determined in accordance with ASTM D1557. In some areas were minor pumping were observed, a layer of Mirafi 600X was installed on top of the subgrade prior to placement of aggregate base material. The approximate lateral limits of Mirafi 600X are shown on the density test location map.
