The Village Green HOA Common Area *Orting, WA*

Report #: 53817-0
Beginning: January 1, 2025
Expires: December 31, 2025

RESERVE STUDY Update "With-Site-Visit"

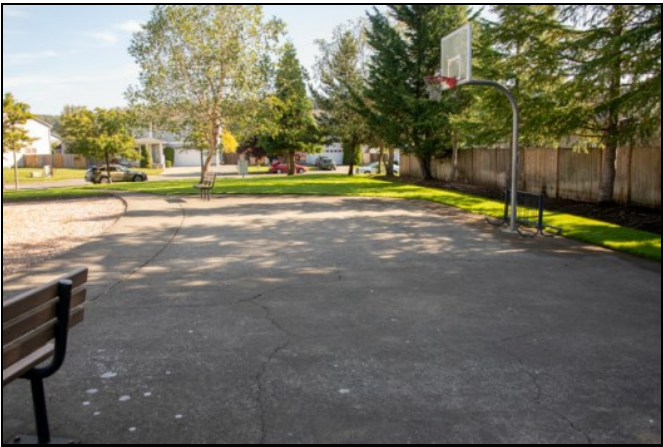
Comp #: 100 Concrete - Repair/Replace

Location: The community walkways and sports court
Funded?: No. Annual repair needs are below the reserves funding threshold.
History: None known

Comments: The concrete was located in a couple of the parks for pathways and for the sports court underneath the basketball hoop. At the time of our site visit, we did not observe root uplift or other safety hazards with the concrete.

As routine maintenance, inspect regularly and pressure wash for appearance. Repair any trip hazards (1/2" difference in height) immediately to ensure safety. Repair promptly, as needed, to prevent water penetrating into the base, which can cause further damage. Factors affecting the quality and service life of the concrete include the preparation of the underlying soil and drainage, thickness and strength of the concrete used, steel reinforcement (none likely), amount and weight of vehicle traffic, and tree roots.

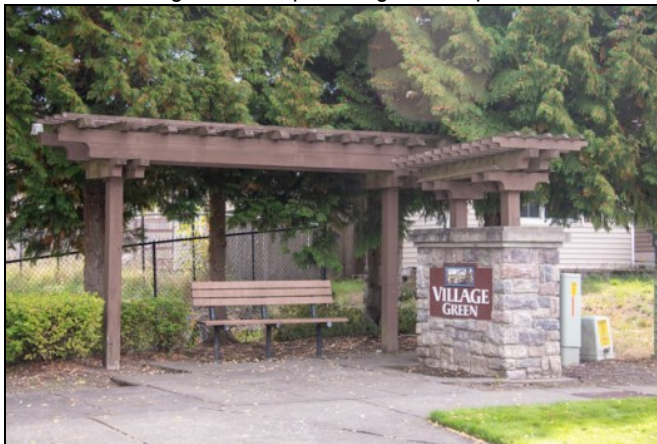
Comp #: 143 Trellis/Arbor - Repair/Replace

Comments: At the time of our site visit, the trellis structure was showing the initial stages of rot, especially at the top of the structure. No access was provided to observe the top of the structure in great detail, which is what receives the most rainfall and tends to rot prior to the remaining structure. The trellis structure was stained.

Useful Life:
20 years

Remaining Life:
0 years

Expect to replace the wood at roughly the time frame shown below. Evaluate it as the remaining useful life approaches zero years, and adjust its life accordingly.

Inspect periodically, and repair as needed. Clean and paint/stain as part of the exterior surfaces paint work (component #533), or as a general maintenance item. Consider installing a metal cap flashing at the top of the wood framing to extend the useful life.

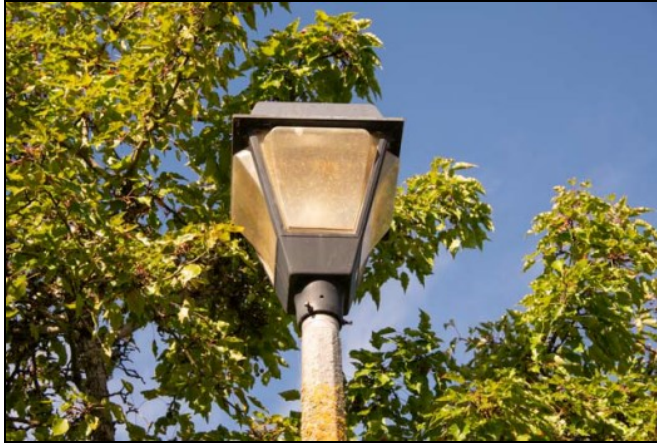
Comp #: 160 Pole Lights - Repair/Replace

Comments: The pole lights were observed during daylight hours and are assumed to be functional. We observed PSE tags on each light, indicating the maintenance responsibility belongs to Puget Sound Energy through the Intolight program. We observed a portion of the lights to be original to the community and a portion had been replaced with LED lights.

Our recommendation is to plan for a large-scale replacement project at roughly the time frame below, for both cost efficiency and consistent quality/appearance throughout the community. There are a variety of materials and styles available and a general mid-range funding allowance is projected below. Cost can vary significantly depending on the quality of the light pole chosen.

As routine maintenance, inspect, repair, and change bulbs as needed. Where possible, take precautions to limit damage from landscaping equipment.

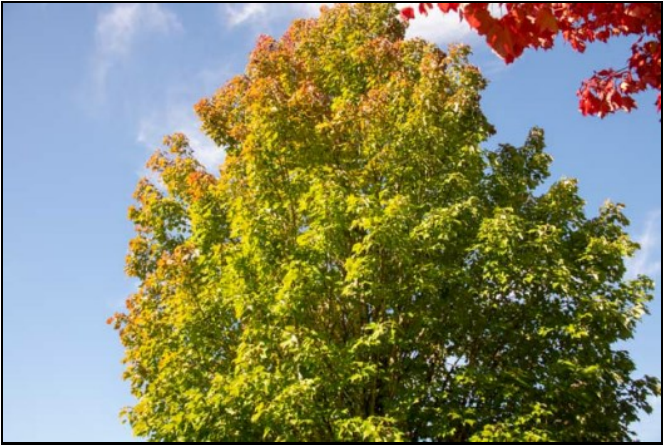
Comp #: 171 Trees - Trim/Remove & Replace

Useful Life:
5 years

Remaining Life:
4 years

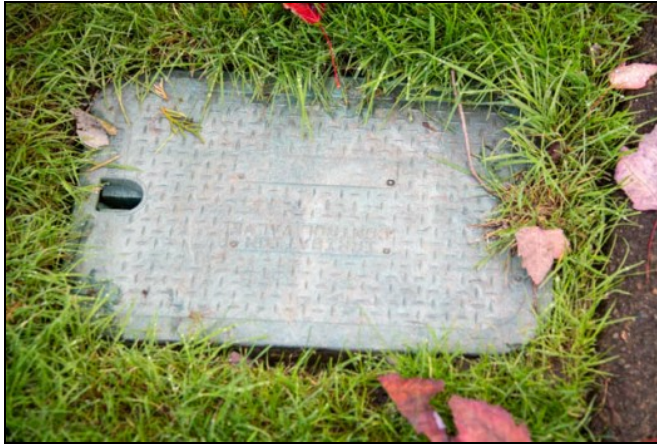
Comp #: 173 Irrigation System - Repair/Replace

Useful Life:
5 years

Remaining Life:
4 years

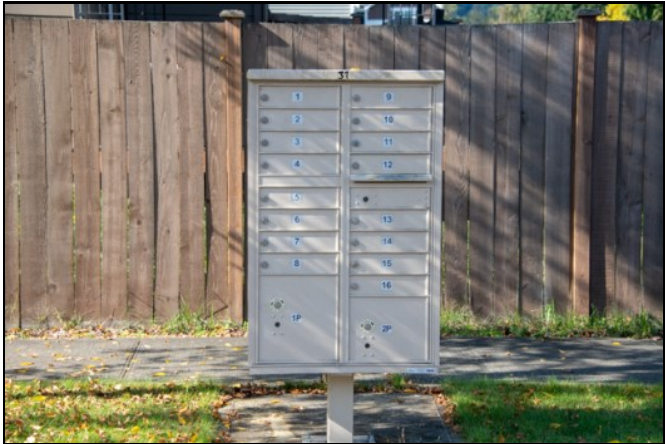
Comp #: 195 Mailboxes (a) - Repair/Replace

Useful Life:
20 years

Remaining Life:
0 years
