New Owners of Lehman SP135 & SP90 HP Engines

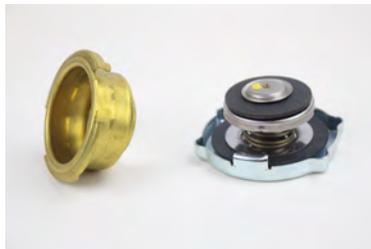
Part Number 822-5007 Recovery Bottle w/ new cap

Add A reclaim bottle and replace the original filler cap with one having an upper gasket for sealing. The recovery system will remove all air from the closed cooling system. You must first check the overflow pipe to be sure it is clear. Most overflows will require drilling out tat the tank. If you have questions phone ADC.

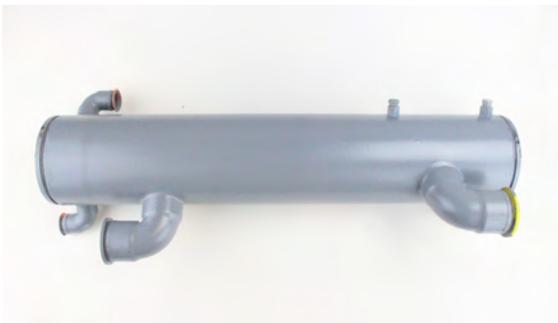
Inspect the main heat exchanger by removing the end covers and looking through the tubes with a light. If necessary, flush with water or remove for more detailed cleaning. Projected life in salt water is 2000 hours, but it is impossible to predict exactly due to other variances of conditions such as electrolysis and sand wear. We suggest carrying a spare exchanger after 2000 hours or if cruising in remote areas.

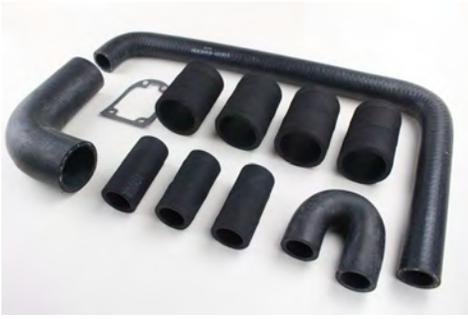
Replace all of your water hoses

Our kit will supply all of the water hoses required on your engine. The hoses are original molded shapes with wire inserts where needed.

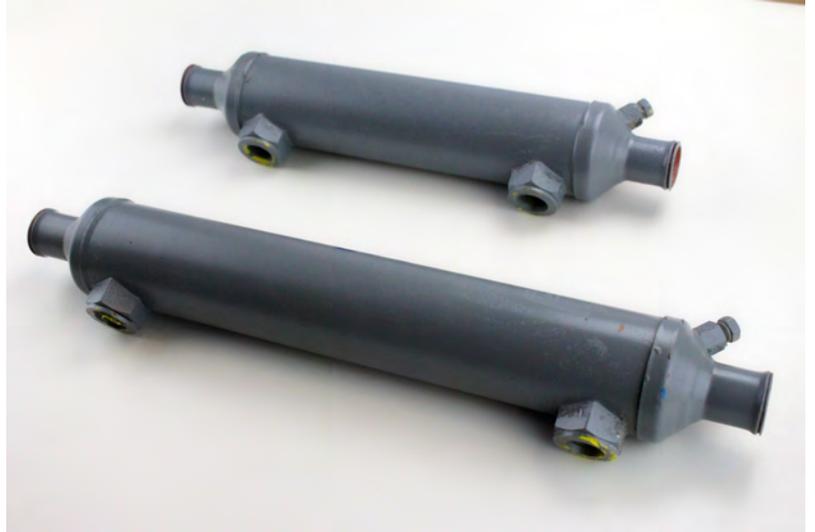
The most critical oil cooler on your Lehman engine is the Borg Warner transmission cooler. When it develops a leak, seawater will fill the Warner gear, requiring the transmission to be taken apart for proper cleaning and re-sealing. Suggested replacement time is at 1200 hours.

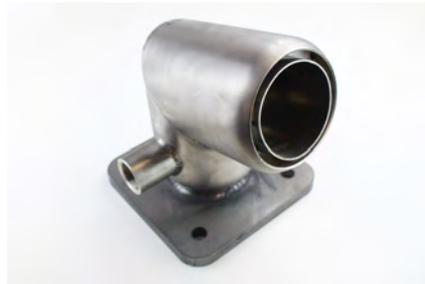
Inspect the exhaust elbow for rust as shown on the attached photo. The original L1A397 Elbow was a cast iron part, which rusted from the inside. Remove 3.5" O.D. exhaust hose from the bib. This will allow inspection of the water port and other internal portions of the elbow. The factory changed the material to stainless steel which is now supplied using the same part number.

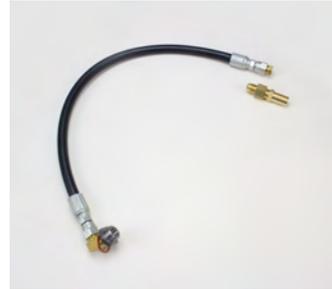
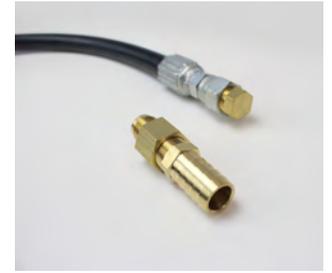
Part Number 510-1020 Oil Drain Kit

Install our oil drain kit in place of the original oil pan drain plug. This kit makes the chore of removing oil a snap. It pulls all oil from the pan in a matter of minutes, with either a hand or electrical pumps. Ask about our electrical oil change packages, available for permanent installation.
