HAWKEYE HOME INSPECTIONS

HOME INSPECTION REPORT

1234 Main St. Bel Air Maryland 21014

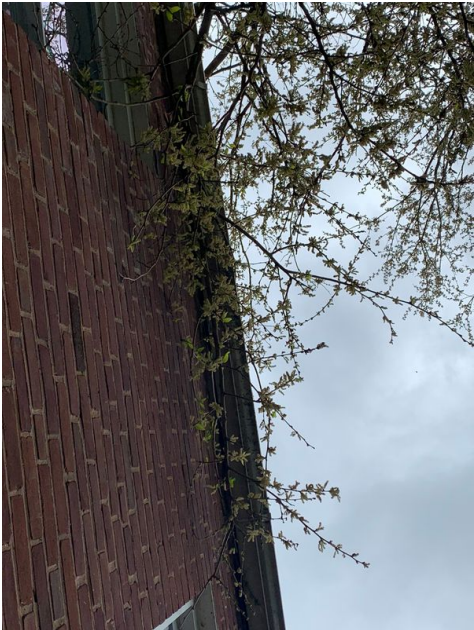
I observed indications that a tree and or tree branch where overhanging the roof and maybe in contact with it. Recommend trimming.

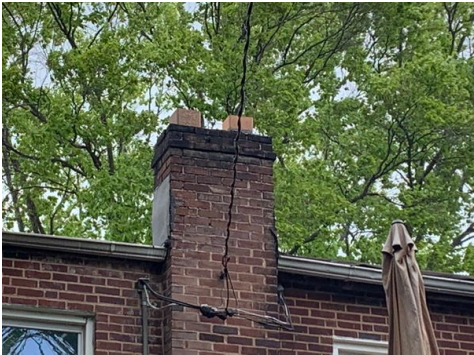
MASONRY CHIMNEY DETERIORATION

There is minor deterioration to masonry chimney exterior. Recommend repointing and evaluation.

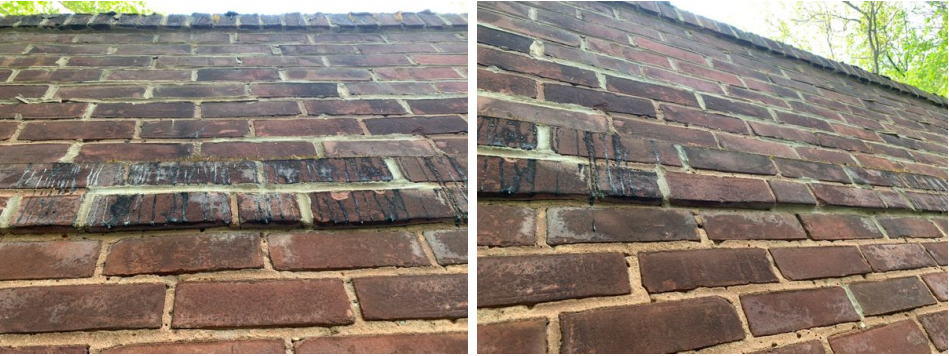
DETERIORATED BRICK/MORTAR

There is minor damage to some exterior bricks and missing mortar in sections. Recommend having repaired.

Contact a qualified professional.

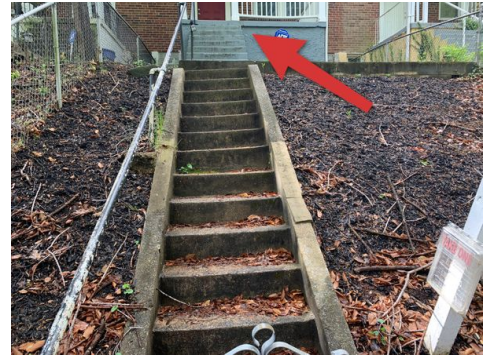
MISSING HANDRAIL

I observed a missing handrail at the exterior steps.

There is more than one step here, and I recommend installing a handrail for safety.

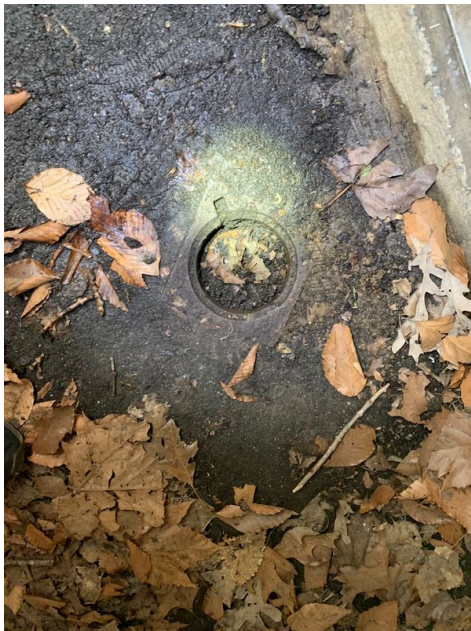
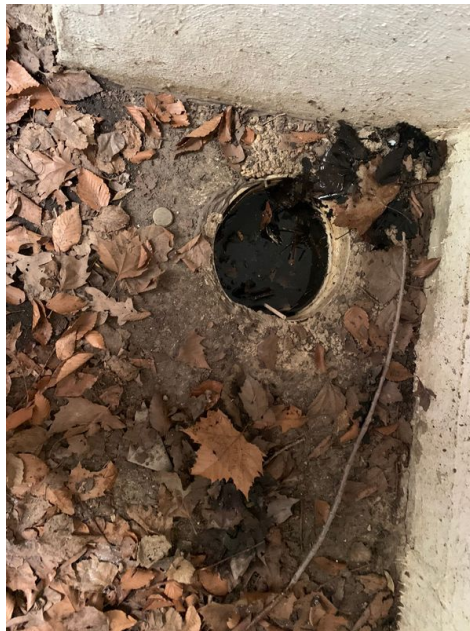
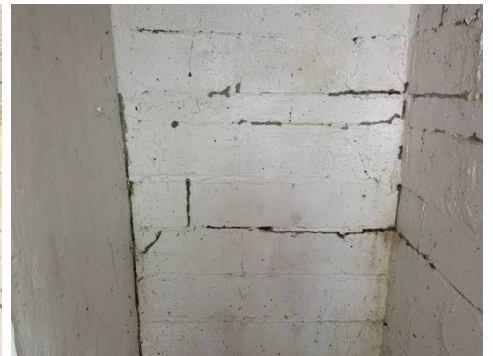
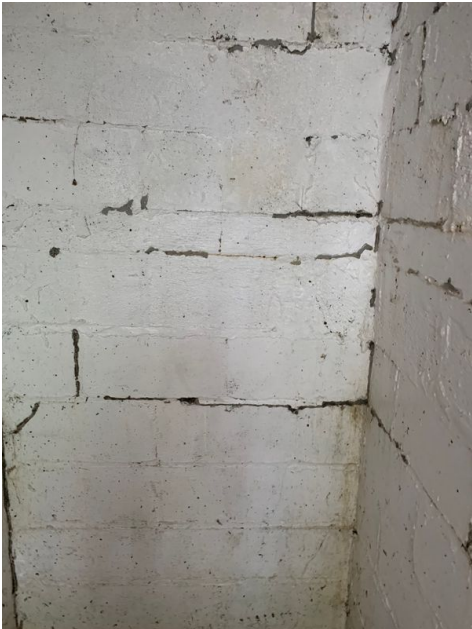
BASEMENT STAIR DRAIN

It should be noted that the drain at the bottom of the exterior basement stairs was severely clogged with debris. The water accumulation appears to have lead to water damage to wall and water intrusion into basement. Recommend having drains cleaned and scoped to ensure there is no damage. Also recommend having exterior wall repaired.

Contact a qualified general contractor.

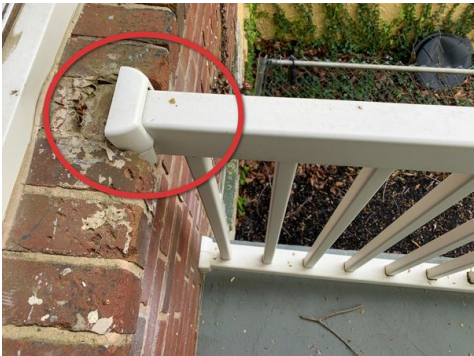
LOOSE RAILING COMPONENT

I observed a loose railing component. This condition is a safety hazard. Recommend having railing properly secured.

Contact a qualified handyman.

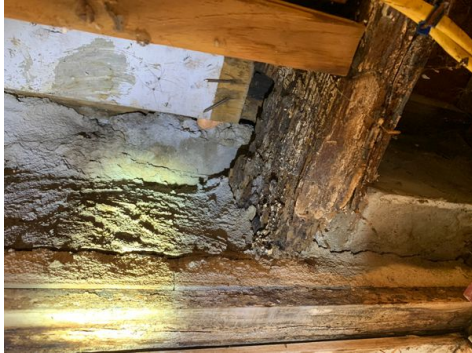
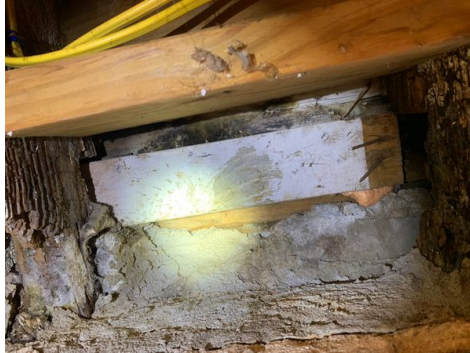
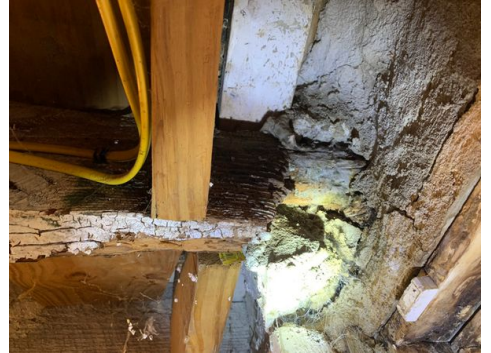
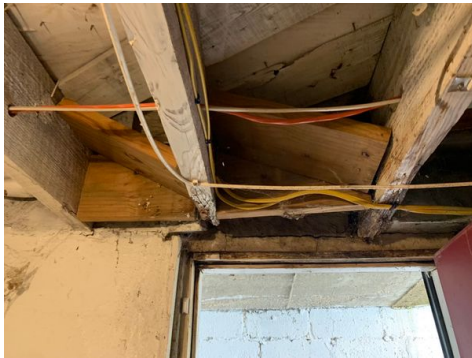
There was severe rot in two floor joists. They should be replaced and /or repaired by a qualified contractor to ensure proper structural support.

Contact a qualified professional.

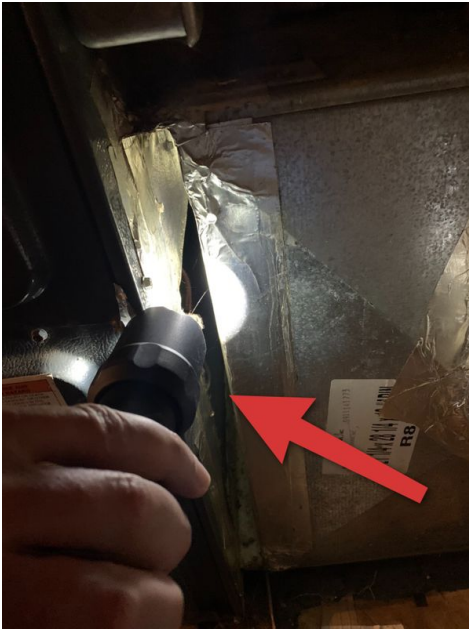
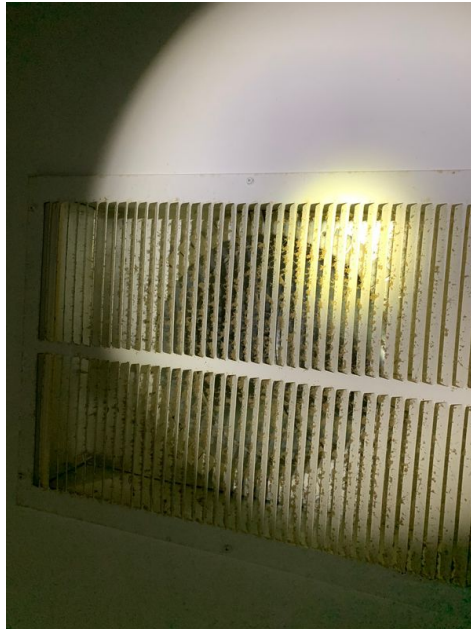
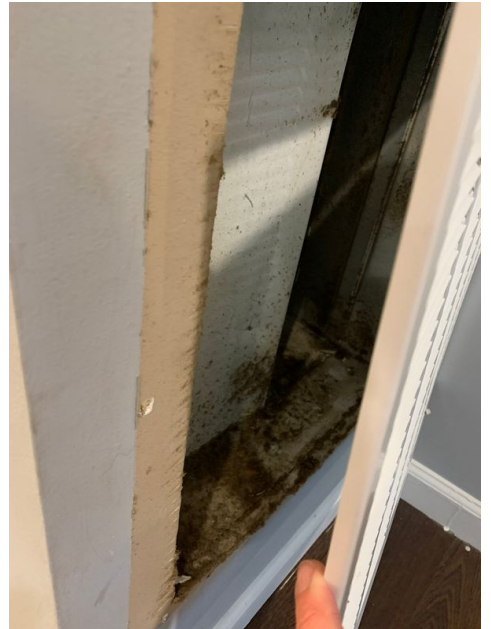
FILTER MISSING

I observed a missing air filter at the furnace. Recommend having all ducts clean due to excessive build up from missing filter.

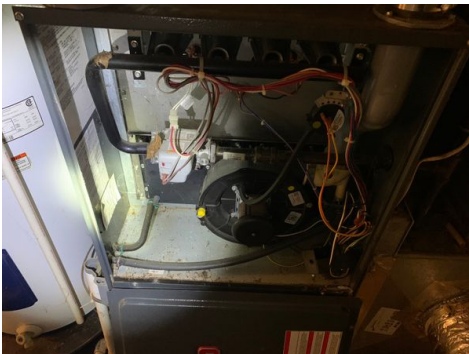
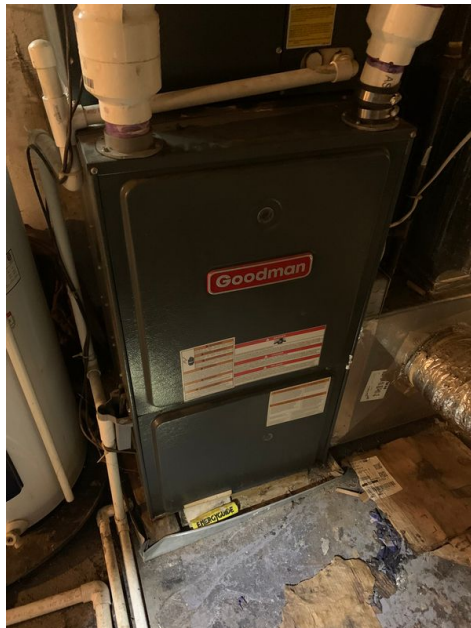
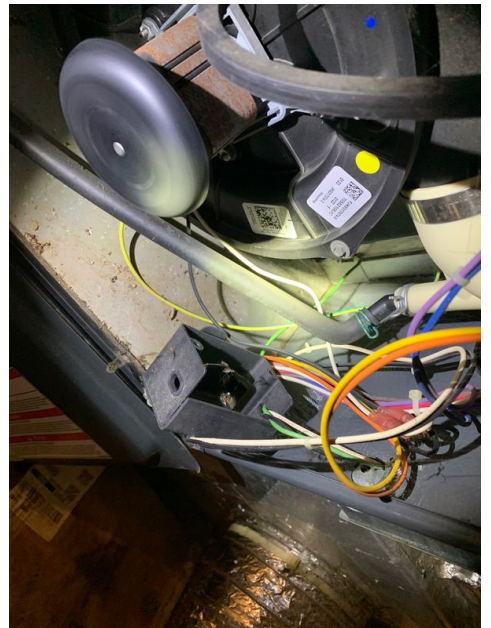
HEATING SYSTEM DID NOT OPERATE

I observed that the heating system did not pump hot air when turning on the system. TheRecommend having repaired by a qualified contractor to ensure proper operation of heat and A/C.

Contact a qualified HVAC professional.

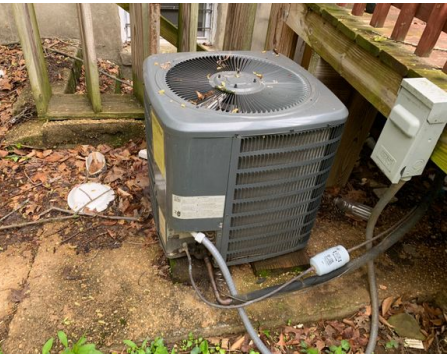
Condensate: Condensate Discharge Confirmed

I observed a discharge pipe apparently connected to the condensate pump installed at the cooling system.

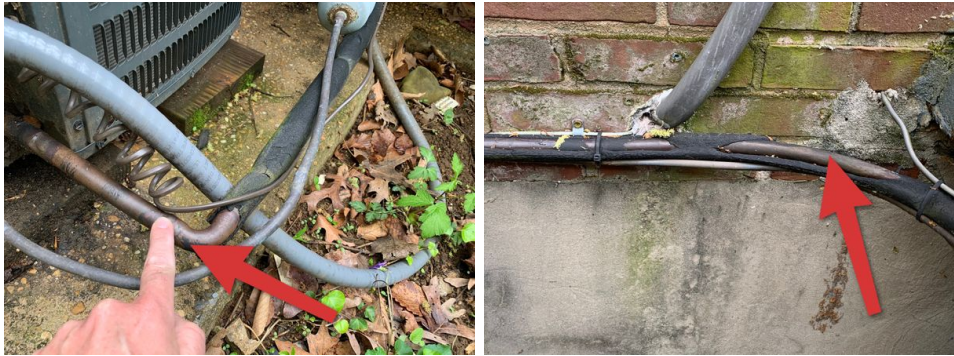
REFRIGERANT LINE INSULATION MISSING OR DAMAGED

I observed missing or damaged foam insulation at the cooling system's refrigerant line, which can cause energy loss and condensation.

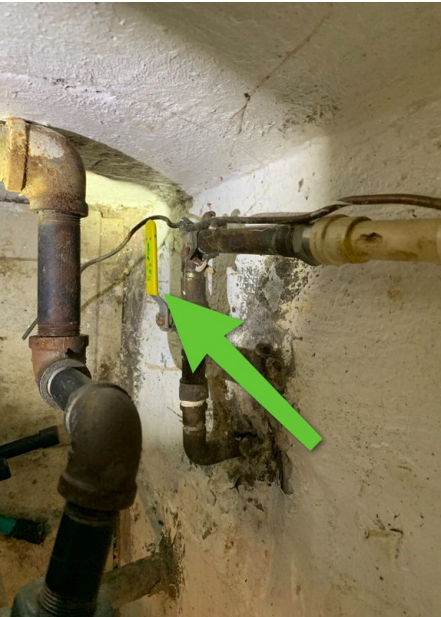
Main Water Shut-Off Valve:	Hot Water Source: Inspected TPR Valve	Hot Water Source: Date of manufacture
Location of Main Shut-Off Valve		
Basement	I inspected the temperature and pressure relief valve.	2014
See photo.

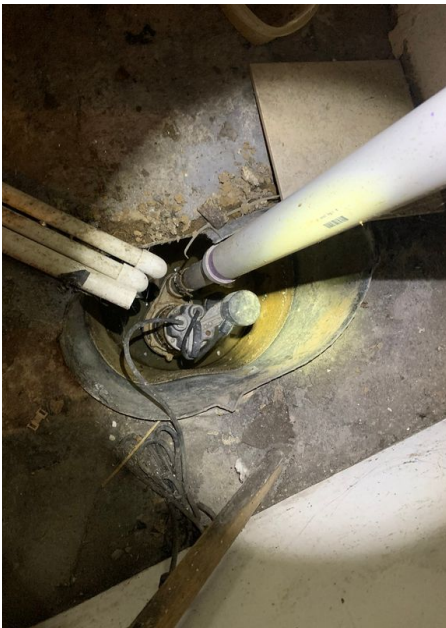
Sump Pump: Sump Pump Installed

A sump pump is installed on the premises. This may indicate that water accumulates inside or below the structure, or may just be a pre-caution. Recommend asking the property owners how often the sump pump operates and for how long at different times of the year. Also, the clients should be aware that the service life of most sump pumps is between five and seven years, and that the pump may need replacing soon depending on its age and how much it operates.

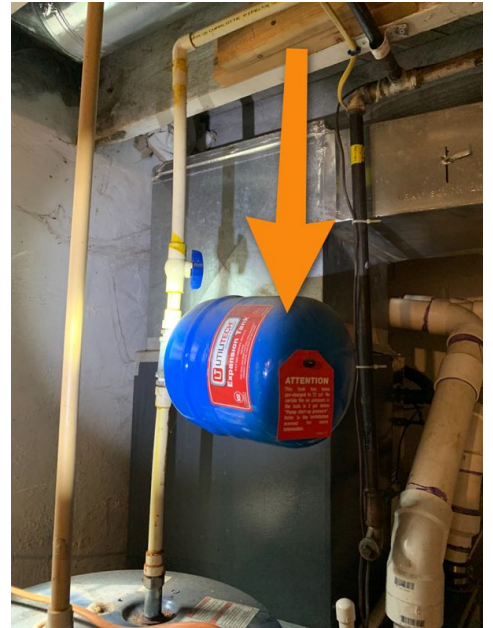
Recommend monitoring expansion tank and potentially adding supports if needed.

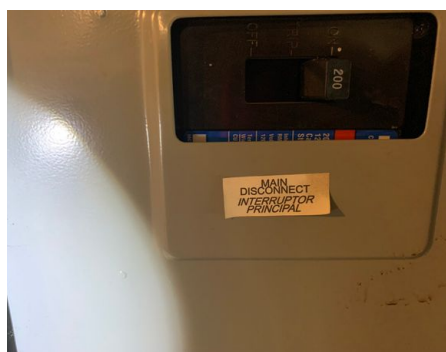
Main Service Disconnect: Main Shutoff

I inspected the electrical main service disconnect.

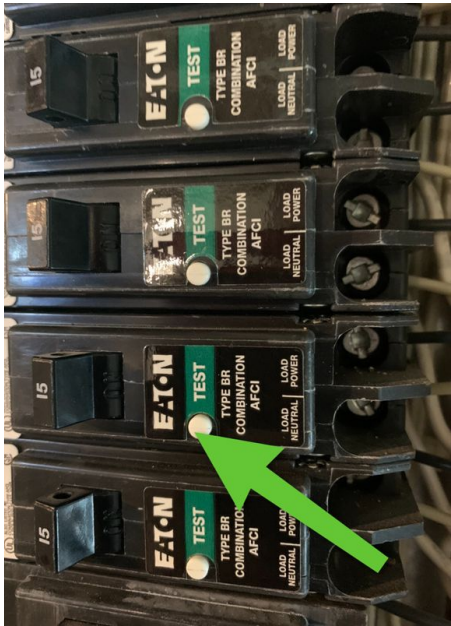
AFCIs: Inspected AFCIs

I inspected receptacles observed that were deemed to be arc-fault circuit interrupter (AFCI)-protected using the AFCI test button, where possible.

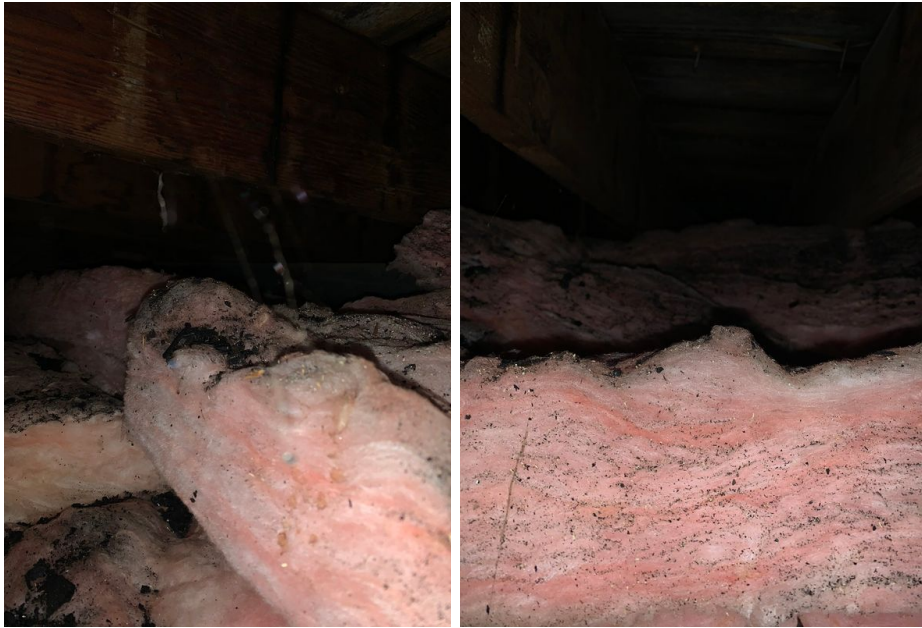
Structural Components & Observations in Attic: Structural Components Were Inspected

Structural components were inspected from the attic space according to the [Home Inspection Standards of Practice](#).

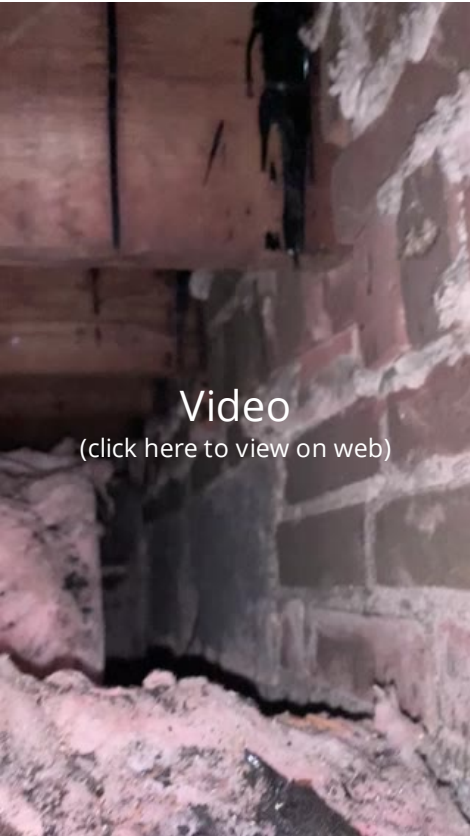
COULD NOT SEE EVERYTHING IN ATTIC

I could not see and inspect everything in the attic space. The access is restricted and my inspection is limited.

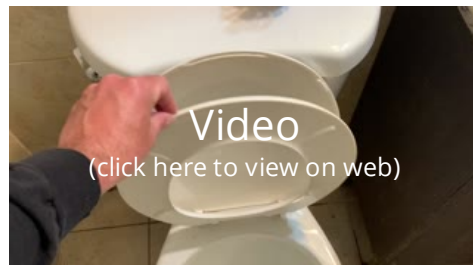
LOOSE HANDLE AT TOILET

I observed a loose handle and seat at the toilet.

Recommended DIY Project

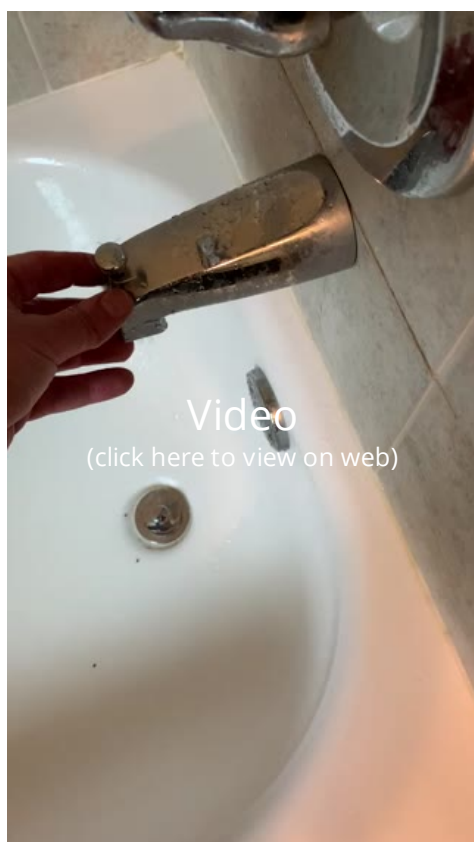
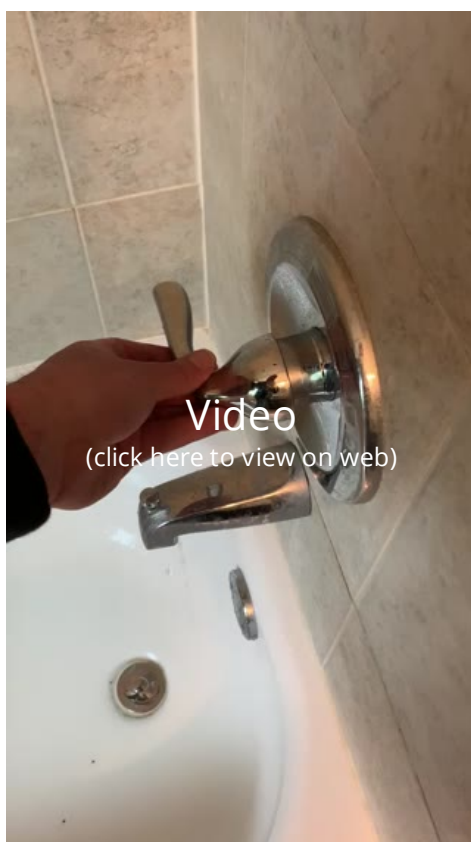
LOOSE FIXTURES

I observed that several fixtures are loose. Recommend having secured and repaired properly.

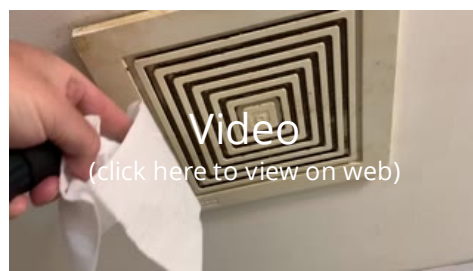
IMPROPERLY EXHAUSTING

I observed that the bathroom fan is improperly exhausting air from the bathroom and it appears to be clogged.

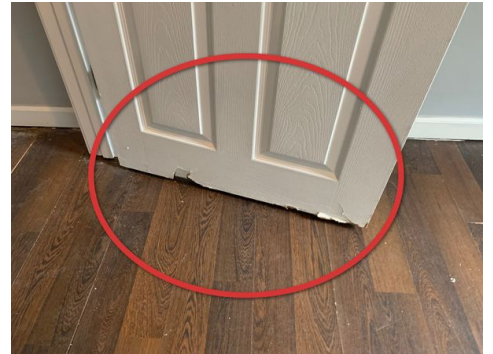
DAMAGED DOOR

I observed damage to the bottom of bedroom door.

Contact a qualified handyman.

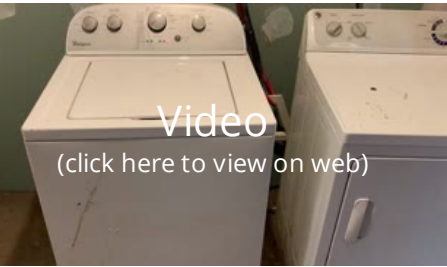
Clothes Washer: Washer inspected

I ran the washing machine and dryer, they were both functioning at the time of the inspection.

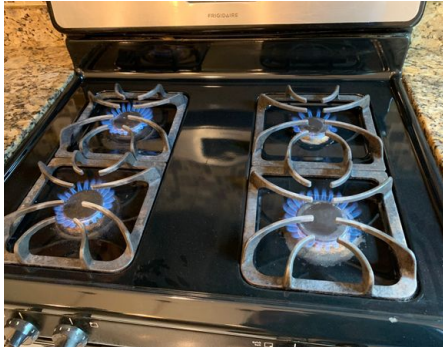
Range/Oven/Cooktop: Turned On Stove & Oven

I turned on the kitchen's stove and oven.
