# HAWKEYE HOME INSPECTIONS

## HOME INSPECTION REPORT

1234 Main St. Bel Air Maryland 21014

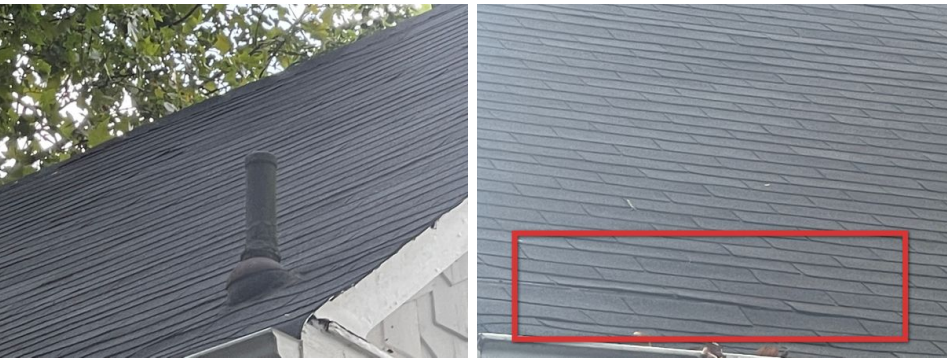
DETERIORATION: MINOR

Asphalt shingles covering the roof of this home exhibited minor general deterioration that appeared to be commensurate with the age of the roof.

Contact a qualified professional.

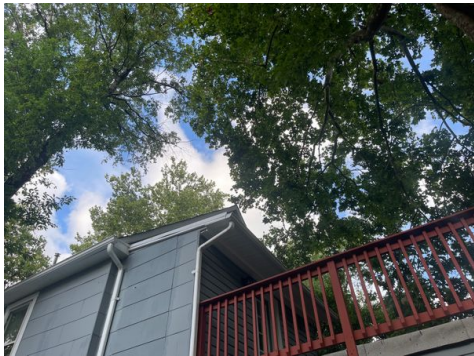
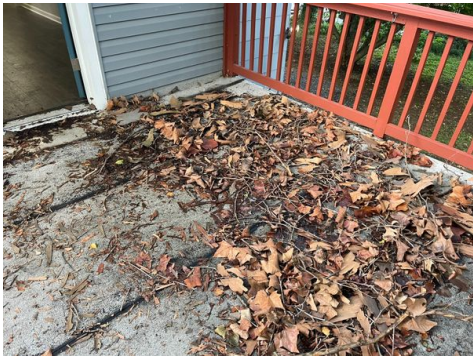
2.2.2 Roof Covering

TREE OVERHANG

Moderate Concern/Repair

I observed indications that a tree and or tree branch where overhanging the roof and maybe in contact with it, this may cause damage if it has not already. The Inspector recommends that all tree branches be cut back so that they do not overhang the roof. All debris should be removed from roof to prevent damage.

Contact a qualified tree service company.

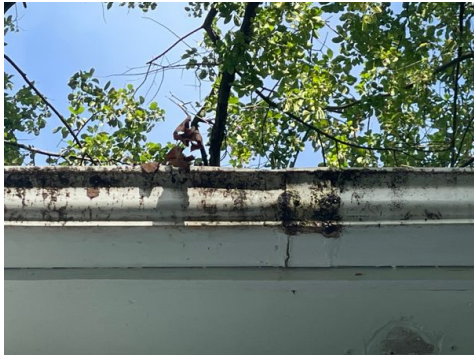
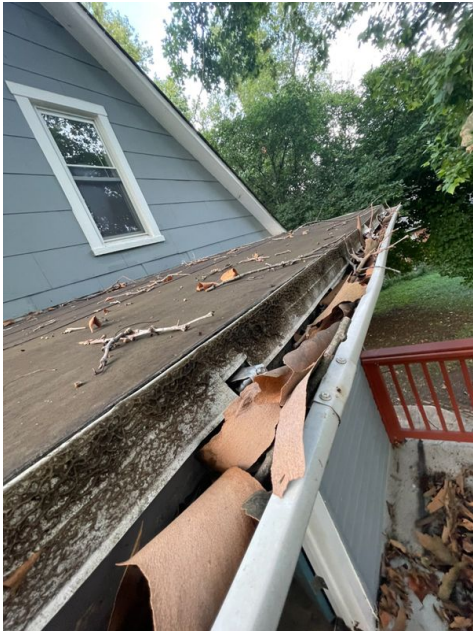
2.4.1 Gutters & Downspouts

**DEBRIS IN GUTTERS**

I observed minimal debris in the gutter. Cleaning and maintenance is recommended regularly to ensure proper runoff away from the homes foundation.

Contact a qualified gutter contractor

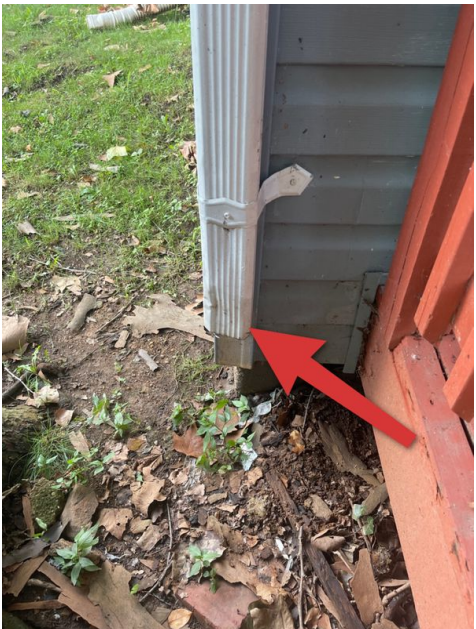
2.4.2 Gutters & Downspouts

**DOWNSPOUTS DRAIN NEAR HOUSE**

One or more downspouts drain too close to the home's foundation and underground downspout extension appears to be clogged. This can result in excessive moisture in the soil and water intrusion at the foundation. Recommend replacing corrugated underground drainage component and installing more effective downspout extensions to drain at least 6 feet from the foundation.

Recommendation  
Contact a qualified landscaping contractor

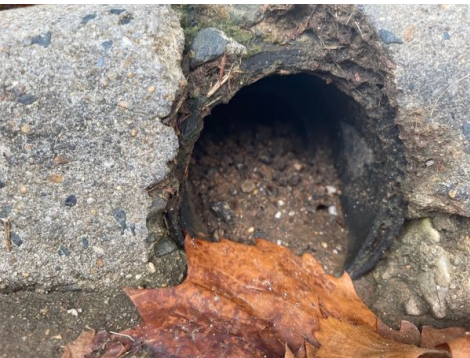
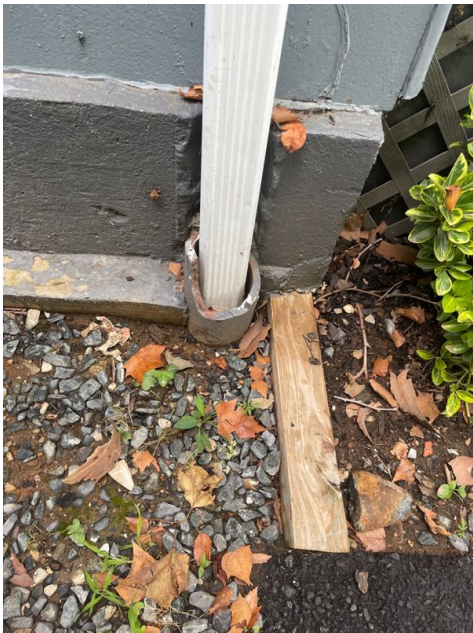
2.4.3 Gutters & Downspouts

**UNDERGROUND DOWNSPOUT**

Appears clogged, recommend clearing or installing alternate extension.

Recommendation  
Contact a qualified professional.

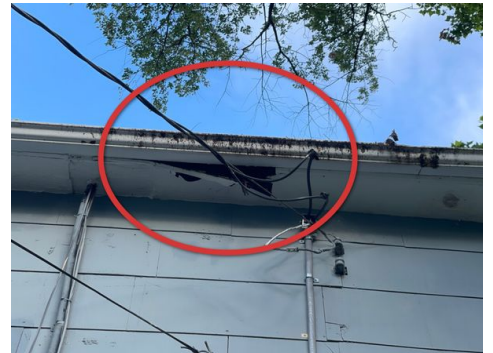
#### **DAMAGE OBSERVED AT SOFFIT**

I observed indications that one or more areas of the soffit was significantly damaged. This is likely due to clogged gutters and water overflowing in this area. Recommend having repaired and Oreo perky sealed to prevent water damage at interior and vermin intrusion.

Serious Concern/Action Needed

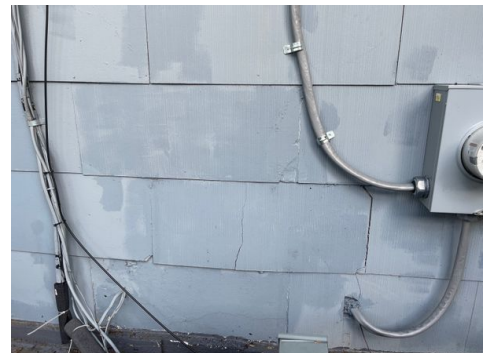
### 3.3.1 Wall-Covering, Flashing & Trim

#### **MINOR CRACKING**

Minor cracking observed at exterior wall. This does not appear to be a structural concern. Recommend sealing to prevent water intrusion and monitoring.

Minor Concern/Maintenance needed

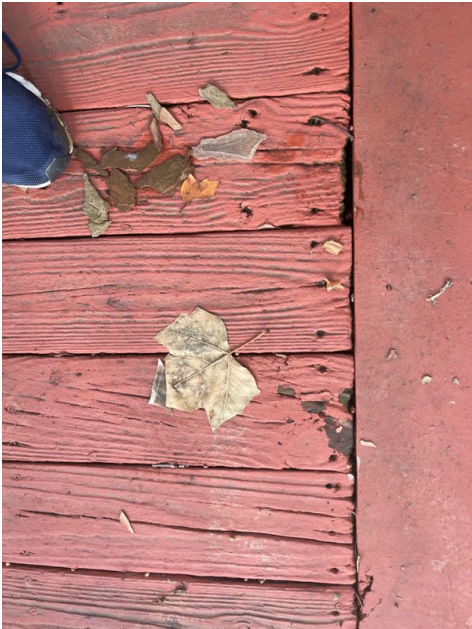
### 3.8.1 Porches, Patios, Decks, Balconies & Carports

#### **DETERIORATED CONDITION AT DECK**

I observed indications of deteriorated conditions at the deck components. Recommend monitoring and resealing/waterproofing as needed.

Minor Concern/Maintenance needed

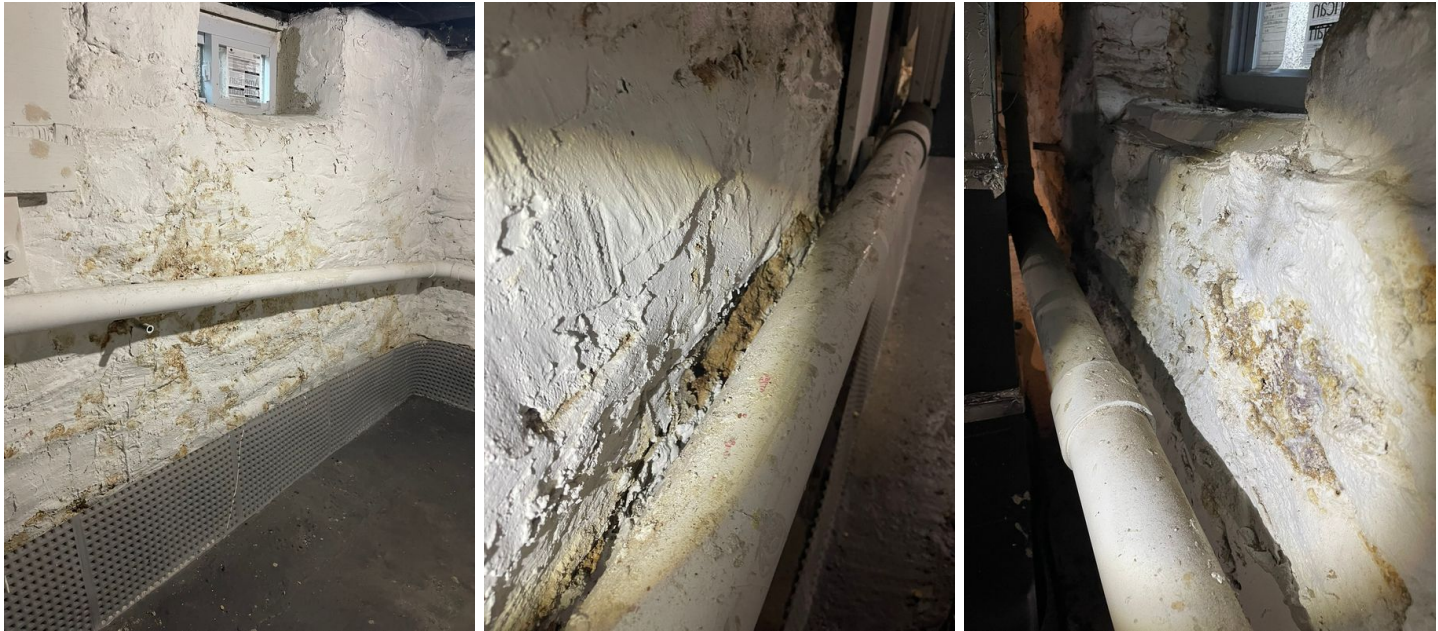
MOISTURE INTRUSION

Moisture and efflorescence was observed at basement wall. This could be a result of the negative grading in this area at the exterior and roof drainage overflow from clogged gutters. Recommend correcting at exterior and observing. A dehumidifier may also be helpful.

Moderate Concern/Repair

Recommendation  
Contact a qualified professional.

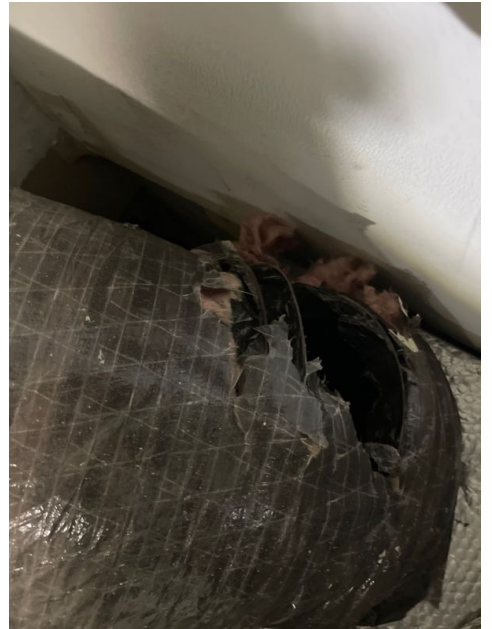
**DUCT DAMAGED**

I observed indications of damage at the ductwork.

Recommended DIY Project

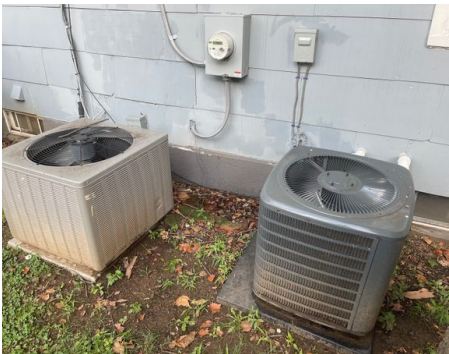
Cooling System Information: Service Disconnect Inspected

I observed a service disconnect within sight of the cooling system.

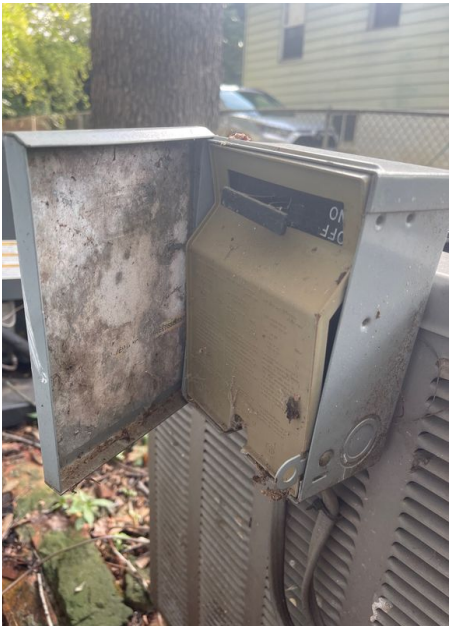
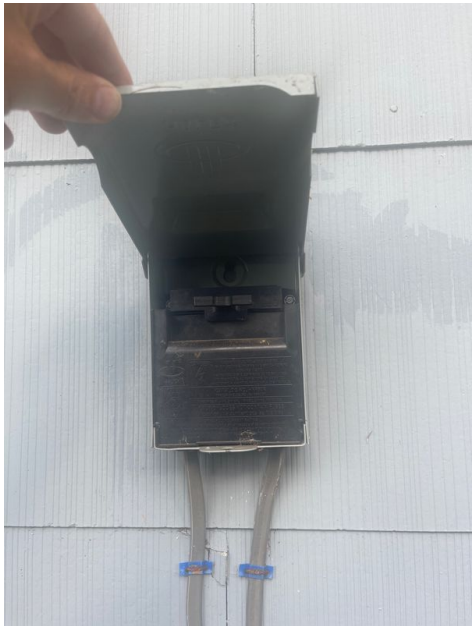
Cooling System Information: Picture Of Data Plate

See data plate for model and serial number

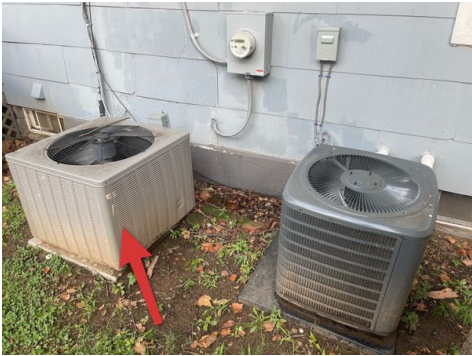
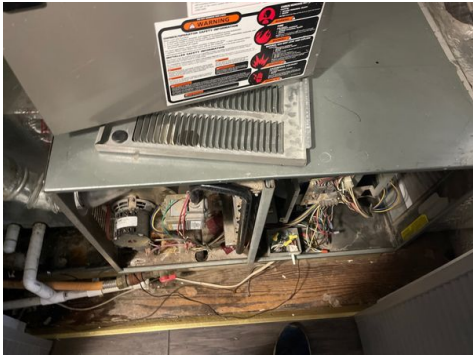
6.1.1 Cooling System Information

I observed during my inspection that the 3rd floor system appeared to be older. Regular maintenance and monitoring of its condition is recommended. Budgeting for repairs and future replacement is recommended. [InterNACHI's Standard Estimate Life Expectancy Chart for Homes](#)

Minor Concern/Maintenance needed

Recommendation  
Recommend monitoring.

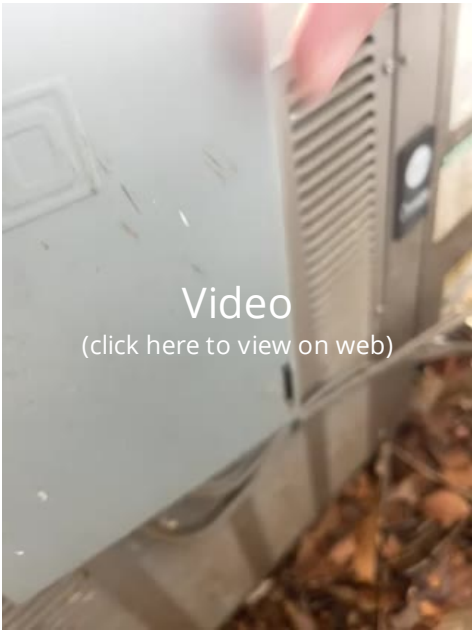
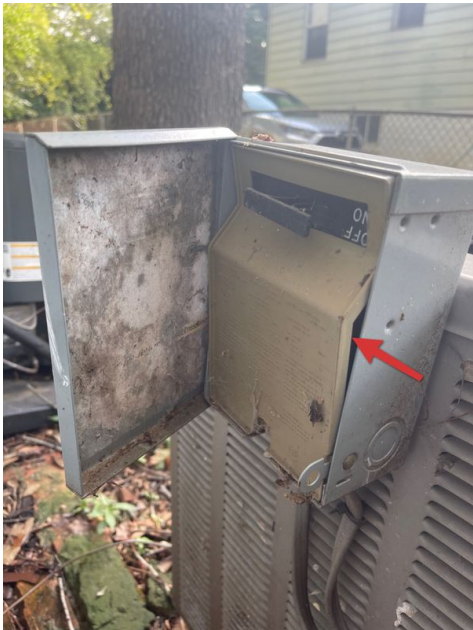
6.1.2 Cooling System Information

**SERVICE DISCONNECT**

Moderate Concern/Repair

The service disconnect would not stay closed and should be secured to prevent water intrusion.

Recommendation  
Contact a qualified professional.

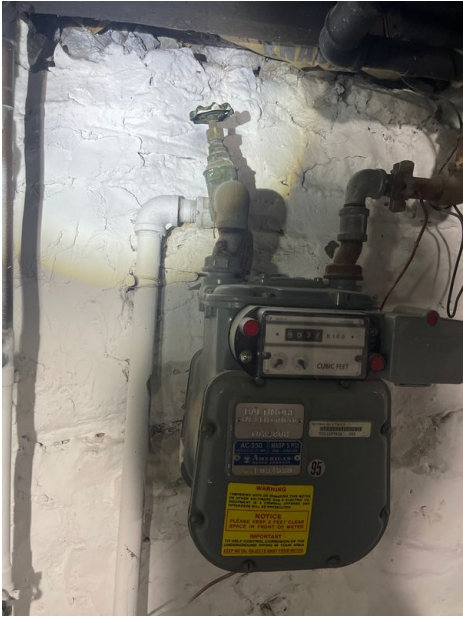
Main Water Shut-Off Valve: Homeowner's Responsibility

It's important to know where the main water and fuel shutoff valves are located, and be sure to keep an eye out for any water and plumbing leaks.

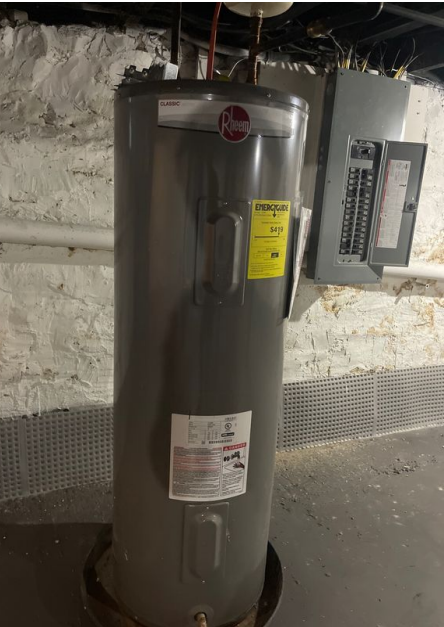
### Hot Water Source: Inspected Hot Water Source

I inspected the hot water source and equipment according to the [Home Inspection Standards of Practice](#).

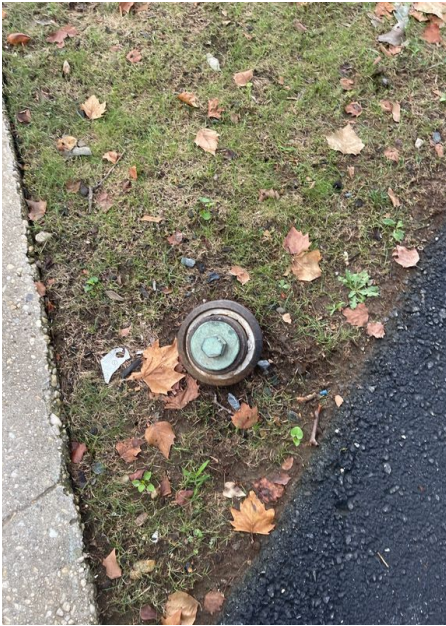
### Water Supply & Distribution Systems: Inspected Water Supply & Distribution Pipes

I attempted to inspect the water supply and distribution pipes (plumbing pipes). Not all of the pipes and components were accessible and observed. There did not appear to be any active leaks at the time of the inspection.

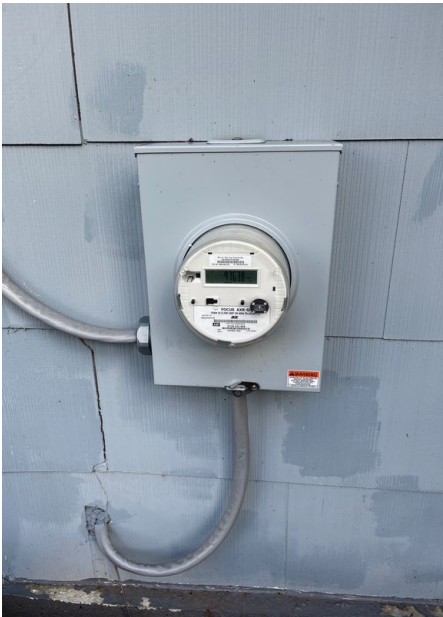
Service-Entrance Conductors: Inspected Service-Entrance Conductors

I inspected the electrical service-entrance conductors.

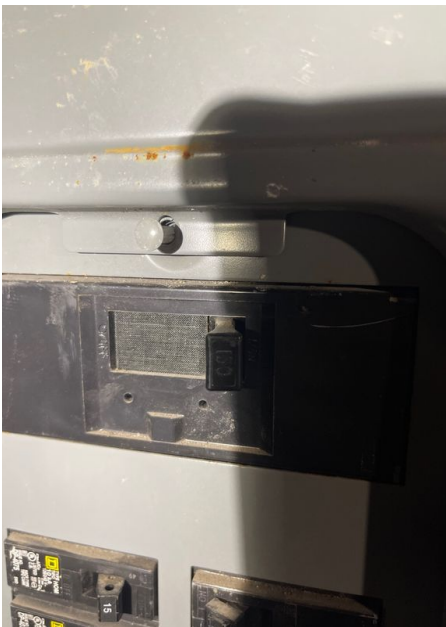
## Panelboards & Breakers: Inspected Main Panelboard & Breakers

I inspected the electrical panelboards and over-current protection devices (circuit breakers and fuses).

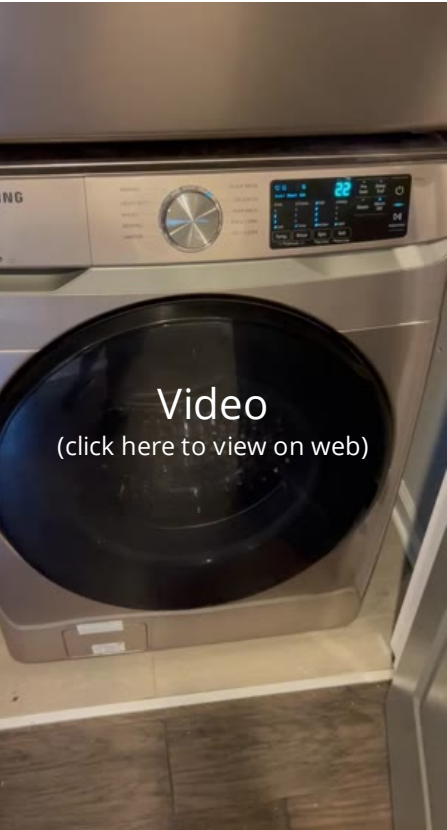
**Clothes Dryer: Dryer Inspected**

I inspected the dryer by running a short cycle and evaluating venting and power source.
