## Whispering Palms *Hemet, CA*

Report #: 14073-3  
Beginning: July 1, 2021  
Expires: June 30, 2022

## RESERVE STUDY Update "With-Site-Visit"

June 9, 2021

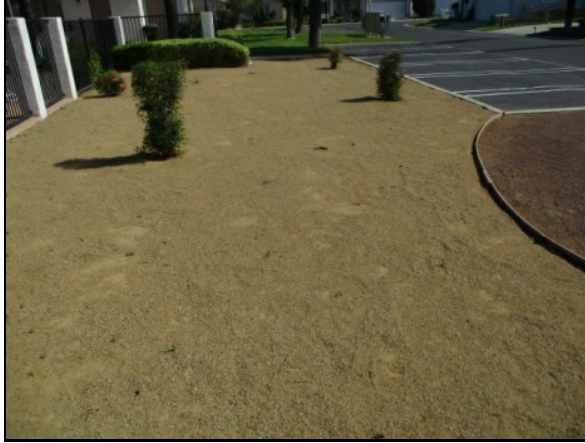
Comments: The association has periodically refurbished the landscaping throughout the community. An allowance has been provided on roughly the schedule below.

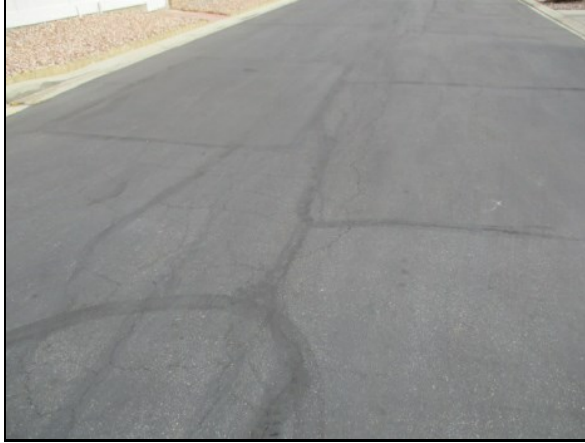
Comments: Regular seal projects are necessary preventative maintenance projects for asphalt surfaces. Conditions vary throughout the property. Areas of cracking observed throughout.

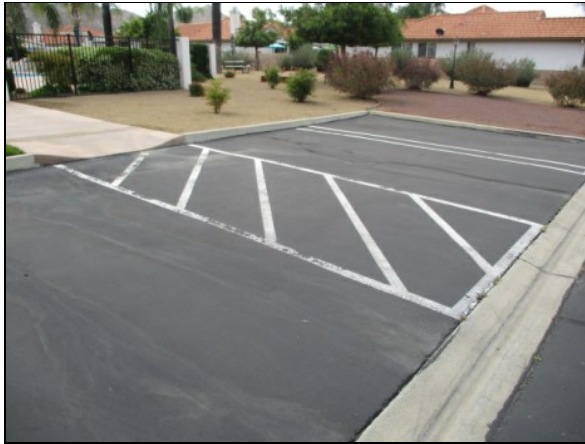
Comments: Regular seal projects are necessary preventative maintenance projects for asphalt surfaces. Fair condition. Plan to seal along with the main sealing project for efficiency.

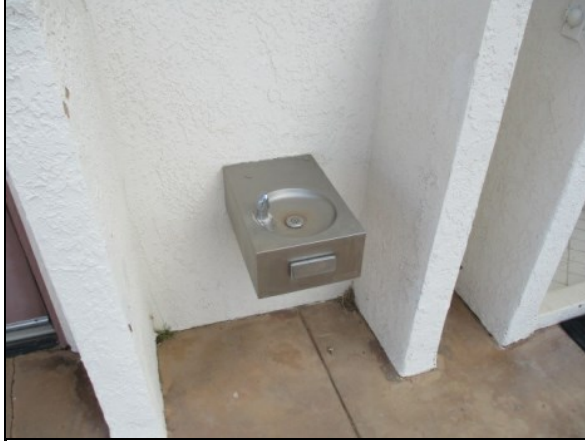
Comments: Replace at the board's discretion.

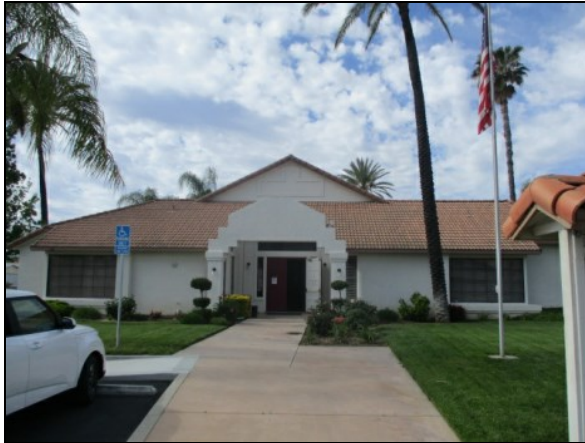
Comments: Plan to periodically repaint in order to maintain an attractive appearance.

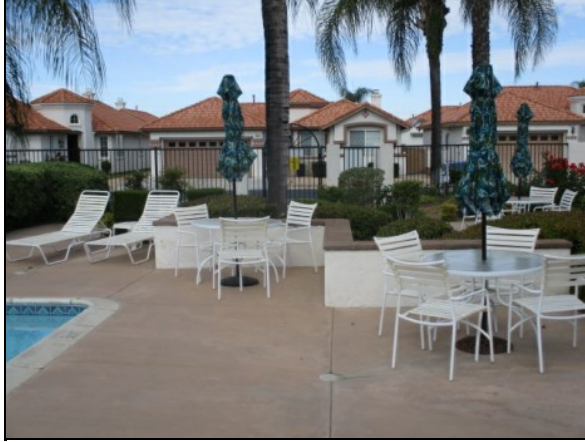
Comments: Expect to replace on roughly the schedule below.

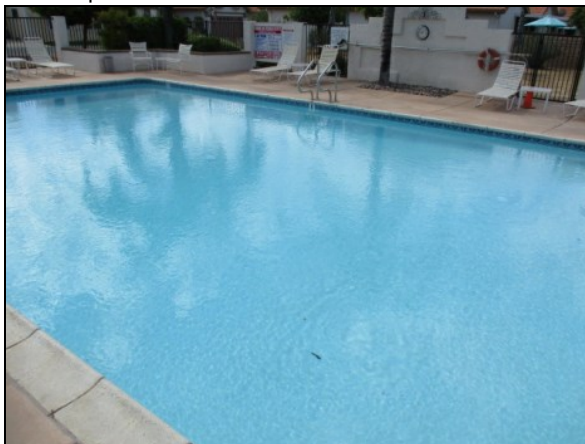
Comments: Pool resurfacing will restore the aesthetic quality of the pool while protecting the actual concrete shell of the pool from deterioration. While drained for resurfacing any other repairs to lighting handrails stairs ladders etc. should be conducted as needed. This type of project is best suited for slow/offseason to minimize downtime during periods when pool is used heavily. Should be expected at the approximate interval shown below; in some cases schedule may need to be accelerated due to improper chemical balances or aesthetic preferences of the Association.
