David Grandpré, P.E., is a structural engineer in Cranston, R.I. Photos by the author, except where noted.

WHY DECKS FALL DOWN

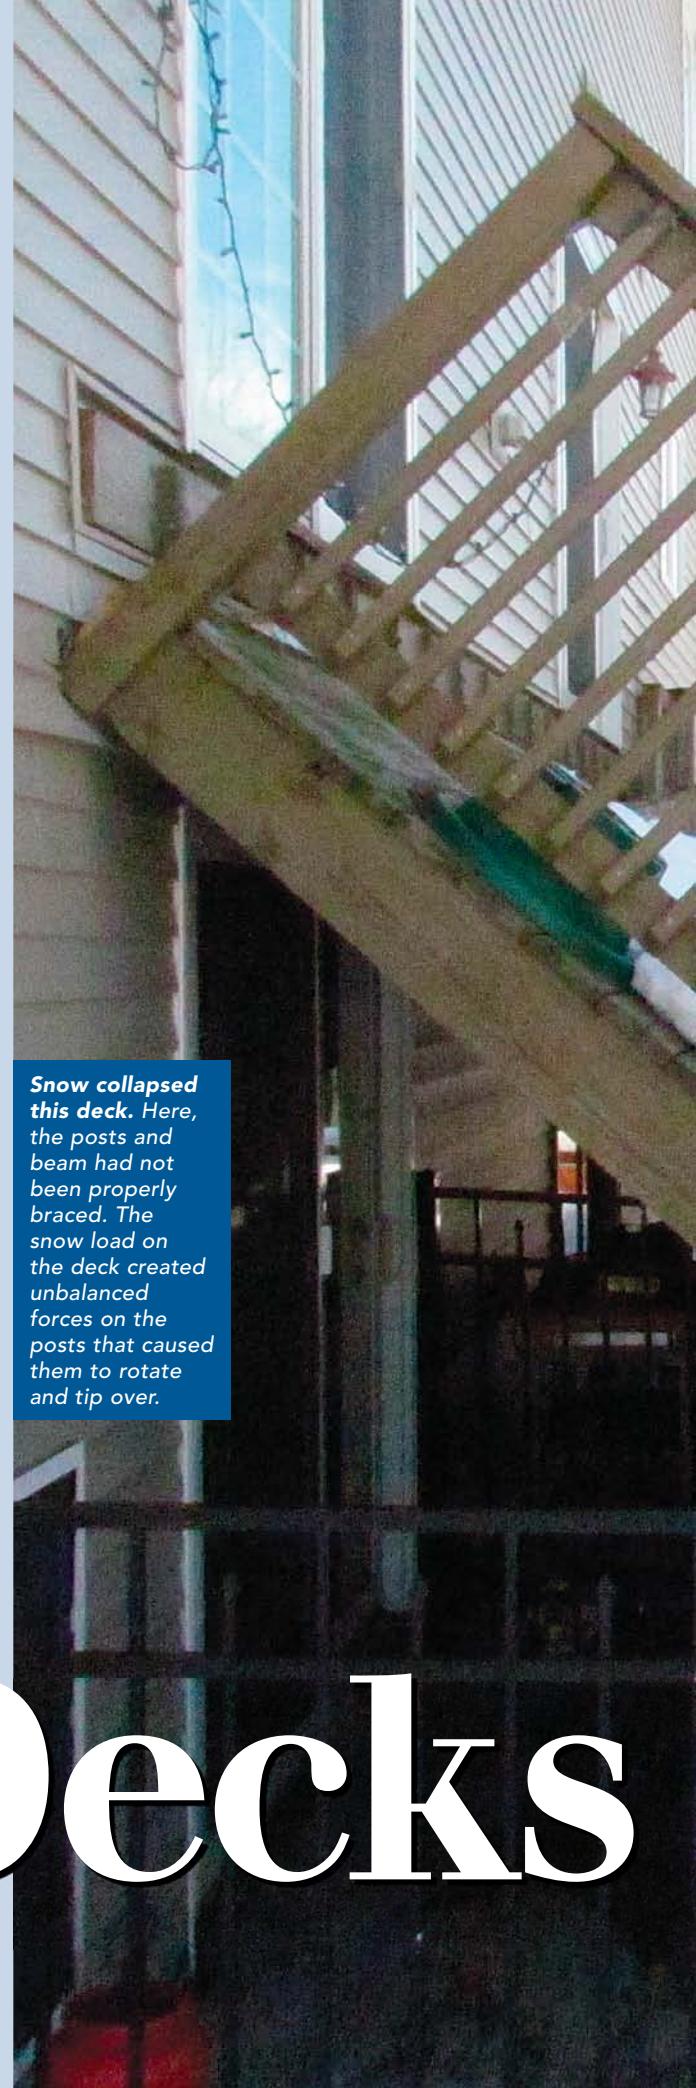
Snow collapsed this deck. Here, the posts and beam had not been properly braced. The snow load on the deck created unbalanced forces on the posts that caused them to rotate and tip over.

While the bolts and tension ties at the ledger keep a deck from pulling away from the house, they do little to prevent lateral motion at the outer beam. If the beam moves far enough laterally, the posts can topple over sideways, causing the deck to collapse. Bracing between the posts and the outer beam is crucial whenever the posts exceed 2 ft. in height, and the taller the posts supporting the outer beam of a deck, the more important bracing becomes.

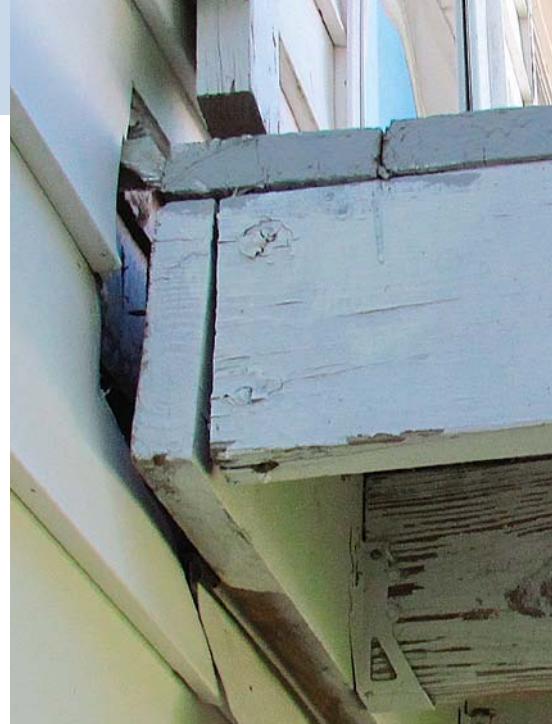
Improper installation of the ledger to the house is probably the most common reason for deck failure. Since the 1980s, codes have required that the deck ledger be bolted to the house, but it's still common to see nailed connections in older decks and in decks built without permits. In some cases, sudden failure at the ledger has resulted in injury and even death. This is a widely discussed topic, and recent editions of the building codes have done a good job of providing prescriptive requirements for fastening deck ledgers.

Detaching ledger. In this case, the homeowner noticed the failure of the nailed connection before the deck gave way. In other cases, decks have given way suddenly, often when they've been loaded with people.

Bolt the ledger and the house together

Code now requires decks to be attached to the rim joist of a house with a minimum of either $\frac{1}{2}$ -in. machine bolts or $\frac{1}{2}$ -in. lag screws; in both cases, the fasteners must be made of hot-dipped-galvanized or stainless steel. Bolt location and spacing is spelled out in both the IRC and the DCA 6-12 and depends on the span of the joists. Additionally, code now requires a lateral-load anchor capable of resisting a 1500-lb. outward pull in two places on each deck. One common method uses threaded rods and tension-tie brackets screwed to the joists in the house and the deck. The details here are for houses with solid-lumber joists. A house with engineered joists or floor trusses requires different details acceptable to the manufacturer.

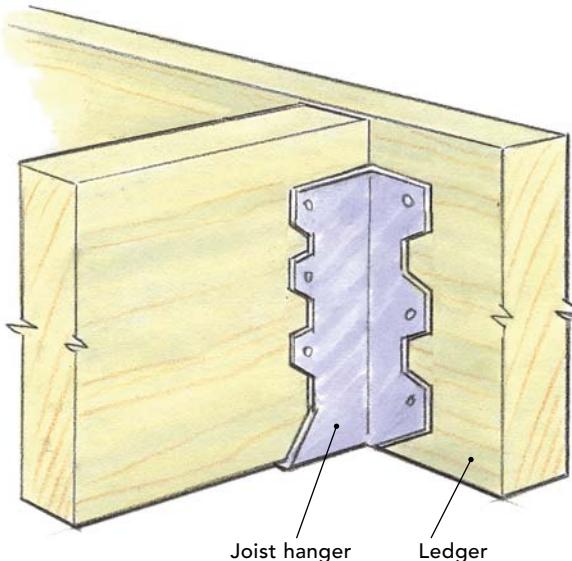
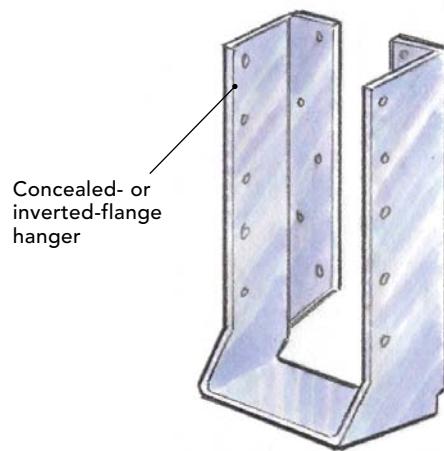
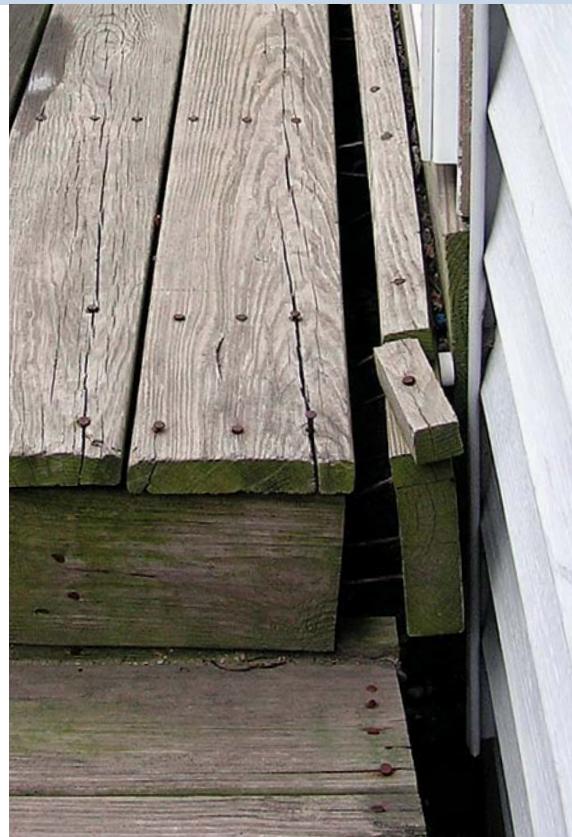
The use of metal joist hangers in joist-to-ledger connections has become an industry standard. Previously, joists were usually toenailed to the ledger. Alternatively, nails were driven through the ledger into the end grain of the joists, with the entire assembly then put in place and the ledger secured. Nails used in these ways don't provide either the shear connection or the withdrawal resistance needed. Any hardware or structural fasteners used on a deck must be stainless steel or galvanized to the G180 standard (which is stamped on the hardware).

Nails alone don't do the job. This small deck was assembled by driving nails through the back of the ledger into the joists' end grain prior to installation. Toenailed joist-to-ledger connections are more common but also likely to fail.

Tie the joists to the ledger with joist hangers

Properly sized joist hangers support vertical loads and help to prevent joists from pulling away from the ledger. Joist hangers with concealed or inverted flanges should be used for joists at the ends of a ledger. They are nailed to the ledger first, and then the joist is placed in the hanger and nailed home. Stainless-steel hardware should be used near the ocean.

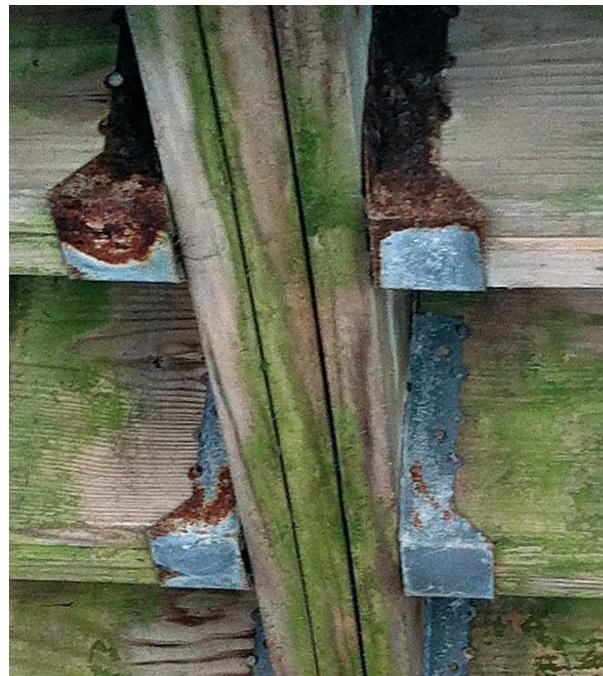
Use the right joist hangers. Although galvanized, the hangers on this seaside deck are rusty and nearing failure. Regular inspection of hardware is a good idea.

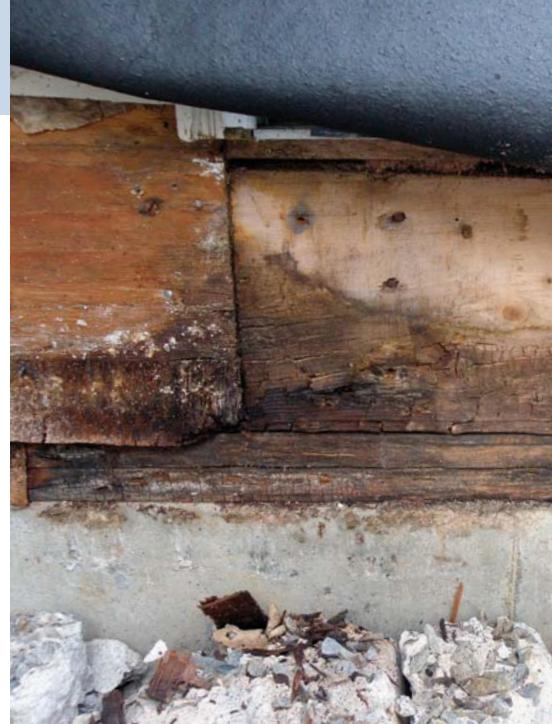
Deterioration of components due to water exposure is a leading cause of deck failures. Decayed deck boards and joists often can be seen and repaired before a deck has a disastrous failure. However, the decay of wood or of fasteners that are not easily observable leads to some of the most dramatic deck failures. The most likely place for hidden decay is at the interface with the house. Not only can ledgers and ends of joists decay, but missing or poor flashing can lead to severe decay of the house's sheathing, rim joist, and mudsill, leaving little for the ledger fasteners to grab.

Poor flashing leads to a rotted house.
Although this deck ledger had flashing, it was not properly integrated with the housewrap or building paper behind the siding. Water found its way to the house framing, rotting the rim joist and mudsill.

Integrate ledger flashing with housewrap

Keeping water out of the joint between the deck and the house calls for multiple layers of flashing. Self-sealing flashing (peel-and-stick) should be applied to the wall sheathing before installing the ledger. The flashing should run below the ledger and at least 6 in. higher up the wall than the top of the ledger. L-shaped metal flashing goes over the top of the ledger and up the wall as high as the peel-and-stick. A narrow band of peel-and-stick over the top of the metal prevents water that gets behind the housewrap from getting behind the ledger. At the least, the housewrap must extend several inches down the face of the metal flashing.

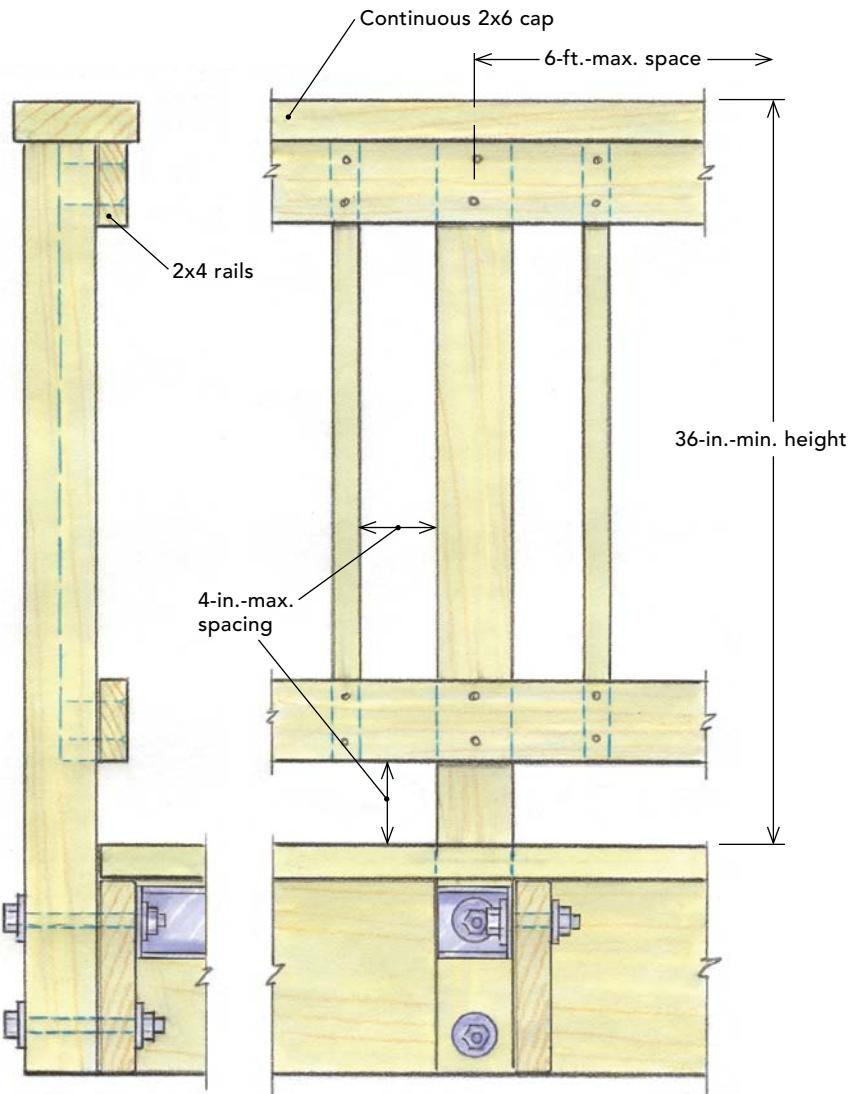
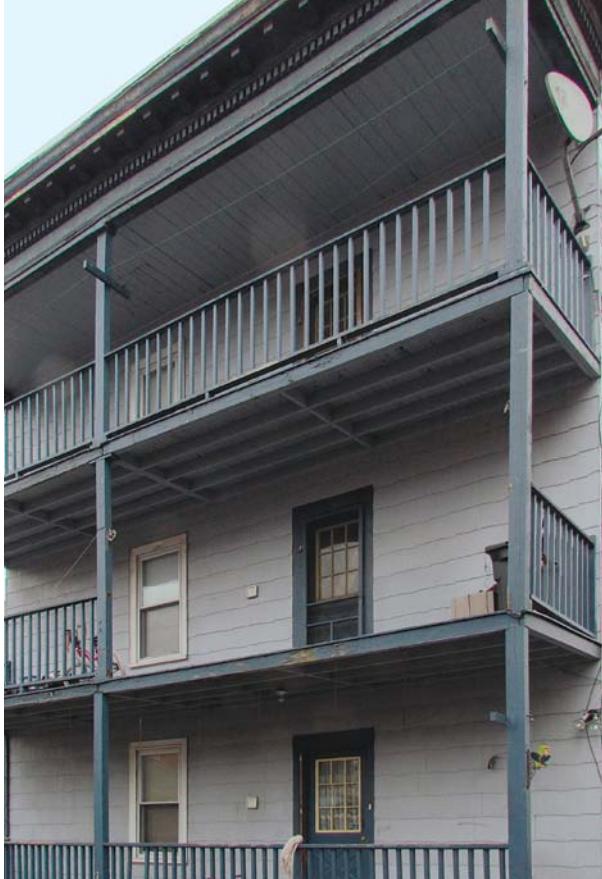
In my experience, very few residential wood railing systems are built to endure code-designed loads. A rail is supposed to be able to withstand a 200-lb. force pushing out on the top. It is a challenge to accomplish this with wood, and in my opinion, the ideal railing is made from welded, hot-dipped galvanized steel. The DCA 6-12 shows details (below) for a wood railing, but I would be more comfortable with 6x6 posts, 2x8 top rails, and 2x6 rails.

Toenailed railing-to-post connection fails.
Over time, the wood decayed and the nails rusted. The weakened railing fell to the ground when someone leaned on it.

Screw rails to the inside of posts

A robust and code-compliant wood railing can be built if you rely on corrosion-resistant screws and place the railing inside the posts. Capping the posts and railing sections with a continuous 2x6 makes the assembly more rigid.

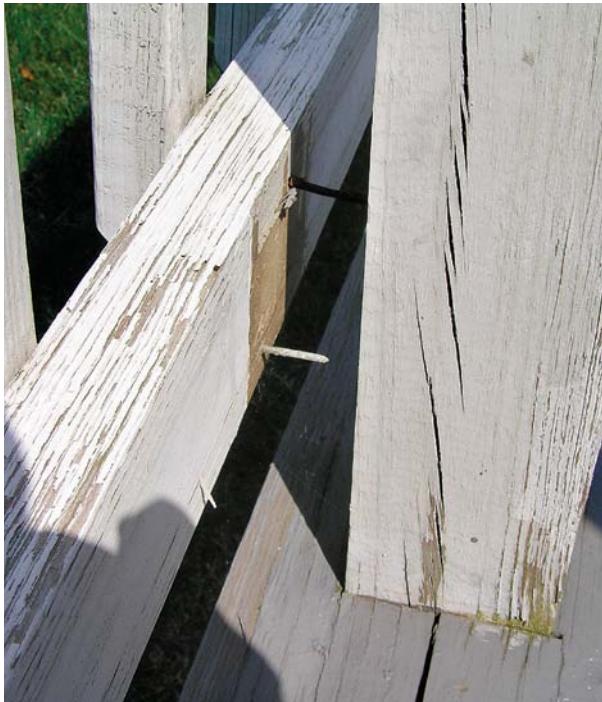
Don't rely on nails. This railing was just nailed to the outside of the posts. The nails eventually withdrew, and the railing pulled away.

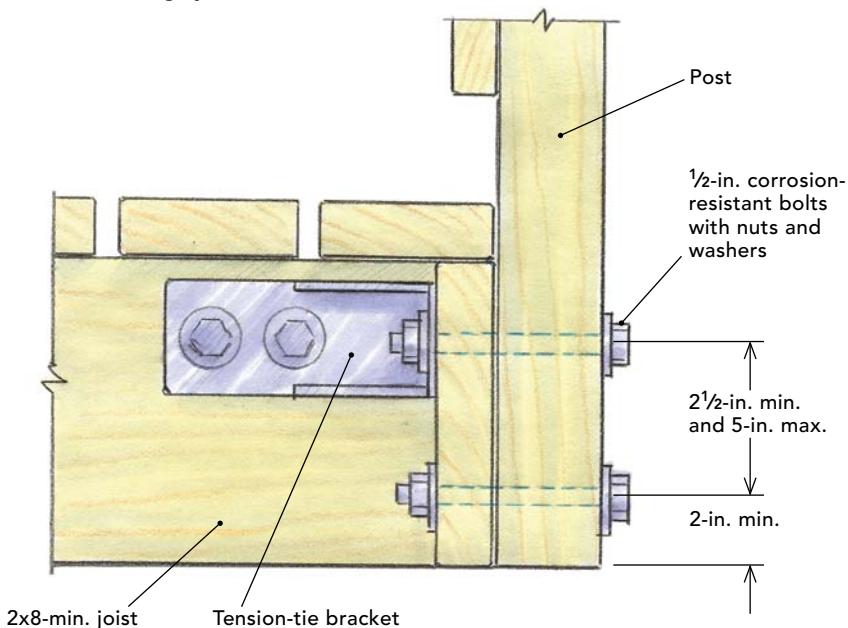
No matter how well a railing is attached to a post, it is bound to fail if the post isn't firmly anchored to the deck framing. This connection hadn't been studied or addressed in the code until recently, so it's common to find loose and shaky railing posts. Although the DCA 6-12 allows 4x4 posts, I prefer 6x6s.

Scabbed-on bracing points to trouble. The post is notched around the joists and nailed into place, but this joint won't meet the code's load requirement. The untreated wood bracing is a poor attempt to address the problem.

Fasten wood posts with metal hardware

One way to achieve the code-required load capabilities is with a combination of bolts and metal tension-tie brackets, although this can only work with joists that are 2x8 or larger. That's because the top of the joist acts as a fulcrum for the post, and 2x6 joists don't provide enough depth for the fasteners to resist the leverage. Shallower, 2x6 joists would require a manufactured surface-mount railing system.

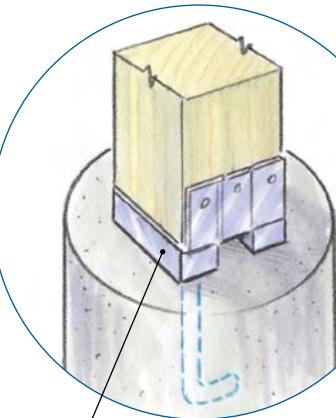
Manufactured post base and anchor

Posts should be at least 6x6 and should join to the beam either by being notched and bolted to two-ply beams, or with an approved metal connector to either two-ply or three-ply beams. Posts must fasten to footings with approved post bases. When the outer posts of a deck are taller than 2 ft., they require diagonal bracing between them and the beam.

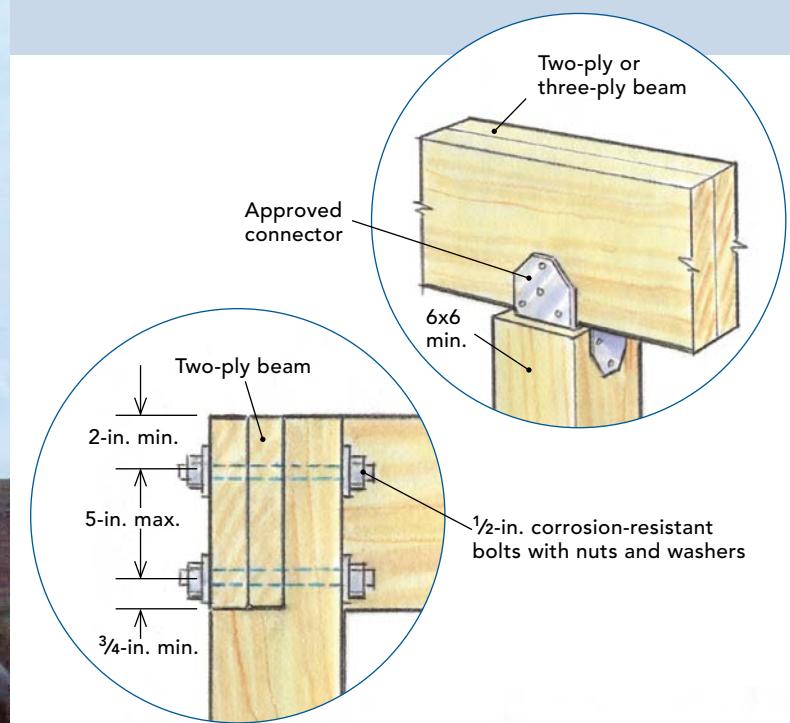
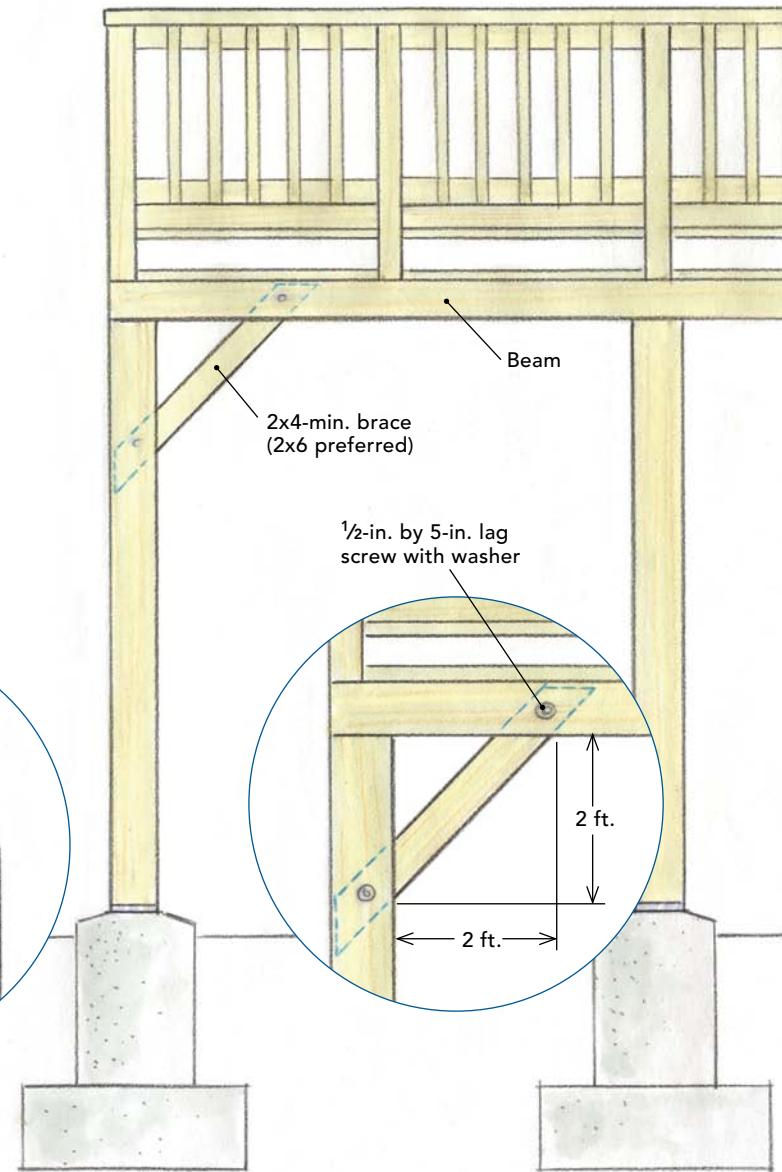
Brace and fasten the posts
