**Attachment A**  
**DPR 523 Forms**

\* Resource Name or #: 4273 Huntington Drive S

\* P11. Report Citation: (Cite survey report/other sources or "none") HPSR for the Soto Street Bridge Removal Project  
September 2002

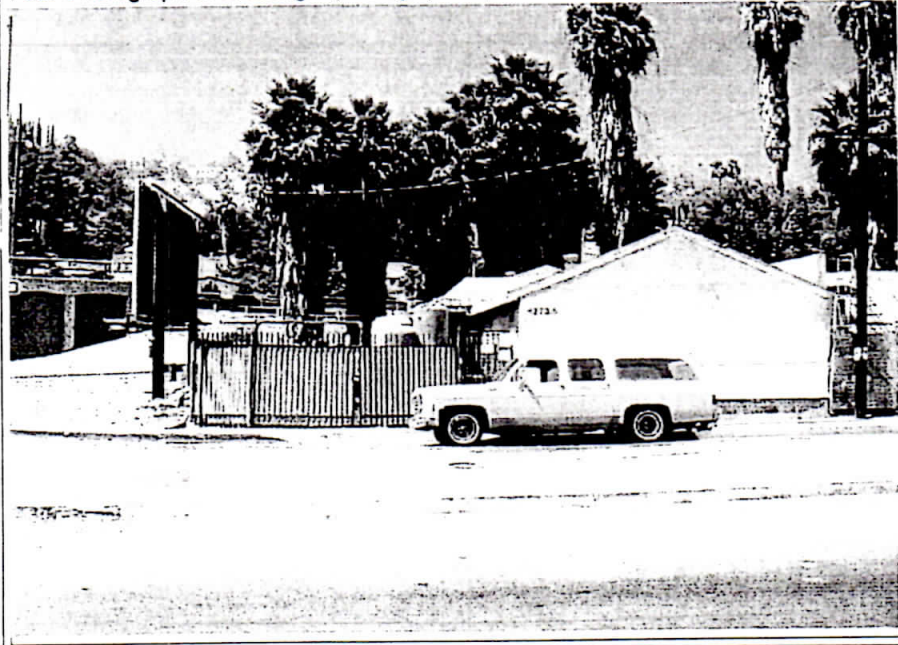
P5a. Photograph or Drawing (Photograph required for buildings, structures, and objects)

\* P3a. Description: (Describe resource and its major elements. Include design, materials, condition, alterations, size, setting, and boundaries.)  
The attached buildings located at 4273 Huntington Drive South are configured in an L-shape, with high security fencing filling in the other sides of the parcel. There are six mature palm trees along the west side of the structure. Inside the small complex are three large metal tanks, possibly related to the shop on the premises. The exterior appears to be stucco, and the cross-gabled roof is clad with a rolled composition covering. The roof has a slight overhanging eave. The type and style of window and door was not evident during the survey of this property. There are no window openings along the Huntington Drive South façade, and the main entry appears to be within the compound on the north "L" of the building.

Looking west from Huntington Drive S.  
9/13/02
