Attachment A
DPR 523 Forms

P11. Report Citation: (Cite survey report/other sources or "none") HPSR for the Soto Street Bridge Removal Project
September 2002

Soto Street Bridge over Mission Road and Huntington Drive North HPSR

Historic Property Survey Report Historic Architecture Survey Report

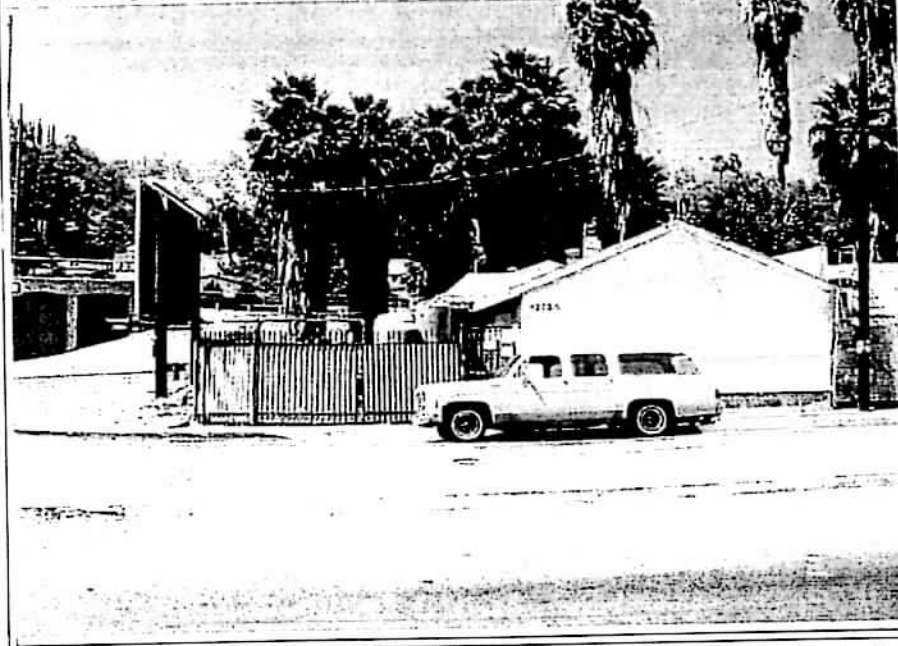
P5a. Photograph or Drawing (Photograph required for buildings, structures, and objects)

P3a. Description: (Describe resource and its major elements. Include design, materials, condition, alterations, size, setting, and boundaries.)
 The attached buildings located at 4273 Huntington Drive South are configured in an L-shape, with high security fencing filling in the other sides of the parcel. There are six mature palm trees along the west side of the structure. Inside the small complex are three large metal tanks, possibly related to the shop on the premises. The exterior appears to be stucco, and the cross-gabled roof is clad with a rolled composition covering. The roof has a slight overhanging eave. The type and style of window and door was not evident during the survey of this property. There are no window openings along the Huntington Drive South façade, and the main entry appears to be within the compound on the north "L" of the building.

P5b. Description of Photo: (View, date, etc.)
Looking west from Huntington Drive S.
9/13/02

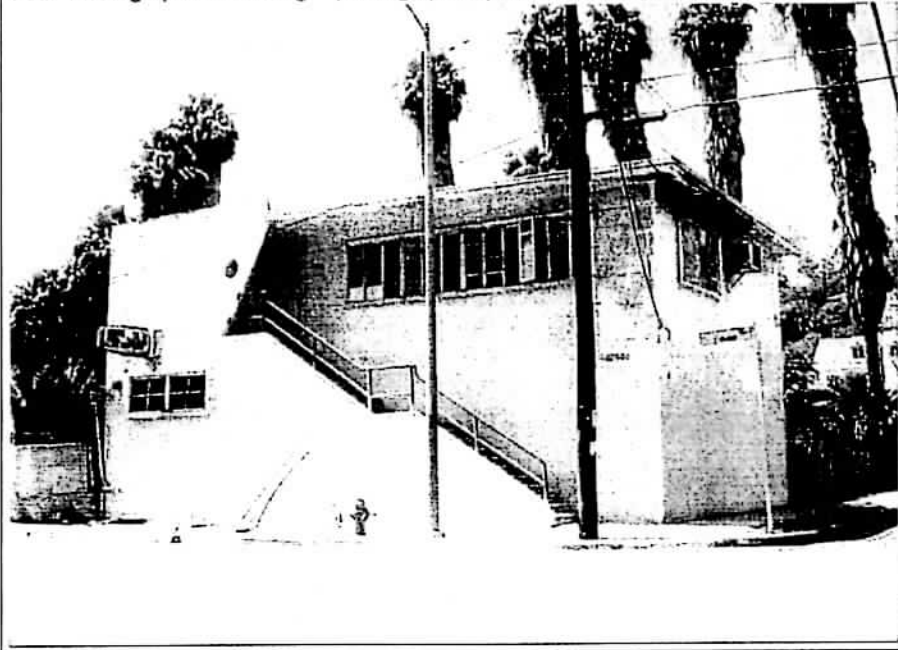
P5a. Photograph or Drawing (Photograph required for buildings, structures, and objects)

* P3a. Description: (Describe resource and its major elements. Include design, materials, condition, alterations, size, setting, and boundaries.)
This two-story commercial structure was constructed with a concrete foundation, stucco or plaster exterior walls and a flat roof that extends slightly over the exterior walls. The main façade faces Huntington Drive South and is dominated by a staircase with a post and pipe railing and two landings. Though it appears that this stairwell is recessed, it is actually along the front façade, with a small bump-out room below it. There is a sheltered entrance to the second floor hidden behind an angular cutout wall with a round opening near the top. There is a ribbon window fixture along the second story façade with four sets of casement windows with multiple panes. Around the corner, facing Tourmaline Street, is a single casement window and next to it a room air conditioner has been inserted into the wall. On the first story, facing Huntington Drive South is another set of windows beneath the stairwell, with sliding sash and multiple panes, set up high in the wall. Directly above this window is a lighted sign attached to the wall, which extends out over the sidewalk, perpendicular to the building. The exterior finish along the stairwell is peeling and spalling. The remaining exterior wall surface is decorated with scored lines in the stucco that gives the impression the building was constructed of large blocks.

Looking W from Huntington Dr. S.
8/13/02

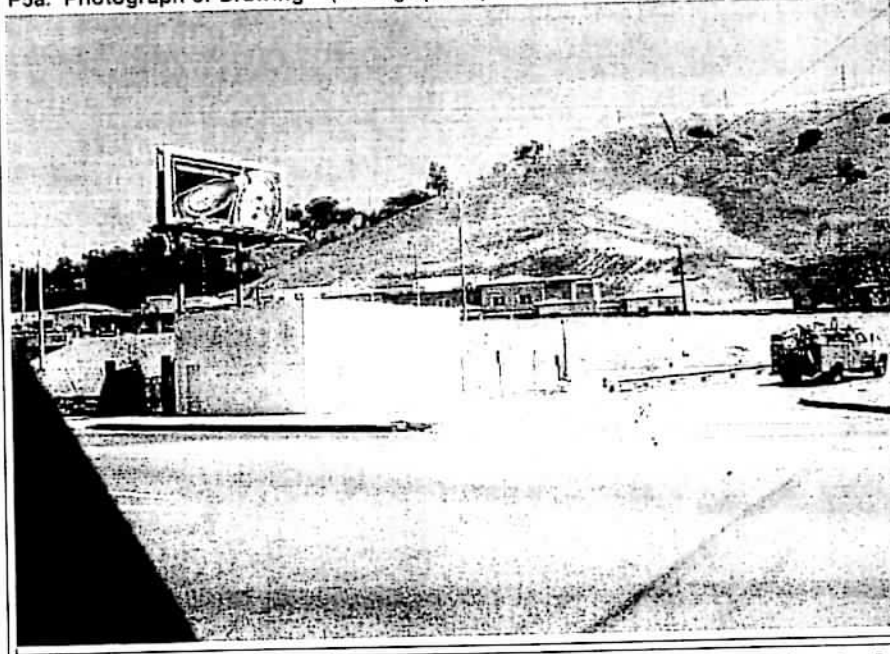
P5a. Photograph or Drawing (Photograph required for buildings, structures, and objects)

P3a. Description: (Describe resource and its major elements. Include design, materials, condition, alterations, size, setting, and boundaries.)
This small, one-story structure is positioned on a triangular parcel between N. Mission Road, Soto Street and an access road from N. Mission Road to the south-bound lanes of Soto Street. The parcel is mostly devoid of landscape elements. The structure itself is plain with a single door on the N. Mission Road façade and an exterior light fixture near the flat roof-line. There is an irregular fence behind the building and two concrete posts along N. Mission Road, guarding the entrance to a driveway. The exterior appears to be stucco or plaster.

Looking E/NE from Mission Road
towards Soto St. on ramp 9/13/02

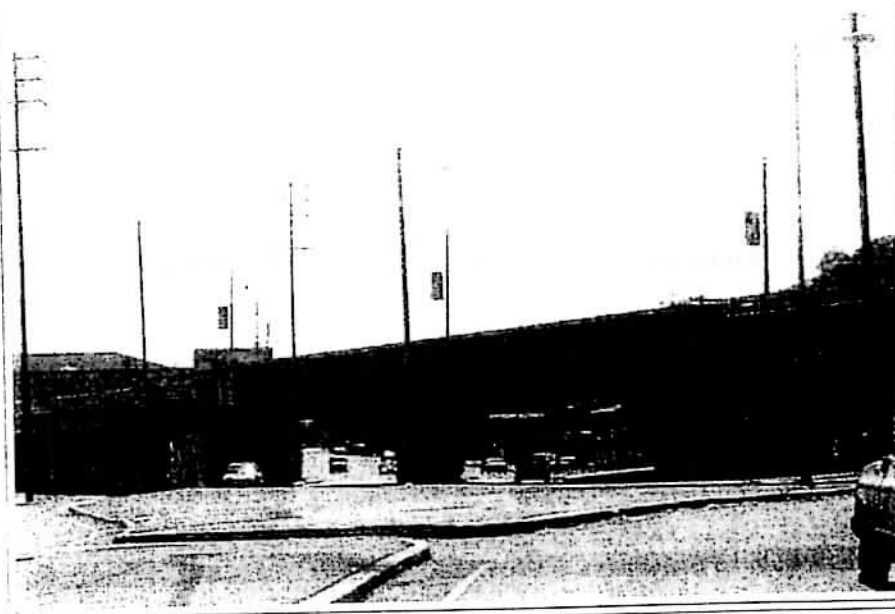
P5a. Photograph or Drawing (Photograph required for buildings, structures, and objects)

* P3a. Description: (Describe resource and its major elements. Include design, materials, condition, alterations, size, setting, and boundaries.)
No changes have occurred to the bridge since the 2001 HPSR was completed. The following text is quoted from the 2001 HPSR by Portia Lee, PhD.: "The bridge is approached from Soto Street (south) and Huntington Drive North by a set of concrete approaches that originally rose to the double-tracked, elevated deck of the railway. Between these 15 approach spans are the two main spans. The main spans consist of steel girders and steel floor beams and the approach spans are cast-in-place concrete T-beams. The total length of the bridge is 149.7 meters. The bridge curb-to-curb width is approximately 13.4 meters. The bridge carries a total of three lanes of traffic (two lanes in the north-bound direction and one lane in the south-bound direction). The bridge spans the intersection of N. Mission Road as it becomes Huntington Drive South. Original details include Art Deco elements such as the deeply scored, curved, semi-circular piers that mark the transition from the concrete portions to the steel section of the bridge. These columns extend the height of the bridge. Access stairways on either side of the bridge were constructed of concrete and the piers below the steel section were also decorated in an Art Deco style. The abutments bents are designed in a closed arch fashion and generally function as retaining walls."

Looking S/SW from Huntington Dr S and
Tourmaline Street 9/13/02

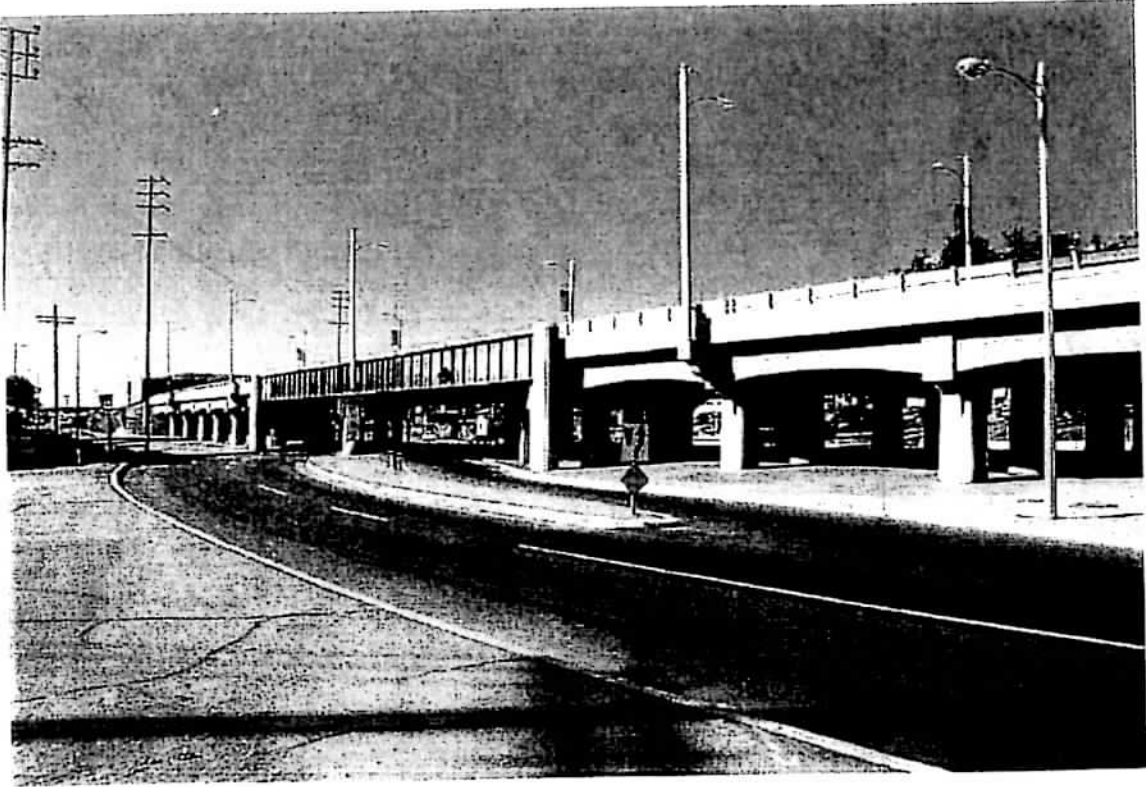
Soto Street Bridge over Mission Road and Huntington Drive
Los Angeles, CA

Looking south, from Huntington Drive South

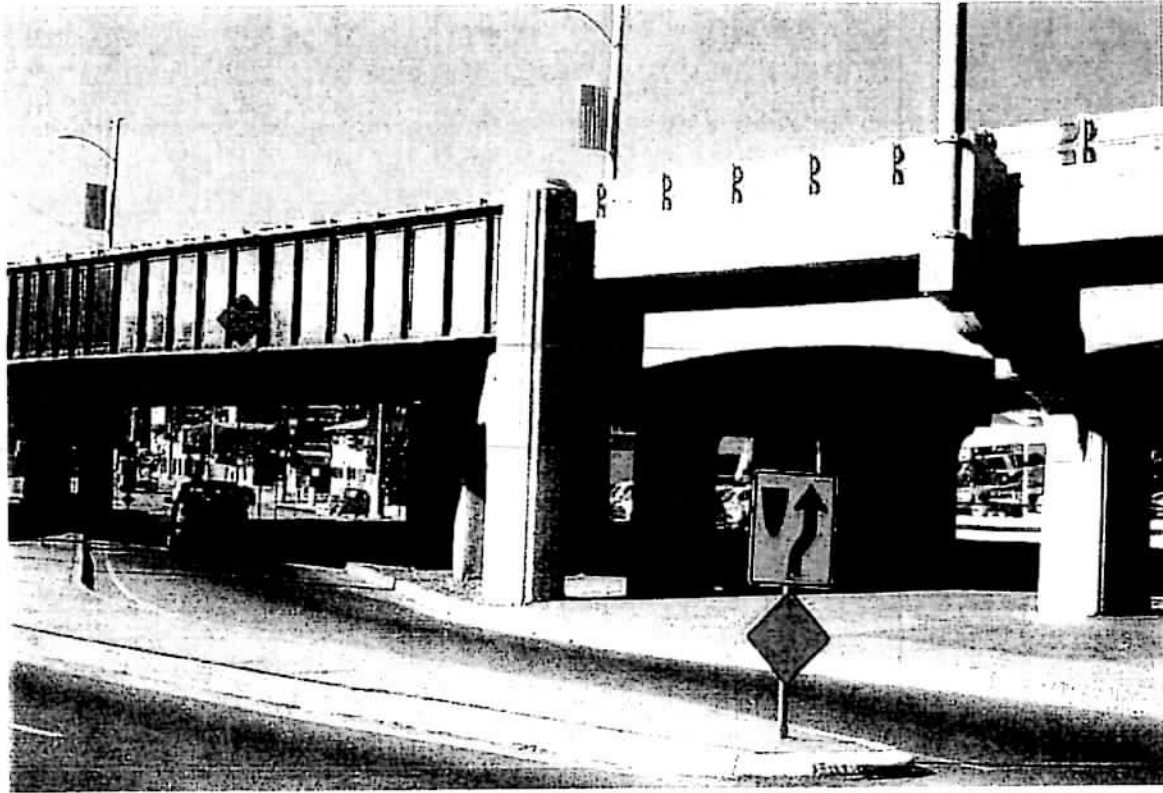
Soto Street Bridge over Mission Road and Huntington Drive
Los Angeles, CA

Looking southwest at one of the piers between steel deck and concrete approach span

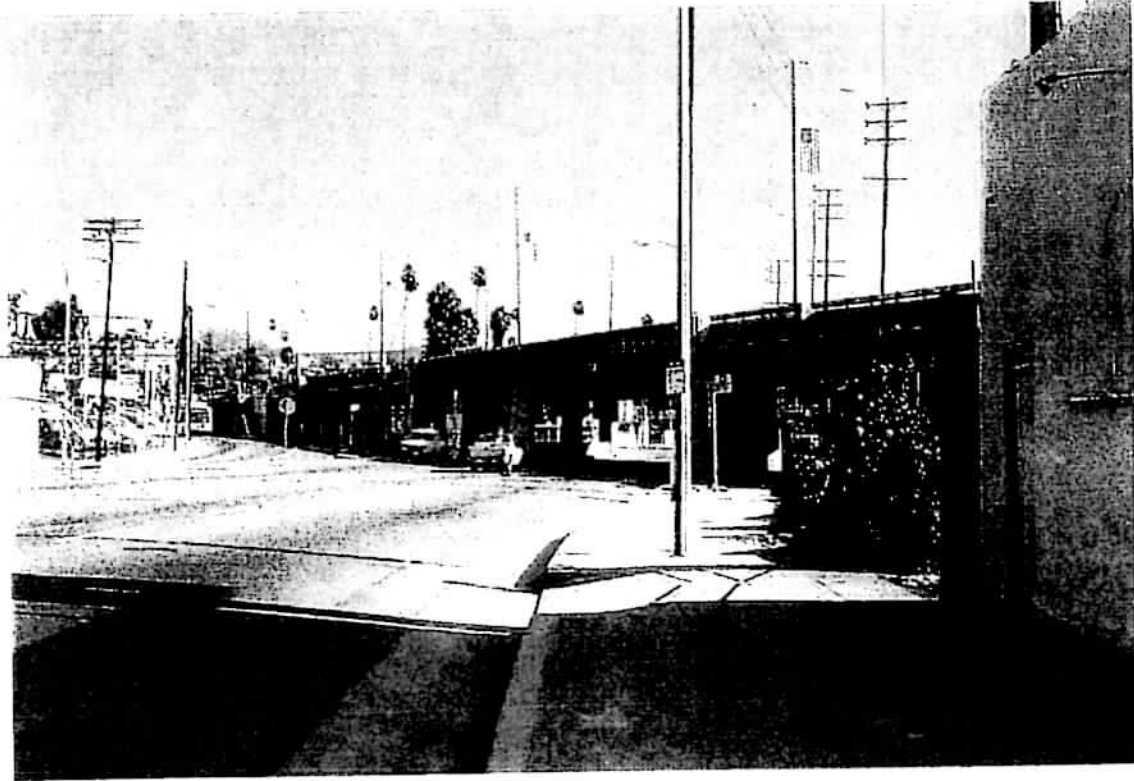
Soto Street Bridge over Mission Road and Huntington Drive
Los Angeles, CA

Looking north from Mission Drive towards the bridge

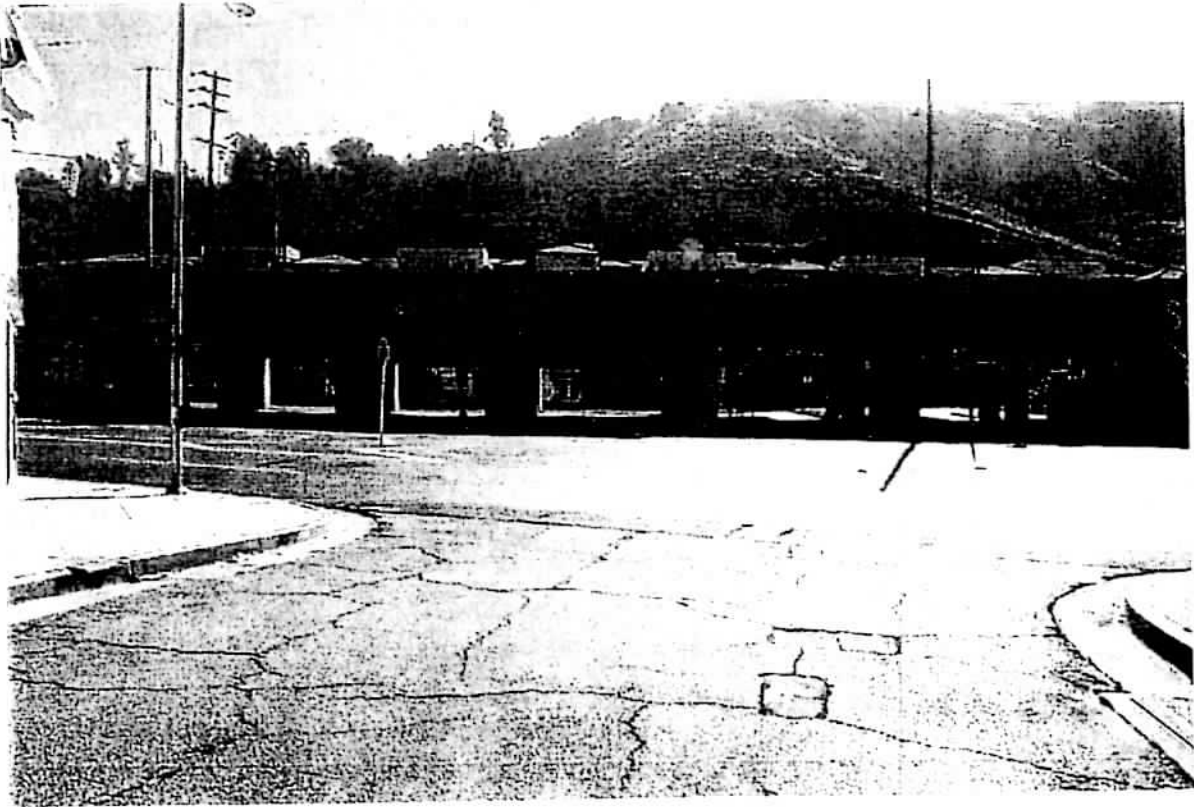
Soto Street Bridge over Mission Road and Huntington Drive
Los Angeles, CA

Looking east from Canto Drive towards the bridge

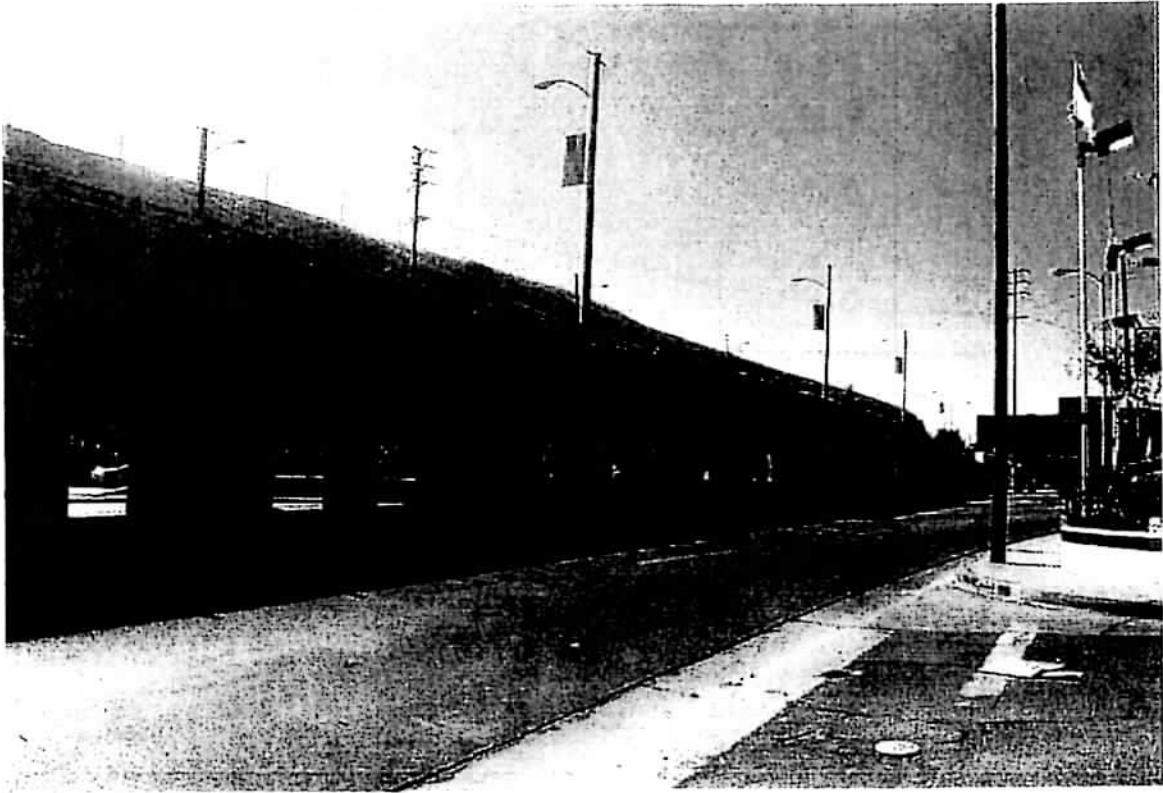
Soto Street Bridge over Mission Road and Huntington Drive
Los Angeles, CA

Looking southeast at the bridge from Huntington Drive North

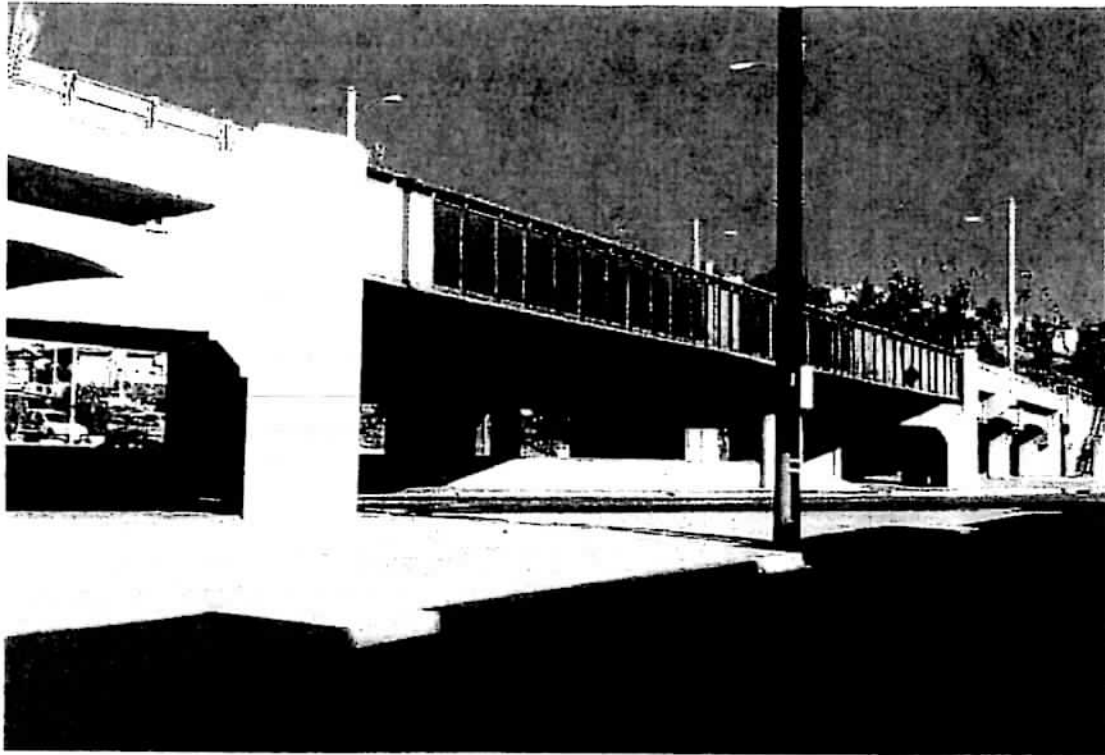
Soto Street Bridge over Mission Road and Huntington Drive
Los Angeles, CA

Looking northwest from Soto Street towards the bridge
