Property Inspection Report

LOCATED AT: 1234 Any St Anytown, Texas 75000

INSPECTED ON: Wednesday, April 24, 2024

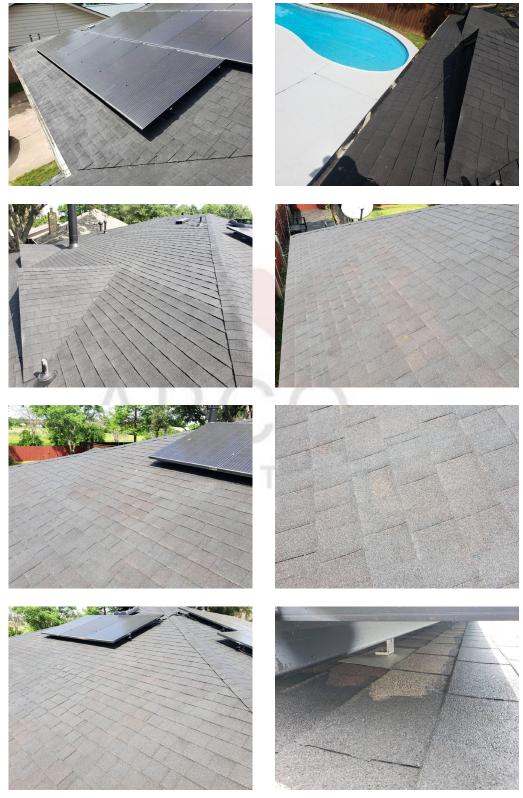
17: Your insurance should also be called to verify that the roof is insurable in its current condition. This roof has been painted over, and the exact condition and age can not be verified.

16: A qualified roofer should be called for further evaluation and repairs.

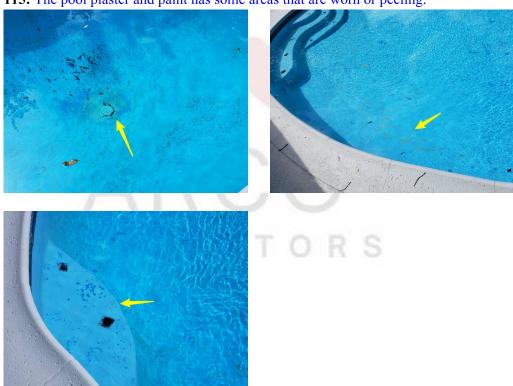
114: This is a slightly older pool that has a single main drain.

116: A qualified pool technician should be called for further evaluation/inspection and repairs.
