LEPARD & SMITHS LTD – SOCIETY PERFORATOR

James Norris

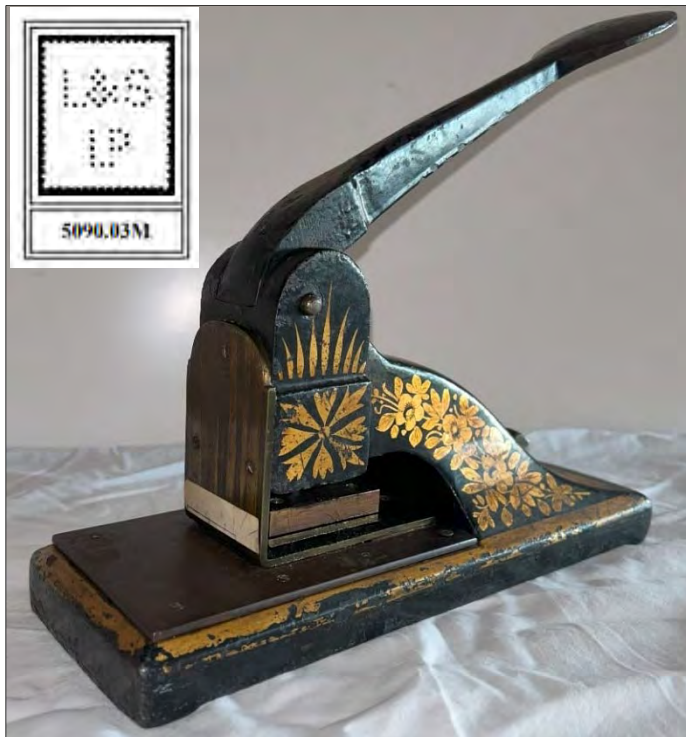
The Perfin is L5090.03M - L&S/Ld, used by **Lepard & Smiths of**

London, the die is a four gang format arranged in a 2x2 configuration, and is illustrated in the Gault Catalogue.

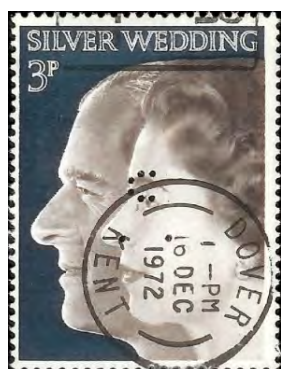
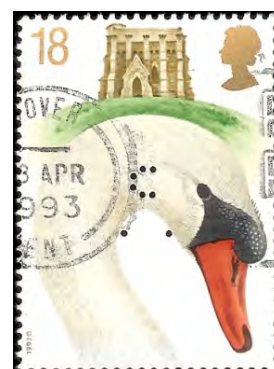
The pins were ingeniously arranged in a 'C' by using the small arc of the 'D' of 'LD' with 2 pins below taken from the upright of the letter 'L'. The two single pins are thought to represent Chris's 'number 2 position' in list of founder members of our society.

A selection of Perfins produced by Chris during the life of the modified die. Most have Dover postmarks as this was where he was residing at the time.

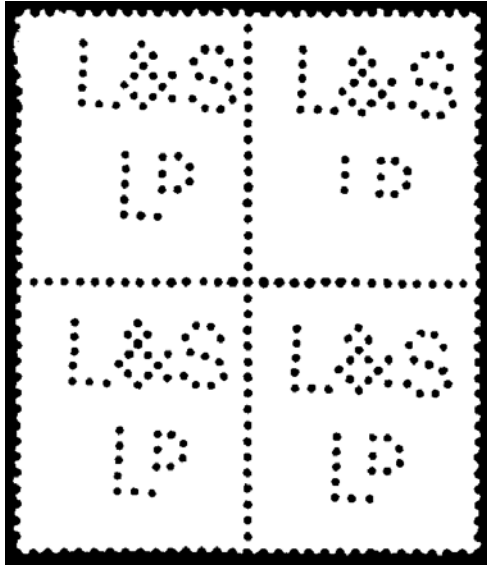
Illustrated opposite is a full strike from the 1960's showing the missing four pins from the top right die. This is where the modifications to the pin configuration were affected by Chris Carr.

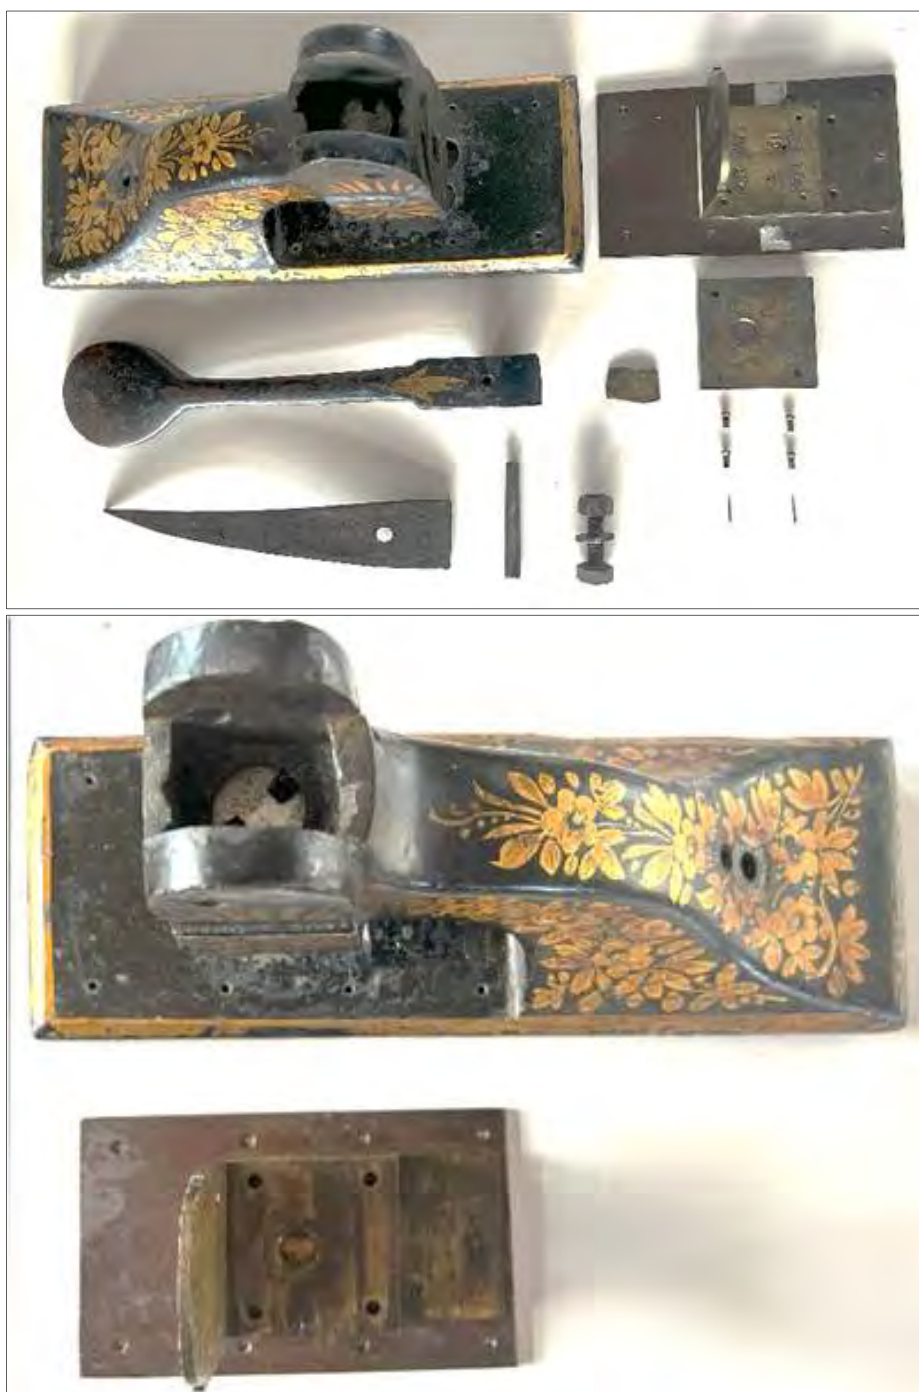
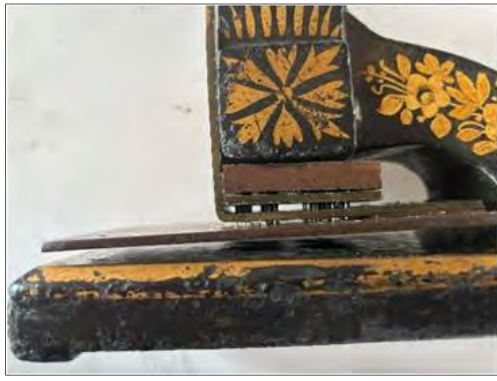
Component parts of the press after dismantling, showing cast iron body, die plate and stripper plate, cam action operating lever, die with threaded attachment plate, linear return spring, tapered pivot pin fixing screws and two single pins for size comparison.

The first task was to carefully dismantle the press, and give it a thorough clean. The principle of perforating is basic mechanics with only a few moving parts, although the tolerance of the mating parts is crucial to allow all the pins to align accurately. It was clogged with decades of dust and compressed 'chad' (small discs of paper left over from the perforating process), which had blocked the stripping plate and was preventing the pins from passing through the plate and jettisoning the new fragments of 'chad'. This was the likely the original cause of the several broken pins referred to in the article

above. The upper right-hand die was the worst affected, (letters LD), but as all of the pins act together in one single motion, the pins could not puncture the stamps evenly, resulting in damage to that portion of the die. In total 12 pins were found to be bent, broken, too corroded or completely missing. Some had signs of surface rust, and so all had to be soaked in penetrating oil before restoration could begin.

Upon inspection it was evident that there were insufficient pins to complete the work, but enough to complete three of the dies - the pin diameter is 0.85mm x 12mm long, and a search for replacements has proved to be unsuccessful but is on-going.

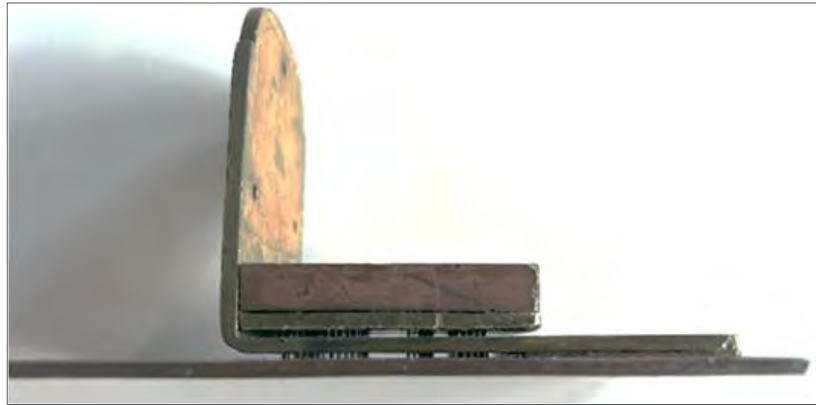
Above, side view showing stripper plate detached from base, but still containing the pins, above the die block and retaining plate, the brass guide plate is attached to the front of the press in an L shape, as well as to the base plate, and second view with complete assembly removed.

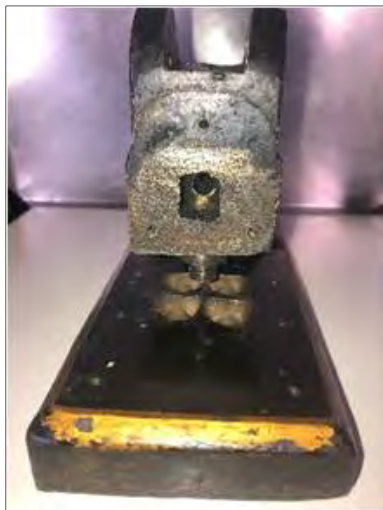
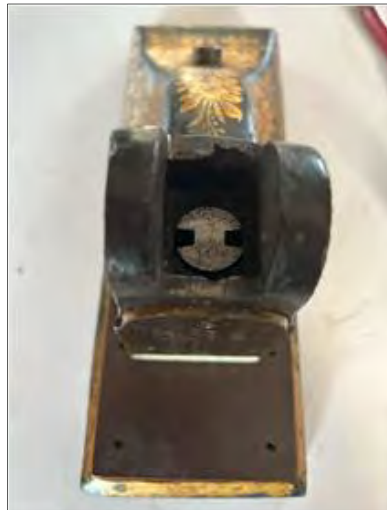
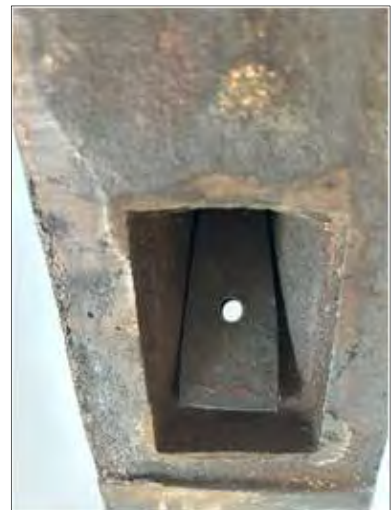
Close up end view (left) showing aperture and hole in piston where lever spring locates, and top view (centre) with the cam lever removed exposing the actuating piston which attaches directly to the die plate. Aperture in underside of base (right) showing mounting hole for the linear return spring.

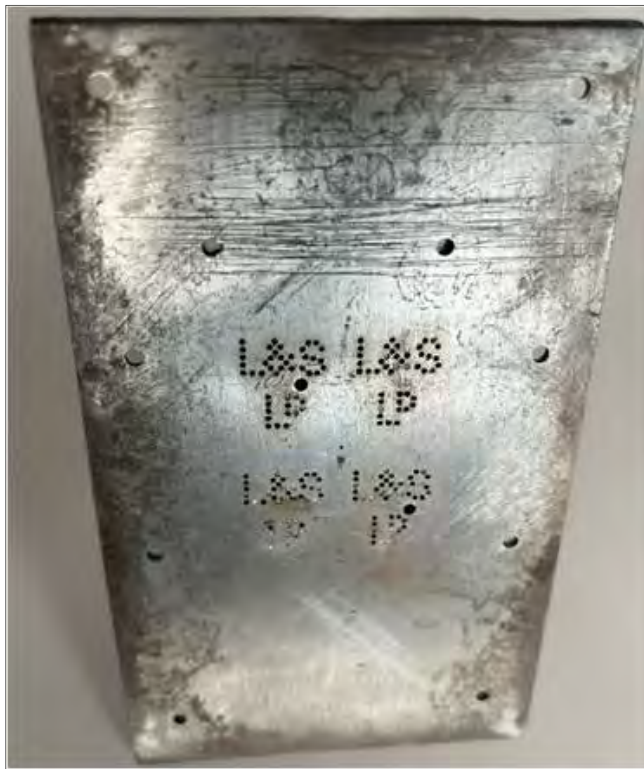
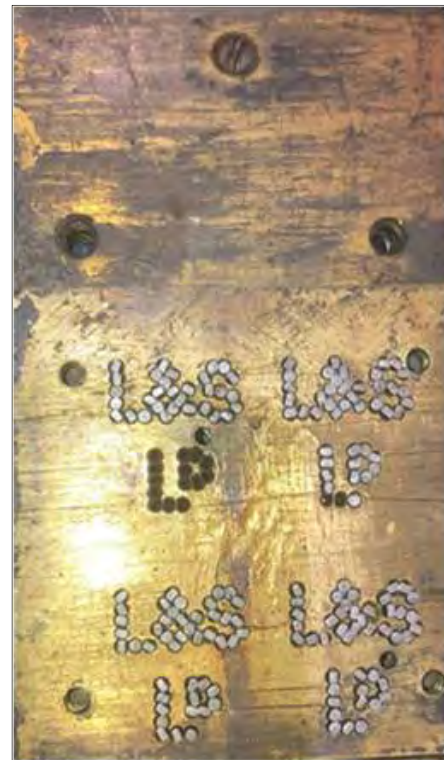
Unassembled views of the bottom of the steel stripper plate (left) and the mating brass die plate (right) with all available pins now in situ.

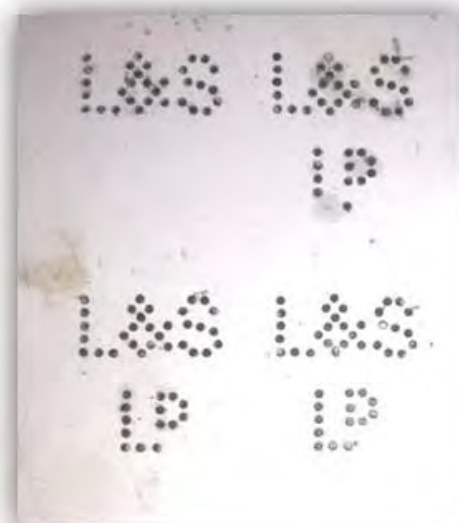
With the press reassembled, it was found that the return spring no longer worked effectively, and may well have lost its torsional strength. The result of this means on the down stroke the path of the pins enters and clears the die stripper plate, but on the up stroke it does not automatically return to the up position – the pins stay seated in the stripper plate. The die needs to be ‘coaxed’ to return to the start position manually. It was possible to produce an impression of the Perfin successfully, and the scan opposite shows how it looks today, using all available pins.

If at some point in the future replacement pins can be sourced, it will be possible to fully restore the press to original working condition. As there is no longer any demand for such precision pins

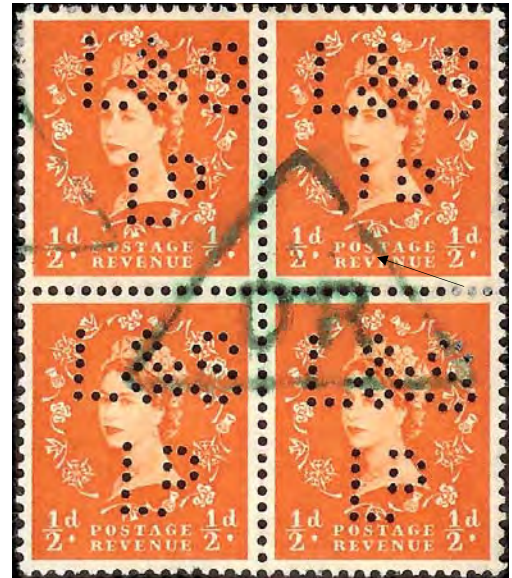
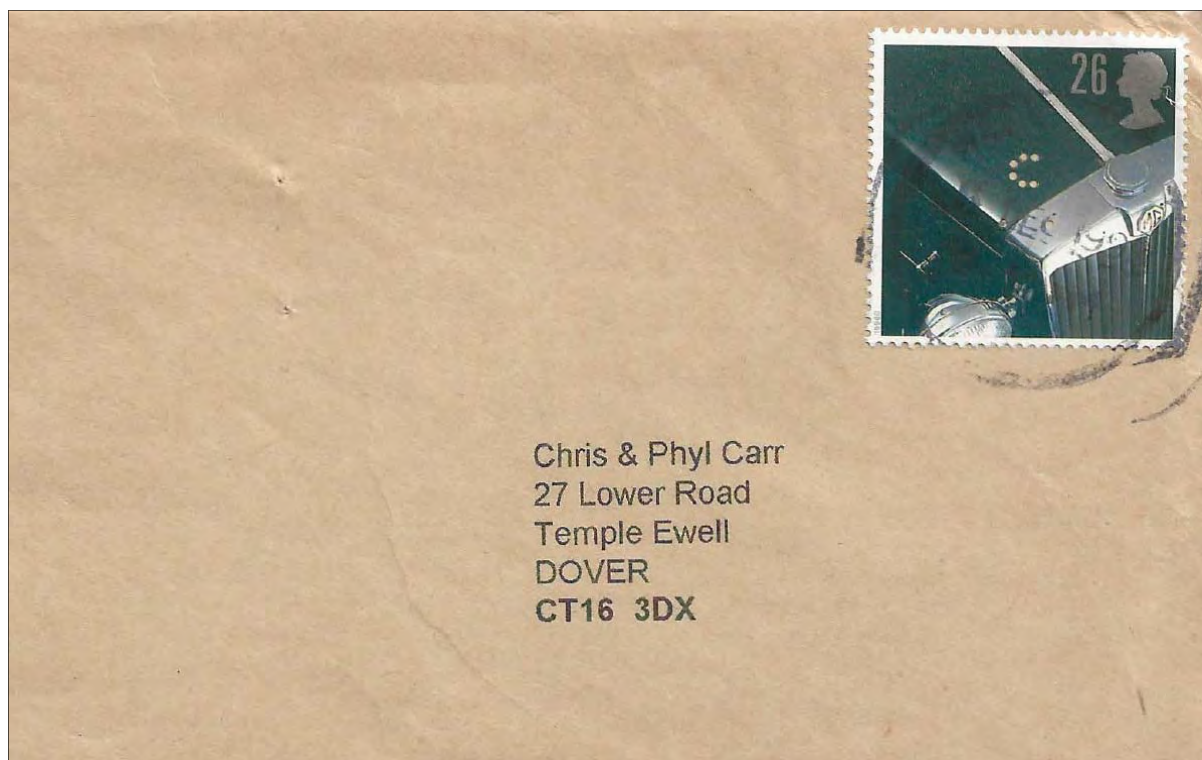
Self addressed cover with QEII 26p commemorative with private perfin
C/. . - C0020.01M
