Bauneg Beg Lake Watershed 2018 Survey Report

November 2018

2018 Bauneg Beg Lake Watershed Survey

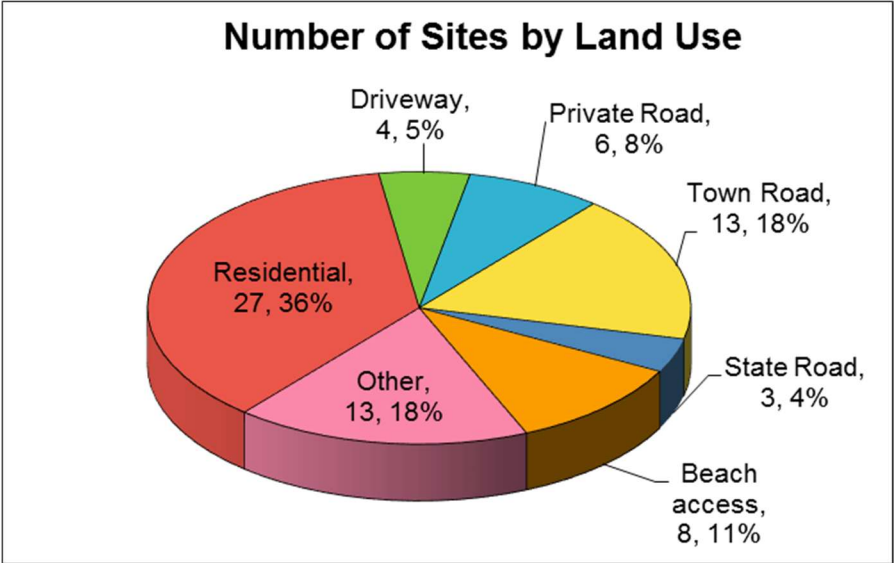
Figure 4: Number and Percent of sites identified by land use category

Residential land use sites accounted for the greatest number of sites (Table 1 and Figure 4). There were a total of 27 sites, which was 37% of all sites identified. Town Roads followed with 18% (13), beach access with 11% (8), and private roads with 8% (6) of sites identified. Boat access, driveways, state roads, cemeteries, stream crossings, trail/paths, and commercial categories combined for 26% of all sites with twenty total sites documented as having an impact. Each of these categories will be explained in more detail in the subsequent land use sections.

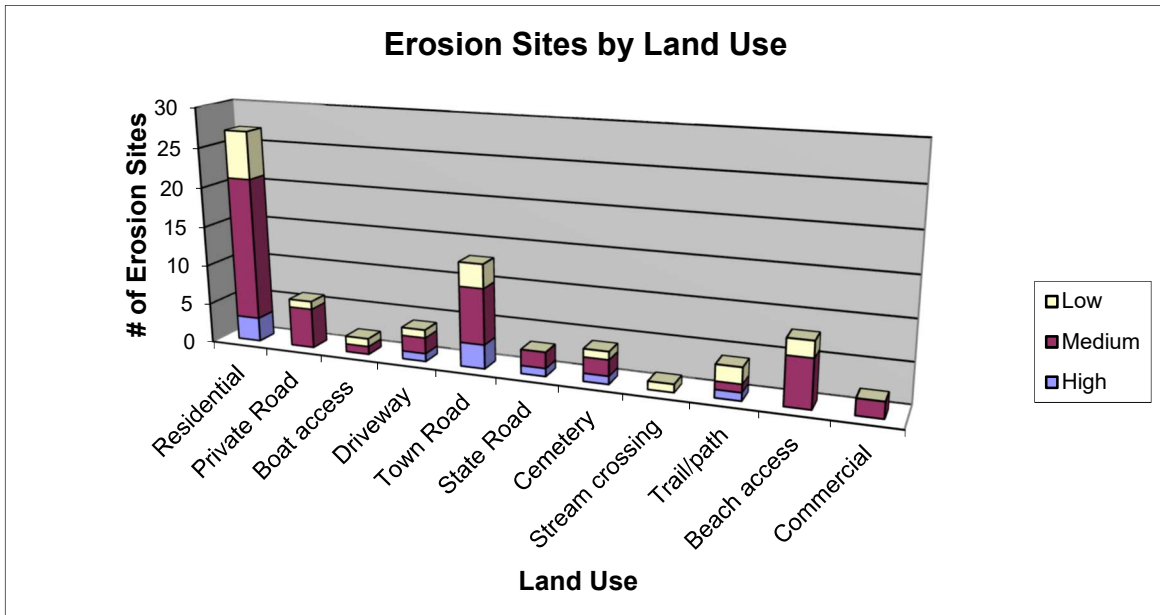
Figure 5: Impact ratings of each land use category

Another way of looking at the data is to compare impact ratings for each land use category (Figure 5). Impact rating is a point system that considers erosion type, impact area size, and presence of buffers or other filters (Figure 2). Residential areas contributed the most high and medium impact sites (21 total). Town Road sites included 10 high and medium impact sites. Beach access sites contributed 6 medium impact sites. Although all sites are important in the overall picture of a healthy watershed, these aforementioned land uses dwarf the number of high and medium impact sites documented as driveways, state roads, cemeteries, and trail/paths. These land uses had a combined total of eleven high and medium impact sites.

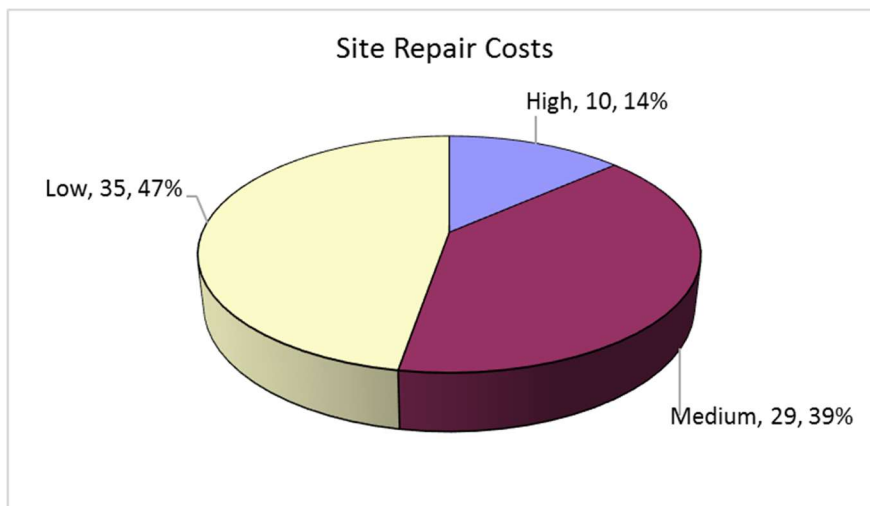
Figure 6: Number and Percent of Repair Costs

The final method of looking at the data collected, is by site repair cost (Figure 6). Estimated costs to fix are evaluated by surveyors (low cost < \$500, medium cost \$500-\$2,500, high cost >\$2,500). Town roads contributed the most to high cost impacts at 7% (5), followed by private roads at 3% (2), and residential areas, state roads, and commercial areas each with one impact site. Residential areas contributed the most to medium and low cost sites at 16% (12) and 19% (14) respectively. Town roads also contributed to medium cost sites at 7% (5), followed by private roads 4% (3), driveways/state roads/cemeteries each 3% (2 sites each), and boat access at one site. Beach access contributed 11% (8) to low cost sites, and all other sites contributing less than 5% each for a total of 17% (13).

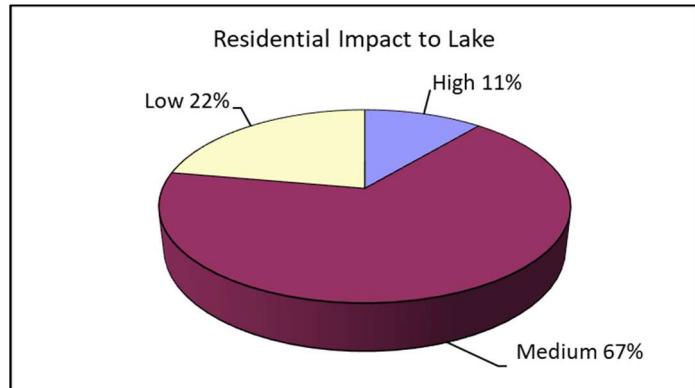
Figure 7: Impact as a Percentage of Total Residential Sites

Residential sites (31) included any erosion that occurred on a residential property, including foot paths, driveways, roof runoff, ditches, shoreline erosion, and any other bare soil areas that delivered soil to a surface water body. The majority of residential sites were medium or low impact, with fewer than 13% of residential sites rated as having high impacts on the lake. Of the 31 residential sites, 30 were determined to be low or medium cost for restoration. In some watersheds, driveways tend to be problematic. In the Bauneg Beg Lake watershed, driveways contributed a small percentage of the overall residential impacts, with a total of four sites. One of the driveway sites was rated as high impact, two were medium impact, and one was low impact. Sheet surface erosion, rill surface erosion, bare soil, and inadequate shoreline vegetation were common problems throughout residential sites.

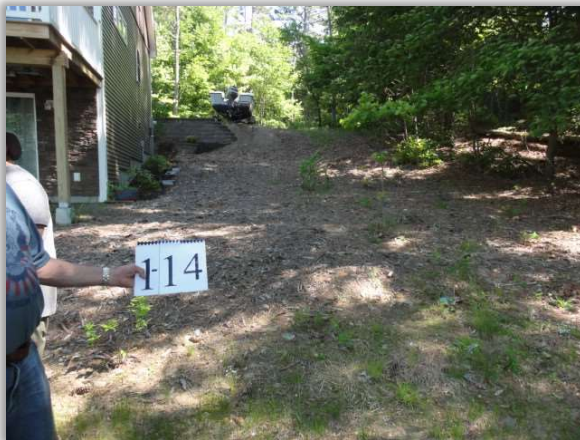
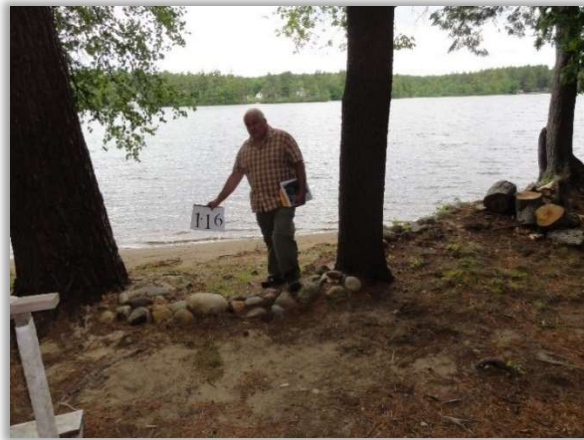
Rill surface erosion and lack of/inadequate shoreline vegetation make residential areas and driveways very susceptible to erosion.

Suggestions for improvements for residential sites included:

- ❖ Establish a vegetative buffer to protect shoreline or other residential areas.
- ❖ Add Erosion Control Mix (ECM)² to flat bare areas where vegetation does not grow easily.
- ❖ Better define or limit footpaths, access to water, and parking areas.
- ❖ Install drywells at gutter downspouts and infiltration trenches at roof drip line.
- ❖ Limit raking of vegetated areas to allow plants and natural duff layer to protect soil.
- ❖ Discontinue use of multiple boat or beach access points.
- ❖ Properly size, repair and replace culverts.
- ❖ Pave or add hard packing gravel to steep driveways.

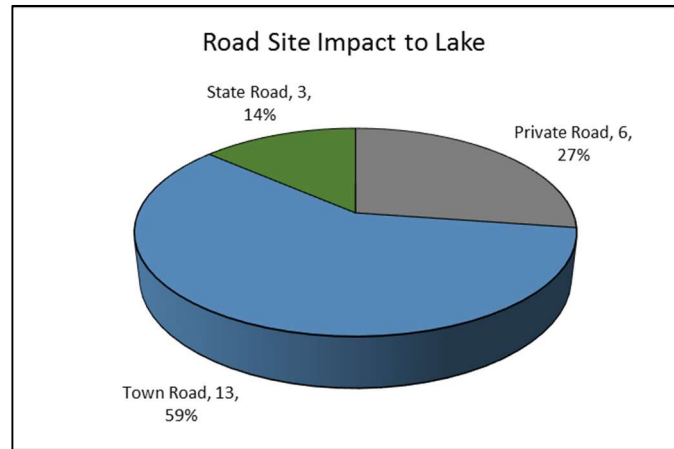
Figure 8: Percent Impact of Road Sites by Category

There were a total of 15 town road sites in Sanford and 7 in North Berwick. The majority of road sites were located in Sanford, mostly near the lake shore. Surveyors identified a total of 22 road sites, consisting of 6 private road sites, 13 town road sites, and 3 state road sites. Of the 22 road sites, 4 were determined to be high impact and high cost, 14 were of medium impact with varying costs, and 3 were of low impact with low or medium cost. Frequent issues found included sheet/rill/gully surface erosion, unstable culverts, and sheet/gully shoulder erosion. Other, less common issues included roadside plow/grader berm, crushed/broken culverts, bare soil, and winter sand.

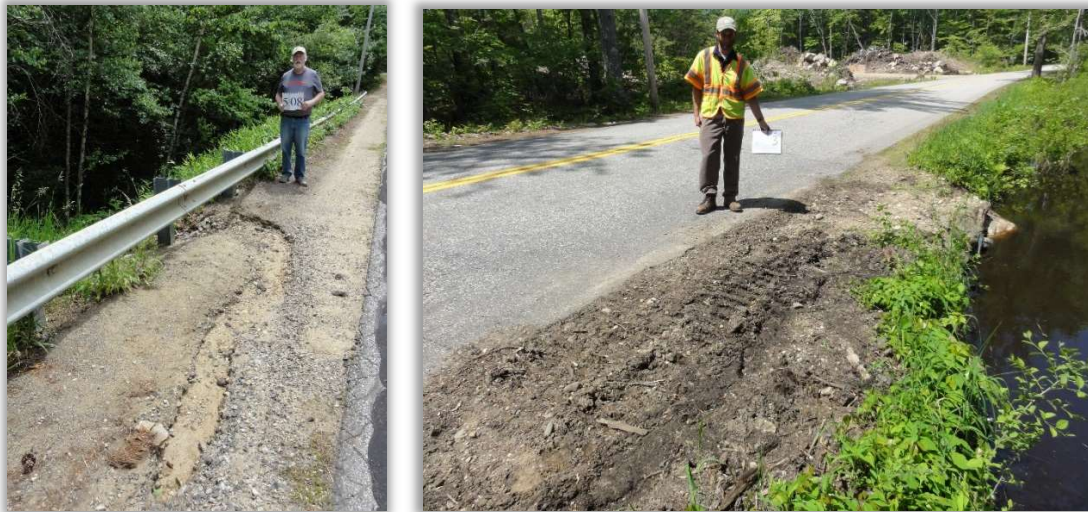
Top Left: Gully surface erosion, sheet/gully shoulder erosion, and unstable culverts contribute to this site's NPS pollution.
Top Right: Rill shoulder erosion, unstable culvert, and bare soil contribute to this site's NPS pollution.

The suggestions for improvements to roads include:

- ❖ Repair, replace, armor, and otherwise improve upon culverts.
- ❖ Add plunge pools, sediment pools, catch basins where appropriate.
- ❖ Remove grader berms on edge of road.
- ❖ Build up road and add new surface material.
- ❖ Armor ditches with stone.
- ❖ Reshape road and tilt away from brook.
- ❖ Remove sand from road near bridge or install diverters to prevent sand from entering water.
- ❖ Stabilize road shoulder with compacted gravel or vegetate where possible.
- ❖ Employ Maine DEP certified contractors for road work.
- ❖ Utilize Maine DEP's guidance documents for forming road association and road maintenance.³

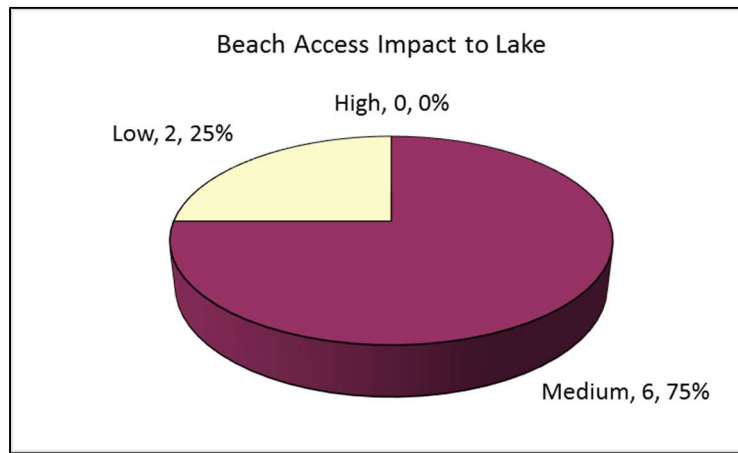
Figure 9: Impact as a Percentage of Total Beach Access Sites

Beach access contributed 8 sites to the overall 74 documented sites (11%), 2 of which were noted to have been located on private beaches. There were no high impact, or high or medium cost sites identified. Common issues found include sheet surface erosion, bare soil, and lack of shoreline vegetation. Less common issues included shoreline erosion, unstable access, and rill surface erosion. Beach access sites are of specific concern due to the ease at which NPS pollution, as well as people, gain direct entry into the lake. By installing runoff diverters, vegetative buffers, and defined erosion-resistant foot paths, impacts from beach access sites may be reduced.

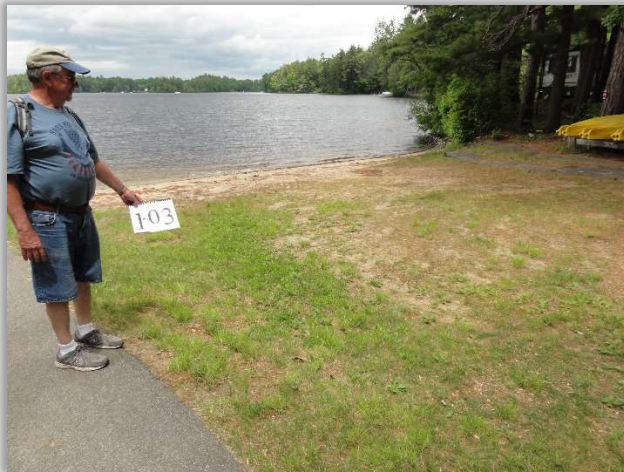
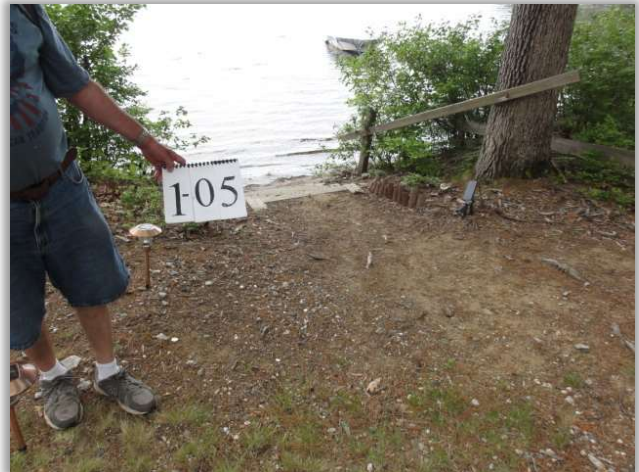
Both sites shown above have sheet surface erosion and bare soil, but the top left also has a lack of shoreline vegetation.

The suggestions for improvements to beach access include:

- ❖ Define and stabilize foot paths & install infiltration steps.
- ❖ Establish vegetative buffer zones.
- ❖ Reseed bare soil & thinning grass.
- ❖ Install road/path runoff diverters such as waterbars.
- ❖ Add a mulch/erosion control mix.

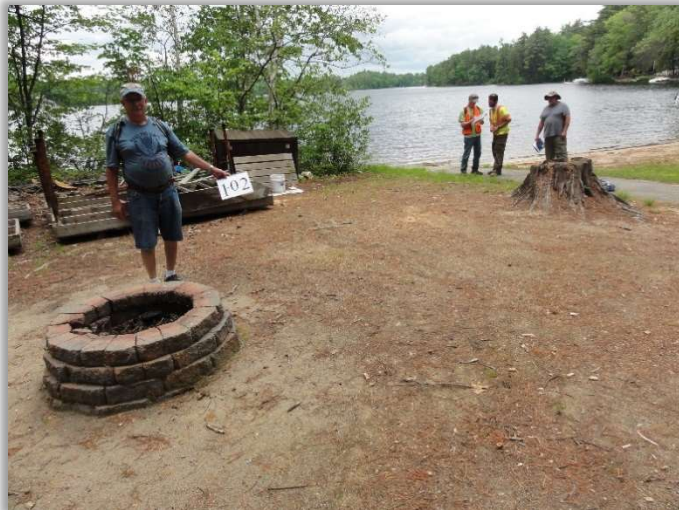
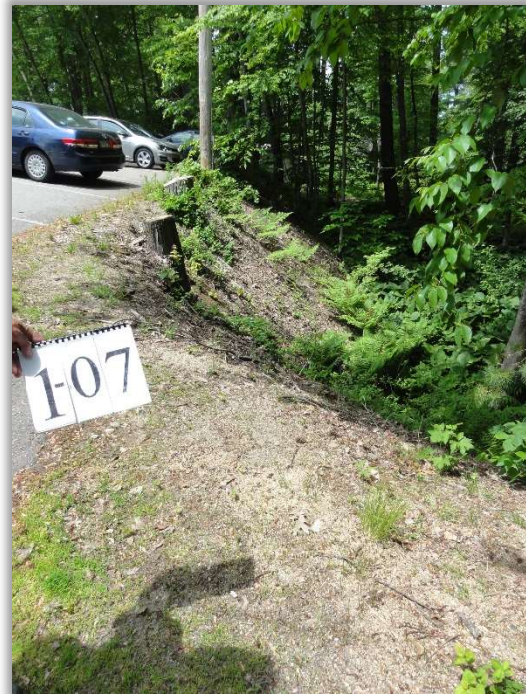
Both sites pictured above have sheet surface erosion and bare soil. The upper right picture also depicts rill surface erosion, an unstable/clogged culvert, and winter sand deposits.

The suggestions for improvements to other site categories include:

- ❖ Establishing buffers.
- ❖ Armoring, unclogging, enlarging & lengthening culverts.
- ❖ Install road/path runoff diverters.
- ❖ Defining & stabilizing foot paths.
- ❖ Installing infiltration steps.
- ❖ Creating rain gardens for diverted runoff.
- ❖ Install ditch turnouts & sediment ponds.
- ❖ Reseed bare soil and thinning grass.
