## Uniform Mitigation Verification

14060 Winchester Ct.

Prepared for  
Reflection Lakes Condo. Association 1

# Uniform Mitigation Verification Inspection Form

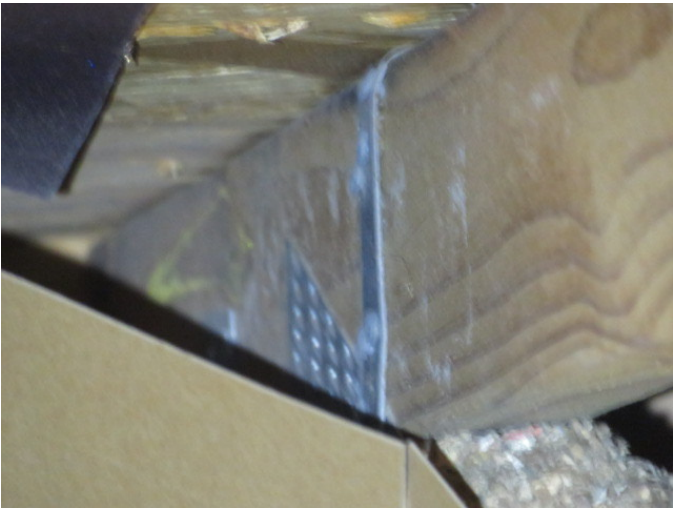
Roof to Wall Attachment

- ☒ Secured to truss/rafter with a minimum of three (3) nails, **and**
- ☒ Attached to the wall top plate of the wall framing, or embedded in the bond beam, with less than a ½" gap from the blocking or truss/rafter **and** blocked no more than 1.5" of the truss/rafter, **and** free of visible severe corrosion.

- ☒ C. Single Wraps
  - Metal connectors consisting of a single strap that wraps over the top of the truss/rafter and is secured with a minimum of 2 nails on the front side and a minimum of 1 nail on the opposing side.

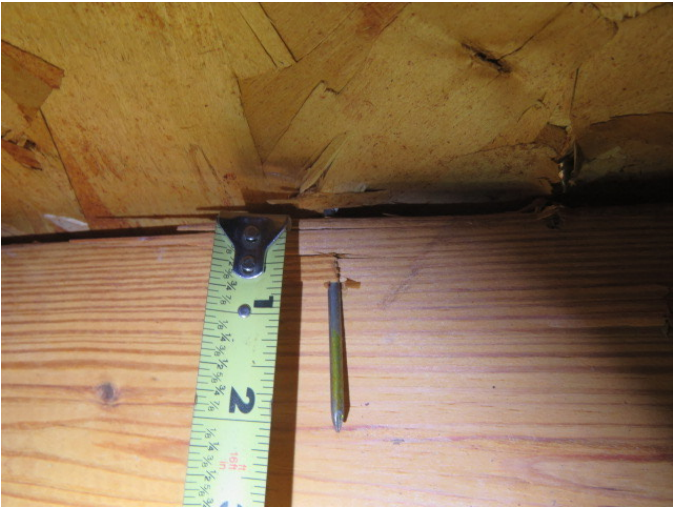
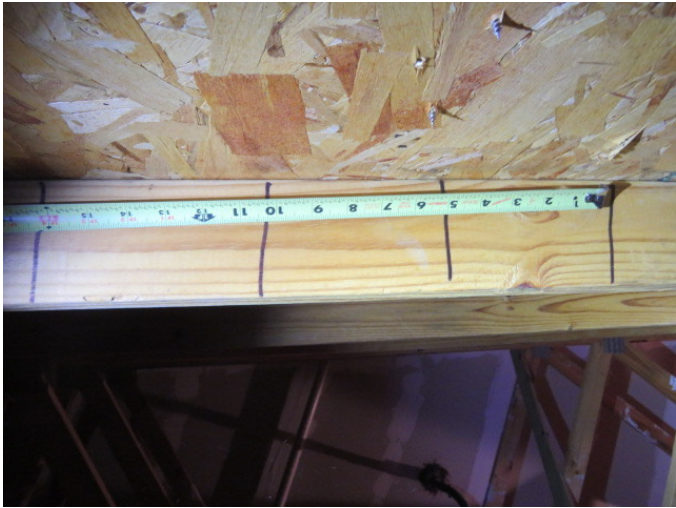
Roof Deck Attachment

- ☒ C. Plywood/OSB roof sheathing with a minimum thickness of 7/16" inch attached to the roof truss/rafter (spaced a maximum of 24" inches o.c.) by 8d common nails spaced a maximum of 6" inches in the field. -OR- Dimensional lumber/Tongue & Groove decking with a minimum of 2 nails per board (or 1 nail per board if each board is equal to or less than 6 inches in width). -OR- Any system of screws, nails, adhesives, other deck fastening system or truss/rafter spacing that is shown to have an equivalent

or greater resistance than 8d common nails spaced a maximum of 6 inches in the field or has a mean uplift resistance of at least 182 psf.

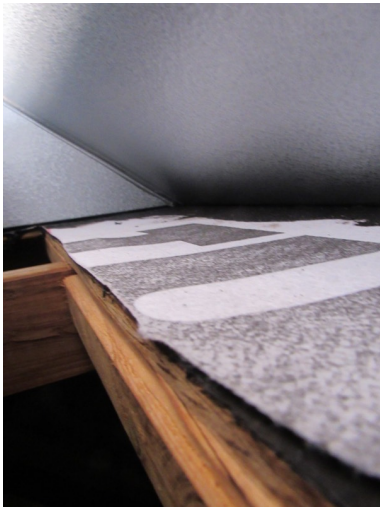
Secondary Water Resistance

- ☒ A. SWR (also called Sealed Roof Deck) Self-adhering polymer modified-bitumen roofing underlayment applied directly to the sheathing or foam adhesive SWR barrier (not foamed-on insulation) applied as a supplemental means to protect the dwelling from water intrusion in the event of roof covering loss.
- ☐ B. No SWR.
- ☐ C. Unknown or undetermined.
