## Uniform Mitigation Verification

14070 Winchester Ct.

Prepared for  
Reflection Lakes Condo. Association 1

# Uniform Mitigation Verification Inspection Form

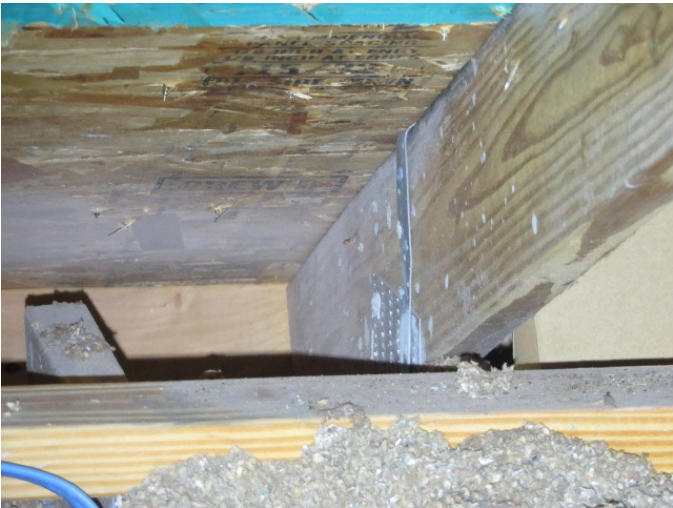
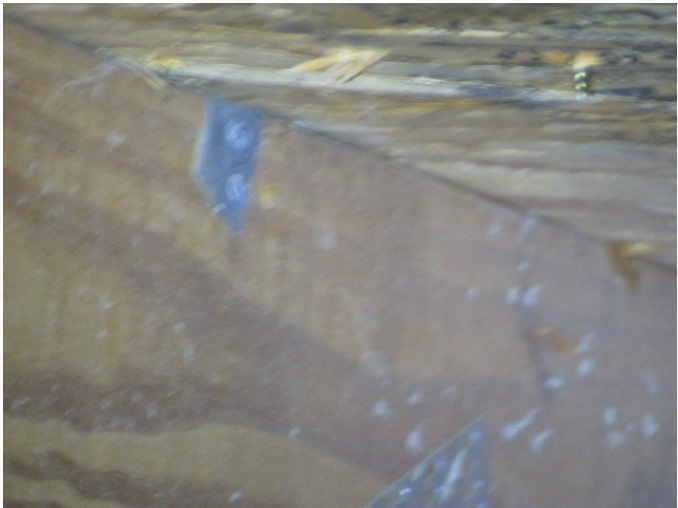
Roof to Wall Attachment

- ☒ Secured to truss/rafter with a minimum of three (3) nails, **and**
- ☒ Attached to the wall top plate of the wall framing, or embedded in the bond beam, with less than a ½" gap from the blocking or truss/rafter **and** blocked no more than 1.5" of the truss/rafter, **and** free of visible severe corrosion.

- ☒ C. Single Wraps
  - Metal connectors consisting of a single strap that wraps over the top of the truss/rafter and is secured with a minimum of 2 nails on the front side and a minimum of 1 nail on the opposing side.

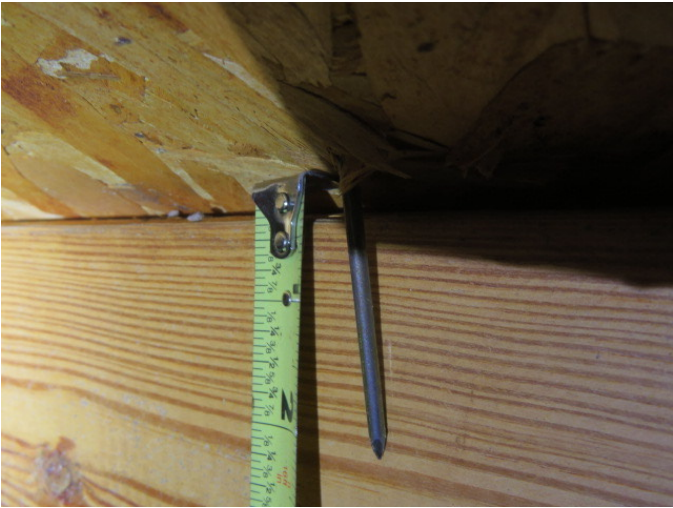
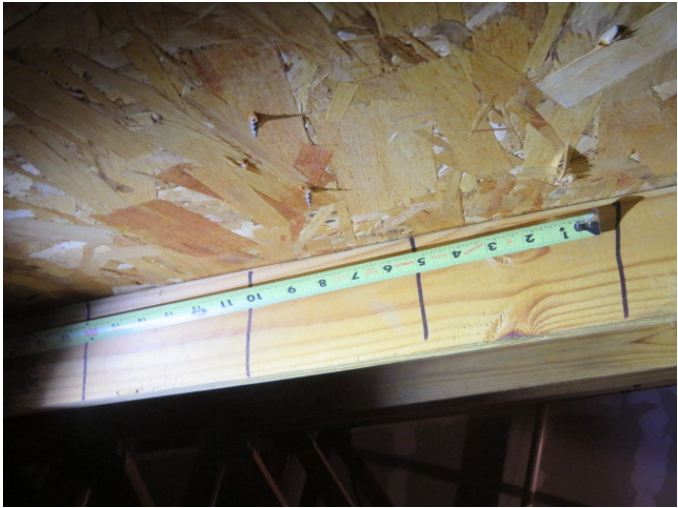
Roof Deck Attachment

- ☒ C. Plywood/OSB roof sheathing with a minimum thickness of 7/16" inch attached to the roof truss/rafter (spaced a maximum of 24" inches o.c.) by 8d common nails spaced a maximum of 6" inches in the field. -OR- Dimensional lumber/Tongue & Groove decking with a minimum of 2 nails per board (or 1 nail per board if each board is equal to or less than 6 inches in width). -OR- Any system of screws, nails, adhesives, other deck fastening system or truss/rafter spacing that is shown to have an equivalent

or greater resistance than 8d common nails spaced a maximum of 6 inches in the field or has a mean uplift resistance of at least 182 psf.

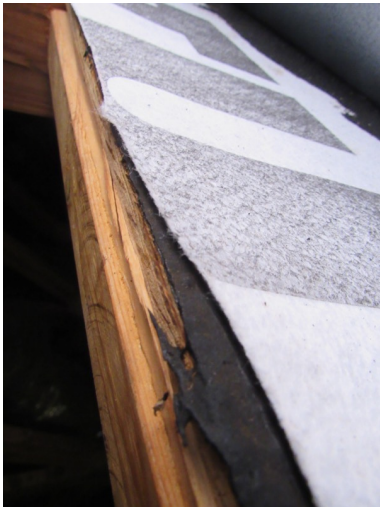
Secondary Water Resistance

- ☒ A. SWR (also called Sealed Roof Deck) Self-adhering polymer modified-bitumen roofing underlayment applied directly to the sheathing or foam adhesive SWR barrier (not foamed-on insulation) applied as a supplemental means to protect the dwelling from water intrusion in the event of roof covering loss.
- ☐ B. No SWR.
- ☐ C. Unknown or undetermined.
