# Kelly Inspection Service

## Uniform Mitigation Verification

14080 Winchester Ct.

# Uniform Mitigation Verification Inspection Form

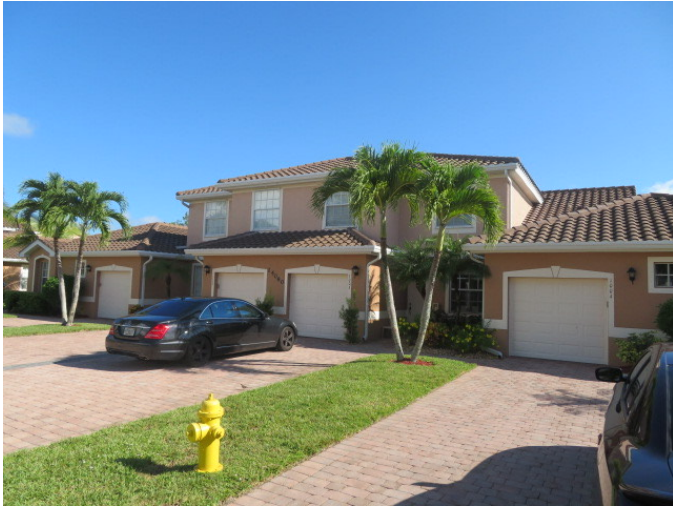
Front Elevation

- ☒ A. Hip Roof
  - Hip roof with no other roof shapes greater than 10% of the total roof system perimeter.
  - Total length of non-hip features: 30 feet; Total roof system perimeter: 360 feet
- ☐ B. Flat Roof
  - Roof on a building with 5 or more units where at least 90% of the main roof area has a roof slope of less than 2:12. Roof area with slope less than 2:12 \_\_\_\_\_ sq ft; Total roof area \_\_\_\_\_ sq ft
- ☐ C. Other Roof
  - Any roof that does not qualify as either (A) or (B) above.

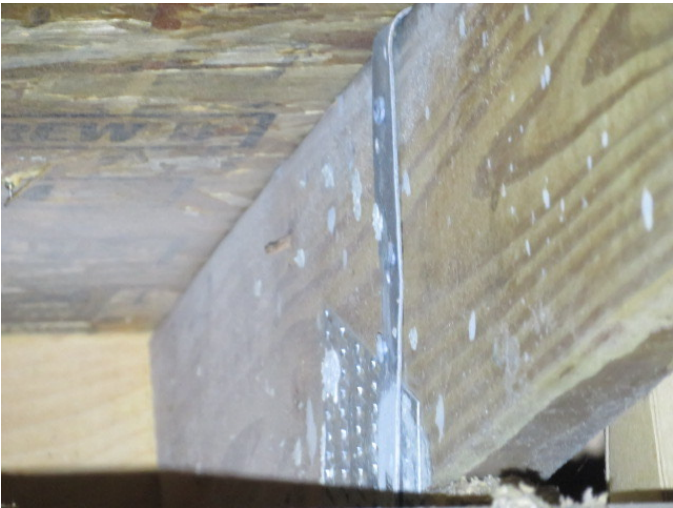
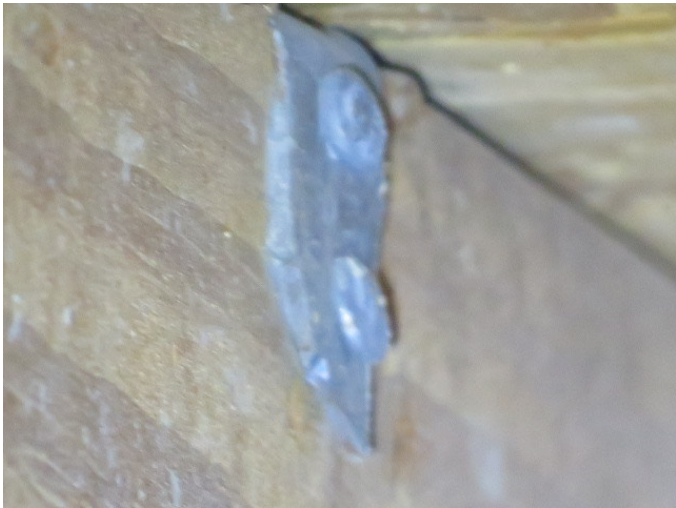
Roof to Wall Attachment

- ☒ Secured to truss/rafter with a minimum of three (3) nails, **and**
- ☒ Attached to the wall top plate of the wall framing, or embedded in the bond beam, with less than a ½" gap from the blocking or truss/rafter **and** blocked no more than 1.5" of the truss/rafter, **and** free of visible severe corrosion.

- ☒ C. Single Wraps
  - Metal connectors consisting of a single strap that wraps over the top of the truss/rafter and is secured with a minimum of 2 nails on the front side and a minimum of 1 nail on the opposing side.

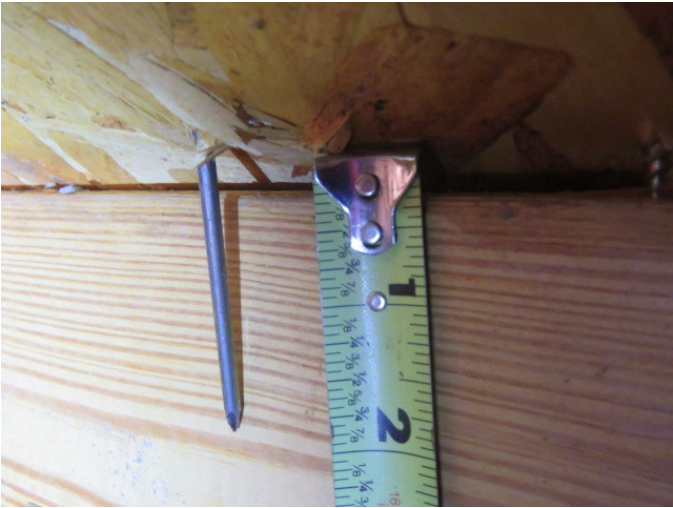
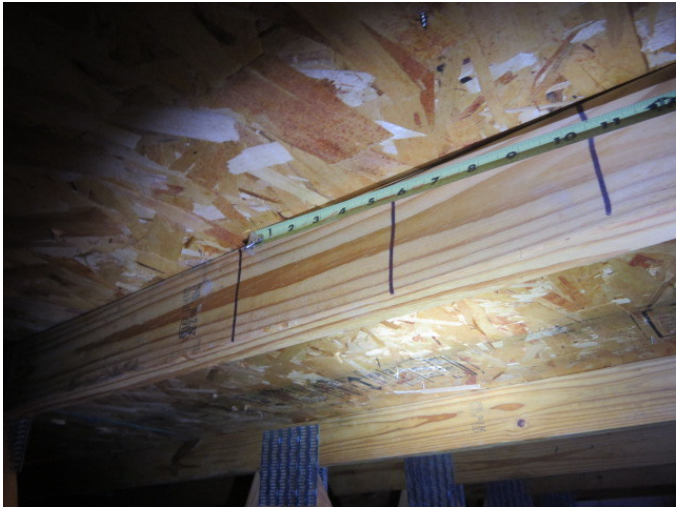
Roof Deck Attachment

- ☒ C. Plywood/OSB roof sheathing with a minimum thickness of 7/16" inch attached to the roof truss/rafter (spaced a maximum of 24" inches o.c.) by 8d common nails spaced a maximum of 6" inches in the field. -OR- Dimensional lumber/Tongue & Groove decking with a minimum of 2 nails per board (or 1 nail per board if each board is equal to or less than 6 inches in width). -OR- Any system of screws, nails, adhesives, other deck fastening system or truss/rafter spacing that is shown to have an equivalent

or greater resistance than 8d common nails spaced a maximum of 6 inches in the field or has a mean uplift resistance of at least 182 psf.

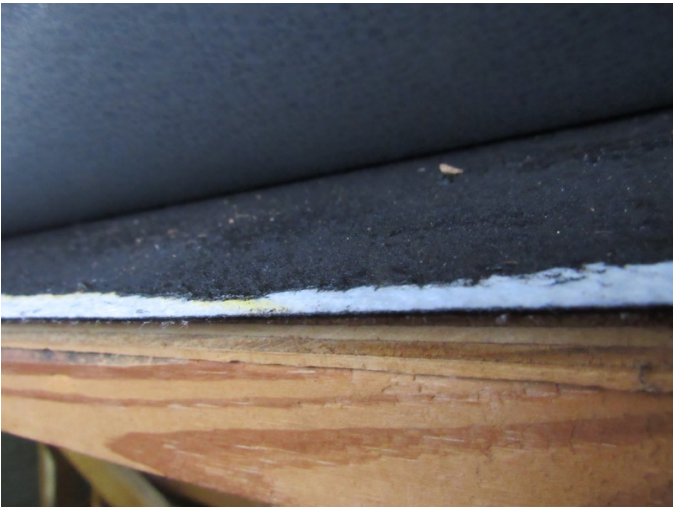
Secondary Water Resistance

- ☒ A. SWR (also called Sealed Roof Deck) Self-adhering polymer modified-bitumen roofing underlayment applied directly to the sheathing or foam adhesive SWR barrier (not foamed-on insulation) applied as a supplemental means to protect the dwelling from water intrusion in the event of roof covering loss.
- ☐ B. No SWR.
- ☐ C. Unknown or undetermined.
