# Kelly Inspection Service

## Uniform Mitigation Verification

14095 Winchester Ct.

# Uniform Mitigation Verification Inspection Form

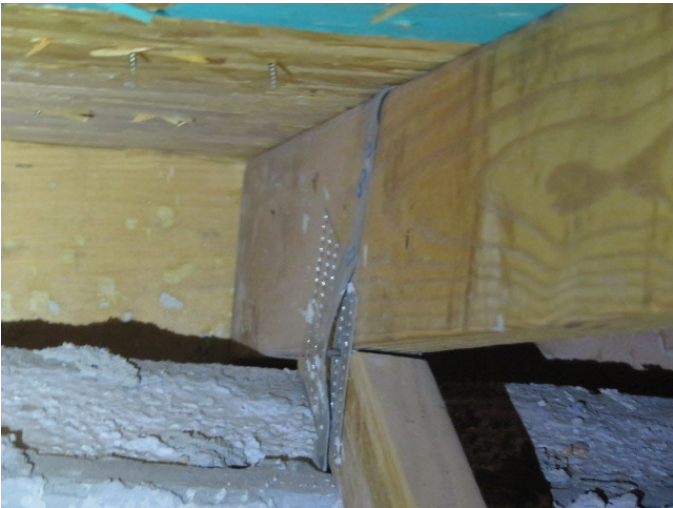
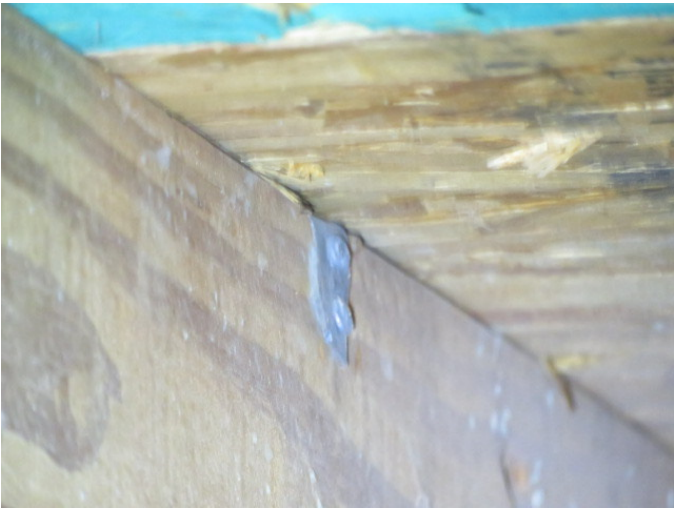
Roof to Wall Attachment

- ☒ Secured to truss/rafter with a minimum of three (3) nails, **and**
- ☒ Attached to the wall top plate of the wall framing, or embedded in the bond beam, with less than a ½" gap from the blocking or truss/rafter **and** blocked no more than 1.5" of the truss/rafter, **and** free of visible severe corrosion.

- ☒ C. Single Wraps
  - Metal connectors consisting of a single strap that wraps over the top of the truss/rafter and is secured with a minimum of 2 nails on the front side and a minimum of 1 nail on the opposing side.

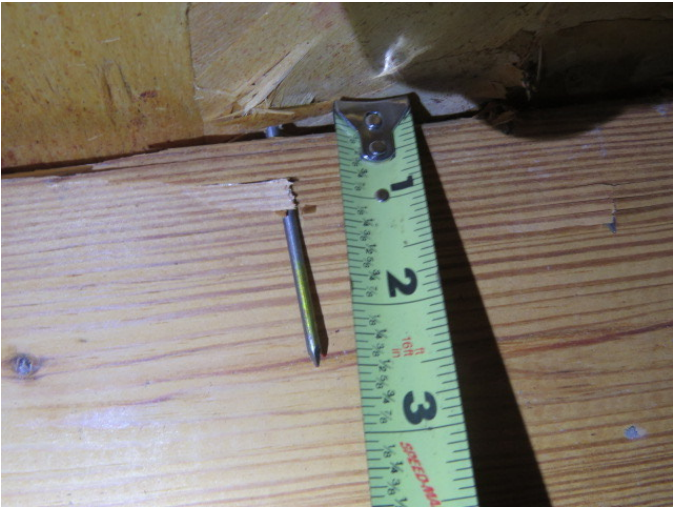
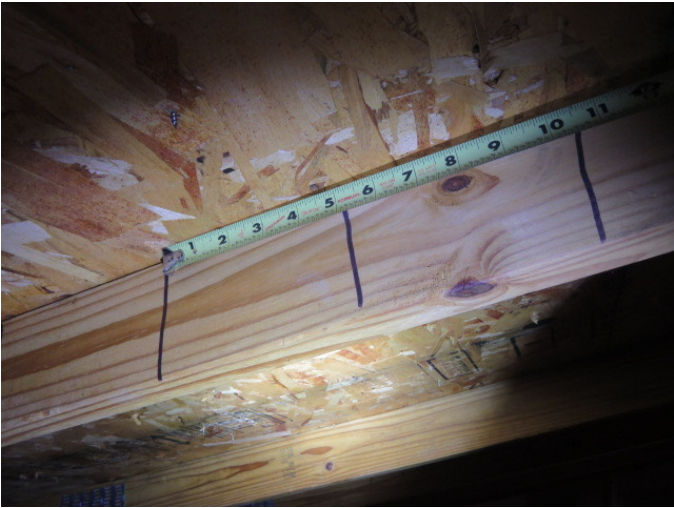
Roof Deck Attachment

- ☒ C. Plywood/OSB roof sheathing with a minimum thickness of 7/16" inch attached to the roof truss/rafter (spaced a maximum of 24" inches o.c.) by 8d common nails spaced a maximum of 6" inches in the field. -OR- Dimensional lumber/Tongue & Groove decking with a minimum of 2 nails per board (or 1 nail per board if each board is equal to or less than 6 inches in width). -OR- Any system of screws, nails, adhesives, other deck fastening system or truss/rafter spacing that is shown to have an equivalent

or greater resistance than 8d common nails spaced a maximum of 6 inches in the field or has a mean uplift resistance of at least 182 psf.

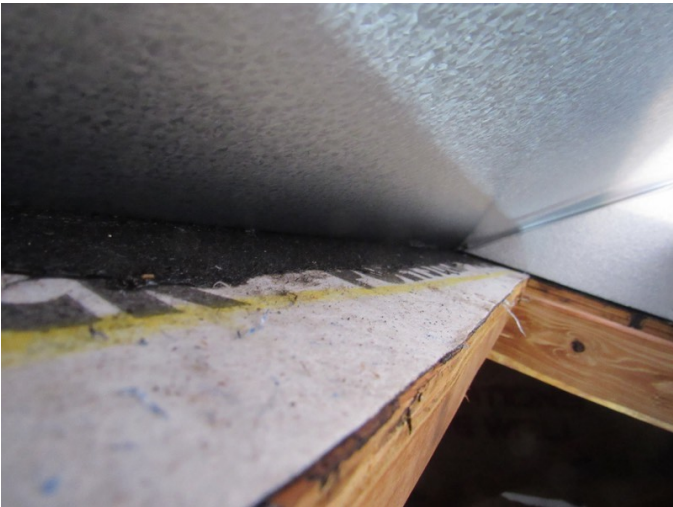
Secondary Water Resistance

- ☒ A. SWR (also called Sealed Roof Deck) Self-adhering polymer modified-bitumen roofing underlayment applied directly to the sheathing or foam adhesive SWR barrier (not foamed-on insulation) applied as a supplemental means to protect the dwelling from water intrusion in the event of roof covering loss.
- ☐ B. No SWR.
- ☐ C. Unknown or undetermined.
