# Kelly Inspection Service

## Uniform Mitigation Verification

14105 Winchester Ct.

Prepared for  
Reflection Lakes Condo. Association 1

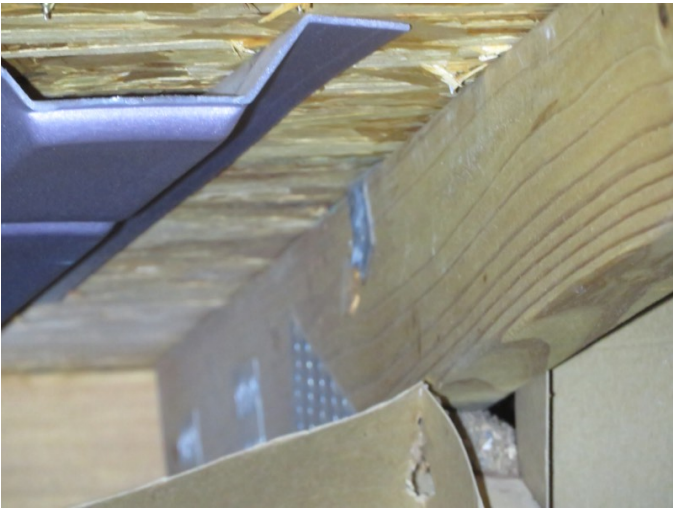
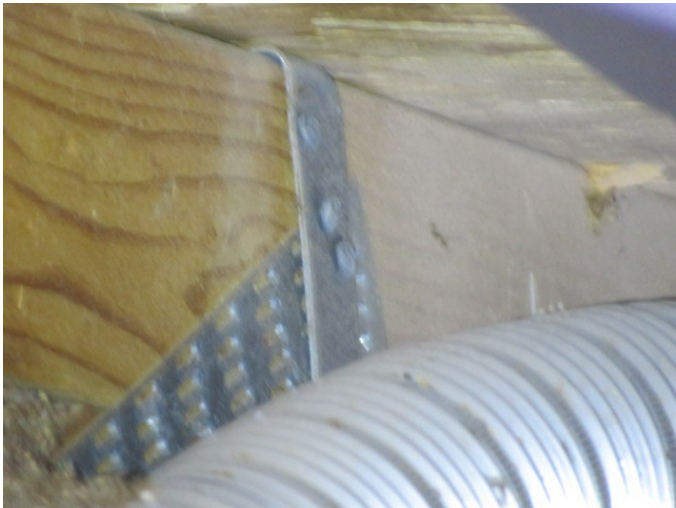
Roof to Wall Attachment

- ☒ Secured to truss/rafter with a minimum of three (3) nails, **and**
- ☒ Attached to the wall top plate of the wall framing, or embedded in the bond beam, with less than a ½" gap from the blocking or truss/rafter **and** blocked no more than 1.5" of the truss/rafter, **and** free of visible severe corrosion.

- ☒ C. Single Wraps
  - Metal connectors consisting of a single strap that wraps over the top of the truss/rafter and is secured with a minimum of 2 nails on the front side and a minimum of 1 nail on the opposing side.

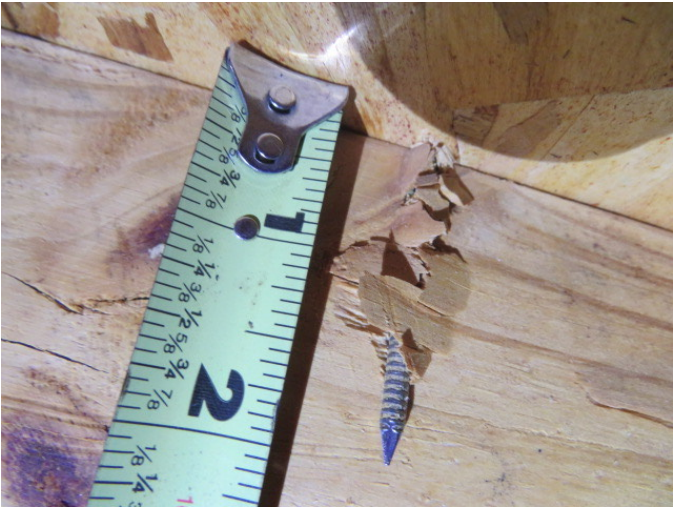
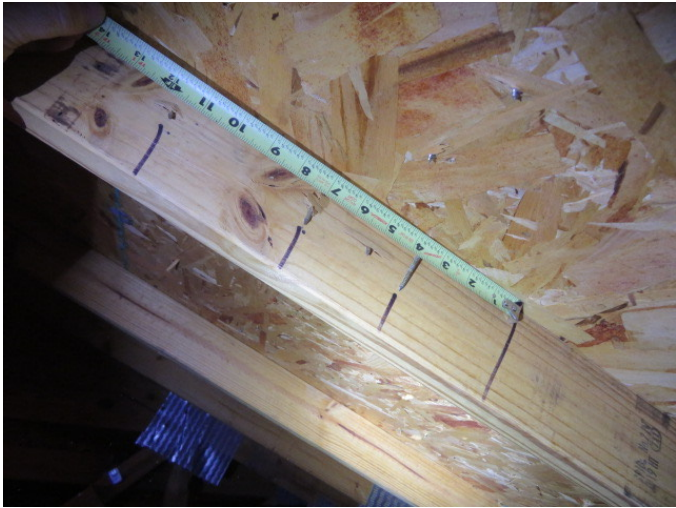
Roof Deck Attachment

- ☒ C. Plywood/OSB roof sheathing with a minimum thickness of 7/16" inch attached to the roof truss/rafter (spaced a maximum of 24" inches o.c.) by 8d common nails spaced a maximum of 6" inches in the field. -OR- Dimensional lumber/Tongue & Groove decking with a minimum of 2 nails per board (or 1 nail per board if each board is equal to or less than 6 inches in width). -OR- Any system of screws, nails, adhesives, other deck fastening system or truss/rafter spacing that is shown to have an equivalent

or greater resistance than 8d common nails spaced a maximum of 6 inches in the field or has a mean uplift resistance of at least 182 psf.
