# Kelly Inspection Service

## Uniform Mitigation Verification

14110 Winchester Ct.

Prepared for  
Reflection Lakes Condo. Association 1

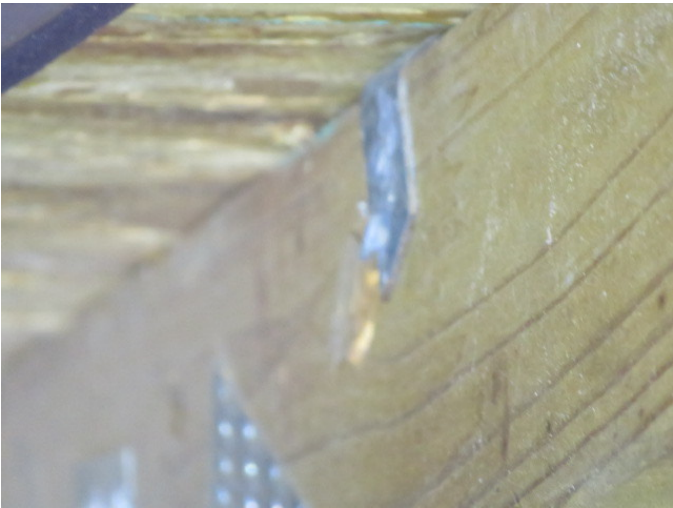
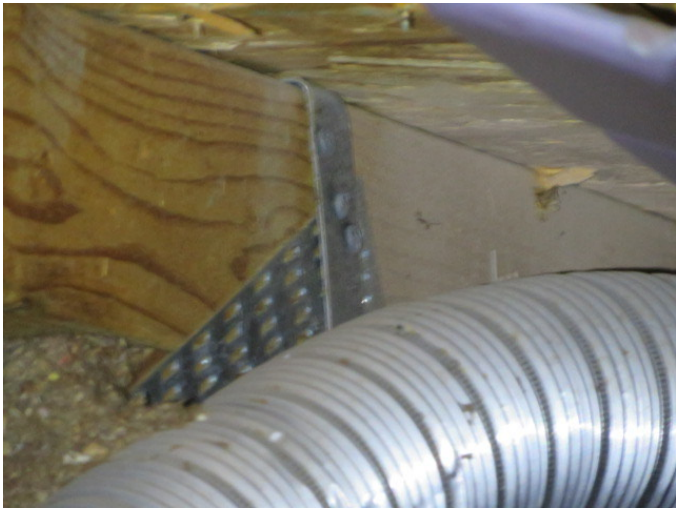
- ☒ Secured to truss/rafter with a minimum of three (3) nails, **and**
- ☒ Attached to the wall top plate of the wall framing, or embedded in the bond beam, with less than a ½" gap from the blocking or truss/rafter **and** blocked no more than 1.5" of the truss/rafter, **and** free of visible severe corrosion.

- ☒ C. Single Wraps
  - Metal connectors consisting of a single strap that wraps over the top of the truss/rafter and is secured with a minimum of 2 nails on the front side and a minimum of 1 nail on the opposing side.

Roof to Wall Attachment

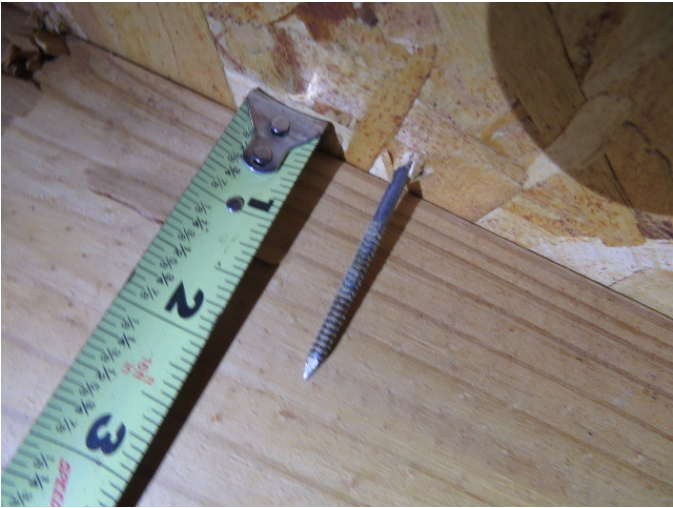
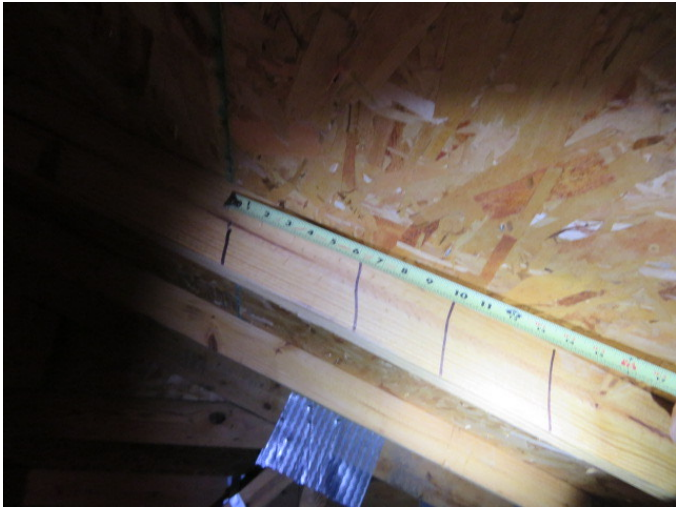
- ☒ C. Plywood/OSB roof sheathing with a minimum thickness of 7/16" inch attached to the roof truss/rafter (spaced a maximum of 24" inches o.c.) by 8d common nails spaced a maximum of 6" inches in the field. -OR- Dimensional lumber/Tongue & Groove decking with a minimum of 2 nails per board (or 1 nail per board if each board is equal to or less than 6 inches in width). -OR- Any system of screws, nails, adhesives, other deck fastening system or truss/rafter spacing that is shown to have an equivalent

Roof Deck Attachment

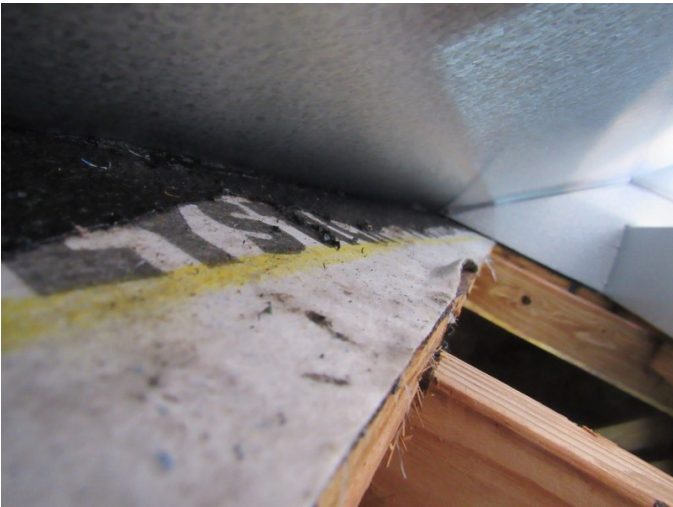
- ☒ A. SWR (also called Sealed Roof Deck) Self-adhering polymer modified-bitumen roofing underlayment applied directly to the sheathing or foam adhesive SWR barrier (not foamed-on insulation) applied as a supplemental means to protect the dwelling from water intrusion in the event of roof covering loss.
- ☐ B. No SWR.
- ☐ C. Unknown or undetermined.

Secondary Water Resistance
