## Uniform Mitigation Verification

14120 Winchester Ct.

Naples

Prepared for  
Reflection Lakes Condo. Association 1

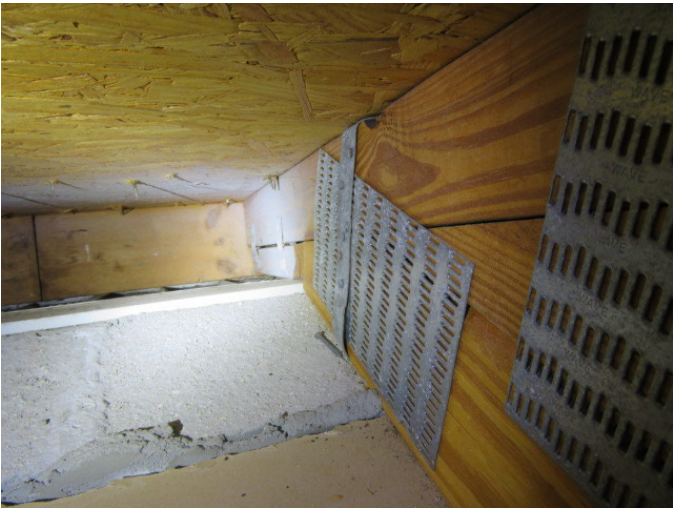
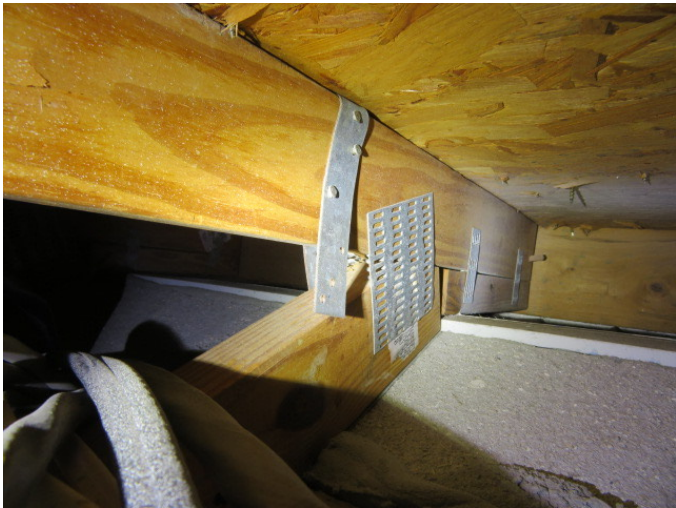
Roof to Wall Attachment

- ☒ Secured to truss/rafter with a minimum of three (3) nails, **and**
- ☒ Attached to the wall top plate of the wall framing, or embedded in the bond beam, with less than a ½" gap from the blocking or truss/rafter **and** blocked no more than 1.5" of the truss/rafter, **and** free of visible severe corrosion.

- ☒ C. Single Wraps
  - Metal connectors consisting of a single strap that wraps over the top of the truss/rafter and is secured with a minimum of 2 nails on the front side and a minimum of 1 nail on the opposing side.

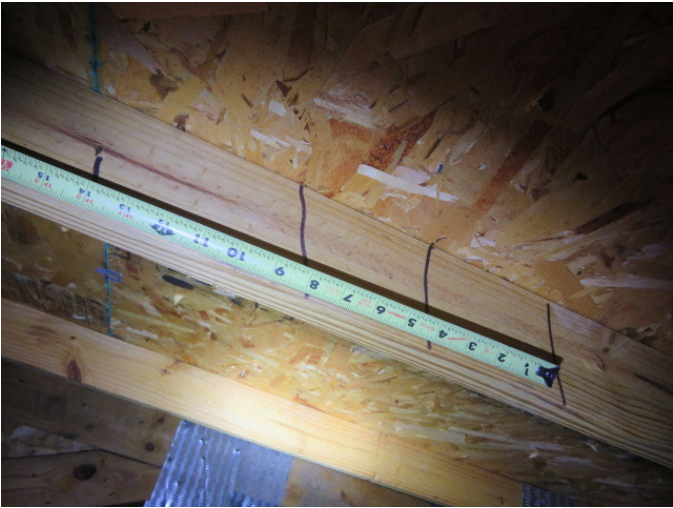
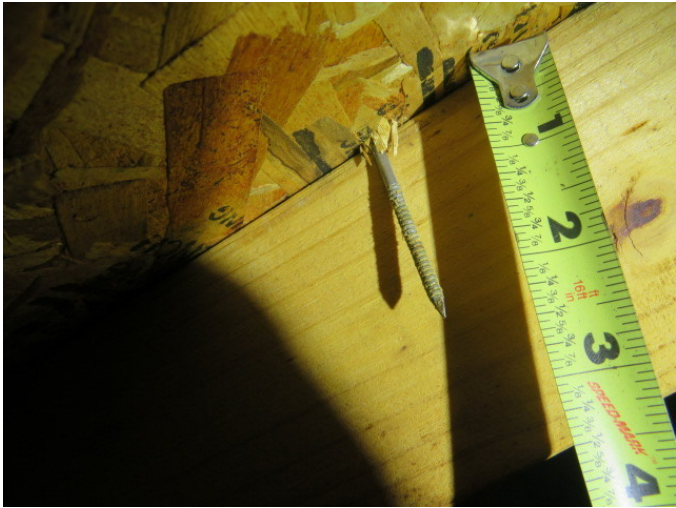
Roof Deck Attachment

- ☒ C. Plywood/OSB roof sheathing with a minimum thickness of 7/16" inch attached to the roof truss/rafter (spaced a maximum of 24" inches o.c.) by 8d common nails spaced a maximum of 6" inches in the field. -OR- Dimensional lumber/Tongue & Groove decking with a minimum of 2 nails per board (or 1 nail per board if each board is equal to or less than 6 inches in width). -OR- Any system of screws, nails, adhesives, other deck fastening system or truss/rafter spacing that is shown to have an equivalent

or greater resistance than 8d common nails spaced a maximum of 6 inches in the field or has a mean uplift resistance of at least 182 psf.

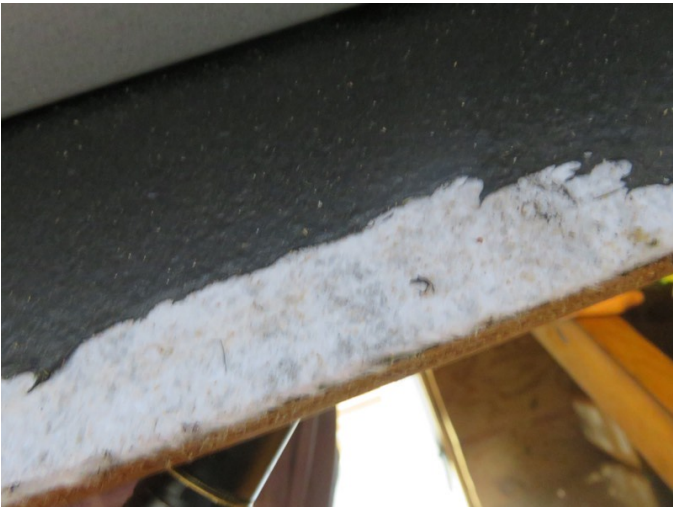
Secondary Water Resistance

- ☒ A. SWR (also called Sealed Roof Deck) Self-adhering polymer modified-bitumen roofing underlayment applied directly to the sheathing or foam adhesive SWR barrier (not foamed-on insulation) applied as a supplemental means to protect the dwelling from water intrusion in the event of roof covering loss.
- ☐ B. No SWR.
- ☐ C. Unknown or undetermined.
