## Uniform Mitigation Verification

14130 Winchester Ct.

Prepared for  
Reflection Lakes Condo. Association 1

# Uniform Mitigation Verification Inspection Form

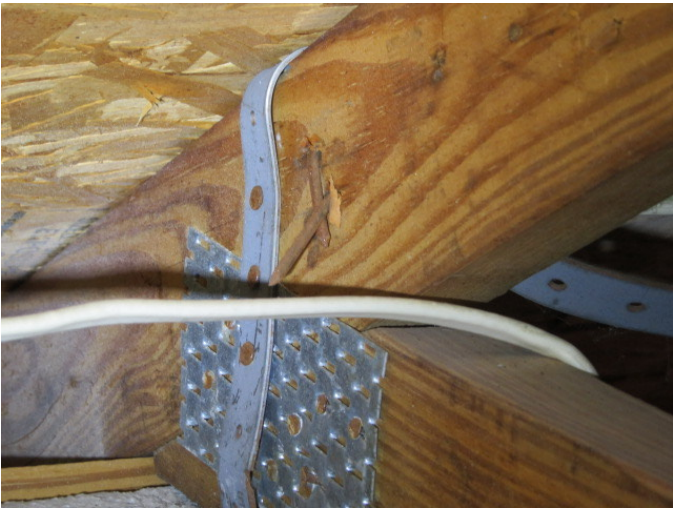
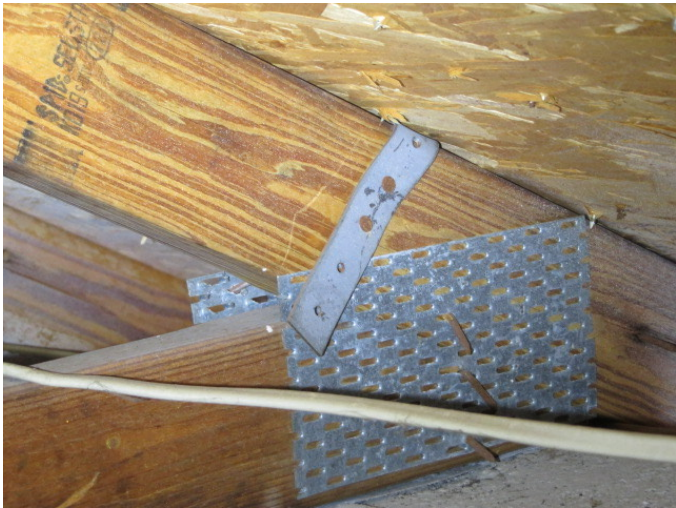
Roof to Wall Attachment

- ☒ Secured to truss/rafter with a minimum of three (3) nails, **and**
- ☒ Attached to the wall top plate of the wall framing, or embedded in the bond beam, with less than a 1/2" gap from the blocking or truss/rafter **and** blocked no more than 1.5" of the truss/rafter, **and** free of visible severe corrosion.

- ☒ C. Single Wraps
  - Metal connectors consisting of a single strap that wraps over the top of the truss/rafter and is secured with a minimum of 2 nails on the front side and a minimum of 1 nail on the opposing side.

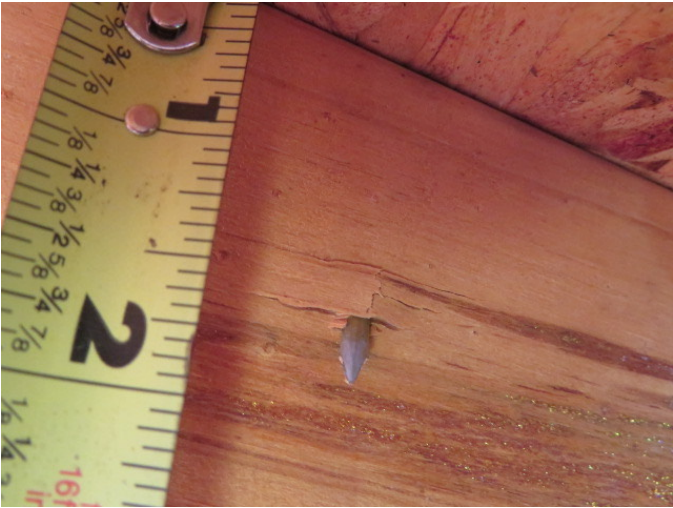
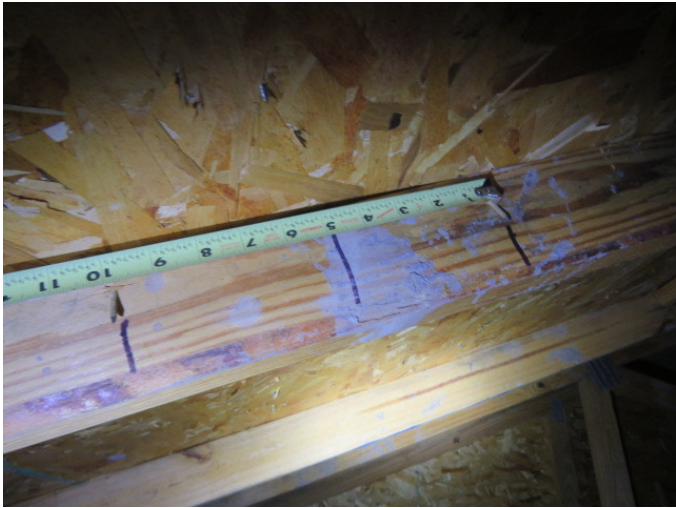
Roof Deck Attachment

- ☒ C. Plywood/OSB roof sheathing with a minimum thickness of 7/16" inch attached to the roof truss/rafter (spaced a maximum of 24" inches o.c.) by 8d common nails spaced a maximum of 6" inches in the field. -OR- Dimensional lumber/Tongue & Groove decking with a minimum of 2 nails per board (or 1 nail per board if each board is equal to or less than 6 inches in width). -OR- Any system of screws, nails, adhesives, other deck fastening system or truss/rafter spacing that is shown to have an equivalent

or greater resistance than 8d common nails spaced a maximum of 6 inches in the field or has a mean uplift resistance of at least 182 psf.

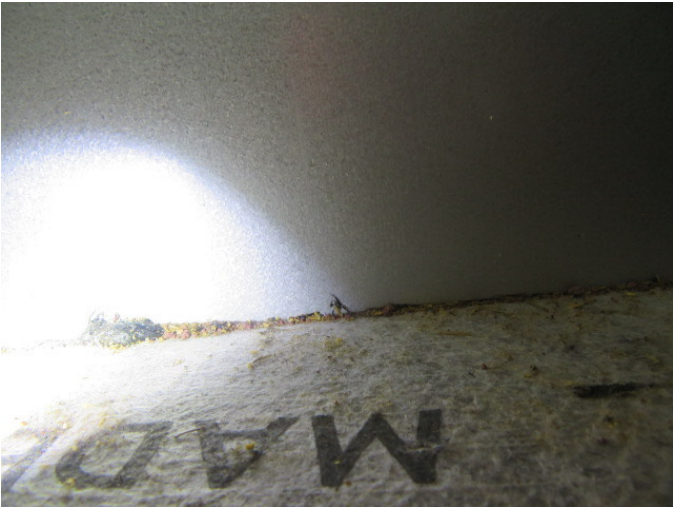
Secondary Water Resistance

- ☒ A. SWR (also called Sealed Roof Deck) Self-adhering polymer modified-bitumen roofing underlayment applied directly to the sheathing or foam adhesive SWR barrier (not foamed-on insulation) applied as a supplemental means to protect the dwelling from water intrusion in the event of roof covering loss.
- ☐ B. No SWR.
- ☐ C. Unknown or undetermined.
