# Kelly Inspection Service

## Uniform Mitigation Verification

14135 Winchester Ct.

# Uniform Mitigation Verification Inspection Form

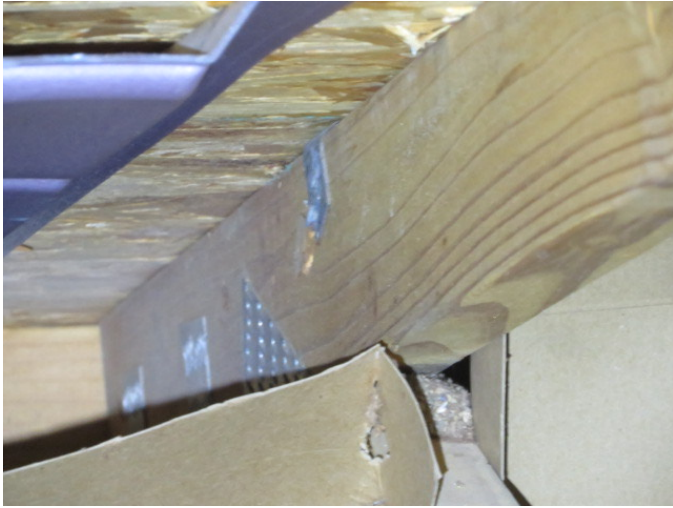
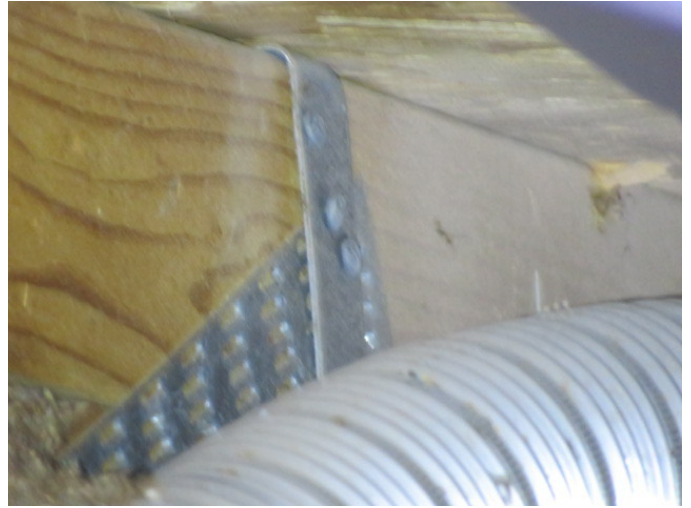
Roof to Wall Attachment

- ☒ Secured to truss/rafter with a minimum of three (3) nails, **and**
- ☒ Attached to the wall top plate of the wall framing, or embedded in the bond beam, with less than a ½" gap from the blocking or truss/rafter **and** blocked no more than 1.5" of the truss/rafter, **and** free of visible severe corrosion.

- ☒ C. Single Wraps
  - Metal connectors consisting of a single strap that wraps over the top of the truss/rafter and is secured with a minimum of 2 nails on the front side and a minimum of 1 nail on the opposing side.

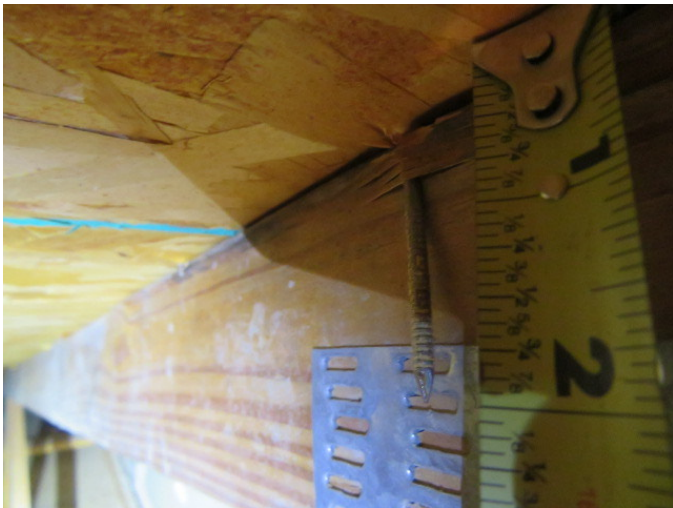
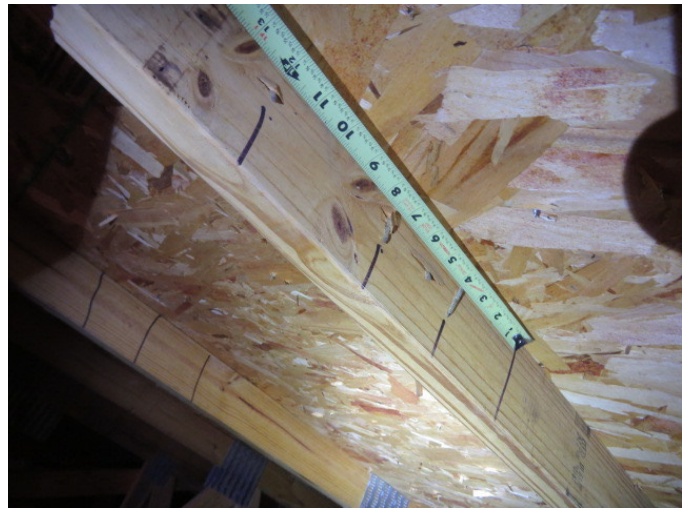
Roof Deck Attachment

- ☒ C. Plywood/OSB roof sheathing with a minimum thickness of 7/16" inch attached to the roof truss/rafter (spaced a maximum of 24" inches o.c.) by 8d common nails spaced a maximum of 6" inches in the field. -OR- Dimensional lumber/Tongue & Groove decking with a minimum of 2 nails per board (or 1 nail per board if each board is equal to or less than 6 inches in width). -OR- Any system of screws, nails, adhesives, other deck fastening system or truss/rafter spacing that is shown to have an equivalent

or greater resistance than 8d common nails spaced a maximum of 6 inches in the field or has a mean uplift resistance of at least 182 psf.

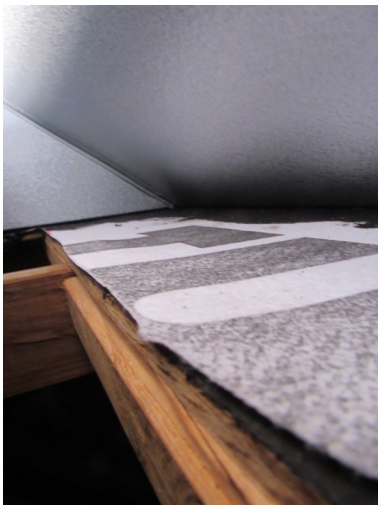
Secondary Water Resistance

- ☒ A. SWR (also called Sealed Roof Deck) Self-adhering polymer modified-bitumen roofing underlayment applied directly to the sheathing or foam adhesive SWR barrier (not foamed-on insulation) applied as a supplemental means to protect the dwelling from water intrusion in the event of roof covering loss.
- ☐ B. No SWR.
- ☐ C. Unknown or undetermined.
