## Uniform Mitigation Verification

14155 Winchester Ct.

Prepared for  
Reflection Lakes Condo. Association 1

# Uniform Mitigation Verification Inspection Form

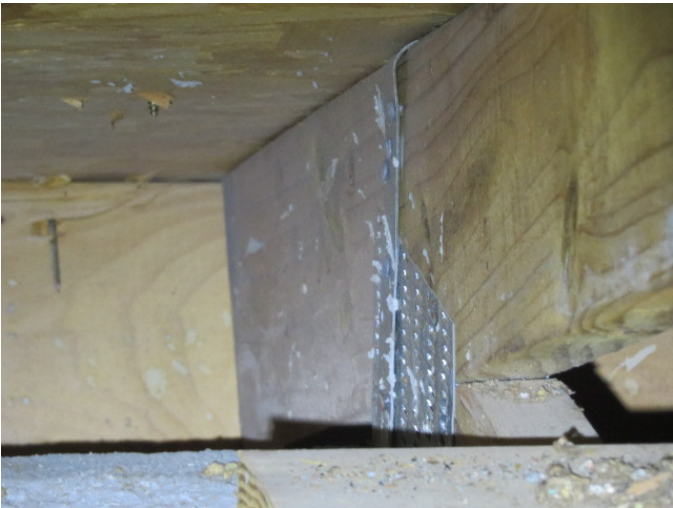
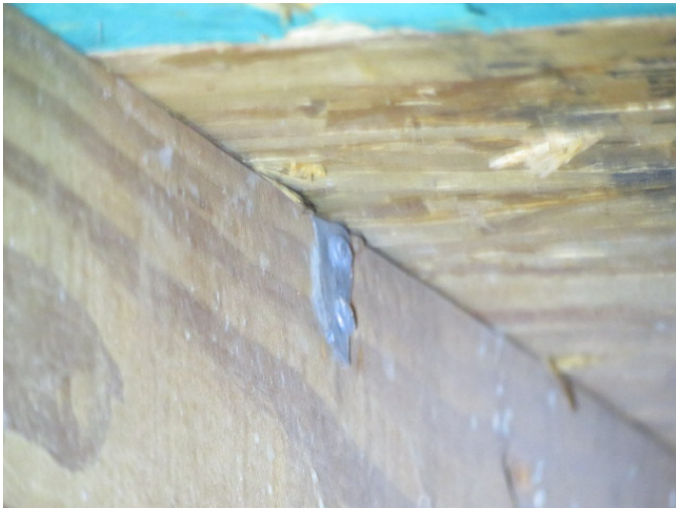
Roof to Wall Attachment

- ☒ Secured to truss/rafter with a minimum of three (3) nails, **and**
- ☒ Attached to the wall top plate of the wall framing, or embedded in the bond beam, with less than a ½" gap from the blocking or truss/rafter **and** blocked no more than 1.5" of the truss/rafter, **and** free of visible severe corrosion.

- ☒ C. Single Wraps
  - Metal connectors consisting of a single strap that wraps over the top of the truss/rafter and is secured with a minimum of 2 nails on the front side and a minimum of 1 nail on the opposing side.

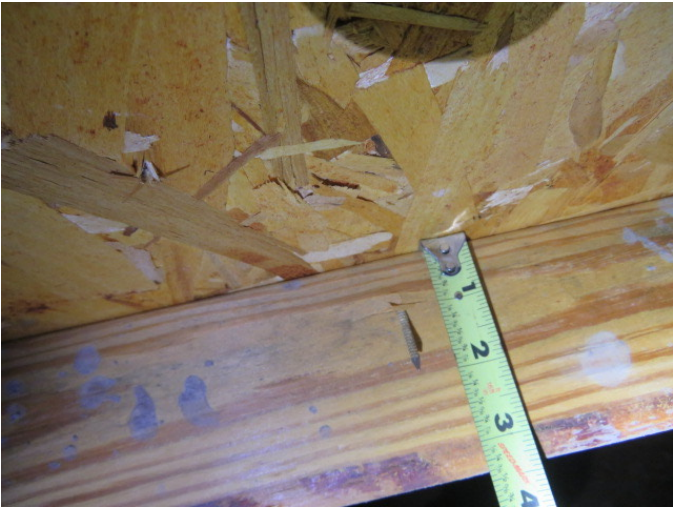
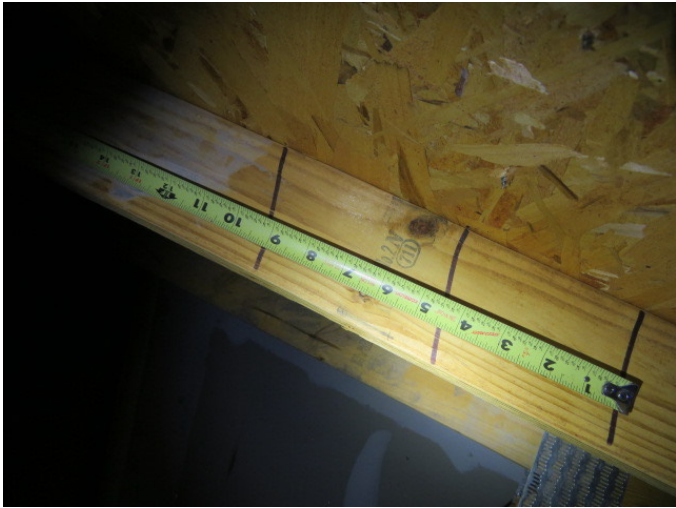
Roof Deck Attachment

- ☒ C. Plywood/OSB roof sheathing with a minimum thickness of 7/16" inch attached to the roof truss/rafter (spaced a maximum of 24" inches o.c.) by 8d common nails spaced a maximum of 6" inches in the field. -OR- Dimensional lumber/Tongue & Groove decking with a minimum of 2 nails per board (or 1 nail per board if each board is equal to or less than 6 inches in width). -OR- Any system of screws, nails, adhesives, other deck fastening system or truss/rafter spacing that is shown to have an equivalent

or greater resistance than 8d common nails spaced a maximum of 6 inches in the field or has a mean uplift resistance of at least 182 psf.

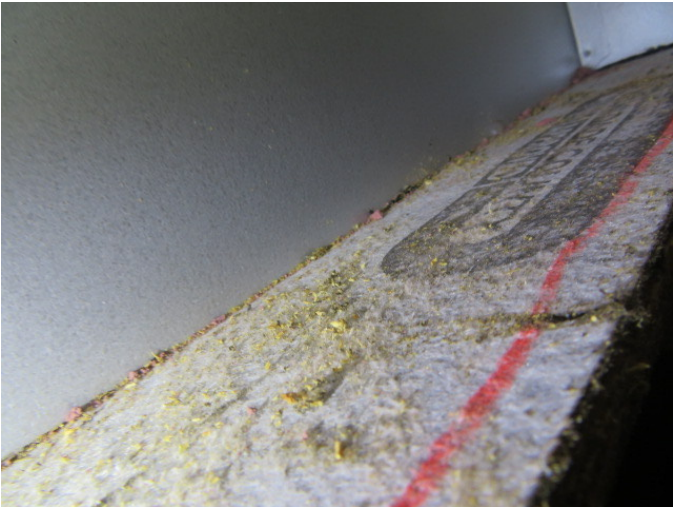
Secondary Water Resistance

- ☒ A. SWR (also called Sealed Roof Deck) Self-adhering polymer modified-bitumen roofing underlayment applied directly to the sheathing or foam adhesive SWR barrier (not foamed-on insulation) applied as a supplemental means to protect the dwelling from water intrusion in the event of roof covering loss.
- ☐ B. No SWR.
- ☐ C. Unknown or undetermined.
