## Uniform Mitigation Verification

14160 Winchester Ct.

Prepared for  
Reflection Lakes Condo. Association 1

# Uniform Mitigation Verification Inspection Form

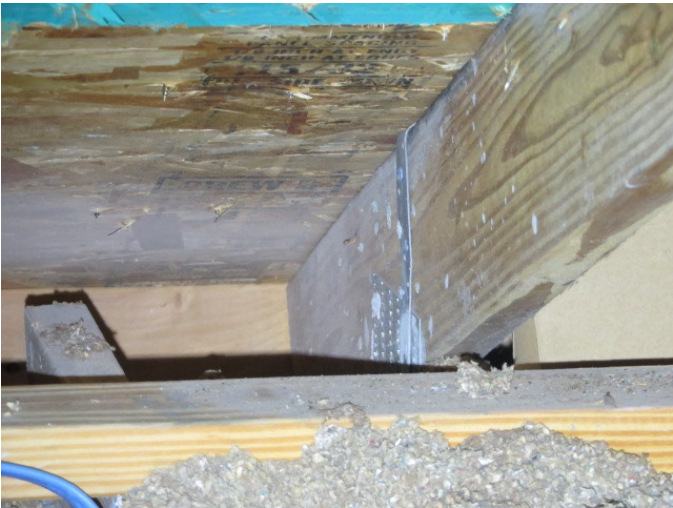
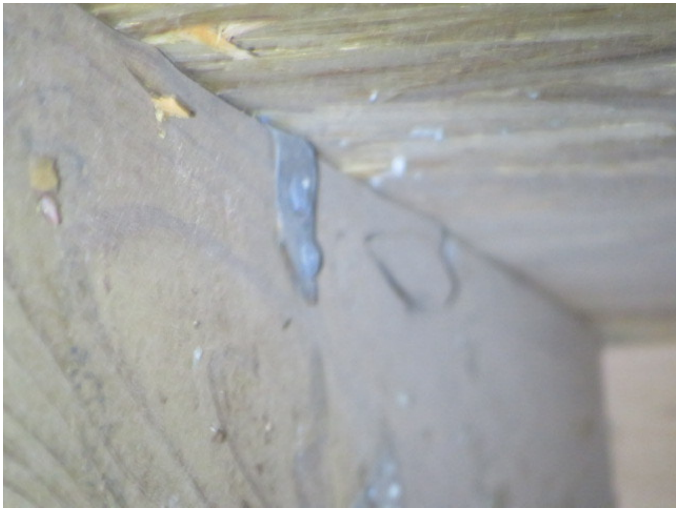
Roof to Wall Attachment

- ☒ Secured to truss/rafter with a minimum of three (3) nails, **and**
- ☒ Attached to the wall top plate of the wall framing, or embedded in the bond beam, with less than a ½" gap from the blocking or truss/rafter **and** blocked no more than 1.5" of the truss/rafter, **and** free of visible severe corrosion.

- ☒ C. Single Wraps
  - Metal connectors consisting of a single strap that wraps over the top of the truss/rafter and is secured with a minimum of 2 nails on the front side and a minimum of 1 nail on the opposing side.

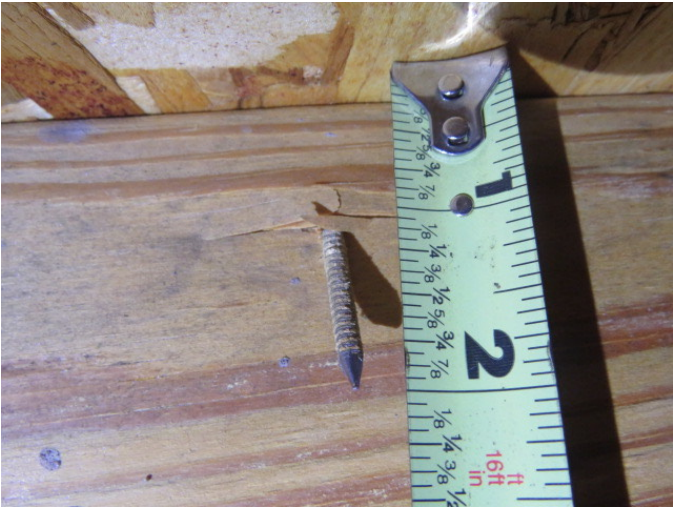
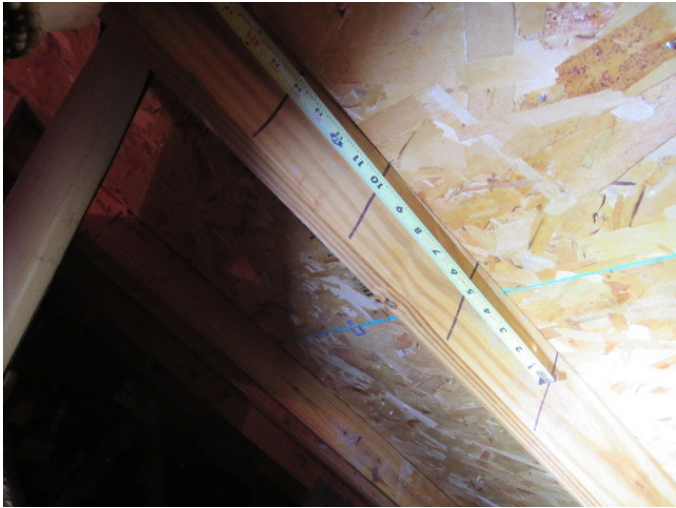
Roof Deck Attachment

- ☒ C. Plywood/OSB roof sheathing with a minimum thickness of 7/16" inch attached to the roof truss/rafter (spaced a maximum of 24" inches o.c.) by 8d common nails spaced a maximum of 6" inches in the field. -OR- Dimensional lumber/Tongue & Groove decking with a minimum of 2 nails per board (or 1 nail per board if each board is equal to or less than 6 inches in width). -OR- Any system of screws, nails, adhesives, other deck fastening system or truss/rafter spacing that is shown to have an equivalent

or greater resistance than 8d common nails spaced a maximum of 6 inches in the field or has a mean uplift resistance of at least 182 psf.

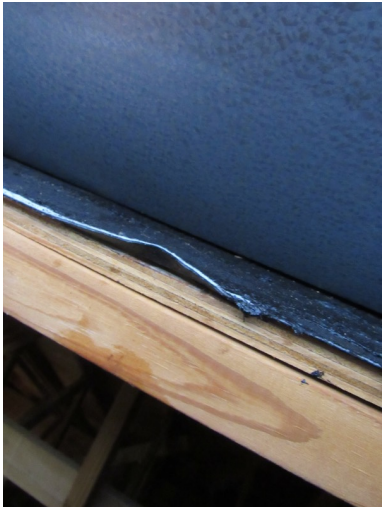
Secondary Water Resistance

- ☒ A. SWR (also called Sealed Roof Deck) Self-adhering polymer modified-bitumen roofing underlayment applied directly to the sheathing or foam adhesive SWR barrier (not foamed-on insulation) applied as a supplemental means to protect the dwelling from water intrusion in the event of roof covering loss.
- ☐ B. No SWR.
- ☐ C. Unknown or undetermined.
