## Uniform Mitigation Verification

14175 Winchester Ct.

Prepared for  
Reflection Lakes Condo. Association 1

# Uniform Mitigation Verification Inspection Form

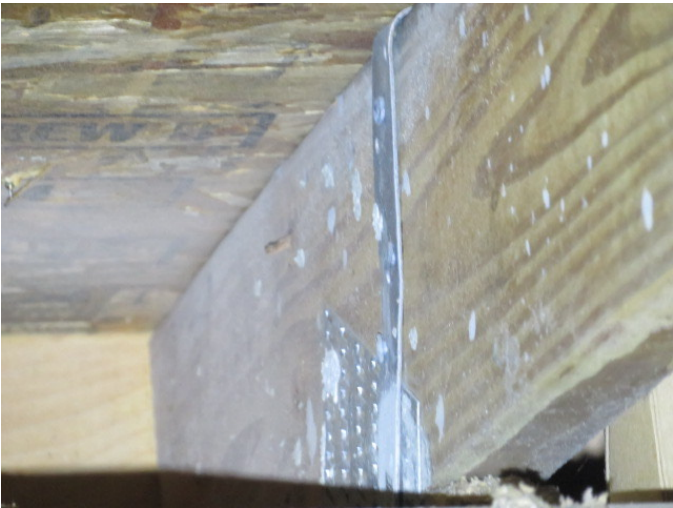
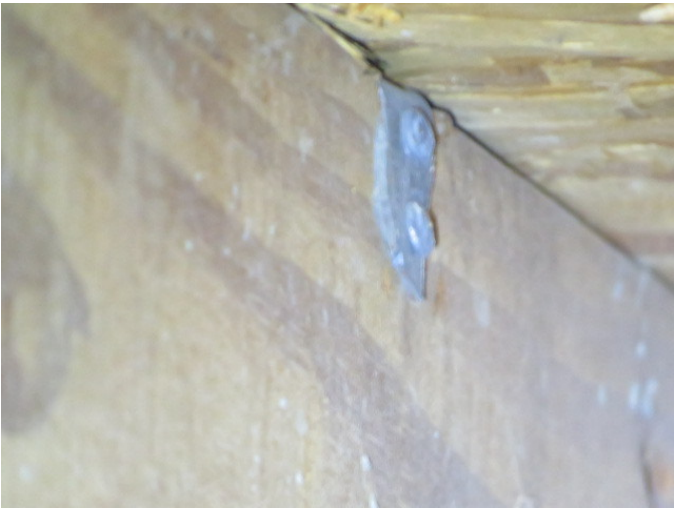
- ☒ Secured to truss/rafter with a minimum of three (3) nails, **and**
- ☒ Attached to the wall top plate of the wall framing, or embedded in the bond beam, with less than a ½" gap from the blocking or truss/rafter **and** blocked no more than 1.5" of the truss/rafter, **and** free of visible severe corrosion.

- ☒ C. Single Wraps
  - Metal connectors consisting of a single strap that wraps over the top of the truss/rafter and is secured with a minimum of 2 nails on the front side and a minimum of 1 nail on the opposing side.

Roof to Wall Attachment

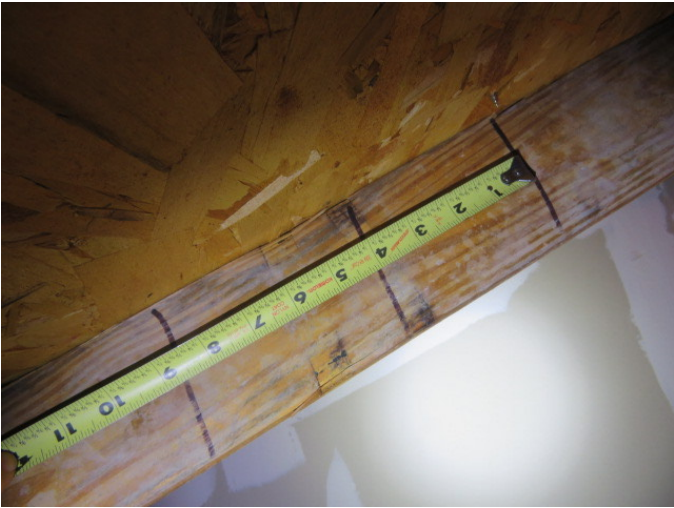
- ☒ C. Plywood/OSB roof sheathing with a minimum thickness of 7/16" inch attached to the roof truss/rafter (spaced a maximum of 24" inches o.c.) by 8d common nails spaced a maximum of 6" inches in the field. -OR- Dimensional lumber/Tongue & Groove decking with a minimum of 2 nails per board (or 1 nail per board if each board is equal to or less than 6 inches in width). -OR- Any system of screws, nails, adhesives, other deck fastening system or truss/rafter spacing that is shown to have an equivalent

Roof Deck Attachment

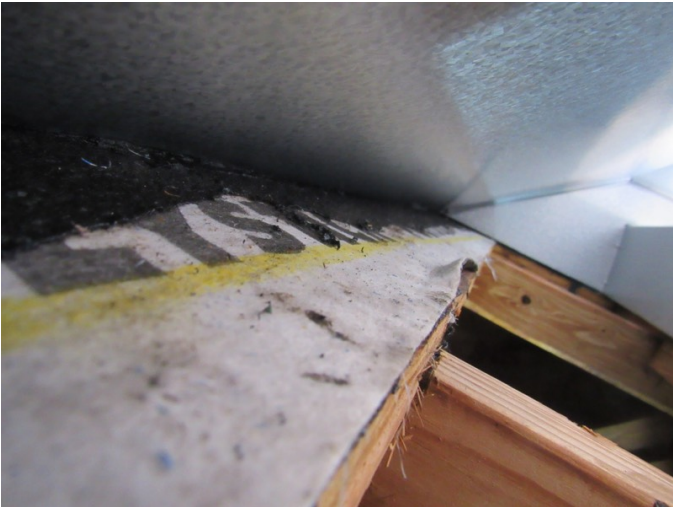
- ☒ A. SWR (also called Sealed Roof Deck) Self-adhering polymer modified-bitumen roofing underlayment applied directly to the sheathing or foam adhesive SWR barrier (not foamed-on insulation) applied as a supplemental means to protect the dwelling from water intrusion in the event of roof covering loss.
- ☐ B. No SWR.
- ☐ C. Unknown or undetermined.

Secondary Water Resistance
