CASE STUDY NO. 2

# WATER BACKUP IN A FINISHED BASEMENT

CAUSE OF LOSS: SUMP PUMP FAILURE

What to do when water backup causes significant damage throughout a finished basement.

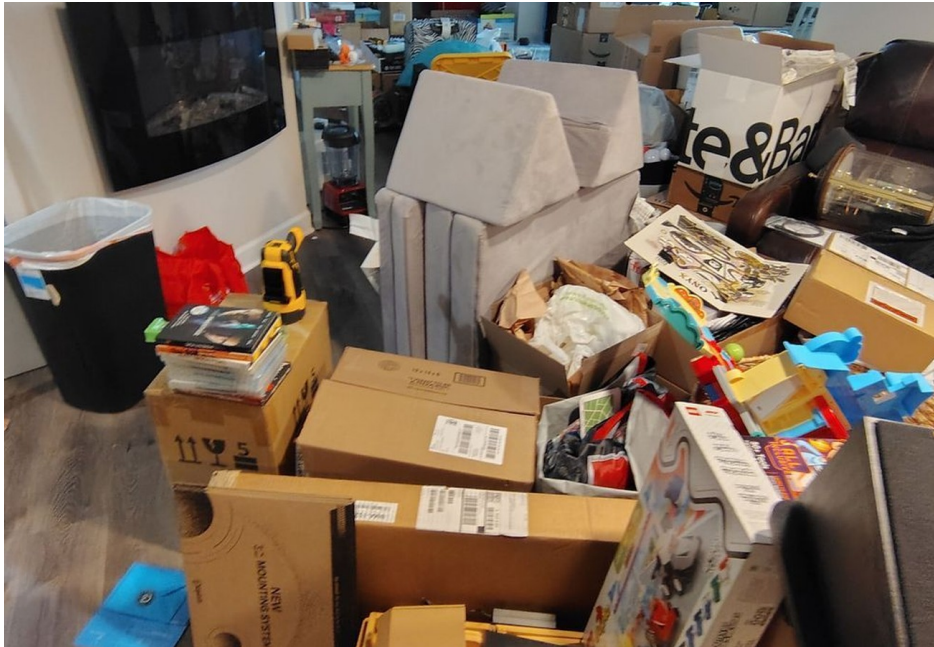
CONTENTS MANIPULATED FOR ACCESS

The basement was heavily congested, leaving little room for emergency work. Content manipulation moved, grouped and protected items within the basement so crews could document the loss, reach wet materials and begin mitigation safely.

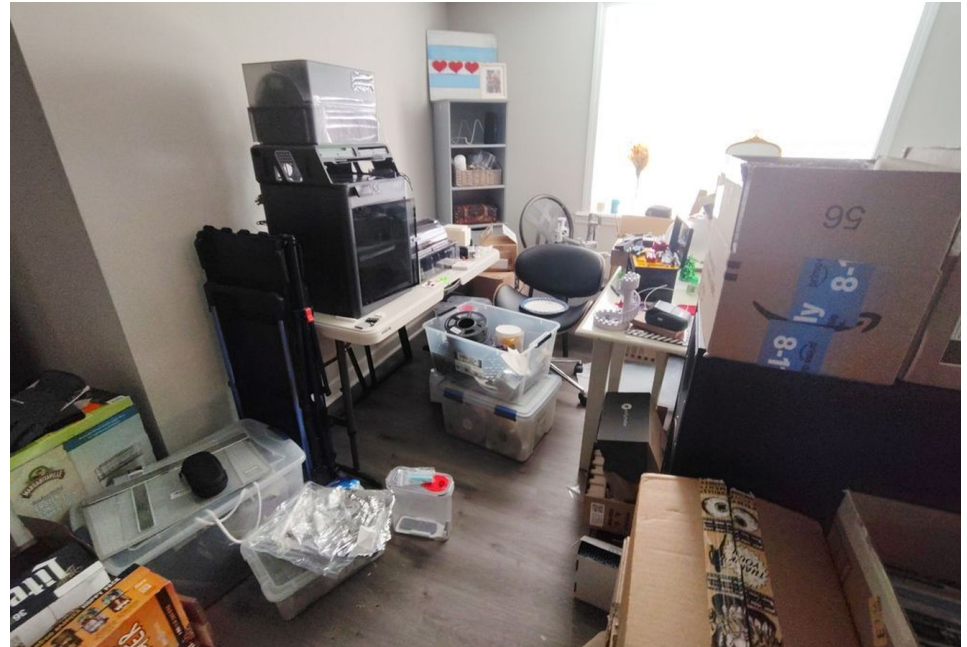
WATER MOVED ACROSS FINISHED AREAS

The team recorded the original contents, standing water, affected rooms, flooring, trim and wall assemblies. Moisture readings and photographs then continued through demolition and drying to support the mitigation scope.

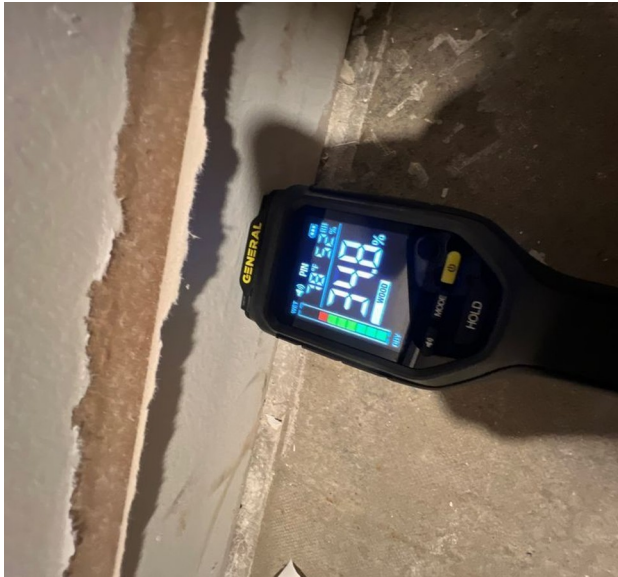
MOISTURE VERIFICATION

Every stage was photographed and supported by moisture readings. That ongoing record explains why materials were removed, shows the conditions discovered behind them and gives the insurance company a clear basis for the mitigation scope.

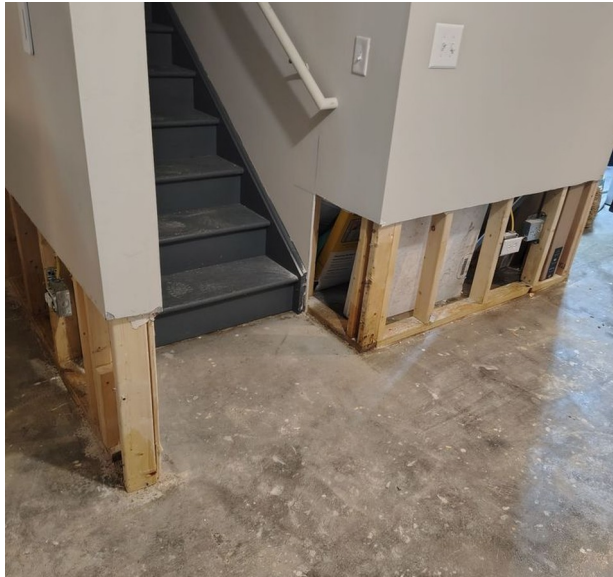
TWO-FOOT FLOOD CUTS

Wet trim and lower wall materials were removed, including two-foot flood cuts where needed. The work exposed wall cavities, allowed the team to evaluate concealed conditions and created a direct drying path for the affected structure.

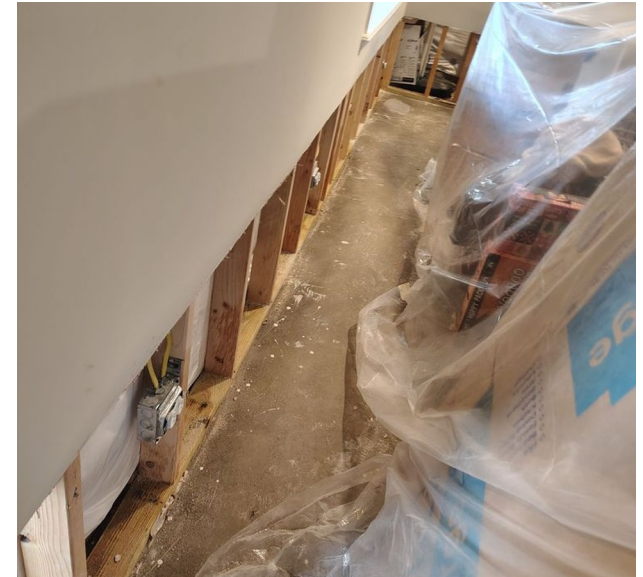
AFFECTED FINISHES REMOVED

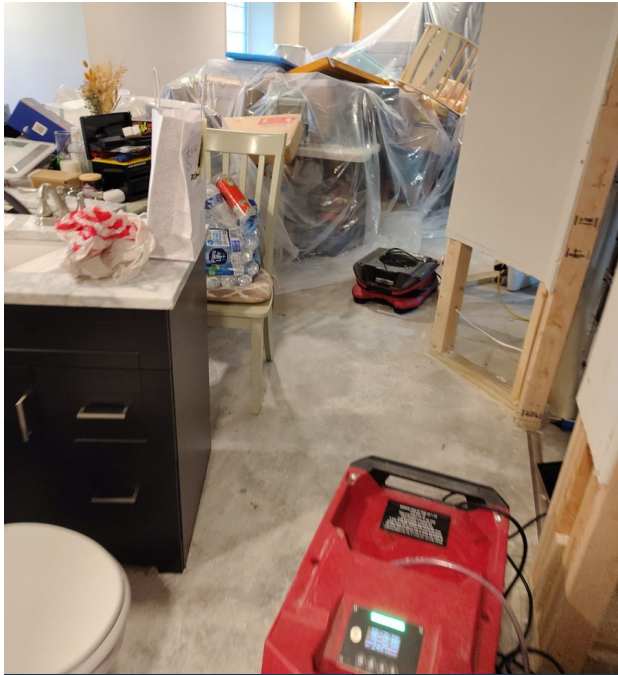
**DEHUMIDIFICATION**

Once wet finishes were removed and the concrete slab and wall cavities were accessible, professional drying equipment was positioned throughout the basement. Contents that remained temporarily onsite were grouped and protected so air could move through the work areas.

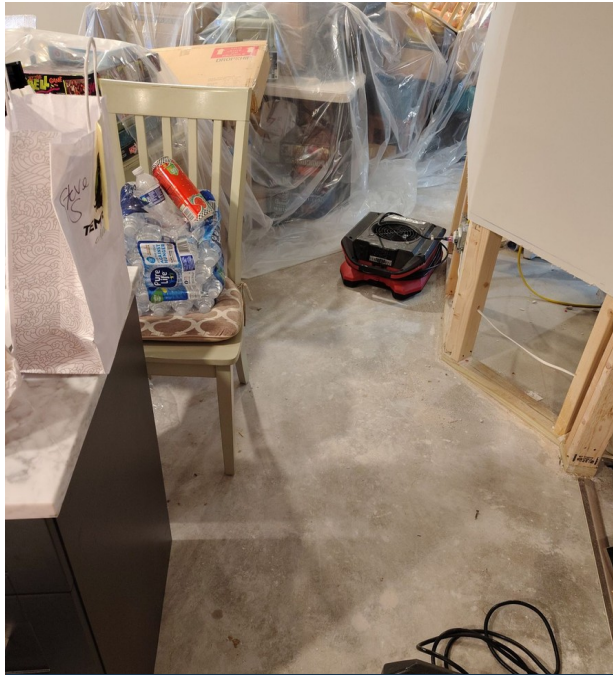
**AIR MOVEMENT**

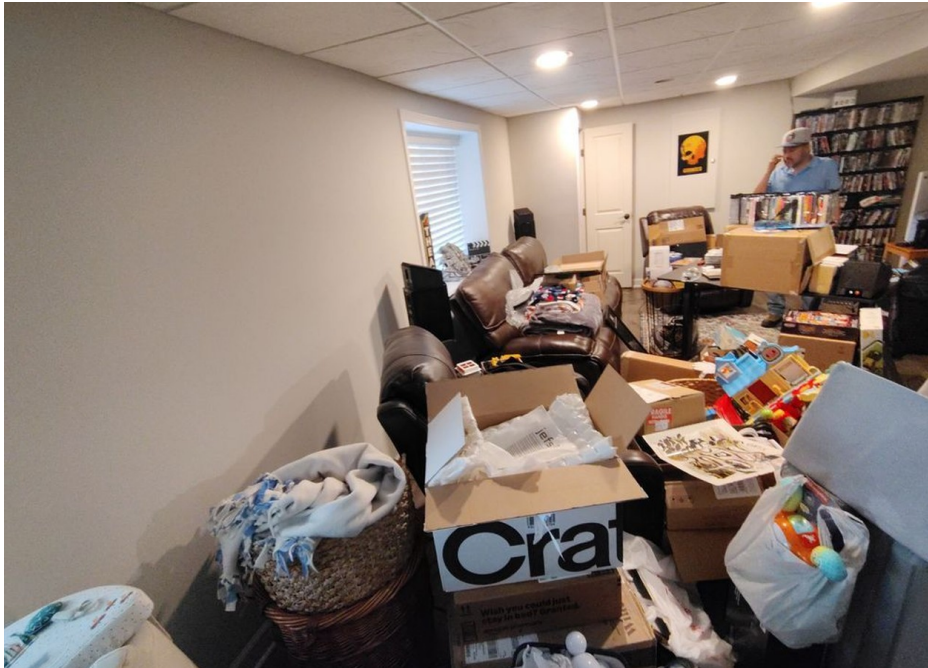
CONTENTS PREPARED FOR PACK-OUT

After emergency mitigation and structural drying were completed, the remaining basement contents were professionally packed and moved to a temperature-controlled storage facility. This protected the homeowners' property and gave the reconstruction team clear, continuous access to the work areas.

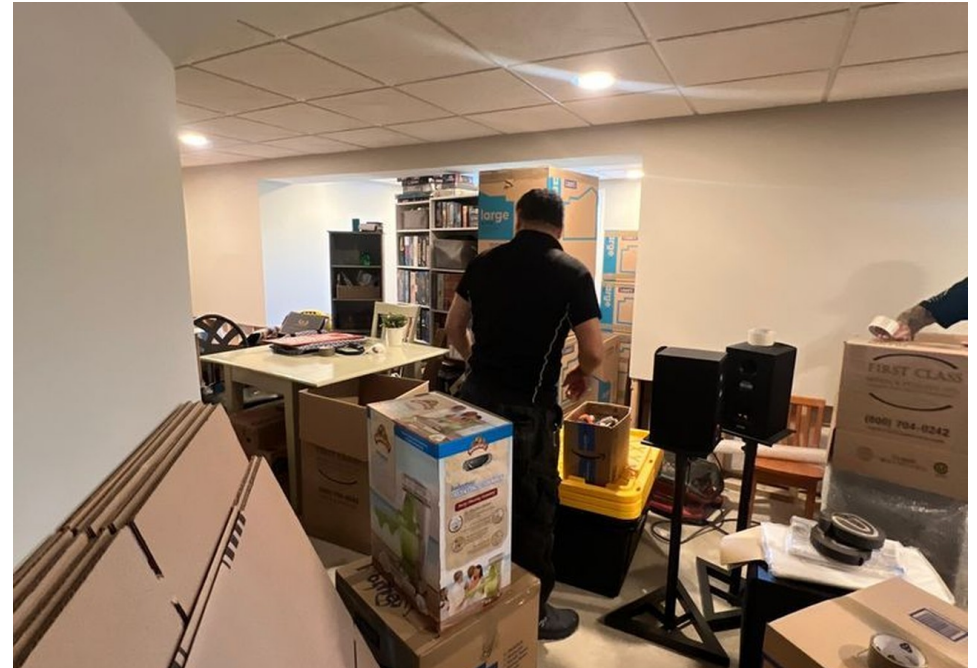
PACK-OUT IN PROGRESS

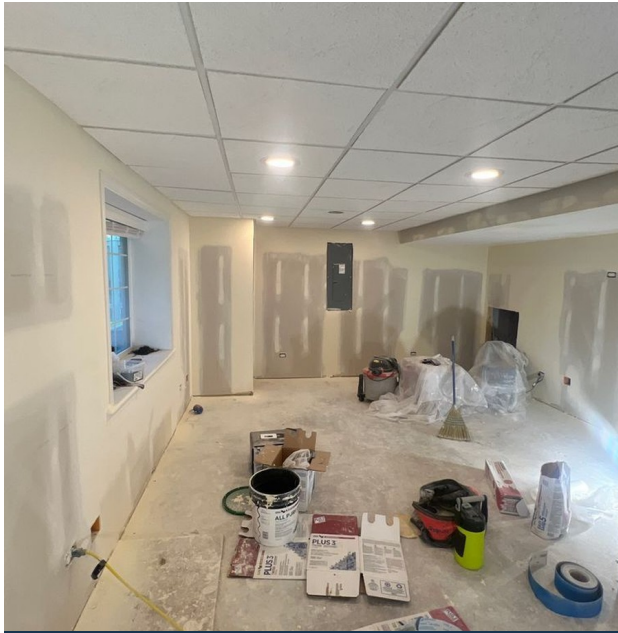
## DRYWALL AND PAINT

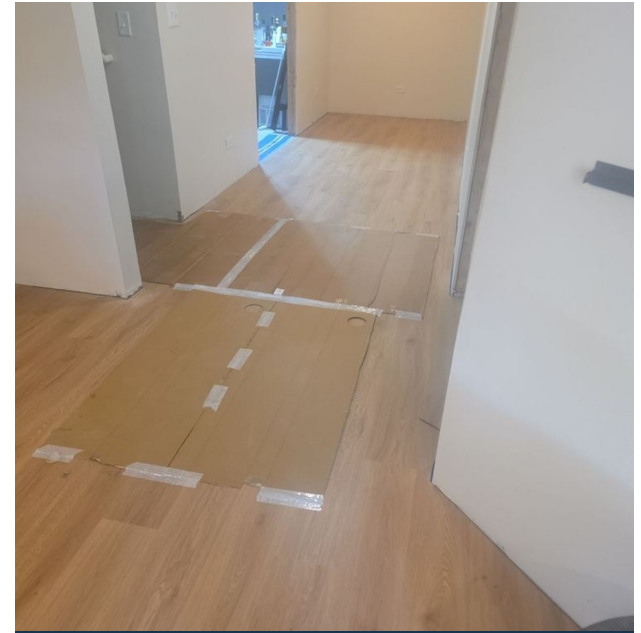
## NEW FLOORING BEGINS

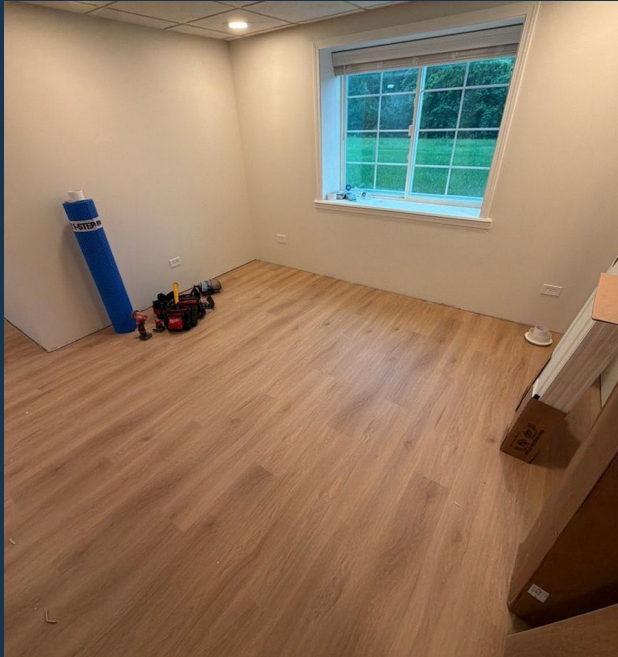
NEW FLOORING

The loss progressed from standing water and crowded contents to content manipulation, documented mitigation, structural drying, professional pack-out and reconstruction. New flooring, drywall, paint and finish work brought the basement back toward normal use while the project team coordinated the financial scope with the carrier.

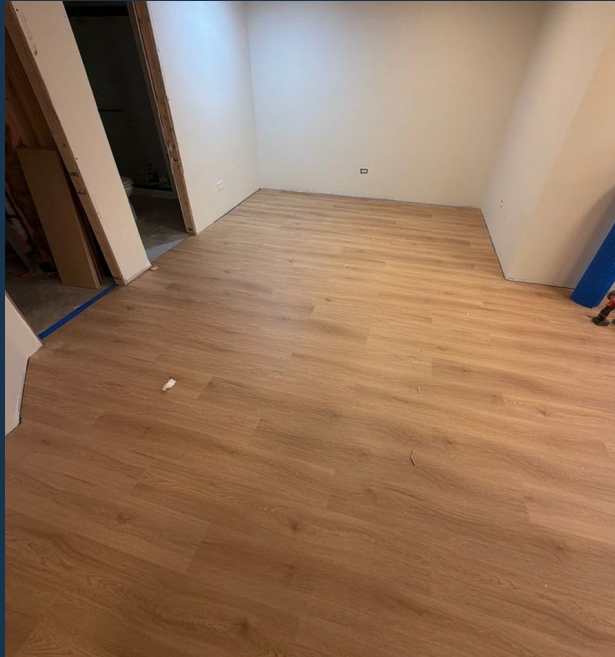
FINISHED AREAS RETURN

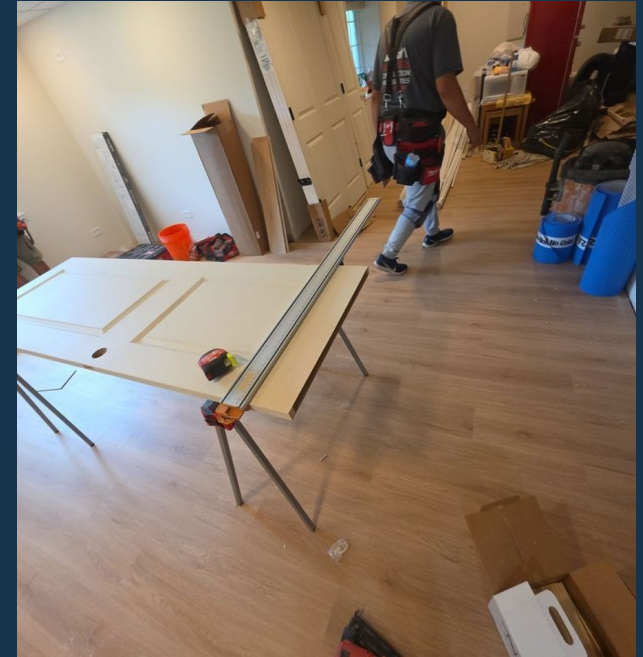
RECONSTRUCTION IN PROGRESS
