CASE STUDY NO. 3

# TORNADO DAMAGE TO A RESIDENTIAL EXTERIOR

CAUSE OF LOSS: TORNADO / CATASTROPHIC WINDS

Impact assessment, emergency weatherization, cleanup, reconstruction and recovery.

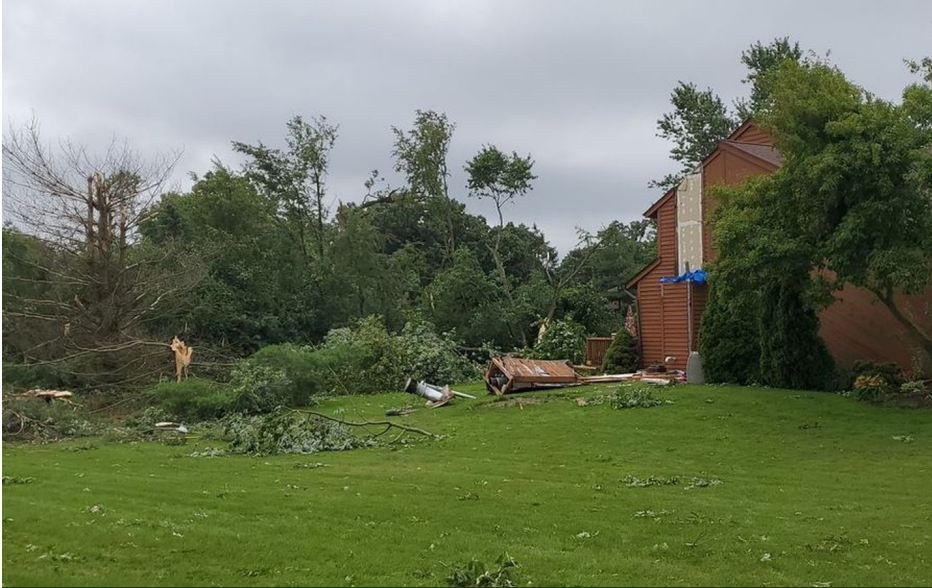
# THE EXTERIOR WAS TORN AWAY IN SECONDS

A tornado tore a large exterior assembly from the rear of the home and scattered building debris across the property. Before cleanup or repair could begin, the team had to determine whether the occupants were safe, whether the remaining structure could be approached and where the home remained open to weather.

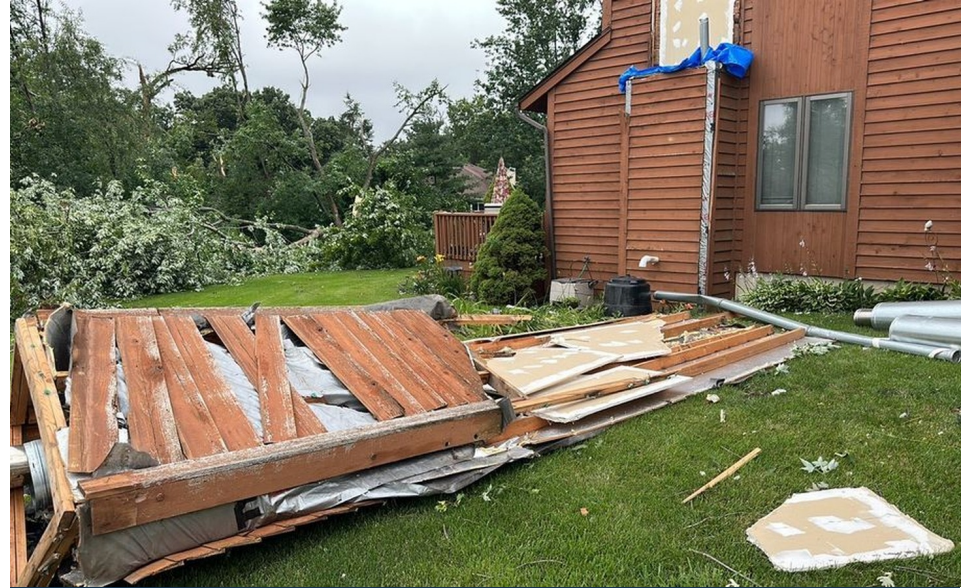
EXTERIOR ASSEMBLY DISPLACED

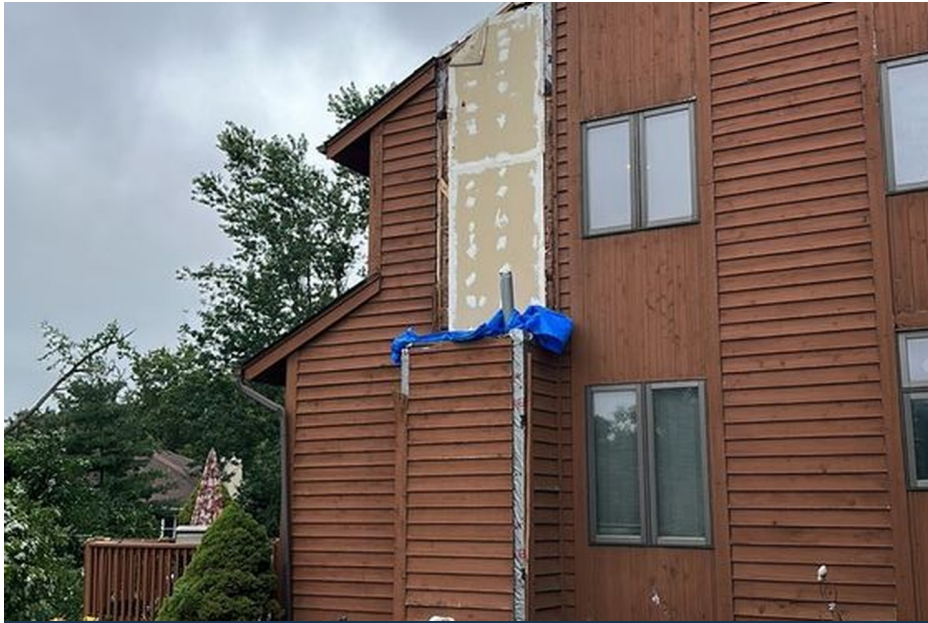
EXTERIOR DAMAGE DOCUMENTED

Large-loss cleanup is deliberate. Loose and displaced materials must be identified, photographed and removed in a controlled sequence so the site becomes safer without erasing evidence of how the tornado damaged the home.

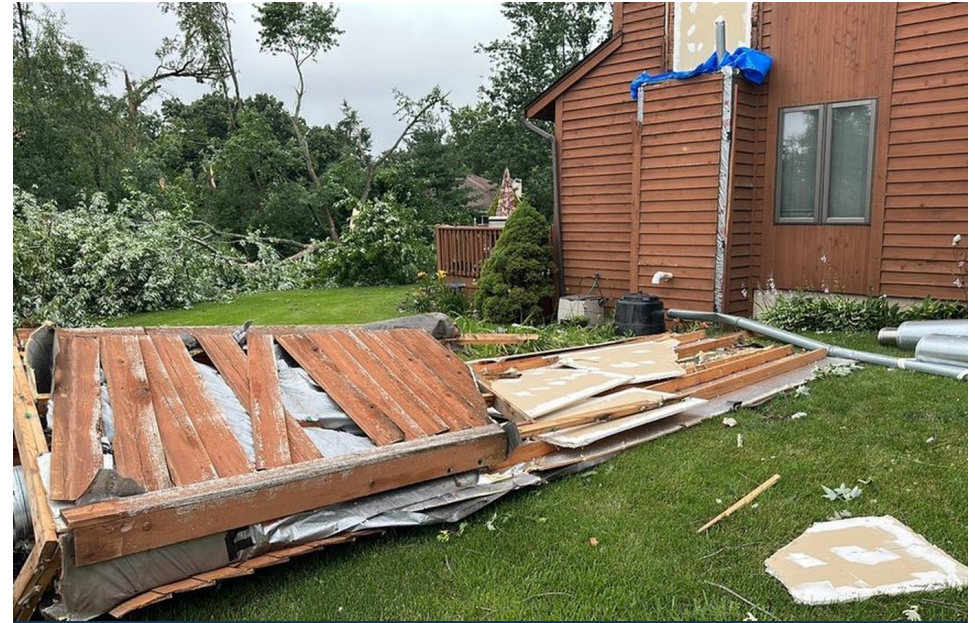
DISPLACED MATERIALS DOCUMENTED

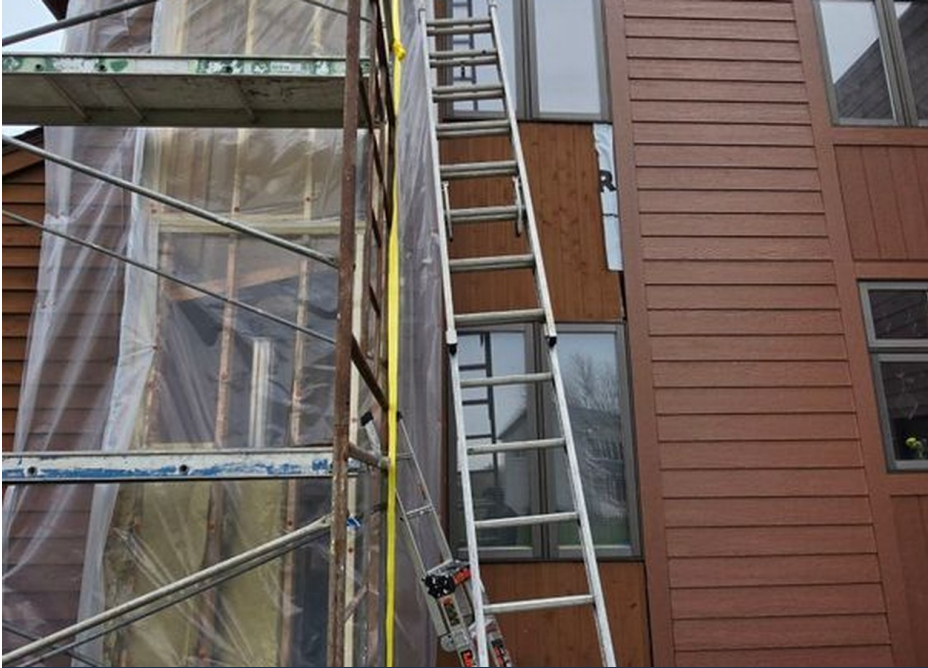
SCAFFOLDED ACCESS

Once the property was stabilized and the insurance scope was in a strong position, reconstruction could begin. Scaffolding created controlled access to the multi-story work area while damaged exterior components were opened, evaluated and rebuilt from the structure outward.

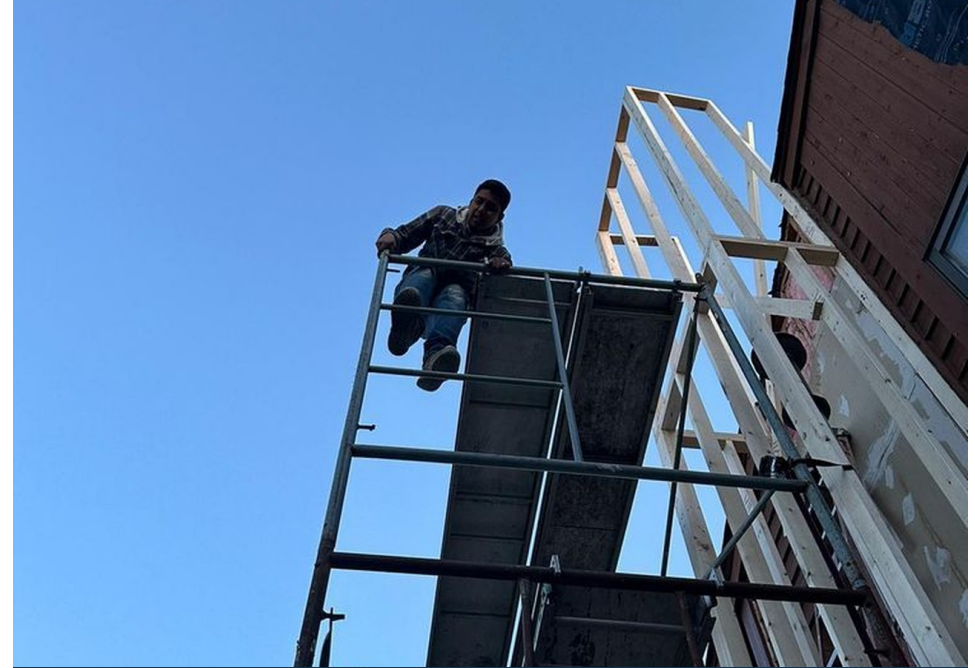
EXTERIOR FRAMING REBUILT

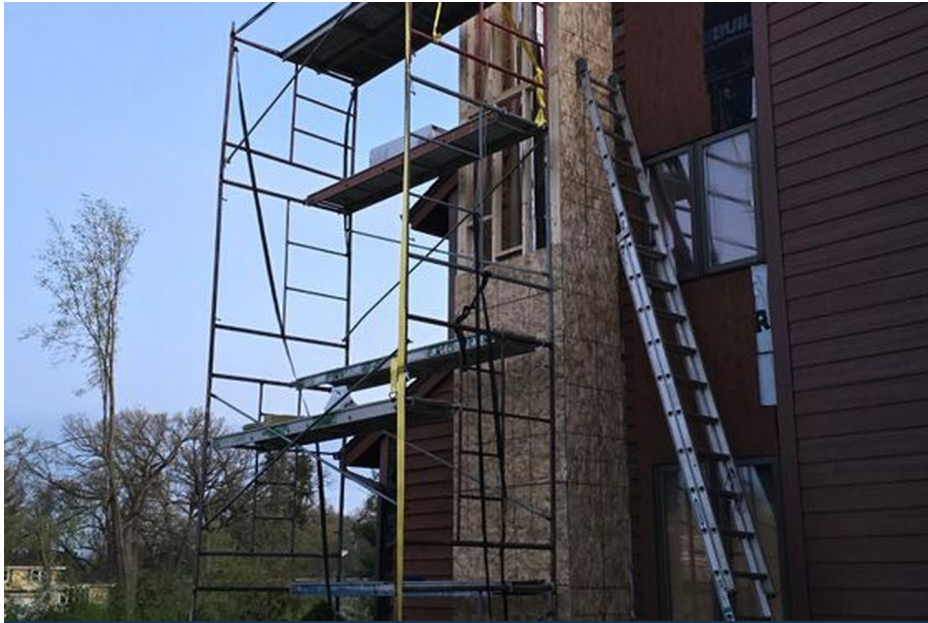
STRUCTURAL FRAMING AND SHEATHING

The damaged wall was reframed and sheathed before the weather-resistive barrier was installed. Maintaining continuity around the chimney, windows and adjacent wall sections helped restore the exterior drainage plane before finish materials were returned.

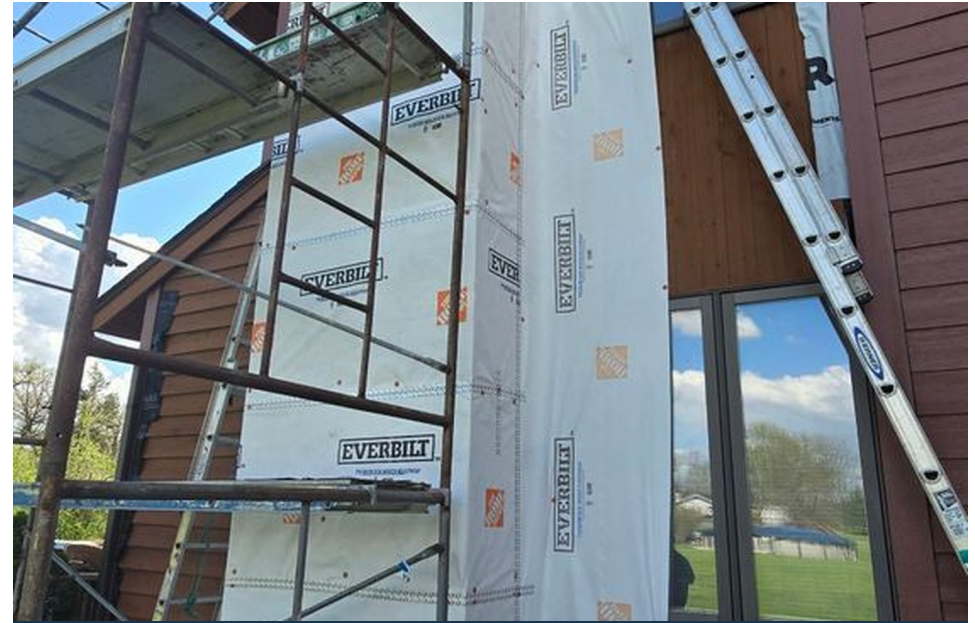
WEATHER-RESISTIVE BARRIER INSTALLED

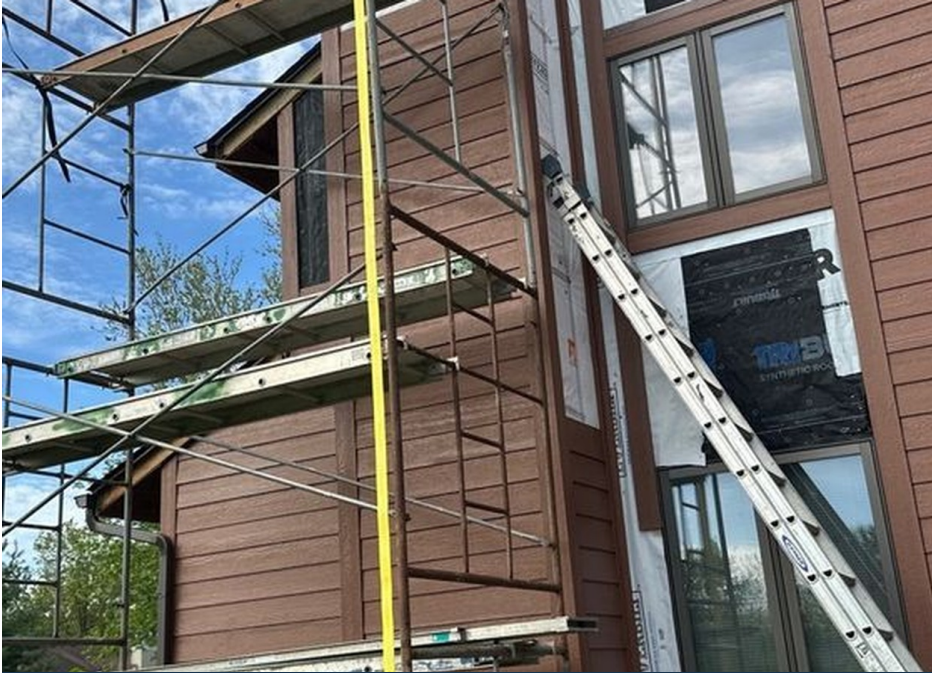
SIDING INSTALLATION IN PROGRESS

With the rebuilt wall protected, the exterior siding and trim could be integrated with the portions of the home that remained. The goal was a finished elevation that looked intentional while preserving the performance of the newly reconstructed assembly.

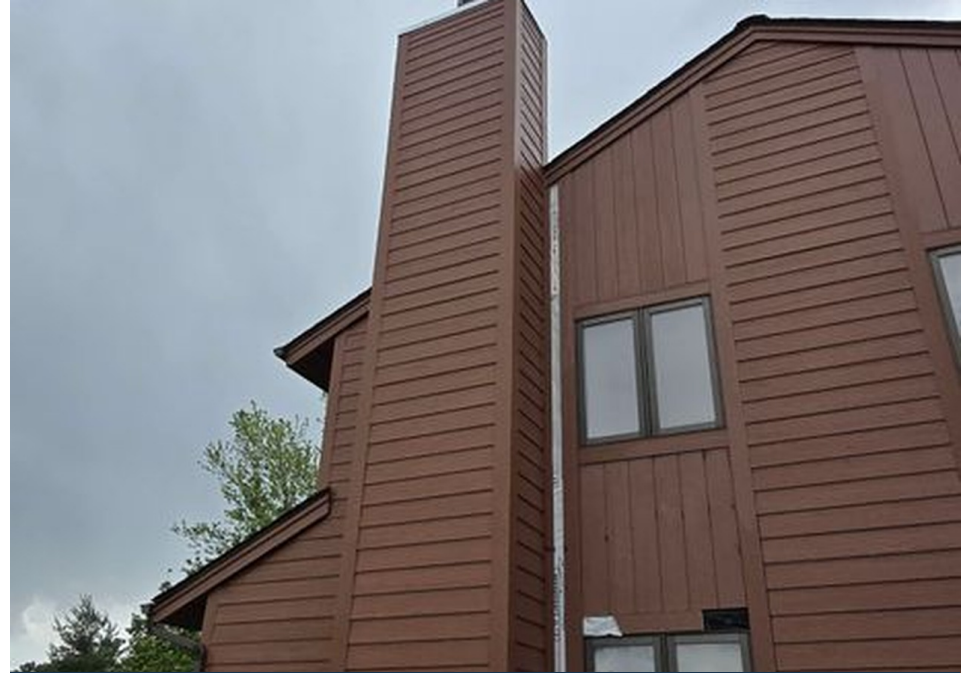
RESTORED EXTERIOR ELEVATION

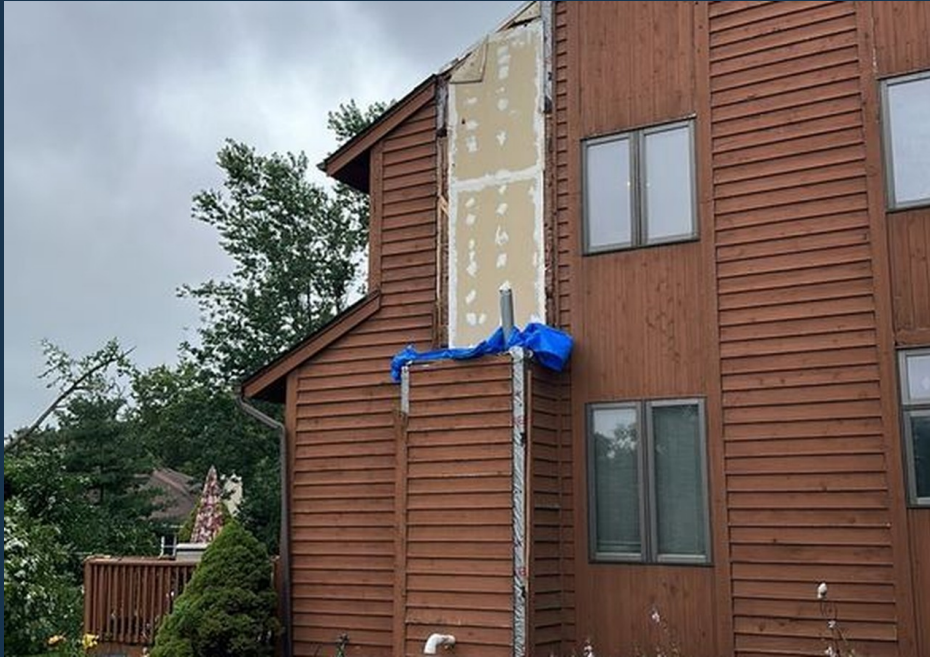
AFTER THE TORNADO

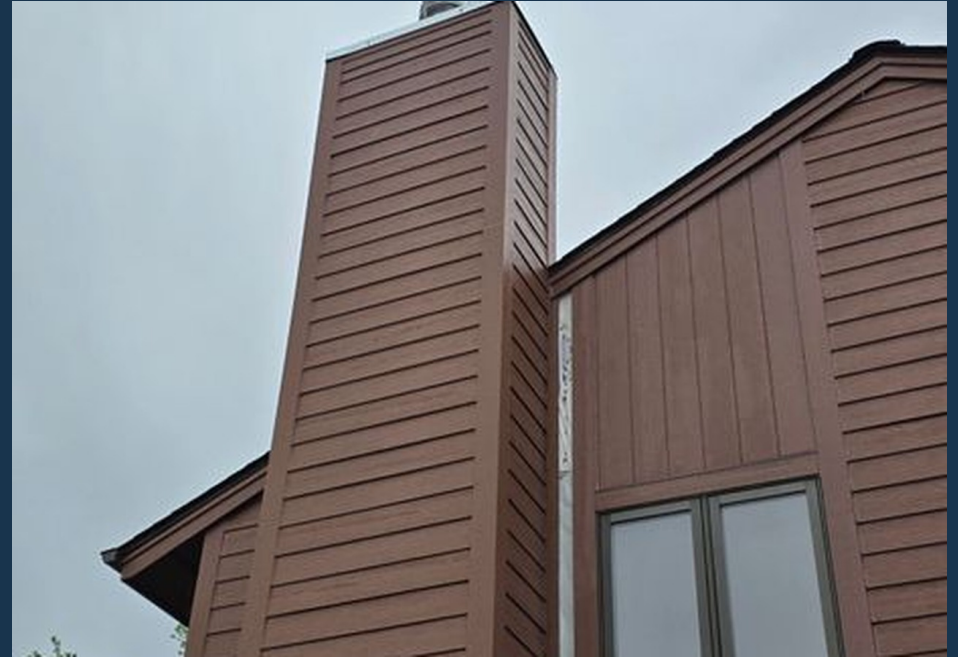
AFTER RECONSTRUCTION

Emergency tarping limited additional exposure. Controlled cleanup and documentation supported the insurance scope. Reconstruction then restored the damaged exterior wall, weather protection and finish materials so the home could move back toward normal use.
