CASE STUDY NO. 4

# CAR TO STRUCTURE

CAUSE OF LOSS: VEHICLE IMPACT

What to do when a vehicle tears through an occupied building and compromises an exterior wall.

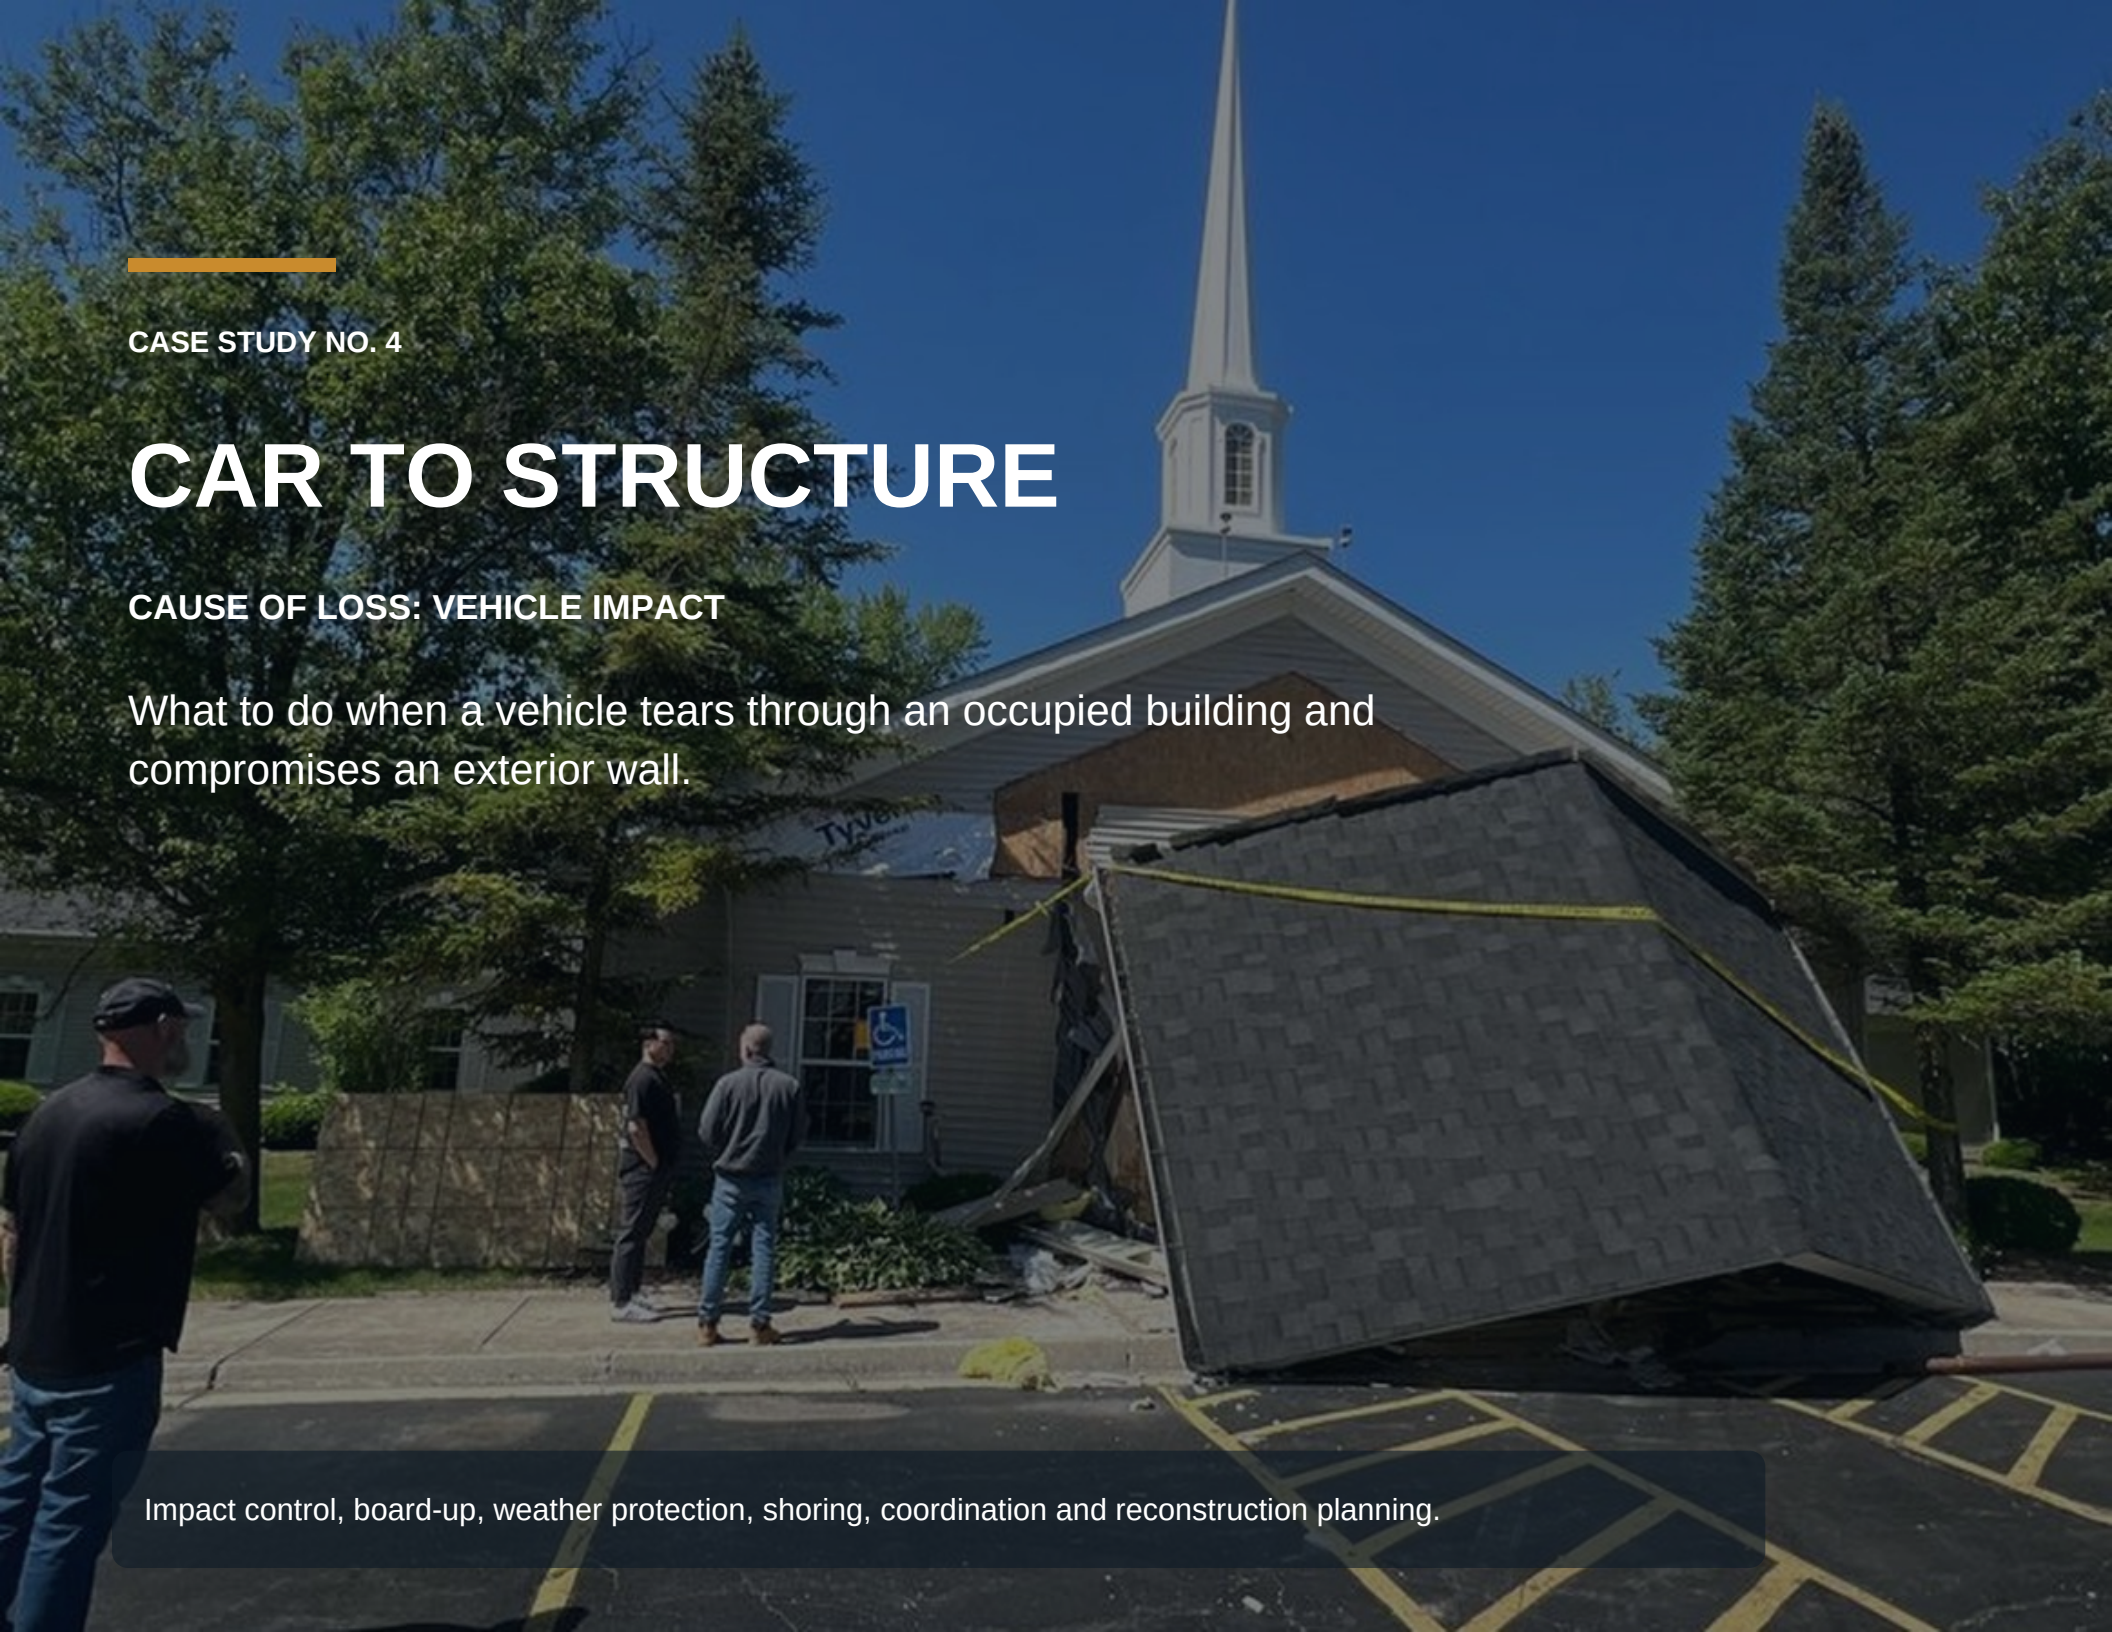
The impact tore the exterior entry assembly away from the building and drove framing, finishes and debris into occupied interior rooms. Before cleanup, the team restricted access, identified unstable components and documented conditions inside and outside the structure.

Impact control, board-up, weather protection, shoring, coordination and reconstruction planning.

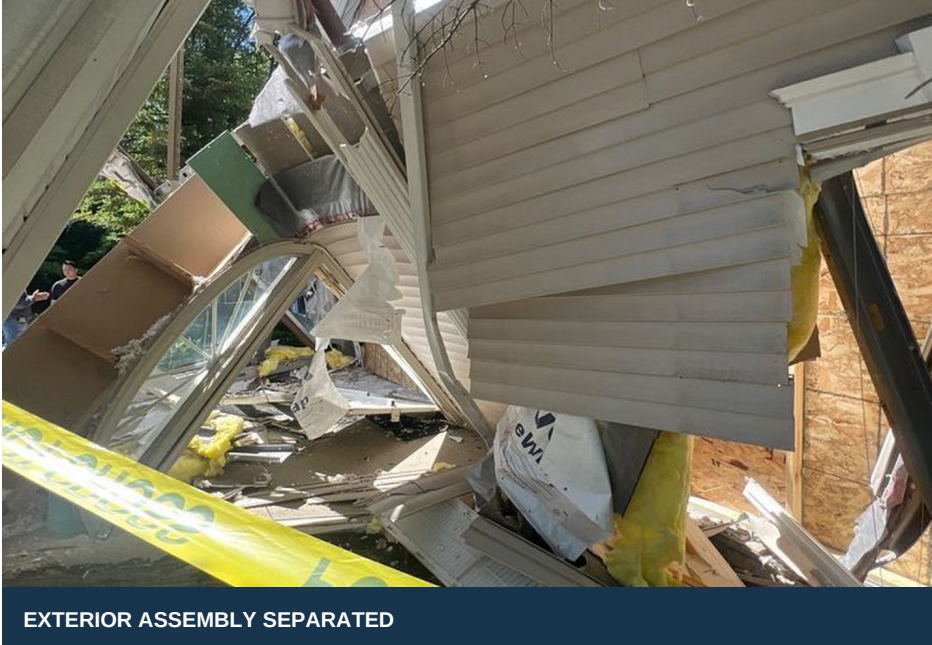
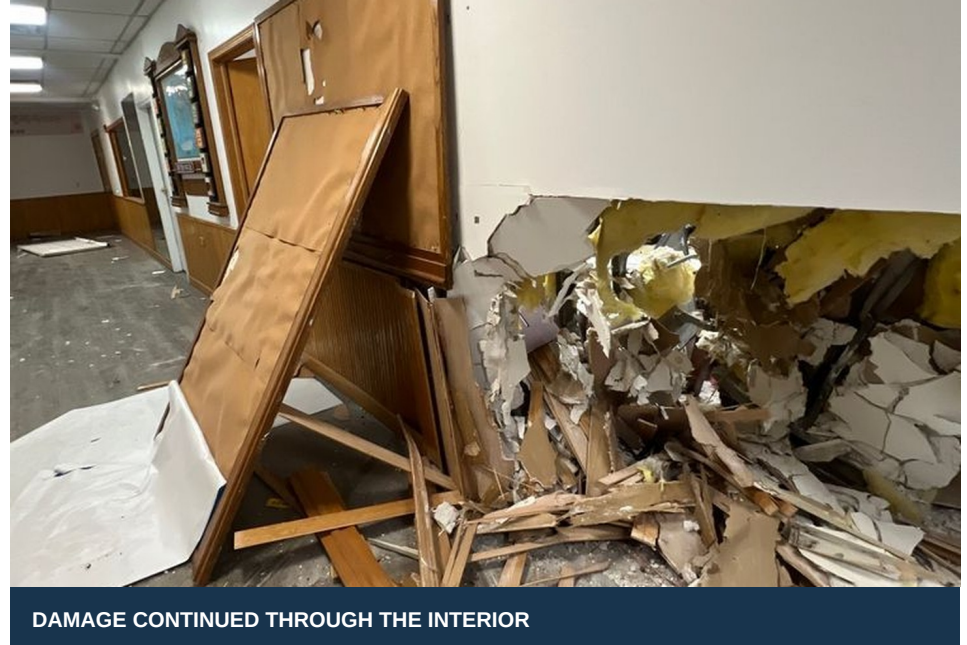
## THE COLLISION DISPLACED AN ENTIRE WALL ASSEMBLY

#### DO NOT DISTURB UNSUPPORTED DAMAGE

Vehicle impact can interrupt load paths that are not obvious from the surface. Removing debris before temporary support is considered can create a second failure.

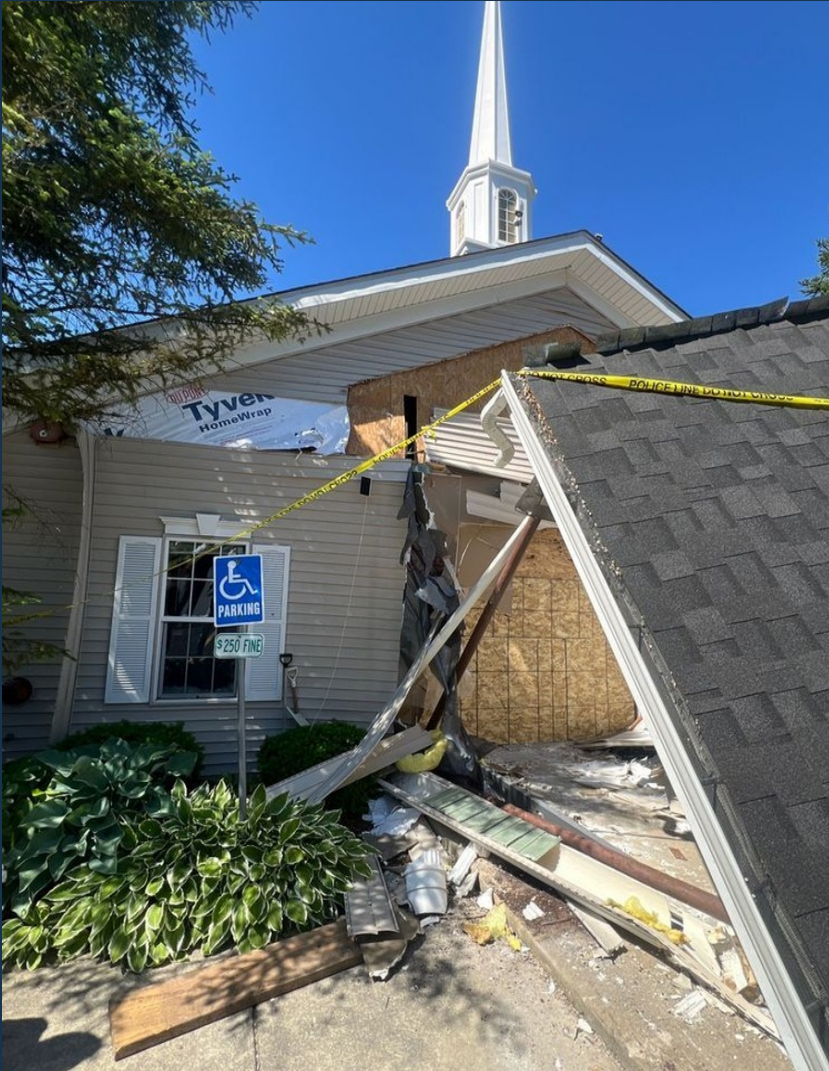
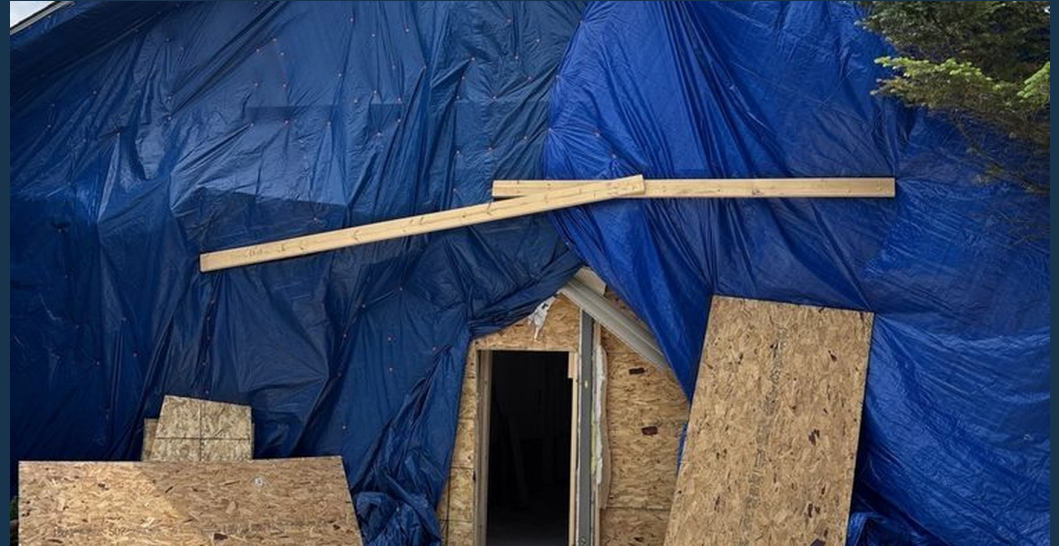
# BOARD UP THE OPENING AND PROTECT IT FROM WEATHER

Temporary board-up and emergency tarping were installed to separate the damaged rooms from the exterior and limit additional water intrusion.

With storms moving through the area, the response had to use the available weather window. The immediate goal was not a finished repair; it was a secure, weather-resistant temporary condition.

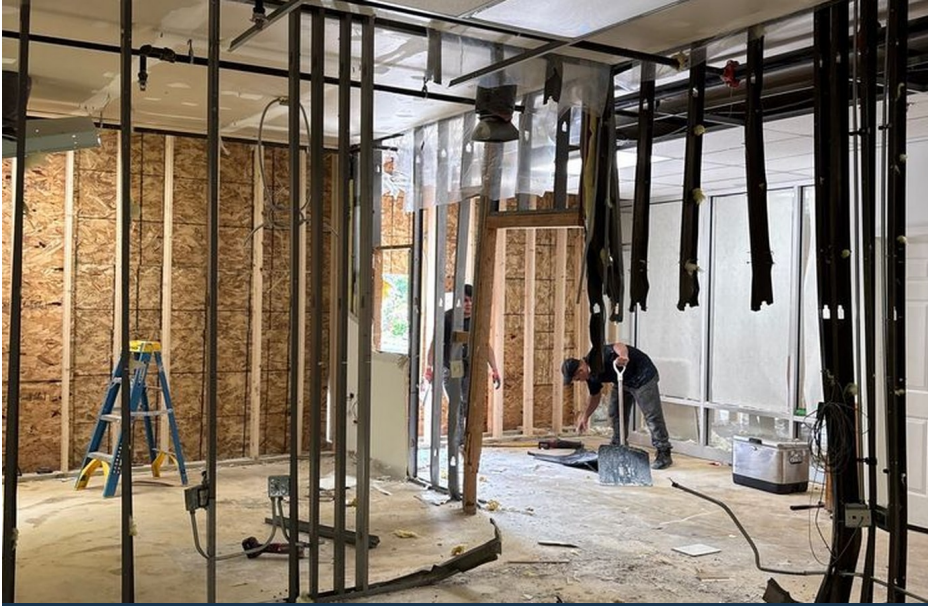
CONTROLLED ACCESS AND DEMOLITION

Temporary shoring was installed as needed to support compromised areas while damaged materials were removed and the structural conditions were opened for evaluation. This protects the building, the workers and the occupied areas that remain outside the controlled work zone.

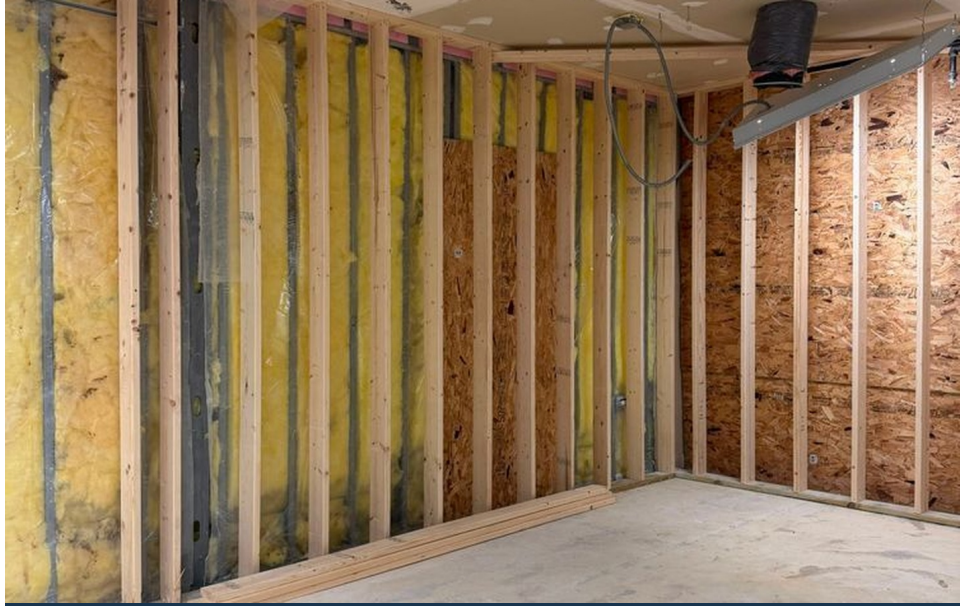
SUPPORT AND FRAMING CONDITIONS EXPOSED

Temporary support controls immediate risk. Engineering and architectural review then determine what must be rebuilt and how the repaired assembly will connect to the existing structure.

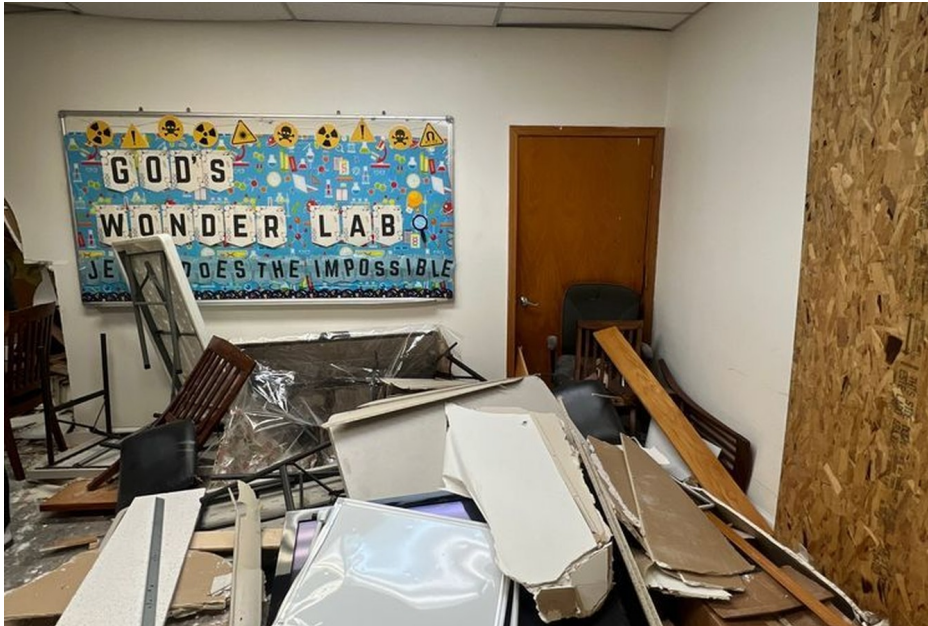
CONTENTS WITHIN THE DAMAGED AREA

Furniture, ministry materials and other contents were documented, packed and relocated from the affected rooms. Clearing the area created safe access for mitigation and structural work while keeping church property organized for return later in the project.

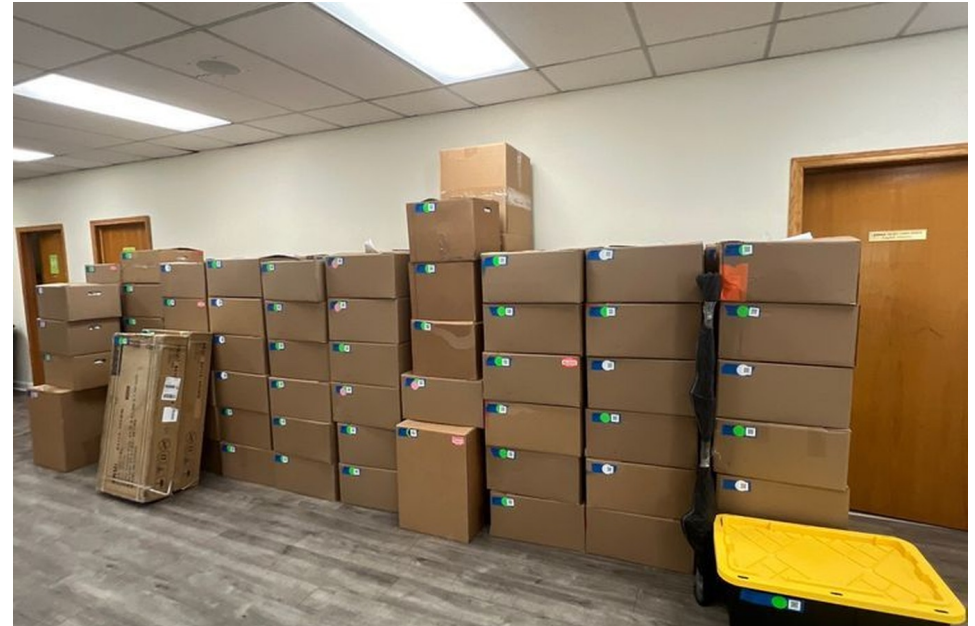
PACKED, LABELED AND MOVED TO SAFETY

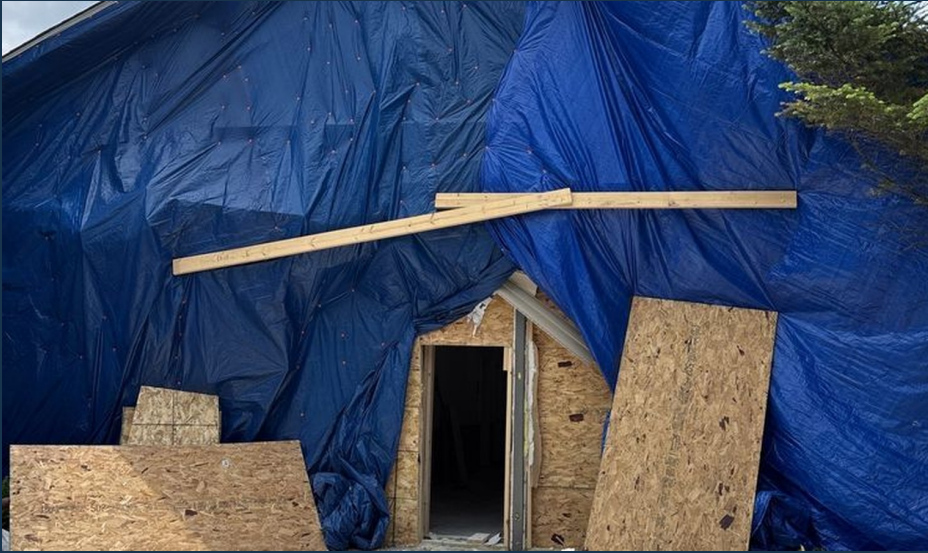
TEMPORARY WEATHER PROTECTION

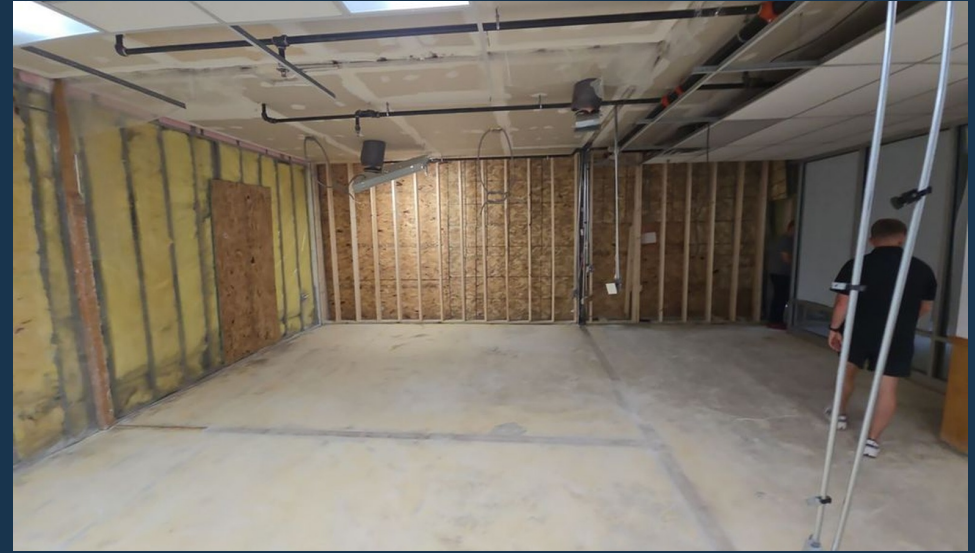
OPENED FOR REVIEW AND RECONSTRUCTION

Evaluate the compromised structure, define temporary support and develop the permanent repair details.

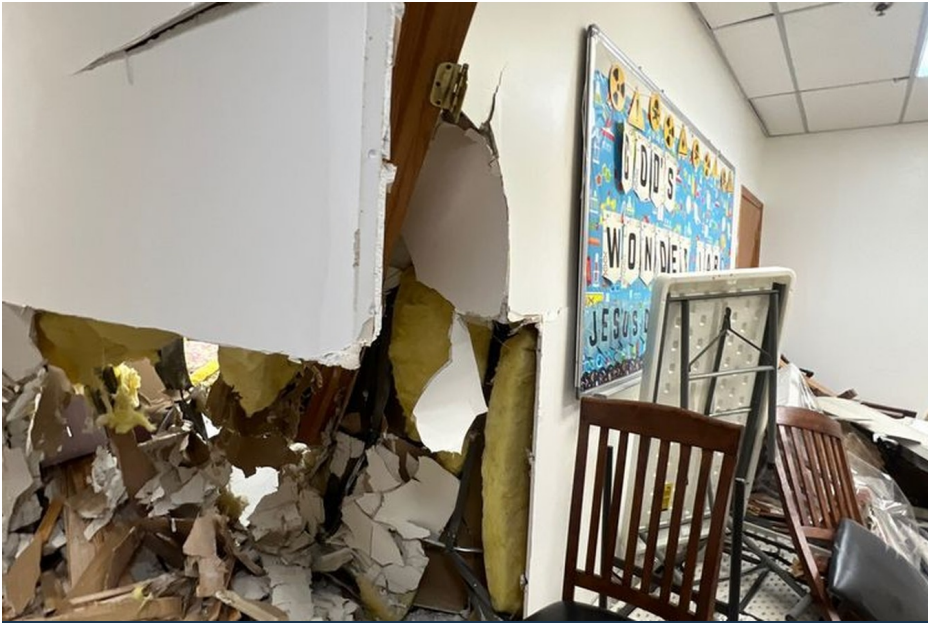
INTERIOR IMPACT AND DEBRIS

Once the temporary protection, contents work and stabilization were complete, crews could remove unsalvageable finishes and damaged framing in a controlled sequence. The structure was left open, clean and accessible so permanent framing and building systems could be restored correctly.

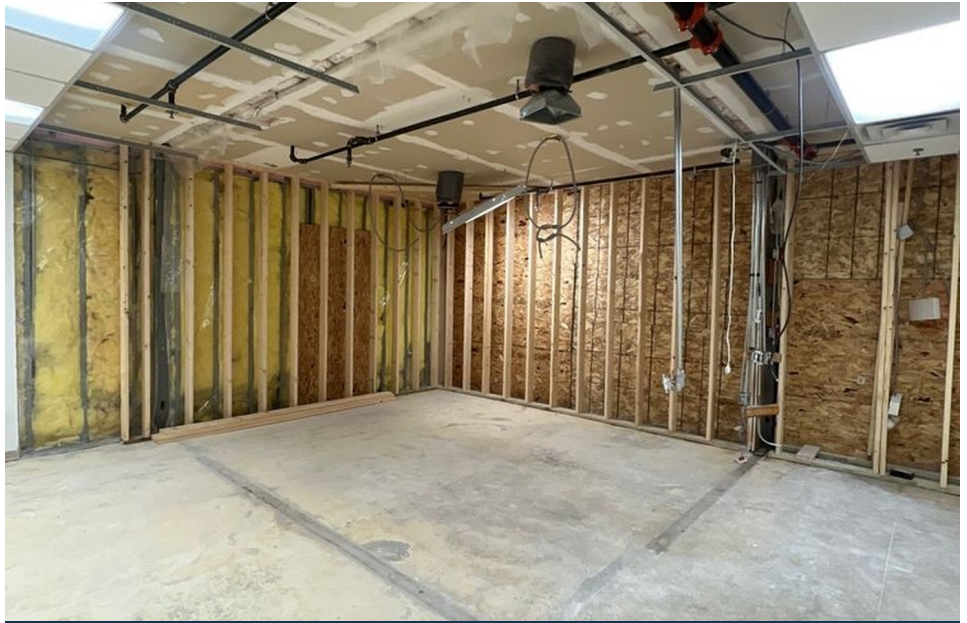
FRAMING OPENED AND REPAIR AREAS DEFINED

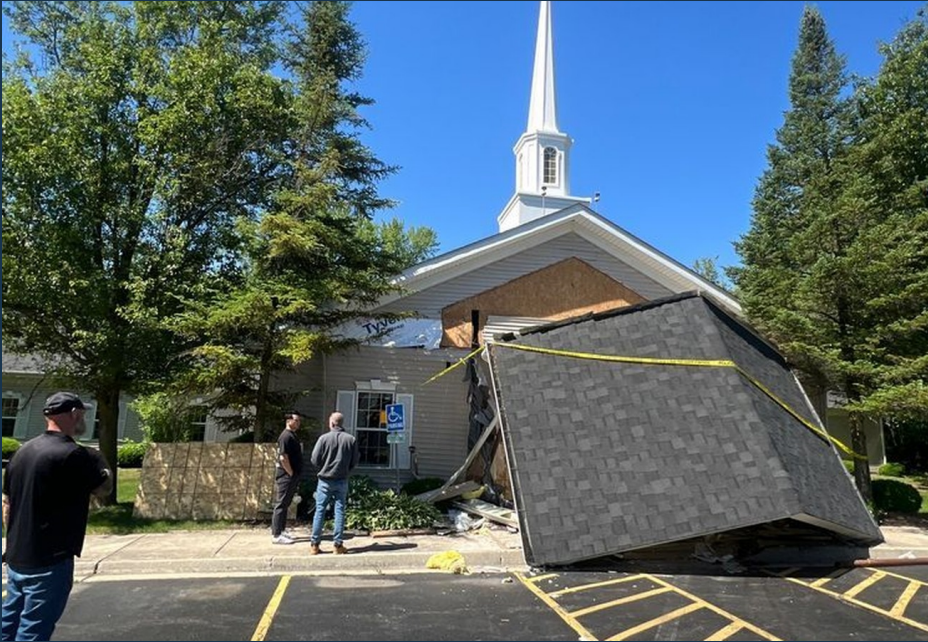
INITIAL VEHICLE IMPACT

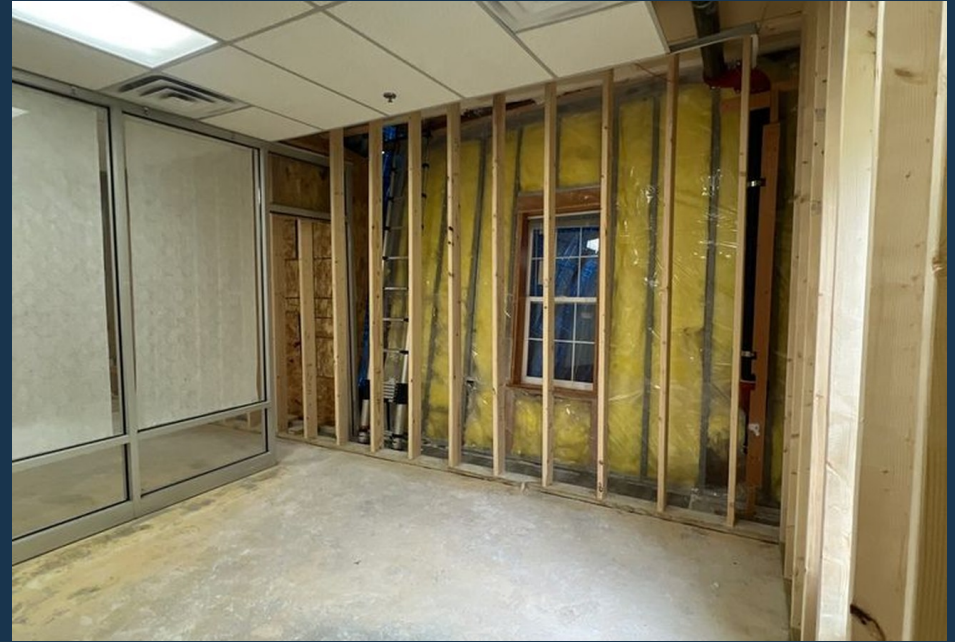
STABILIZED AND MOVING INTO RECONSTRUCTION

The impact area was secured, weather exposure was controlled, compromised areas were supported, contents were cleared and the structure was opened for a coordinated repair. With temporary plans in place, the church could continue serving its congregation outside the restricted work zone while permanent reconstruction moved forward.
