# LEVEL 2 REPLACEMENT RESERVE REPORT FY 2025 CHARLESTOWNE VILLAGE

## CHARLESTOWNE VILLAGE

GREENBELT, MARYLAND

March 12, 2025

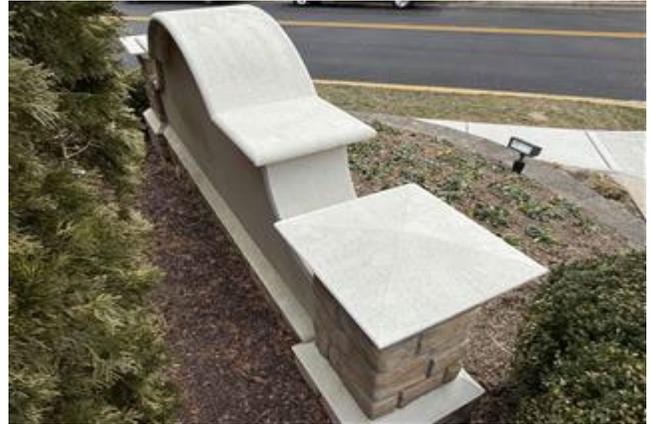
**Entry Monument and Signage.** The Association maintains an entry monument with piers. The monument is made of wood, fiberboard, foam board, and EIFS and appears to be in good condition, with no noted damaged areas or weathering. We recommend replacing it every 10 to 15 years to keep it fresh and appealing. Community signage, including speed, stop, street, and other miscellaneous signs, is not considered in this study and should be replaced using other funds.

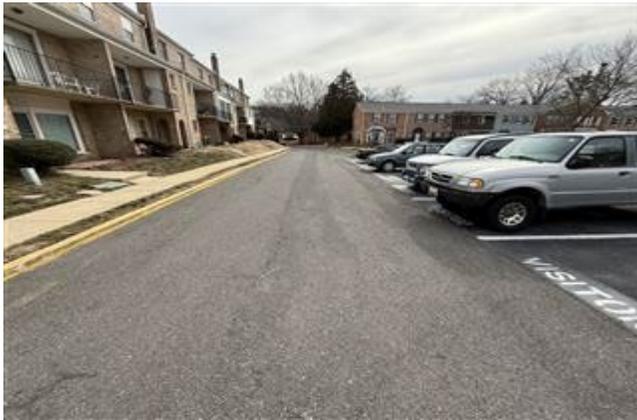
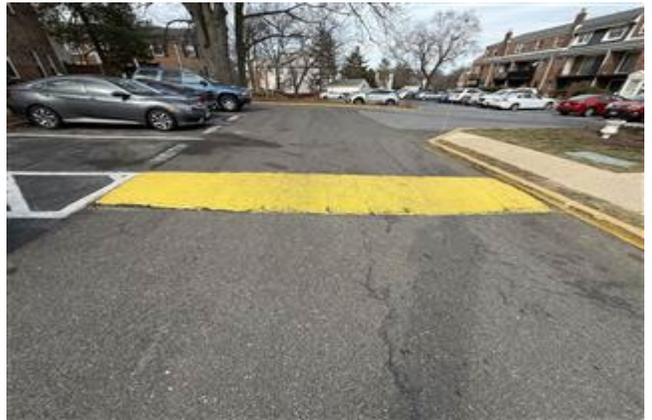
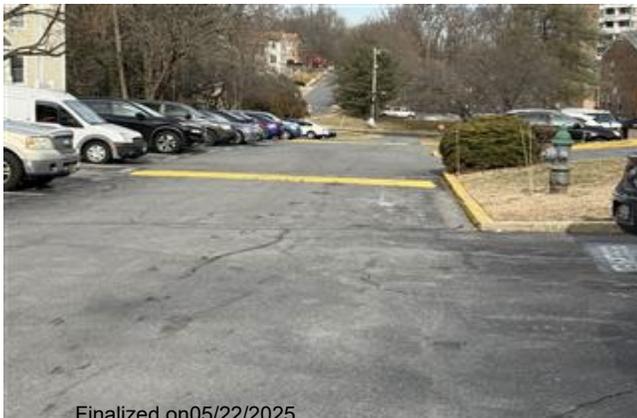
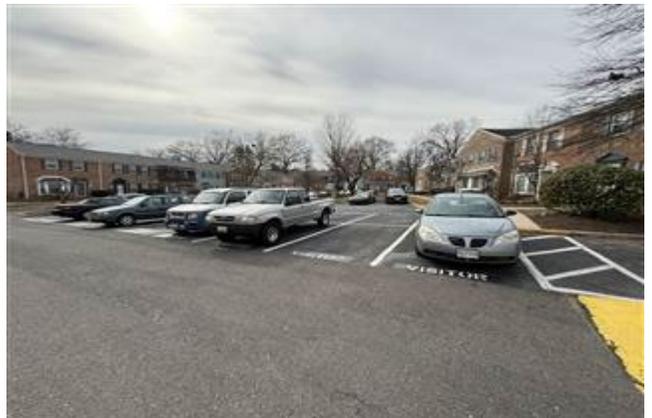
**Asphalt Pavement.** The Association is responsible for the roadways and parking areas within the community. The city, county, or other municipality maintains other roadways. The Association's asphalt pavements generally appear to be in fair condition. Asphalt overlay and sealing work completed in 2020 indicates that the Association is working to keep all asphalt surfaces in serviceable condition. The report segregates asphalt mill & overlay at areas re-worked in 2020 from the remainder of the asphalt areas not recently re-worked, with appropriate remaining economic life factors assigned to each.

Several different products are available for seal coating. The older, more traditional seal coating product is paint. They coat the surface of the asphalt, and they are minimally effective. However, the newer coating materials, such as those from Total Asphalt Management and Asphalt Restoration Technologies, Inc., are penetrating. They are engineered, so to speak, to 'remoisturize' the pavement. Asphalt pavement is intended to be flexible. Over time, the volatile chemicals in the pavement dry, the pavement becomes brittle, and degradation follows as cracking and potholes. Remoisturizing the pavement can return its flexibility and extend the life of the pavement.

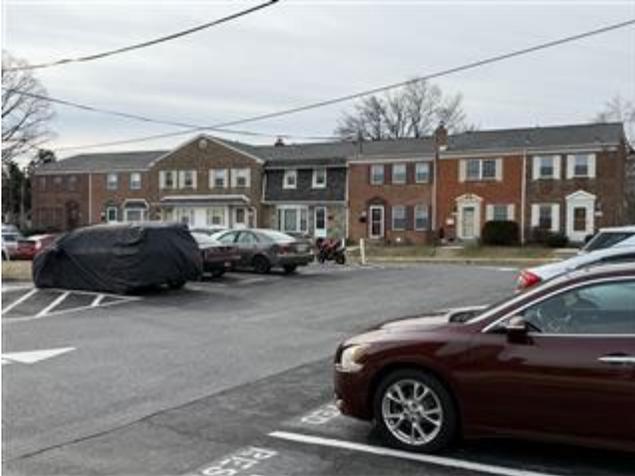
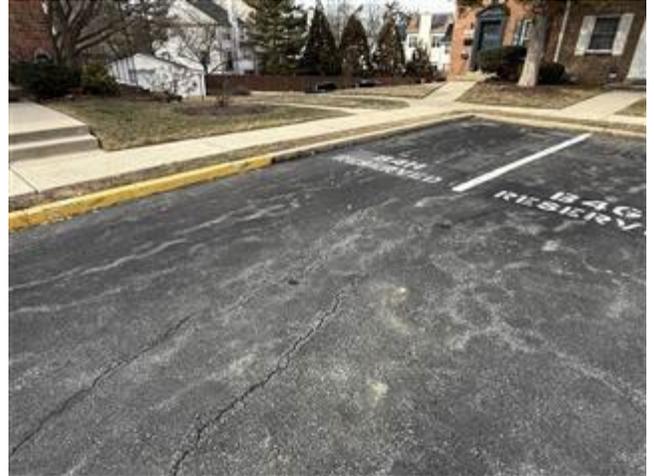
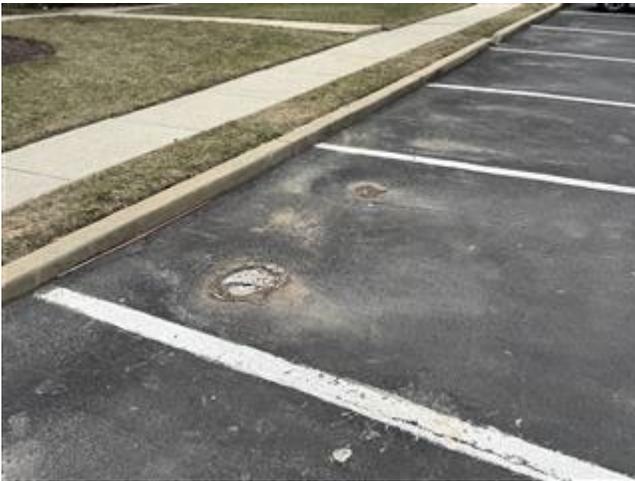
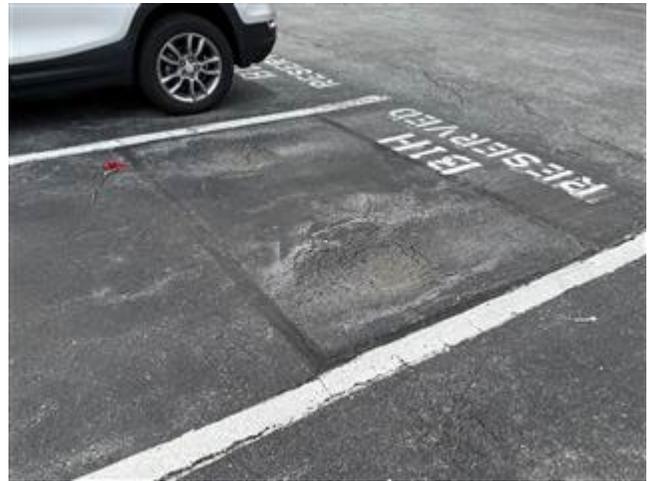
**Traffic Calming.** The community currently maintains 7-speed humps, which appear to be in overall fair condition with areas of general deterioration, including cracking and areas of separation, and one damaged, most likely by snowplow. The approximately 3' X 20' speed humps are raised traffic calming devices (approximately 2,940 square feet) that range in height from 3 to 4 inches. They are parabolic in shape and are placed across the road to slow traffic. Speed humps are the most popular physical traffic calming measure in the United States today.

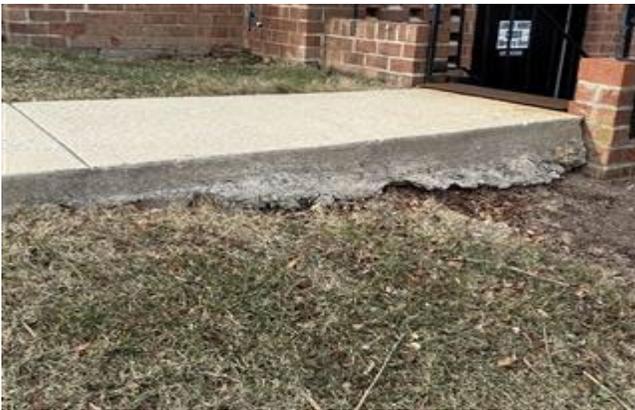
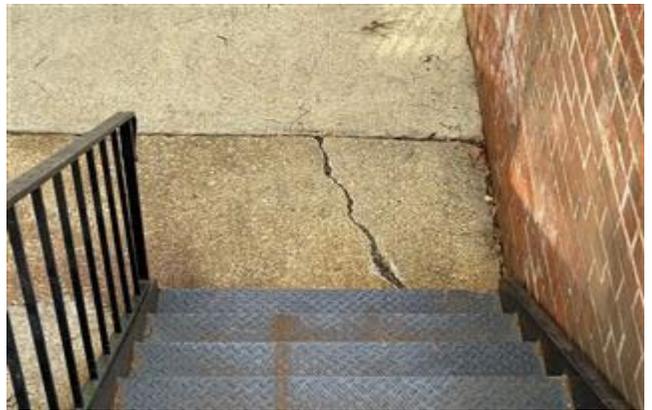
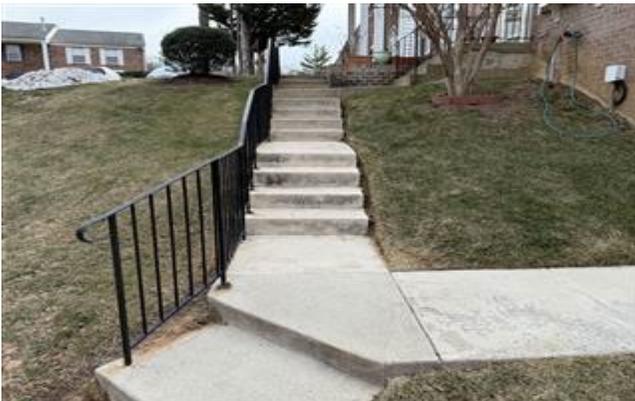
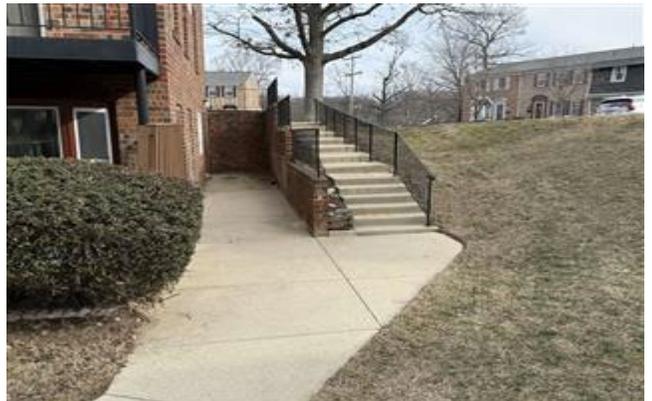
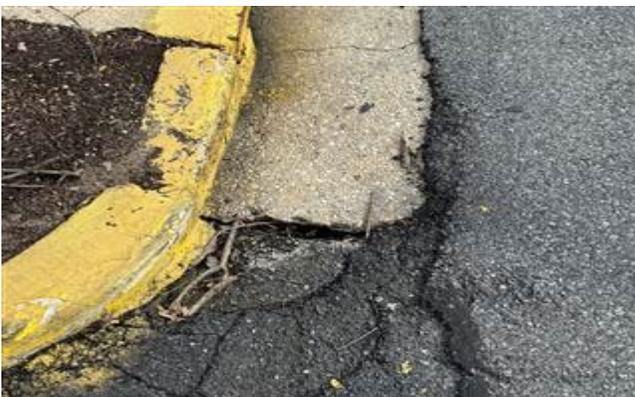
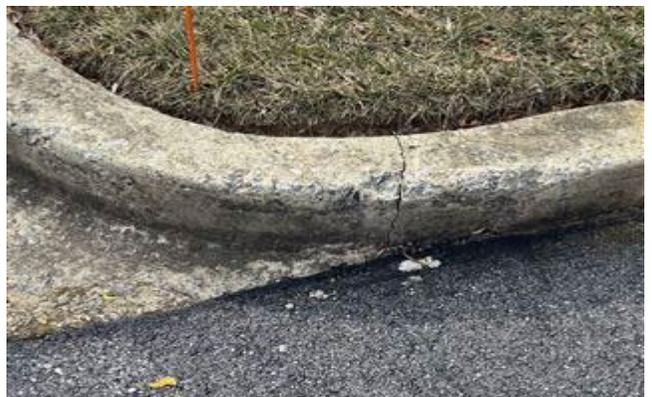
The overall condition of the concrete work varies from recently replaced to concrete work that has cracked, settled, and spalled. We noted instances of tripping hazards and recommended that these areas be promptly replaced. Another

- Trip hazard, ½ inch height difference.
- Severe cracking.
- Severe spalling and scale.
- Uneven riser heights on steps.
- Steps with risers in excess of 8¼ inches.

Because it is highly unlikely that all of the concrete components will fail and require replacement during the study, we have programmed funds for the replacement of these inventories and spread the funds over an extended timeframe to reflect the incremental nature of this work.

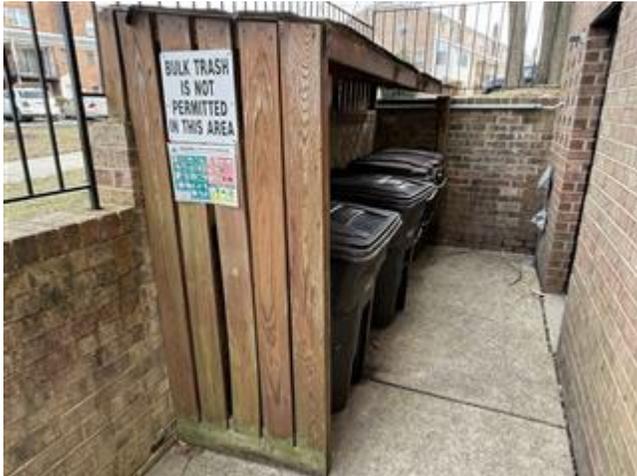
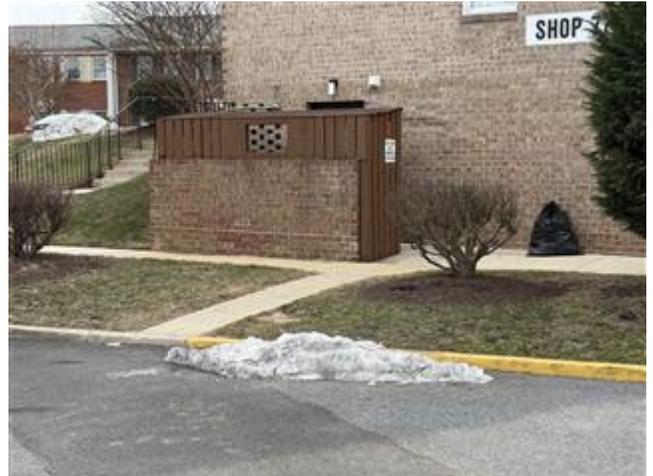
**Trash Corrals.** The community has 15 trash corrals, one at each building. The trash corrals include a concrete pad and wood enclosures with asphalt shingle roofs, which appear to be in good to fair condition.

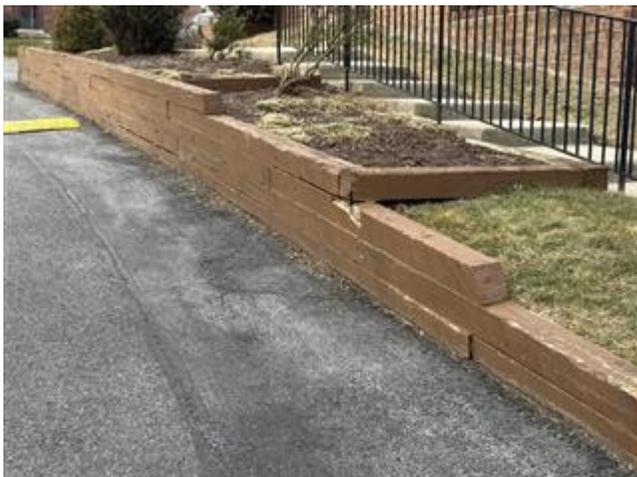
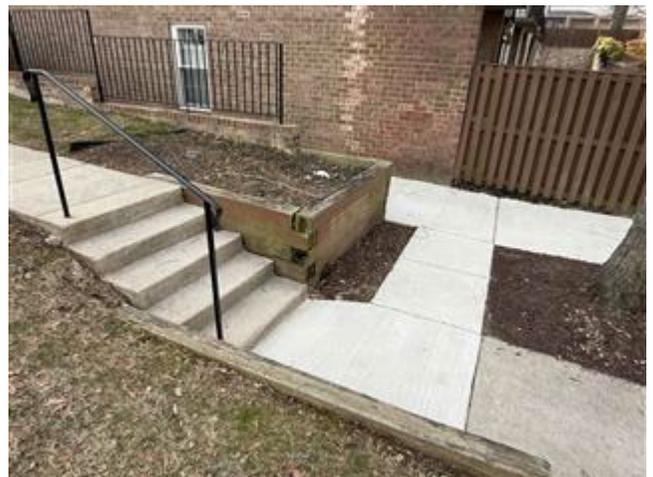
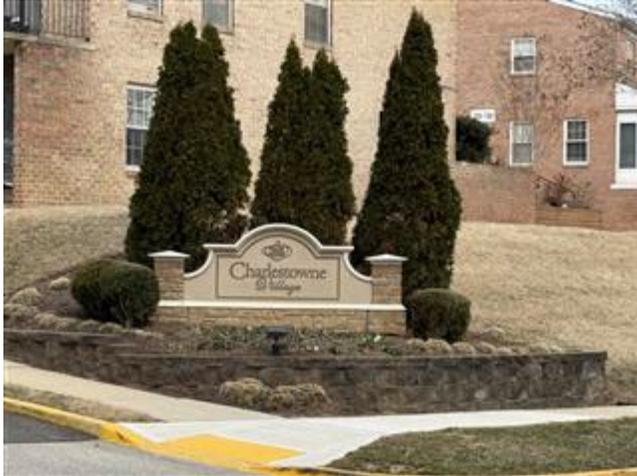
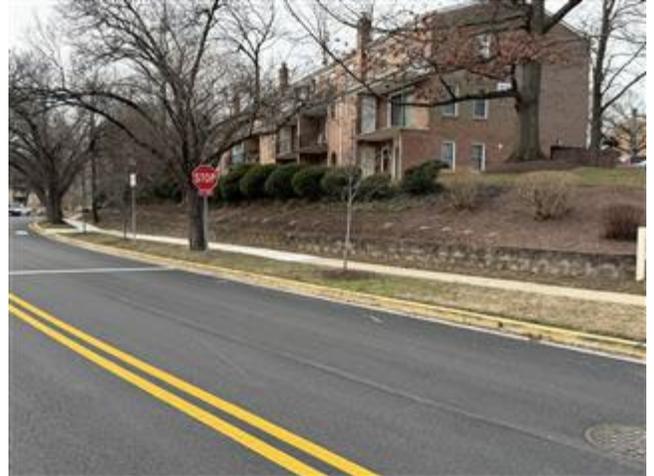
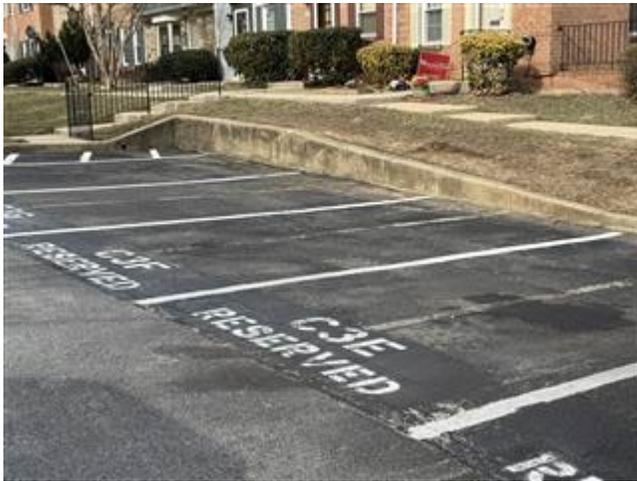
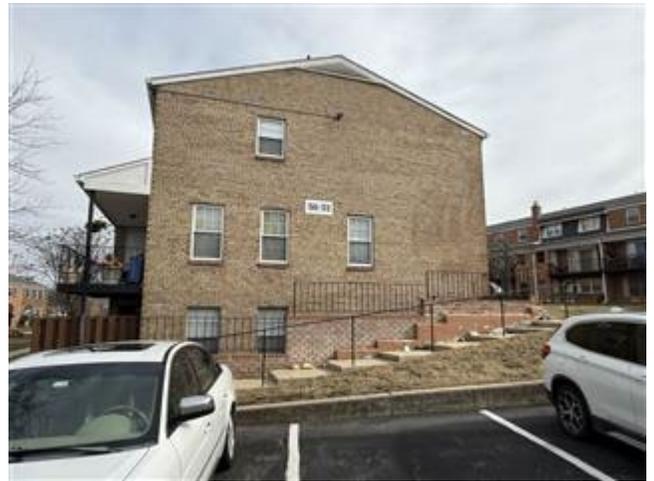
**Retaining Walls.** The Association maintains several retaining walls, including treated wood, segmental block, poured concrete, brick, and concrete block masonry. The treated wood retaining walls throughout the property mostly appear to be in poor condition. We noted numerous instances of rotting and loose connections.

The movement and displacement of any retaining wall is a sign of general settlement or failure. This typically is in the form of leaning and bowing and can involve the entire wall or localized sections of the wall. Typically, these types of movements are gradual and may require the replacement of the wall. The movement of retaining walls located near other buildings or structures may negatively affect the stability of the adjacent structure. These conditions can become extremely costly if not properly identified, monitored, and addressed.

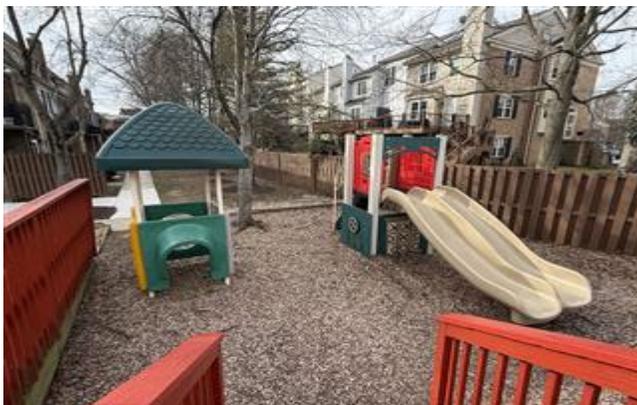
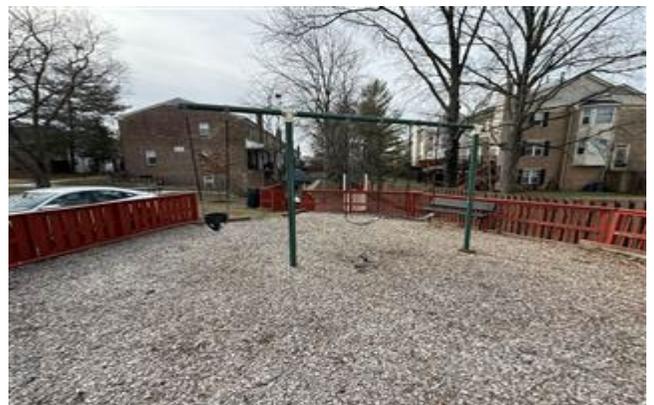
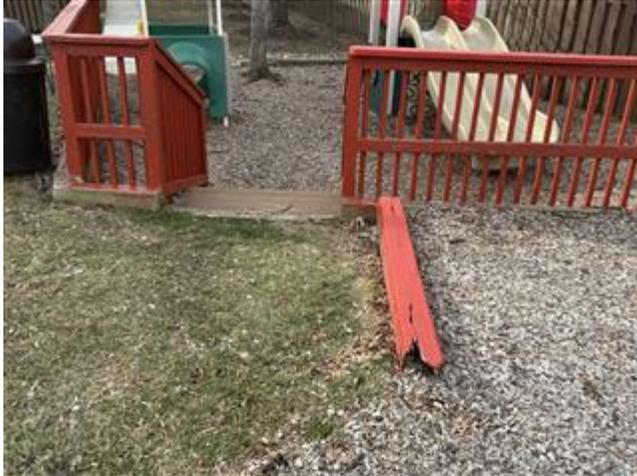
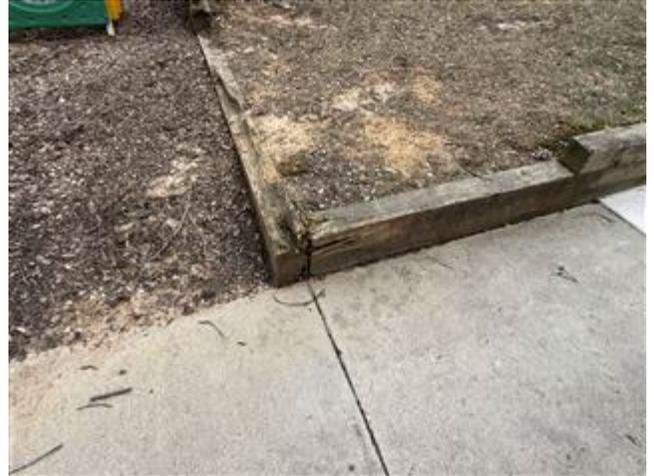
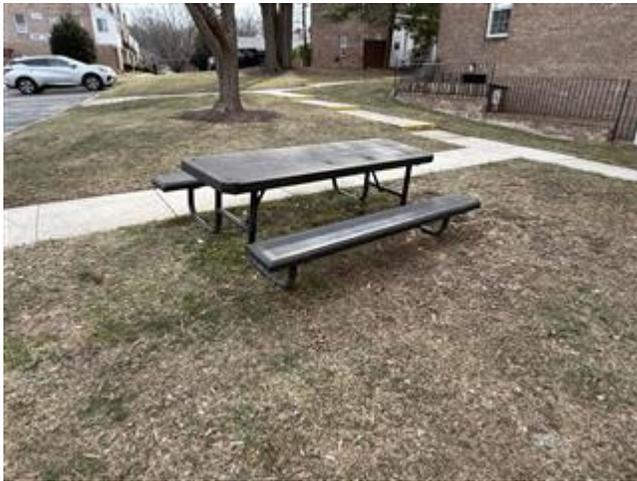
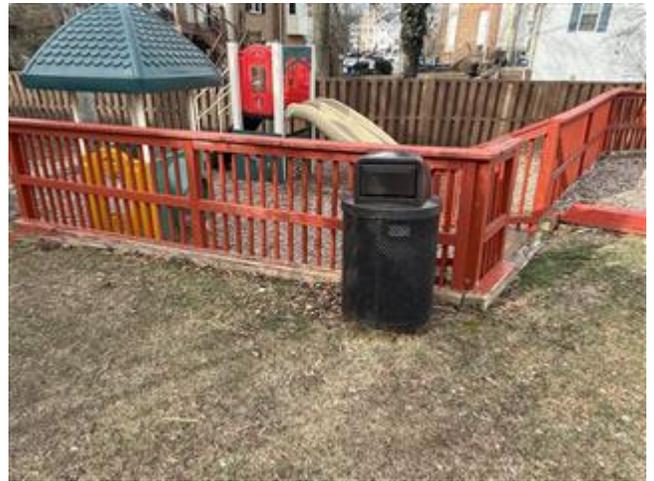
**Tot Lots.** The community maintains a tot lot, including two play structures and a three-seat swing. The play surface comprises two levels connected by a treated wood stair. The play surface is of wood chips surrounded by a treated wood border. The play area is enclosed on one side by the board-on-board fence at the property line (included under the Site Items) and on two sides by a wood rail and batten fence, portions of which are attached to the treated wood border. The remaining side of the play area is open.

A metal picnic table and a metal bench are located at the Tot Lot, and both appear to be in good condition. Two wood picnic tables elsewhere are in poor condition and should be replaced. One wood picnic table with metal support appears to be in fair condition. When evaluating a playground, the safety of each piece of playground equipment and the layout of the entire play area should be considered. The installation and maintenance of protective surfacing under and around all equipment are crucial. Please note that the evaluation of the equipment and safety of these facilities is beyond the scope of this work.

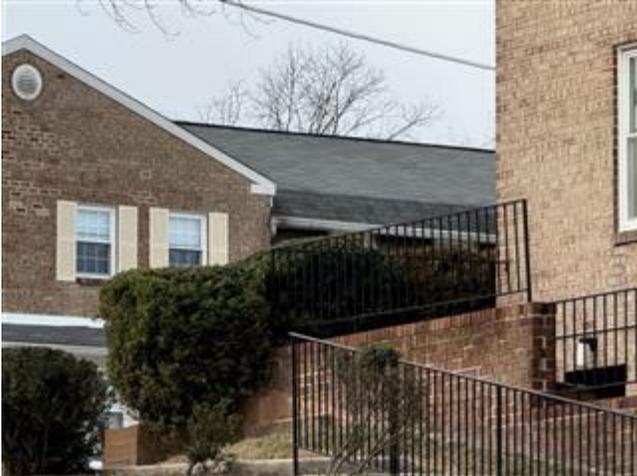
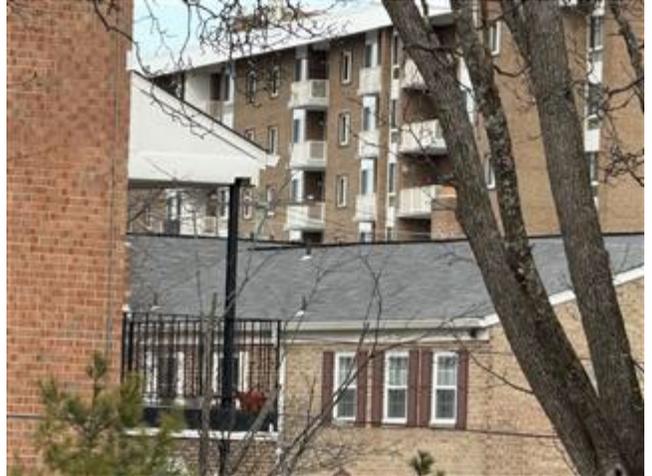
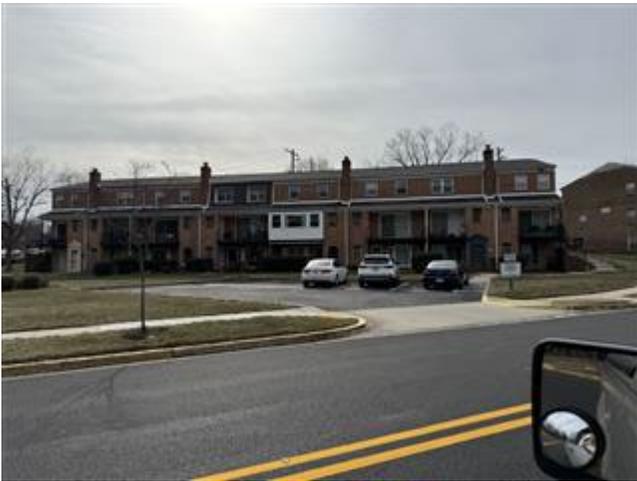
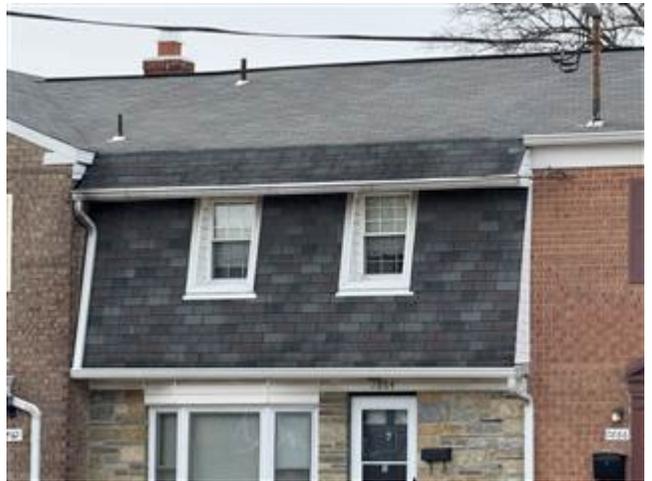
**Building Roofing.** The roofs at all 15 townhouse buildings, the storage/maintenance building, and each trash enclosure are covered with shingles. According to the Association, these roofs have been replaced with 25-year fiberglass shingles within the last 8 years, with the latest replacement completed last year.

Asphalt shingle roofs can last 20 to 50 years, depending on the weight and quality of the shingle. Weathered, curled, and missing shingles indicate that they may be nearing the end of their useful life.

We recommend annual inspections, with cleaning, repair, and vegetation mitigation performed as needed. Access, inspection, and repair work should be performed by contractors and personnel who are experienced in the types of roofing used for the facility with the appropriate access equipment.

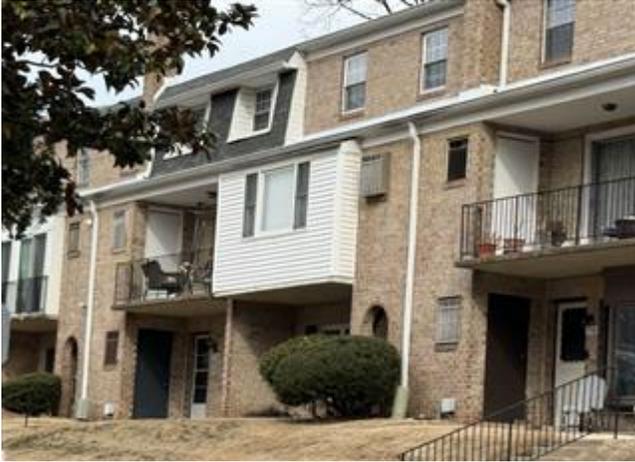
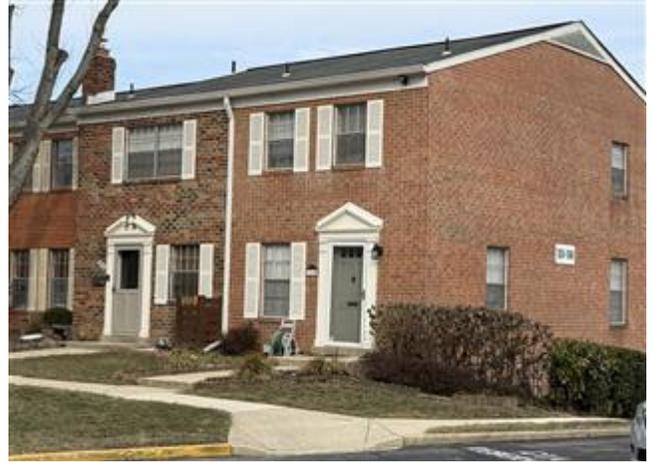
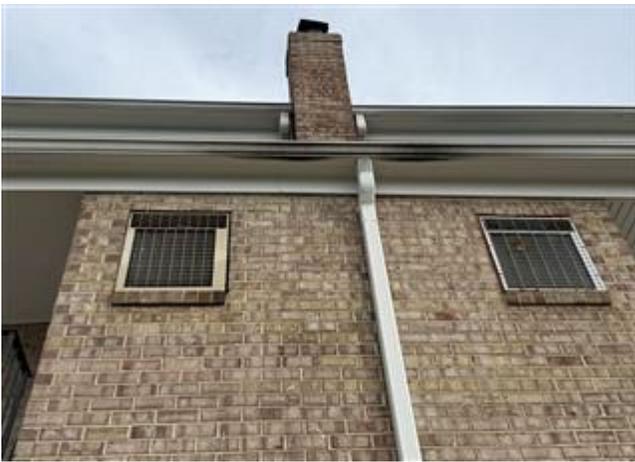
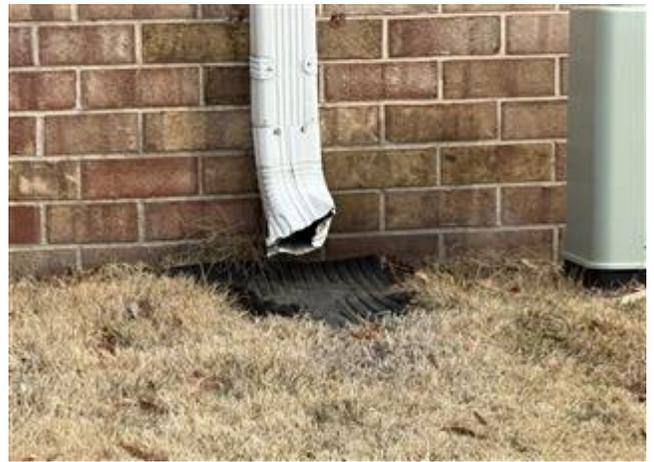
**Vinyl Shutters.** There are 350 windows with shutters. The vinyl shutters appear to be in fair condition, and we have used an average cost for their replacement. Vinyl window shutters have a typical economic life of 20 to 30 years, depending on several factors, including the quality of the shutter, how well it was installed, and exposure to sunlight and wind. In addition, the community is responsible for the unit entrance portico trim, including the pilasters and pediments.

In general, we recommend coordinating the replacement of these units with other exterior work, such as siding and roof replacements. The weather tightness of the building envelope often requires transitional flashing and caulking that should be performed in coordination with each other. Warranties and advantages in 'economy of scale' can often result in lower overall replacement costs and more reliable results. Lastly, coordinated replacements offer the opportunity to correct initial construction defects and improve the effectiveness of details with improved construction techniques and materials. For more information, please see our links at <https://mdareserves.com/resources/links/building-exterior>.

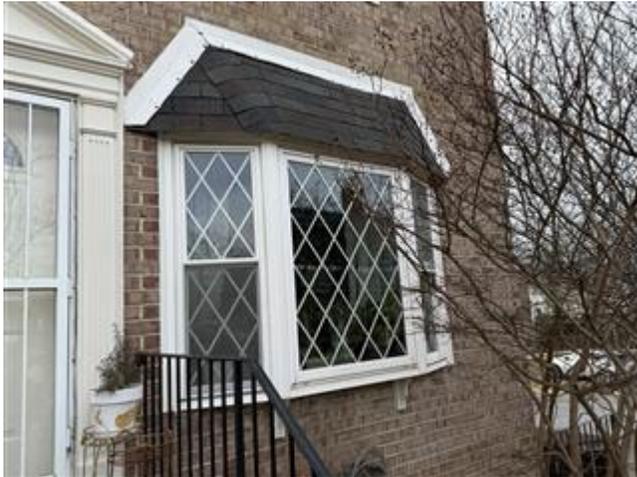
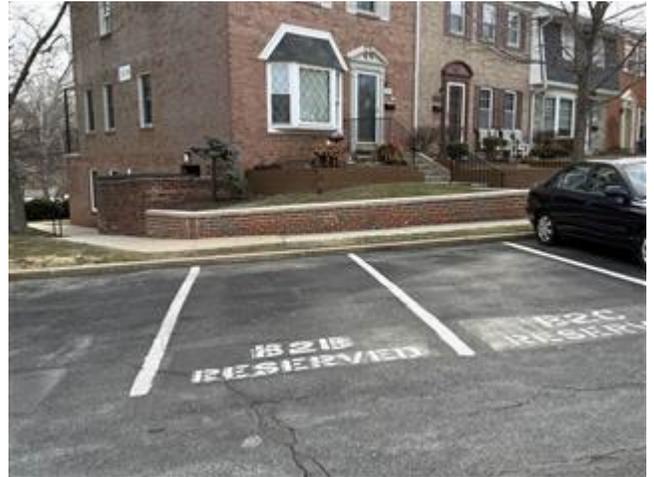
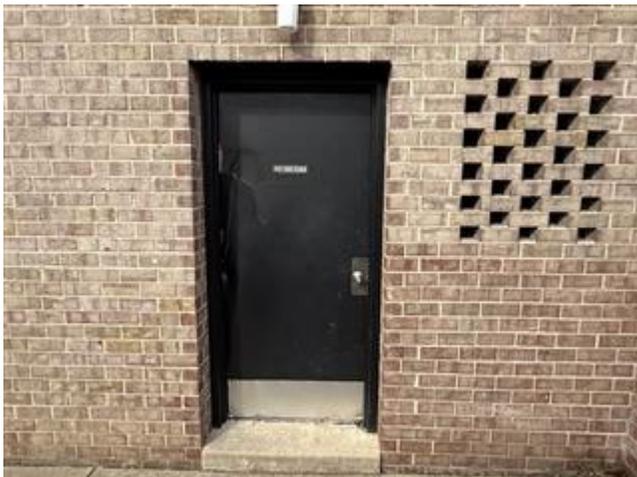
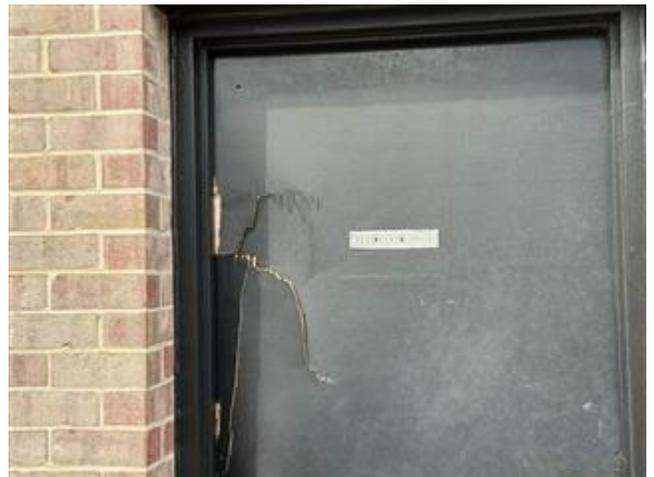
The bay windows appear to be in good serviceable condition. Most of the metal doors to the laundry and storage areas exhibit deterioration in the form of rust, particularly at the lower parts of the metal frames in contact with the concrete slab. In some cases, this deterioration has advanced to the degree that the integrity of the door and frame system is compromised. We also noticed a broken door. The remaining economic life of these doors and frames has been adjusted to accommodate this condition.

For Associations, where the unit owner is responsible for the replacement of their own windows and exterior doors, we recommend that the Association consider offering the unit owners an option to have their replacements performed in conjunction with the Association's work. This can be performed either by a separate agreement between the unit owner and the Association's selected contractor or by back-charging the unit owner.

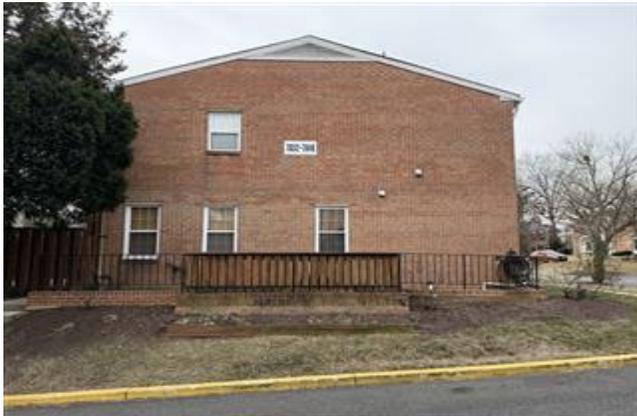
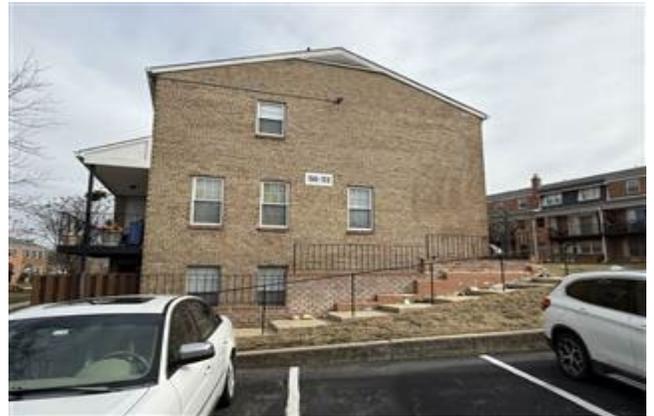
**Masonry.** The brick veneer masonry appears to be in fair condition. Brick masonry is used as the primary exterior cladding of the building. As masonry weathers, the mortar joints will become damaged by water penetration. As additional water gains access to the joints, repeated freeze-thaw cycles gradually increase the damage to the mortar joints. If allowed to progress, even the masonry units, such as brick, can have their surfaces affected, and masonry units can become loose.

We noted the repaired spalling of the brick face at the exterior building walls. Face brick spalling indicates water intrusion into the brick surface and freezing. A program to manage loose and missing mortar at brick joints and the discoloration of the brick due to organic growth is apparent. Wall areas where brick has been replaced and re-pointed suggest this is an ongoing issue.

In the previous study, in 2022, settlement cracking was noted in particular interior concrete masonry walls in laundry/storage rooms. Settlement cracking at concrete slabs exterior to these rooms suggests settlement issues may be related to stormwater management problems. We recommend that a qualified building inspector further examine these issues. In general, masonry is considered a long-life item and is therefore excluded from reserve funding. However, because weather and other conditions result in the slow deterioration of the mortar in masonry joints, we have included funding for repointing in this study. Repointing is the process of raking and cutting out damaged sections of mortar and replacing them with new mortar.

Periodic repointing and local replacement of damaged masonry units will limit the damage done by moisture penetration. For this study, we assume that 10 percent of the masonry will require repointing every 10 years after approximately 30 years.

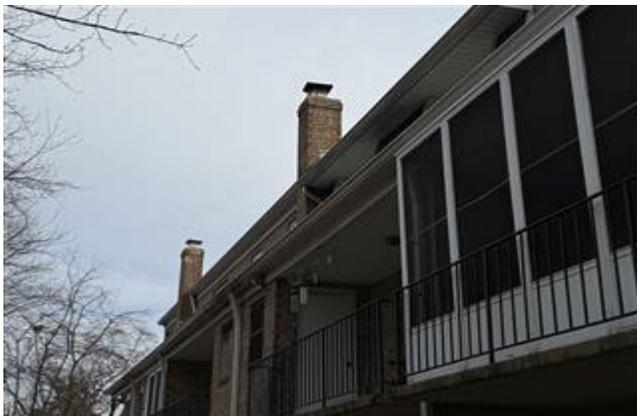
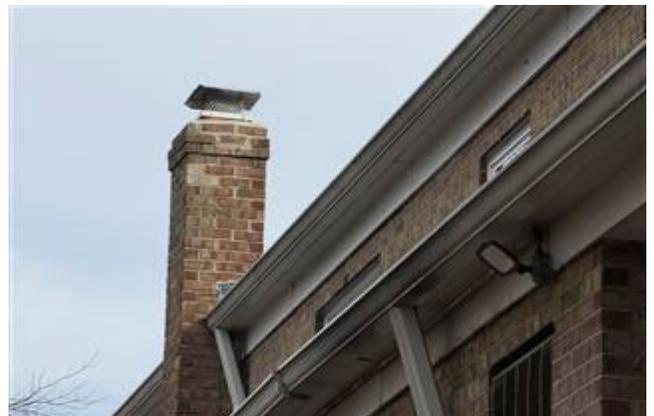
**Masonry Chimneys.** There are about 75 chimneys in the buildings, and they appear to be in fair condition. Chimney caps have a typical service life of 20 years. All chimney caps were observed from the ground level. We noted corrosion on a number of the caps, open mortar joints, or a loose brick on the top of a chimney.

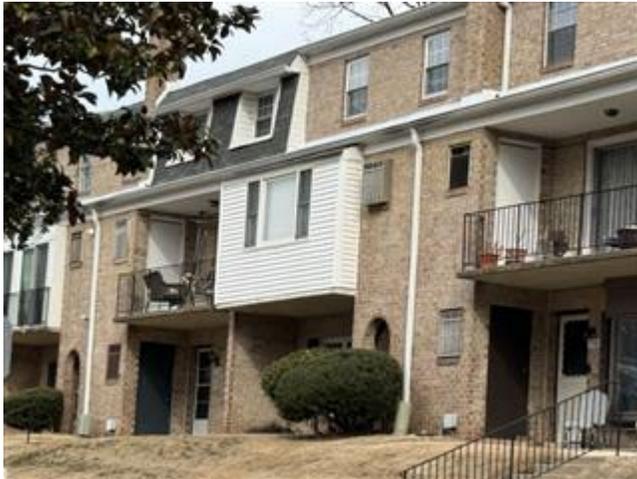
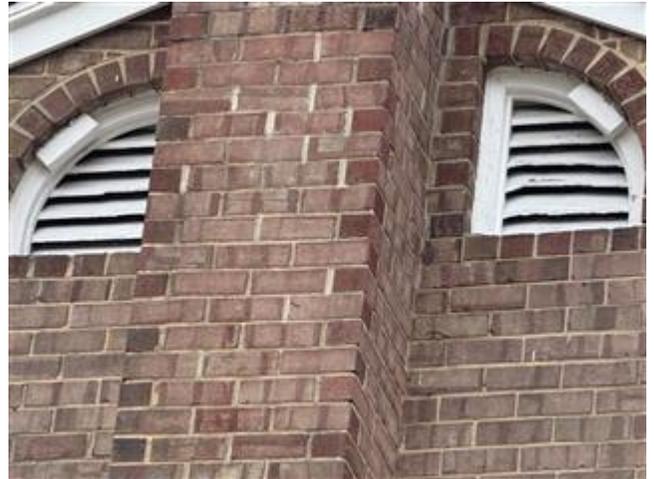
**Caulking.** The caulking on the facility's exteriors appears to be in fair to poor condition. We noted separated caulk joints.

When recaulking, a simple overlay of the old caulk is improper. Rather, defective caulk joints should be completely cut out, cleaned, and prepped, with new backer materials installed as needed. New caulk can then be applied according to the manufacturer's guidelines and recommendations.

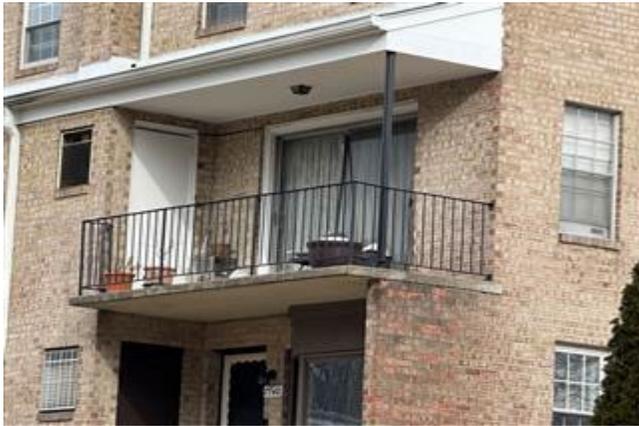
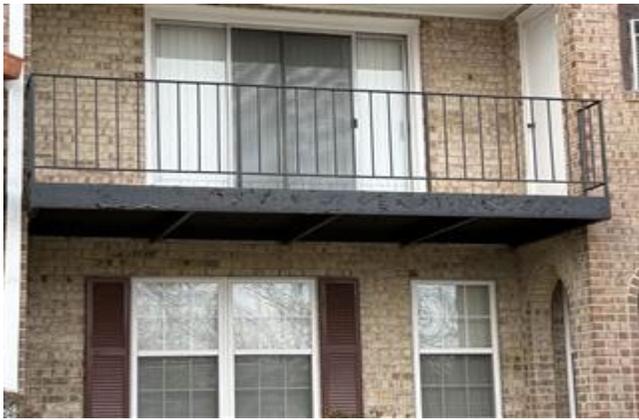
**Concrete Balconies.** The Association maintains the concrete balconies at each of the 15 townhouse buildings. We observed two types of balcony structures: self-supporting slabs and slabs supported by a metal deck and steel beam and column system. The condition of these balconies, as assessed from the ground level, appears to be generally good; this includes the concrete slabs (visible areas of the bottom surfaces and at the edges), supporting steel column structures, and the wrought iron railings. The condition of the balcony surfaces has not been verified.

Based upon casual observation of the visible parts of the decks from the ground, it appears that these deck structures exhibit a normal aging process, with some cracking and initial concrete degradation. Areas of previous repair were also noted. However, a detailed observation of the deck structures, railings, connections, and other appurtenances has not been made. As this report does not intend to assess the structural integrity of these deck structures, it is recommended that the Association retain the services of a structural engineer to perform a comprehensive inspection of the elevated deck structures and their support systems to establish their structural integrity.

The previous study in 2022 noted no major defects that appear significant, although cracking in the concrete decks near support structures, cracks in supporting brick masonry, and brick spalling at balcony-bearing locations. These defects should be closely monitored to determine if these conditions worsen over time. We noted replaced brick at the edges of some balconies, indicating an ongoing masonry pointing and repair program.

We recommend that the Association implement an annual inspection and power-washing program. Carpet or other water-trapping coverings should be prohibited, and potted plants should be placed on raised feet for proper air circulation and drying.

Additionally, we recommend applying appropriate sealants or coatings to the concrete deck's top surface and exposed edges and re-caulking all railing posts mounted into the deck slab. The underside of the concrete deck should be left untreated or treated with a breathable finish to allow entrapped moisture to escape.

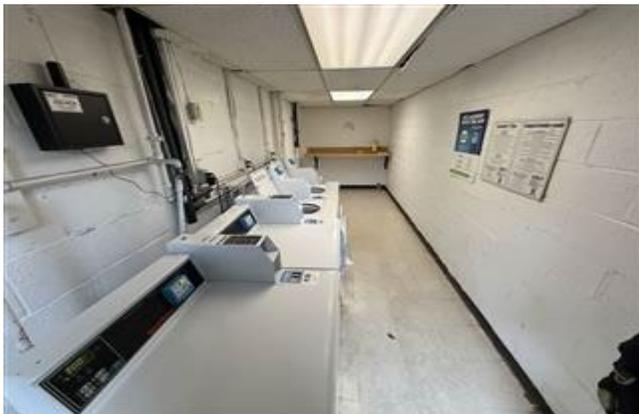
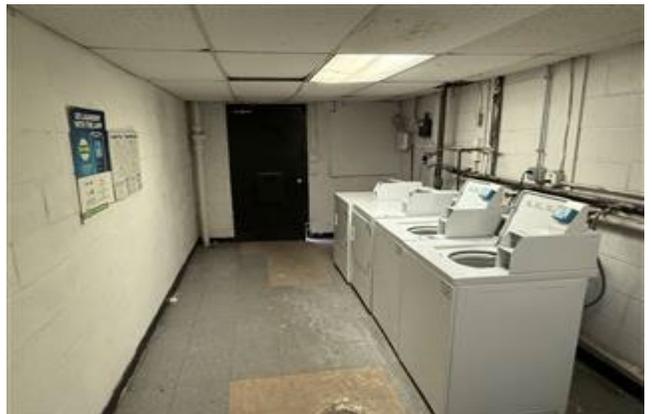
**Flooring, Vinyl Tile.** The Association maintains the vinyl tile flooring in the common laundry rooms and areas where the laundry rooms and storage rooms are in the same space. The floors in the separate storage rooms are painted concrete and are excluded from the study.

The vinyl flooring tile condition appears fair. Water intrusion into a few of these rooms can cause these tiles to buckle and discolor. Tiles that have become loose have the potential to become tripping hazards. Some drainage systems have been installed in a few of these spaces to divert surface water to sump pits. In 2022, in some cases, the covers to the sump pit are incorrectly installed, which may present a hazard. We did not observe sump pits in this study.

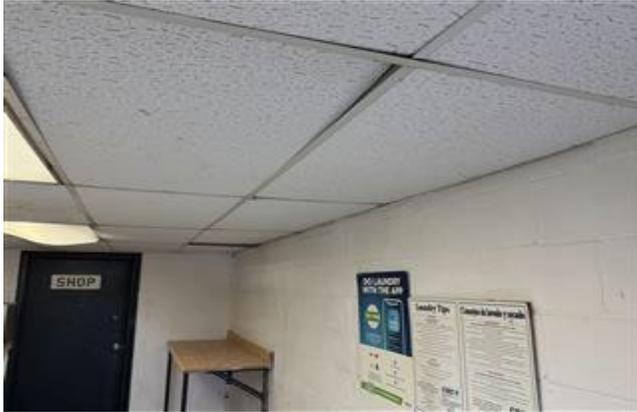
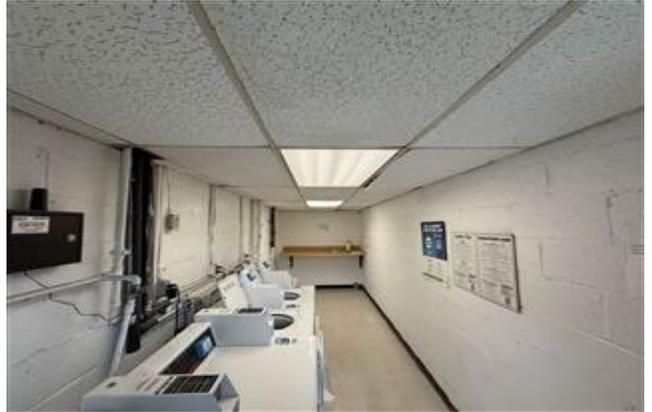
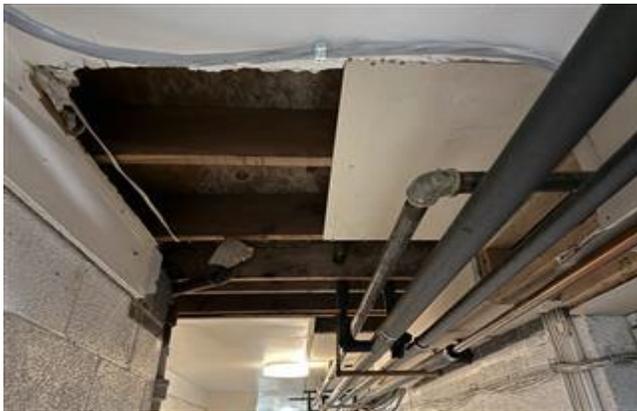
**Ceiling Tile.** The Association maintains suspended acoustic tile ceilings in the common laundry rooms. The ceiling areas where the laundry and storage rooms are in the same space and in the separate storage rooms are painted gypsum board and excluded from the study. We noted openings in the drywall ceilings in the storage areas, presumably for piping or wiring repairs. This condition may negatively affect the assembly's fireproofing integrity. We noted the condition of these ceilings ranges from fair to poor, with numerous instances of loose, missing, stained, and damaged ceiling panels. It is important that the integrity of these ceiling tiles be maintained, as they help to insulate the above spaces to protect the piping installed above them. Any gaps or missing tiles will allow cold air to penetrate the space above the tile, increasing heat loss from the conditioned space and increasing the chances of freezing the piping above the tile. We recommend that the tile be inspected in the fall and after any work is completed in the space above the tile.

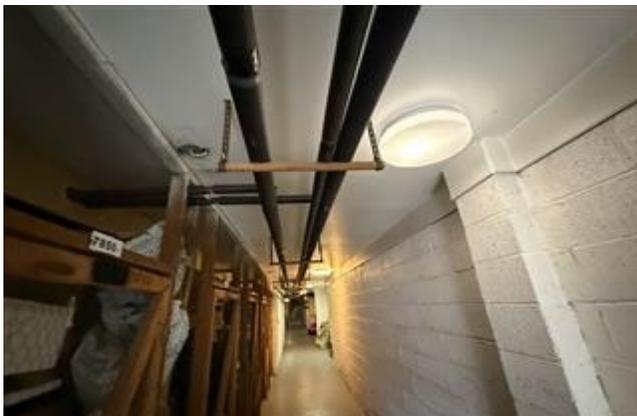
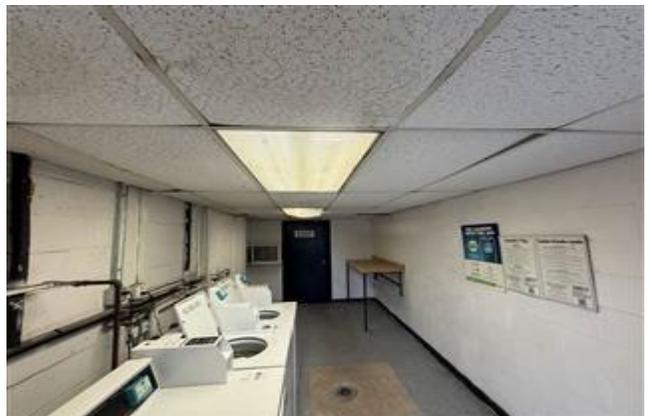
**Interior Lighting:** The Association maintains the interior lighting in the laundry and storage rooms. The lighting in the individual laundry rooms consists of 2x4 lay-in fluorescent fixtures. The lighting consists of various types, including surface-mounted 2x4 fluorescent lights, incandescent lights, and LED lights in areas where the laundry and storage rooms and separate storage rooms are in the same space. The condition of these light fixtures ranges from good to poor. Some fixtures appear to be newer or have been retrofitted with LED luminaires, while others are in poor condition. We noted inoperative luminaries and stained diffusers.

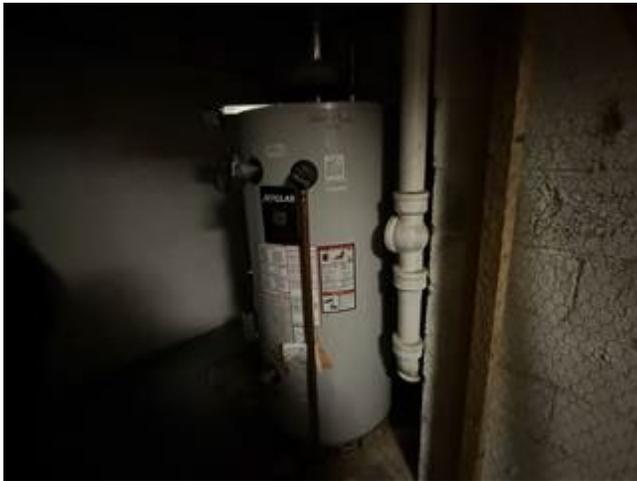
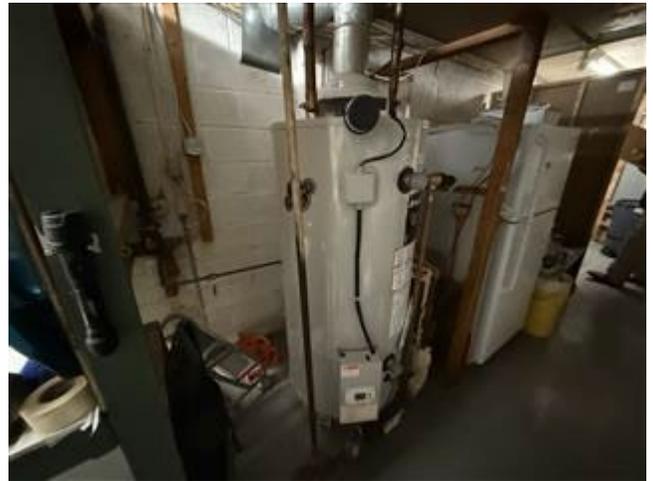
**Water Heater.** The Association maintains fifteen 80-gallon gas-fired storage water heaters that appear to be in good condition. Water heaters of this type and in this application have an expected useful life of 15 years.

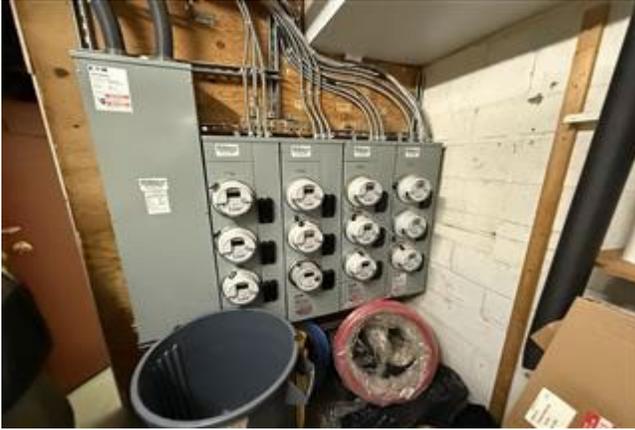
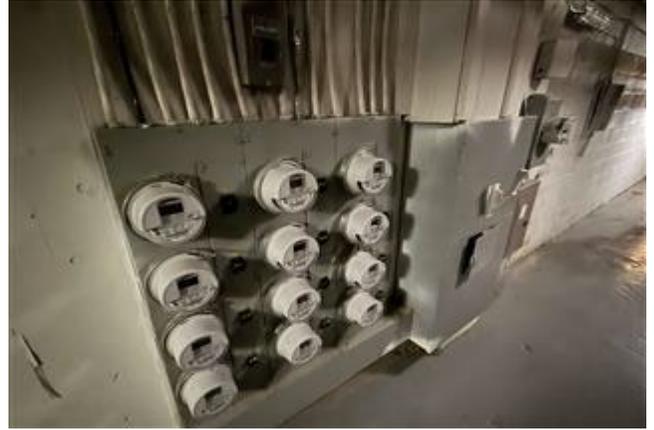
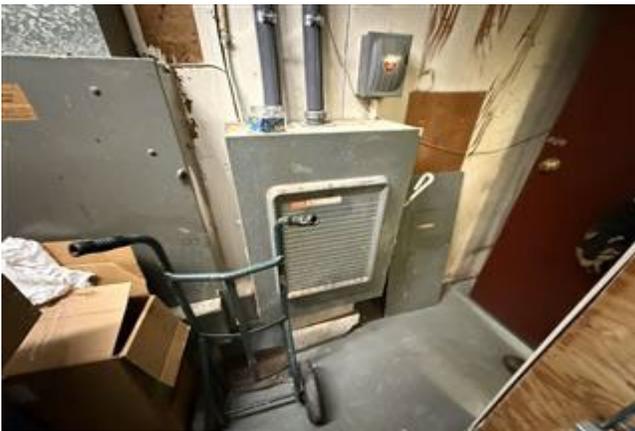
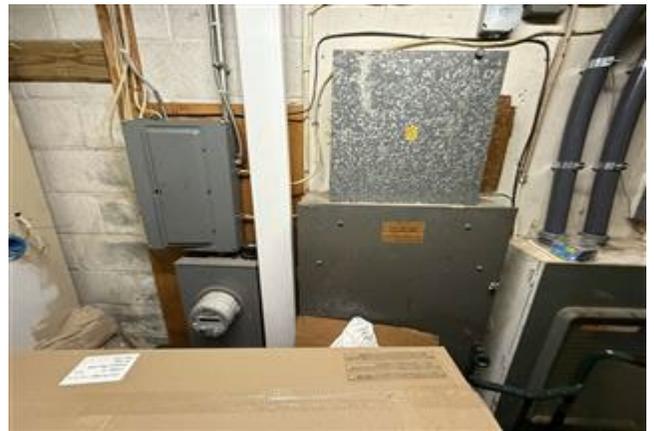
**Electrical Distribution Panels.** The electrical distribution panels located throughout the facility were replaced in 2019. For the purposes of this study, it is assumed that these panels have a rated service life of 50 years or more.
