# LEVEL 2 REPLACEMENT RESERVE REPORT FY 2025 CHARLESTOWNE VILLAGE

## CHARLESTOWNE VILLAGE

GREENBELT, MARYLAND

March 12, 2025

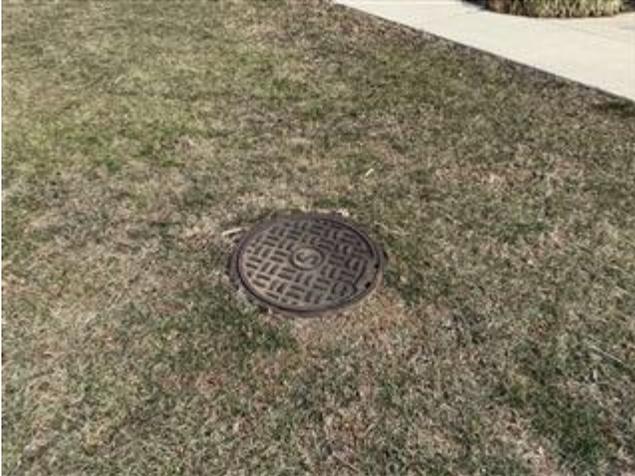
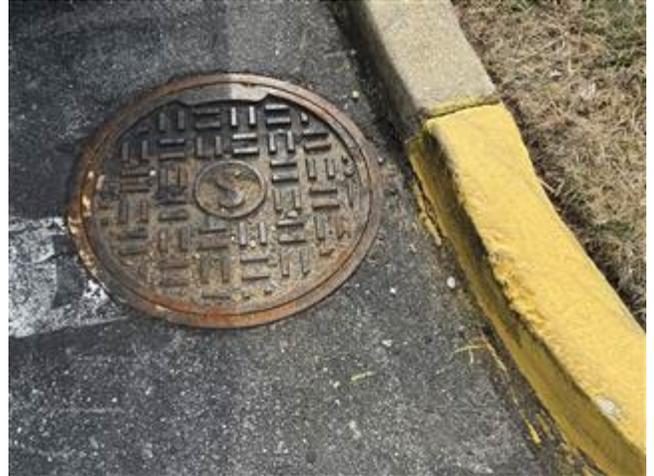
**Building Piping.** Copper water supply piping has been used in the main service piping and risers to the buildings.

To gain a better understanding of the condition of this facility's pipes and water supply lines, we recommend having an expert evaluation of the piping performed. This evaluation should provide an estimation of the remaining useful life of the piping systems, the condition of the water supply, and recommendations for replacement to maximize the remaining useful life of this facility's piping systems.

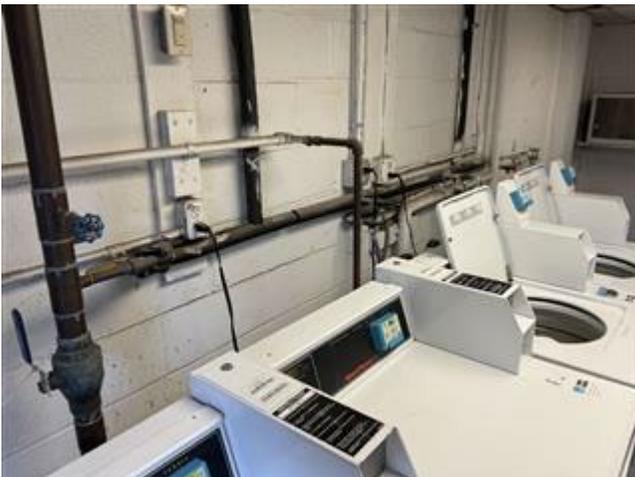
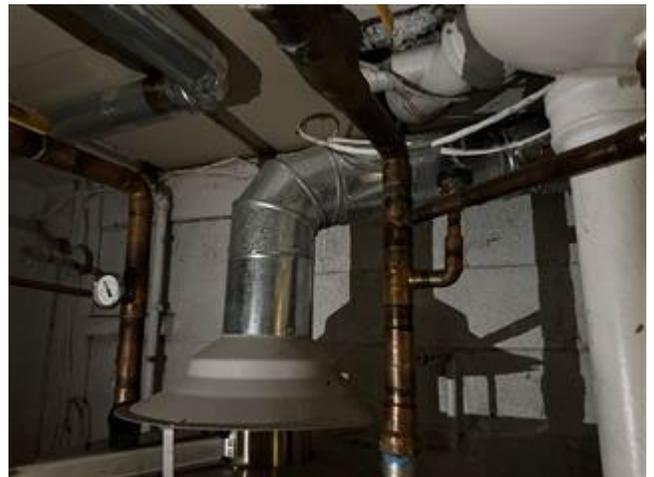
Copper Piping. As a result of changes in water chemistry that have been brought on by federal clean water legislation, copper piping throughout the Washington, DC metropolitan area has been developing pin-hole leaks which lead to high maintenance costs and a significantly shorter normal service life. For further information about the problem and research that is being conducted, go to [www.wssc.dst.md.us](http://www.wssc.dst.md.us), click on the dropdown box labeled "Customers", and click on the listing for "PinHole Leaks". As a result of this problem, the piping will have to be replaced at some point in time. Assuming that the chemical deterioration from the water content is inevitable, we have included funding for this work in the reserve study. In estimating the amount to be reserved, we have assumed that the cost of any unit plumbing lines will be paid by unit owners and that the cost of funding risers will be paid from reserves.

For budgeting purposes, an allowance every 25 years is included in this study for repiping work. Please note that this work has a high degree of variability depending on the layout of the facility and accessibility to the piping components.

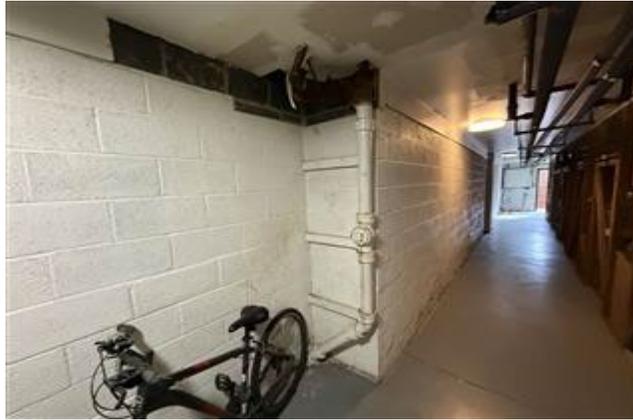
**Cast Iron Drain, Waste, & Vent Piping.** Cast iron piping was originally installed in the building. Properly installed cast iron drain, waste, and vent (DWV) piping systems can have a service life of 100 years or more. The most common problems with cast iron DWV systems are failures of the joints, cracks, and corrosion. We understand that no significant problems have been reported with the system's operation. The system is reported to be in good operating condition with no leaks. We have assumed that minor repairs will be paid for with maintenance funds and are therefore excluded from the Reserve Analysis. We have included an allowance for more significant repairs to the piping system periodically.

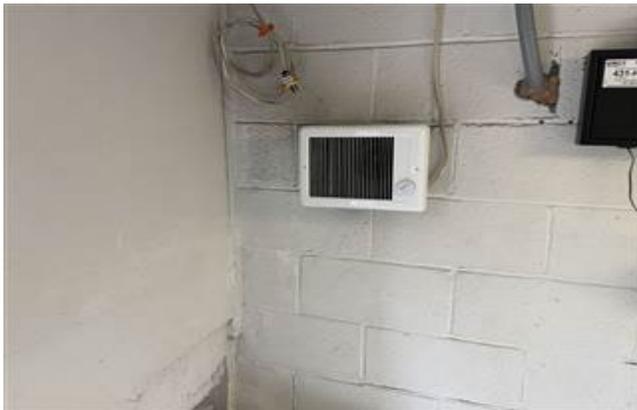
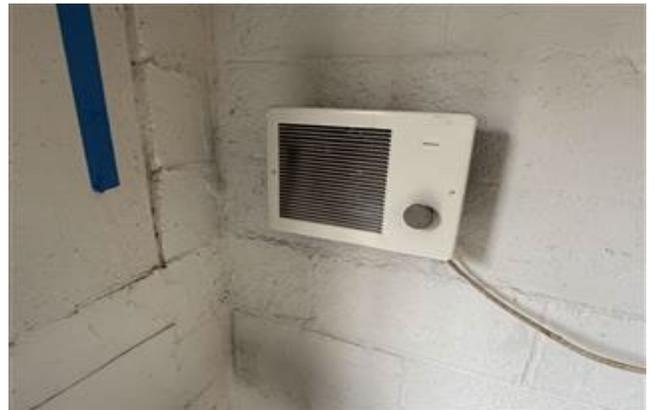
**Wall Heaters.** The buildings' laundry rooms have electric wall heaters. We did not observe any conditions related to the electric heaters that require immediate capital expenditure. The heater units were reported as operational. Wall heaters are being replaced as needed.

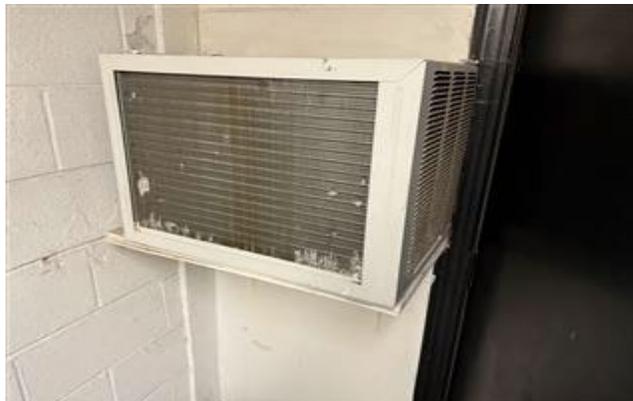
**HVAC Systems.** The facility's air conditioning (HVAC) consists of one window air conditioning unit located in the basement and is reported to be in good operating condition. Detailed inspection and testing of these systems are beyond the scope of this study. The A/C unit is excluded from the Reserve Analysis and should be replaced as needed with other funds. As with most equipment, proper maintenance is essential to achieve a maximum useful economic life. In some cases, proper and proactive maintenance can greatly extend the useful life of these components.
