Public Water System Annual Report

Southwest Regional Water Treatment Plant & Southwest Regional Water Co-op
2012

Date Prepared: 3/13/2013

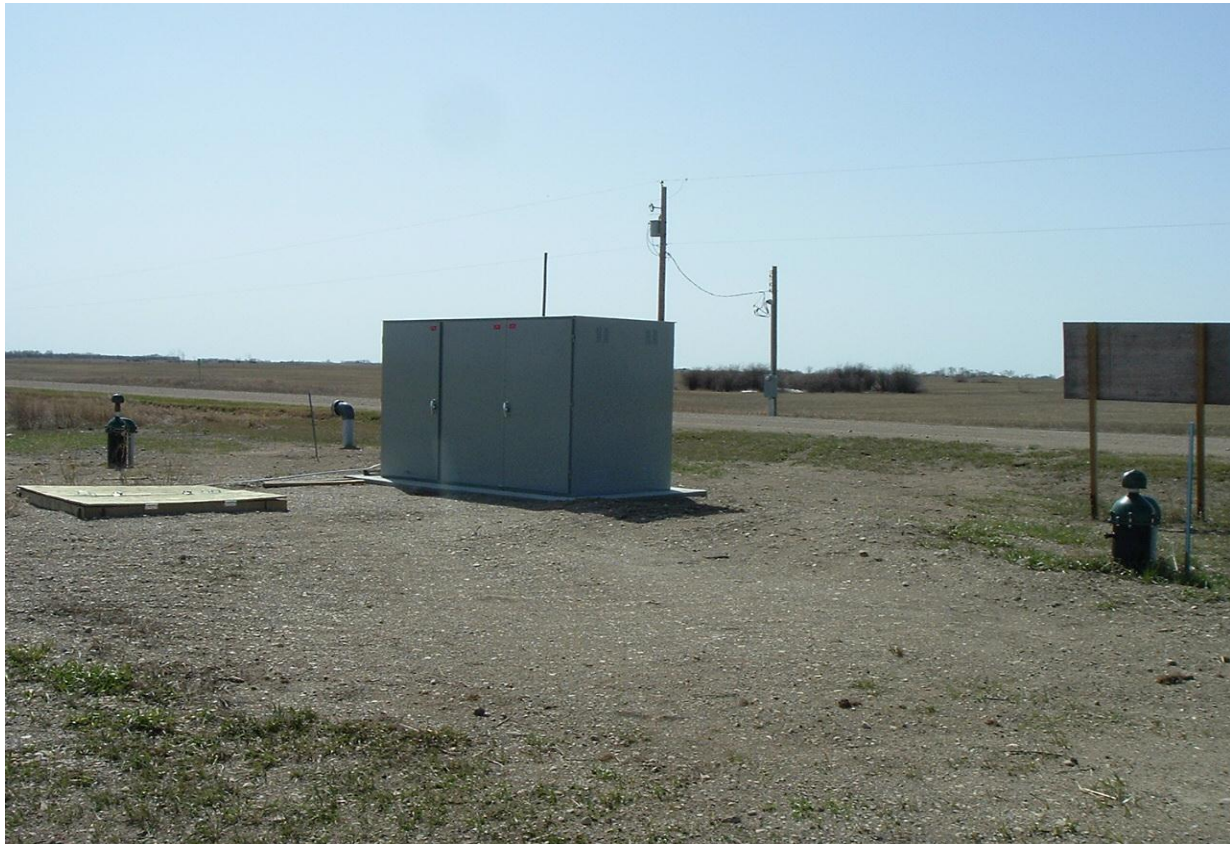
Well Site 1

The WTP receives groundwater from four wells located at 16 km North East of Melita @ NW23-5-27W. The wells draw groundwater from the Oak Lake Aquifer. The wells were drilled to a depth of 33 feet. Raw water pumped from the wells into a 200 mm (8 inch) pipeline where it flows directly into the WTP for processing and treatment.

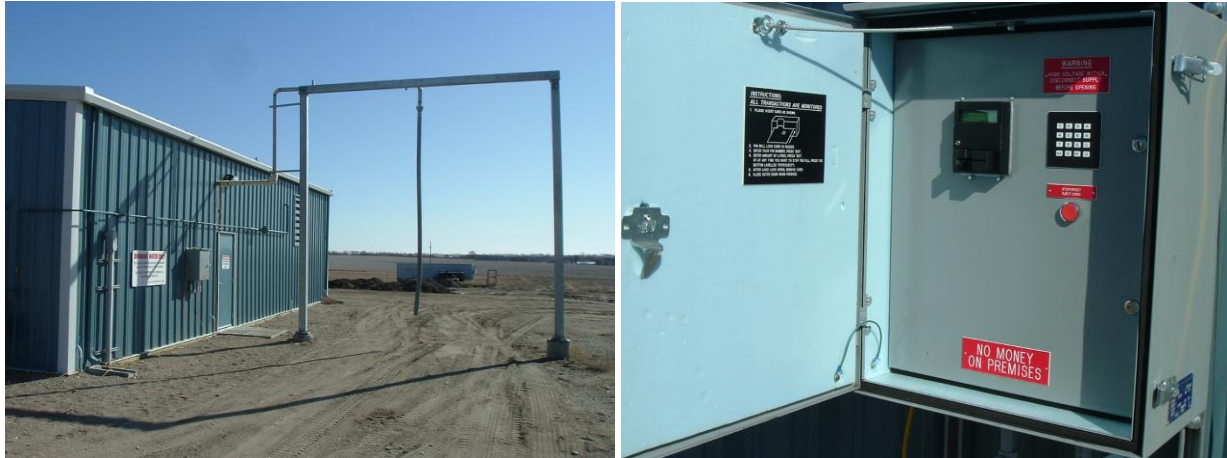
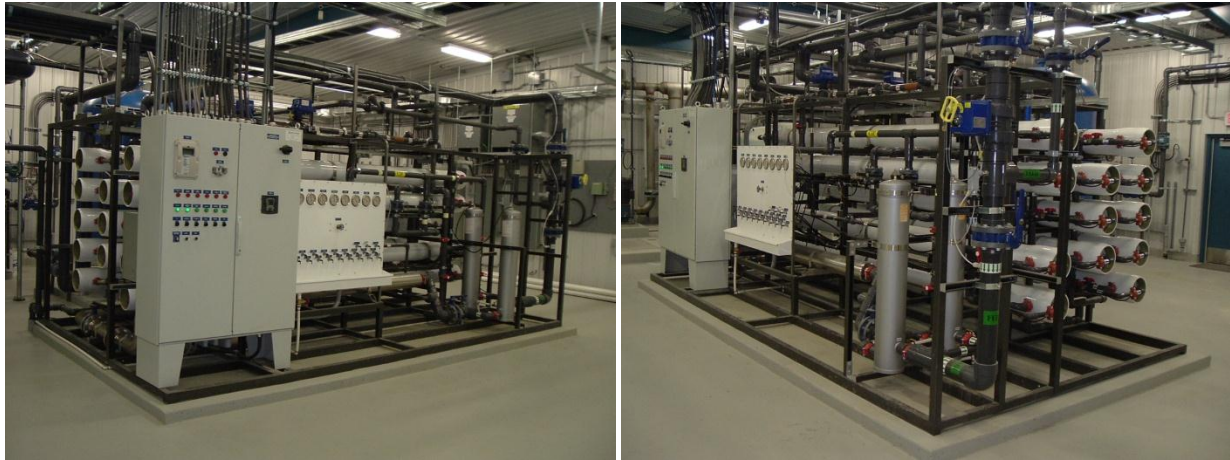
The MTU (Main Treatment) Unit

Raw water is pumped to the WTP where approximately 90% of the flow is directed through a combination of nano-filtration and reverse osmosis membranes. The remaining 10% by-passes through a sand-filter with 3 new UV (ultraviolet) units prior to blending with membrane permeate. Blended flow is chlorinated with sodium hypochlorite and then stored in a 1,000,000 litre concrete reservoir for distribution. Since membranes remove most dissolved minerals, blending permeate with filter water allows the operation to produce treated water with a more desirable hardness and PH. Approximately 13% of membrane flow (11% of the raw water) is discharged as membrane concentrate to the Souris River. Treated water is distributed to the Co-op and a bulk water (truck) fill is available for rural usage.

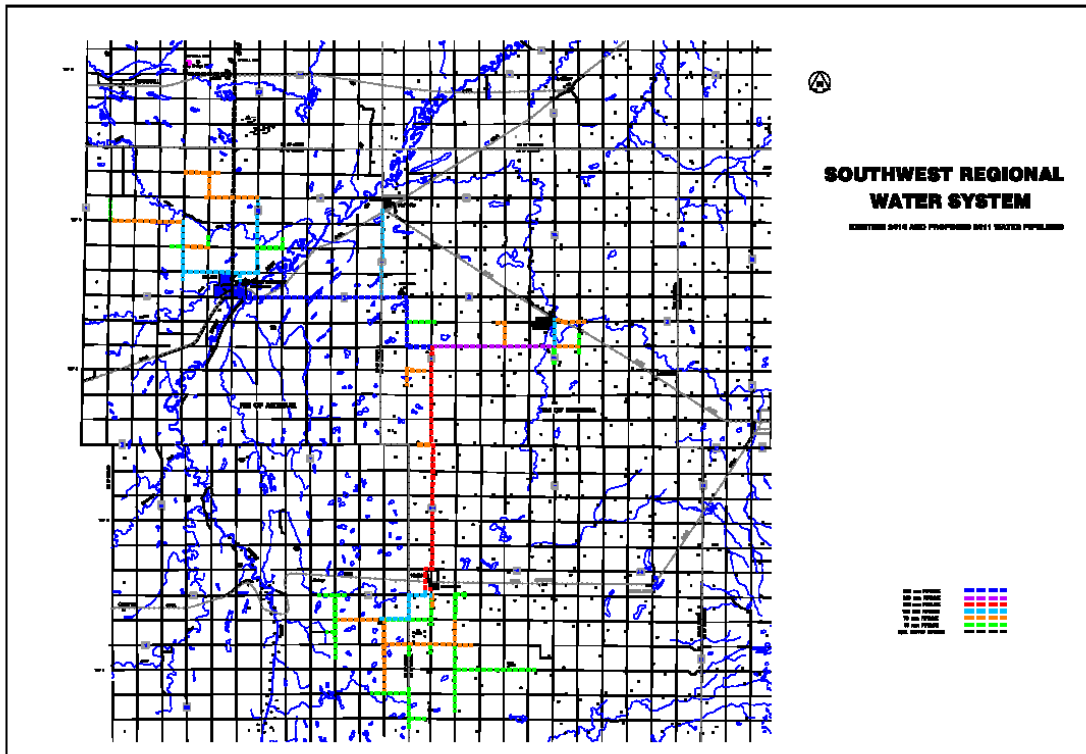
The Distribution Pumps

Treated water from the reservoir, located underneath the WTP, is pumped throughout the Melita distribution system via two 7.5 horsepower duty pumps, with one 30 horsepower emergency standby pump for firefighting purposes. The SWRWC has one 7.5 horsepower duty pump. The SWRWC consists primarily of High Density Polyethylene Pipe. 12 miles of 8" raw water supply line, the distribution consists of the following 11 miles of 10", 5 miles of 8", 10 miles of 6", 18 miles of 4", 23 miles of 3", 25 miles of 2", for a total of 104 miles of pipe in the ground. A map of the current distribution system as it looks today is on the next page, the Waskada Rural Water Co-op already had several miles of pipe in place but is now part of the overall distribution system. The WTP also has a natural gas powered generator located in the building that powers the distribution pumps during times of a power failure.

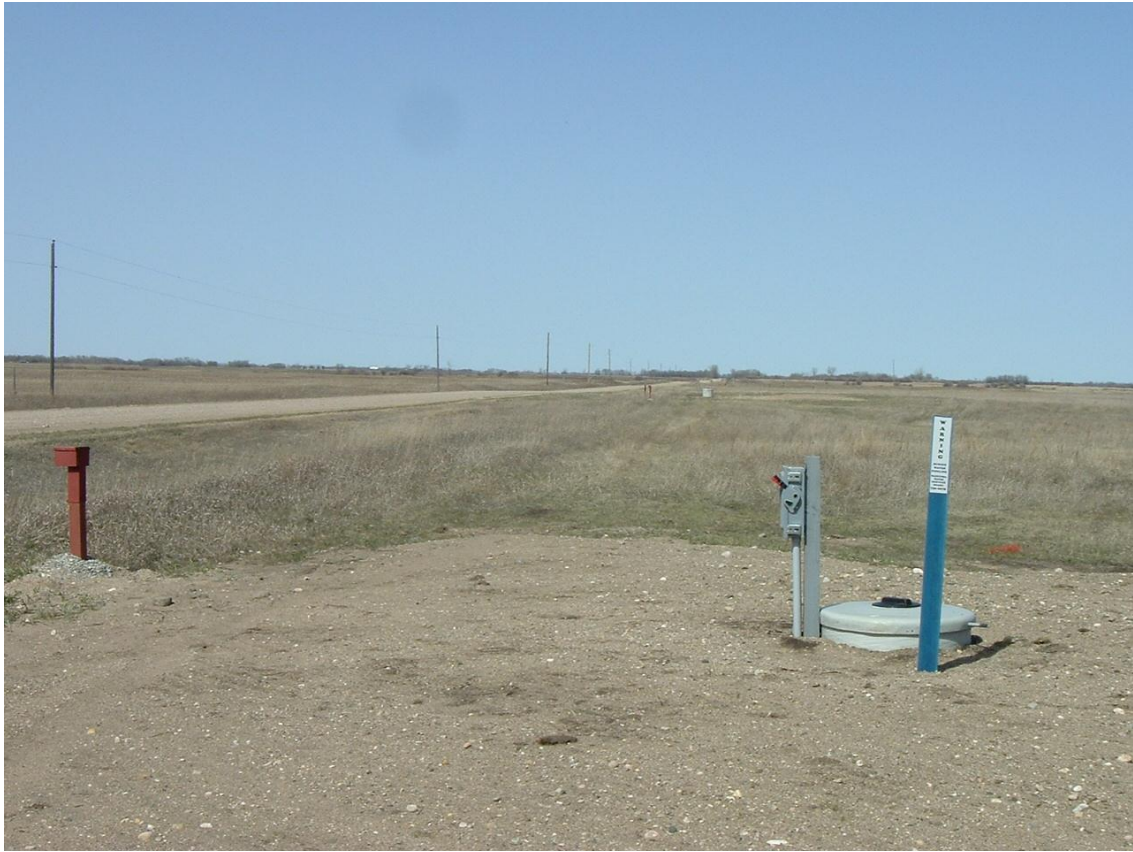
Recharge Wells

Since the middle basin could only be pumped intermittently, the north basin well was temporarily equipped with a pump, generator and overland pipeline to speed up the water table recovery. Pumping from this basin occurred from September 3rd to September 21st until water levels significantly recovered and the north basin water table prevented further pumping. The water table in the north basin has since recovered. In 2012 the north basin was converted to a supplemental well to improve operating pressures and flows to the plant when it is in operation.

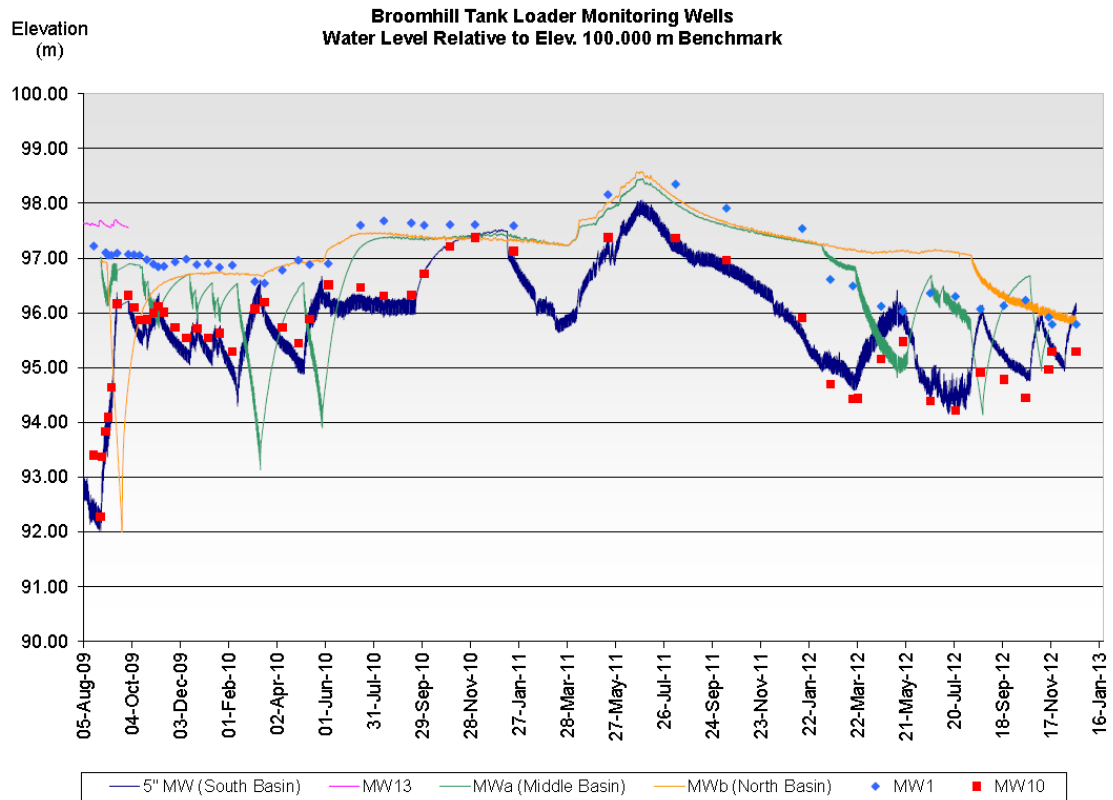
Groundwater monitoring commenced in July 2009. As many as four pressure transducers were initially set-up and currently three pressure transducers are continuous and manual readings. This graph uses a benchmark of 100.00 m in order to compare levels in each the three basins.

The locations of all monitoring wells are shown in the appendices. 5" MW represents the water table depth near the production well, while MWa and MWb represent the water table depth in the middle and north basins.

The updated graph on page 11 shows ground water levels at various points at and around the original wells.

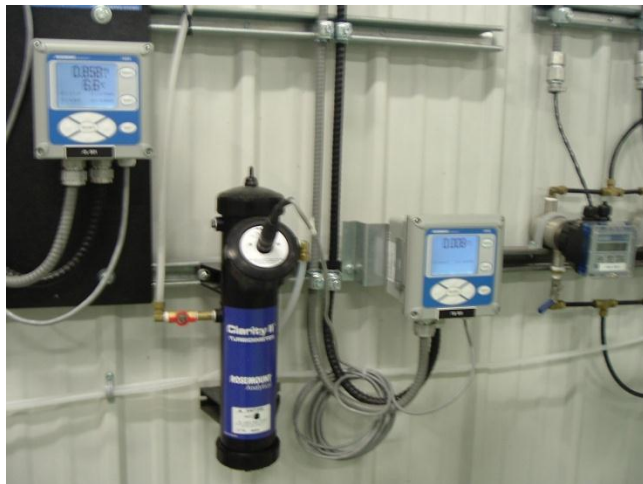
Online Monitoring Equipment

monitored continuously by an online monitor that monitors the water continuously as it leaves the WTP. We also monitor the residuals daily at the WTP and in the distribution system; these tests are performed at the WTP after the samples are collected. The results of all tests are recorded on our records at the WTP as well as Monthly Chlorination Report forms which are sent to the regional *Drinking Water Officer* at the end of each month, to check for standard compliance.

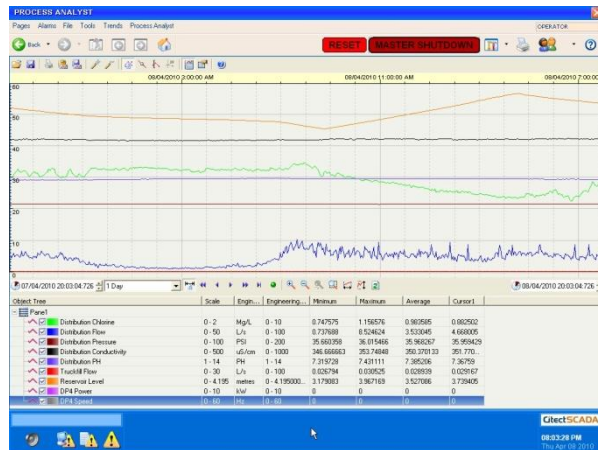
The WTP is monitored continuously by the computer system; it is continuously taking readings from 60 different locations by sensors, probes and meters. This information is displayed in real-time on a different number of screens (*see Figure A, B, C which show three different computer screens*) and is also recorded and compiled in the form of a trend. These trends can be accessed at any time and show a history of plant operation in various areas (*see Figure D for an example of a trend screen*).

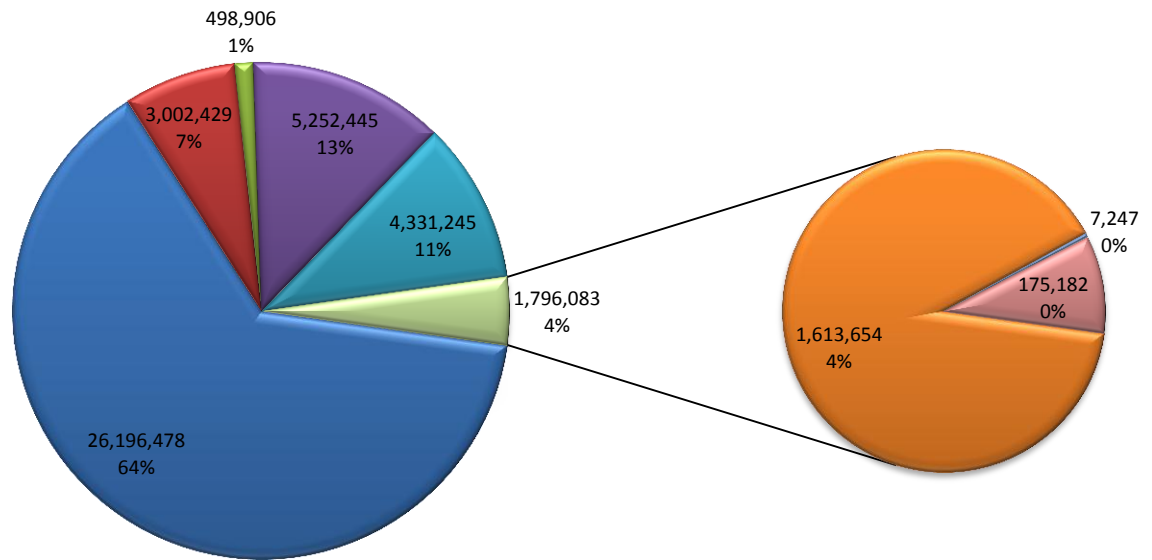
2012 Usage Chart in Imperial Gallons

■ Melita ■ Napinka ■ Medora ■ Waskada
■ Rural ■ Melita Truck Fill ■ Napinka Truck Fill ■ Waskada Truck Fill

The treatment system capacity was designed to meet a 20 year future demand for Melita as well as additional capacity for the rural water system. Although that has proven to be incorrect and will be revised accordingly as after only 4 years several upgrades have already taken place and more scheduled for this year. The water system production and usage are summarized in the following charts in ***Appendix "A" – Usage Charts.***
