Public Water System Annual Report

Southwest Regional Water Treatment Plant & Southwest Regional Water Co-op
2014

Date Prepared: 2/20/2015

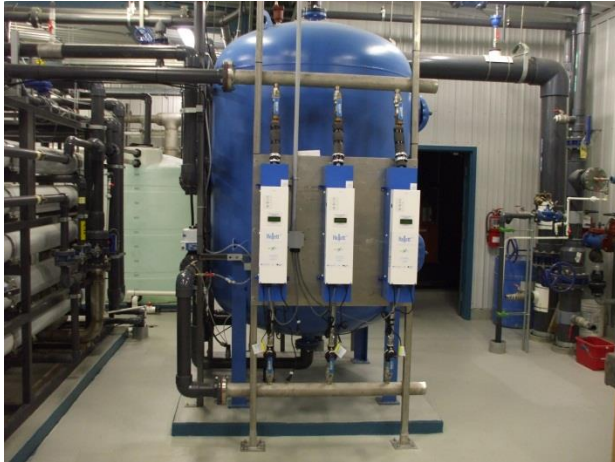
The Original Sand Filter with UV upgrade

The Melita WTP disinfects by adding a 12% sodium hypochlorite solution to the water via 3 chlorinator pumps. One for the raw water before it enters the sand-filter (pre-treatment) and two for the blended water before it enters the reservoir. In 2012 three UV units were added after the filter. In 2014 three more UV units were added after the second filter.

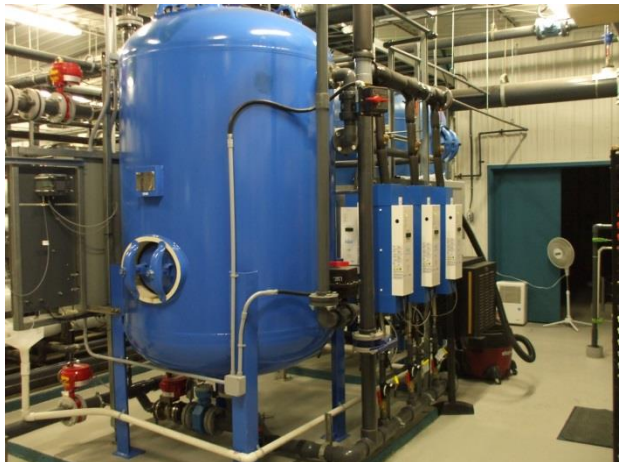
The New Sand Filter with UV

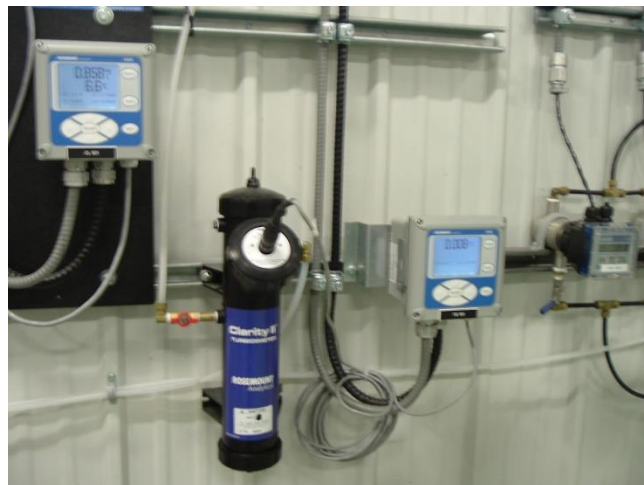
Online Monitoring Equipment

As required by the *Drinking Water Safety Act* the Melita PWS ensures continuous disinfection is maintained at the WTP by keeping in stock all spare parts required for the chlorinators, as well there are two spare chlorinator pumps kept at the plant. Disinfection residuals are monitored continuously by an

online monitor that monitors the water continuously as it leaves the WTP. We also monitor the residuals daily at the WTP and in the distribution system; these tests are performed at the WTP after the samples are collected. The results of all tests are recorded on our records at the WTP as well as Monthly Chlorination Report forms which are sent to the regional *Drinking Water Officer* at the end of each month, to check for standard compliance.

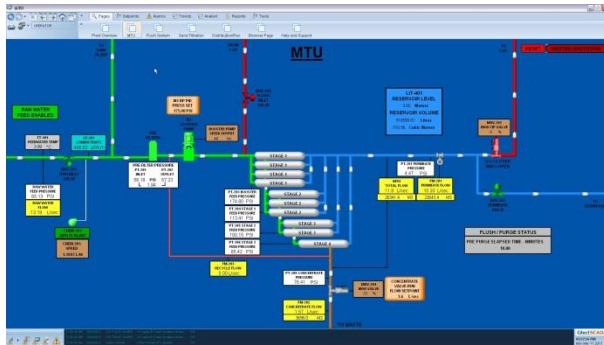
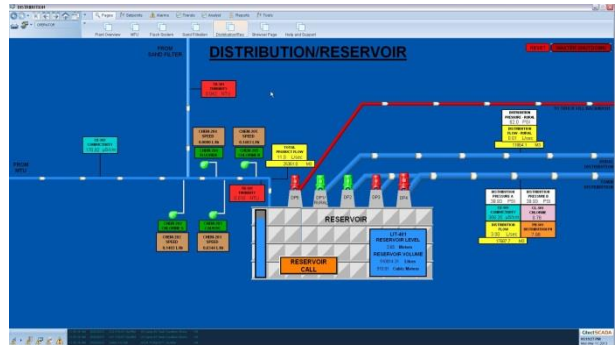
Figure A

The WTP is monitored continuously by the computer system; it is continuously taking readings from 85 different locations by sensors, probes and meters. This information is displayed in real-time on a different number of screens (*see Figure A, B, C which show three different computer screens*) and is also recorded and compiled in the form of a trend. These trends can be accessed at any time and show a history of plant operation in various areas (*see Figure D for an example of a trend screen*).
