Public Water System Annual Report

Southwest Regional Water Treatment Plant & Southwest Regional Water Co-op
2015

Date Prepared: 3/1/2016

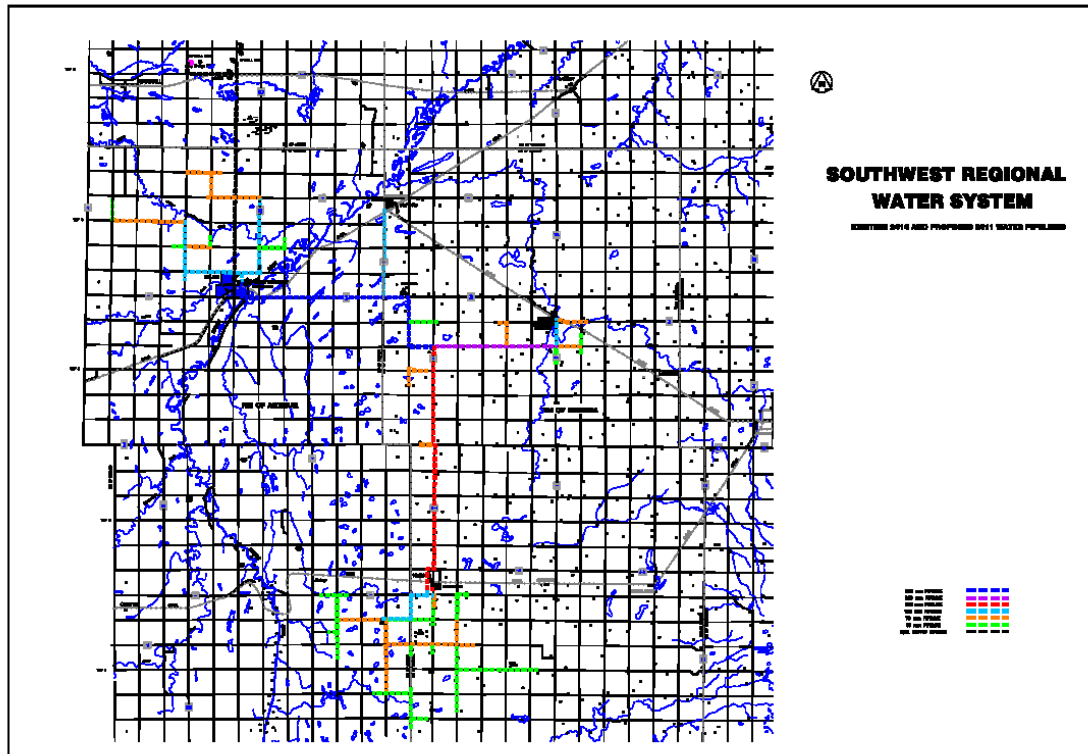
The Distribution Pumps

Treated water from the reservoir, located underneath the WTP, is pumped throughout the Melita distribution system via two 7.5 horsepower duty pumps, with one 30 horsepower emergency standby pump for firefighting purposes. The SWRWC has one 7.5 horsepower duty pump. The SWRWC consists primarily of High Density Polyethylene Pipe. 12 miles of 8" raw water supply line, the distribution consists of the following 11 miles of 10", 5 miles of 8", 10 miles of 6", 18 miles of 4", 23 miles of 3", 25 miles of 2", for a total of 104 miles of pipe in the ground. A map of the current distribution system as it looks today is on the next page, the Waskada Rural Water Co-op already had several miles of pipe in place but is now part of the overall distribution system. The WTP also has a natural gas powered generator located in the building that powers the distribution pumps during times of a power failure.

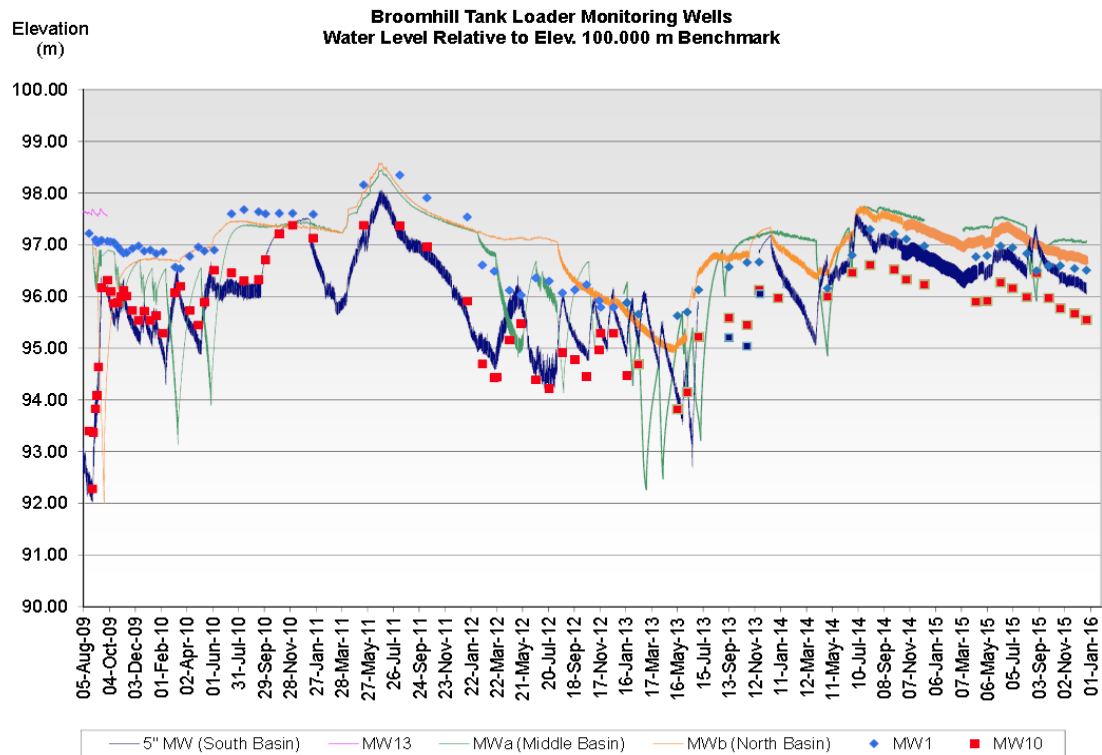
Groundwater monitoring commenced in July 2009. As many as four pressure transducers were initially set-up and currently three pressure transducers are continuous and manual readings. This graph uses a benchmark of 100.00 m in order to compare levels in each the three basins.

The locations of all monitoring wells are shown in the appendices. 5" MW represents the water table depth near the production well, while MWa and MWb represent the water table depth in the middle and north basins.

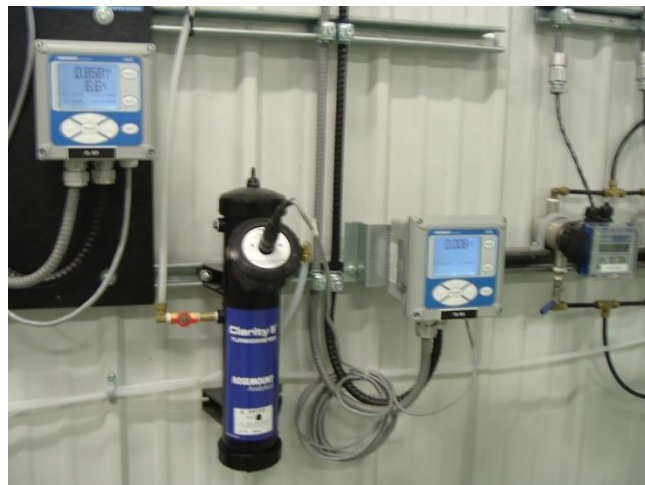
Online Monitoring Equipment

two spare chlorinator pumps kept at the plant. Disinfection residuals are monitored continuously by an online monitor that monitors the water continuously as it leaves the WTP. We also monitor the residuals daily at the WTP and in the distribution system; these tests are performed at the WTP after the samples are collected. The results of all tests are recorded on our records at the WTP as well as Monthly Chlorination Report forms which are sent to the regional *Drinking Water Officer* at the end of each month, to check for standard compliance.

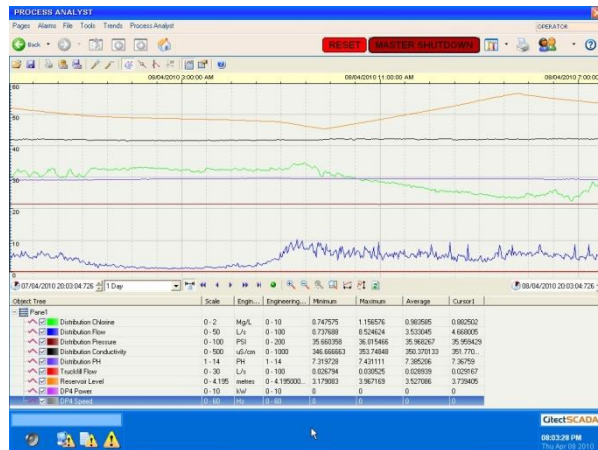
The WTP is monitored continuously by the computer system; it is continuously taking readings from 85 different locations by sensors, probes and meters. This information is displayed in real-time on a different number of screens (*see Figure A, B, C which show three different computer screens*) and is also recorded and compiled in the form of a trend. These trends can be accessed at any time and show a history of plant operation in various areas (*see Figure D for an example of a trend screen*).

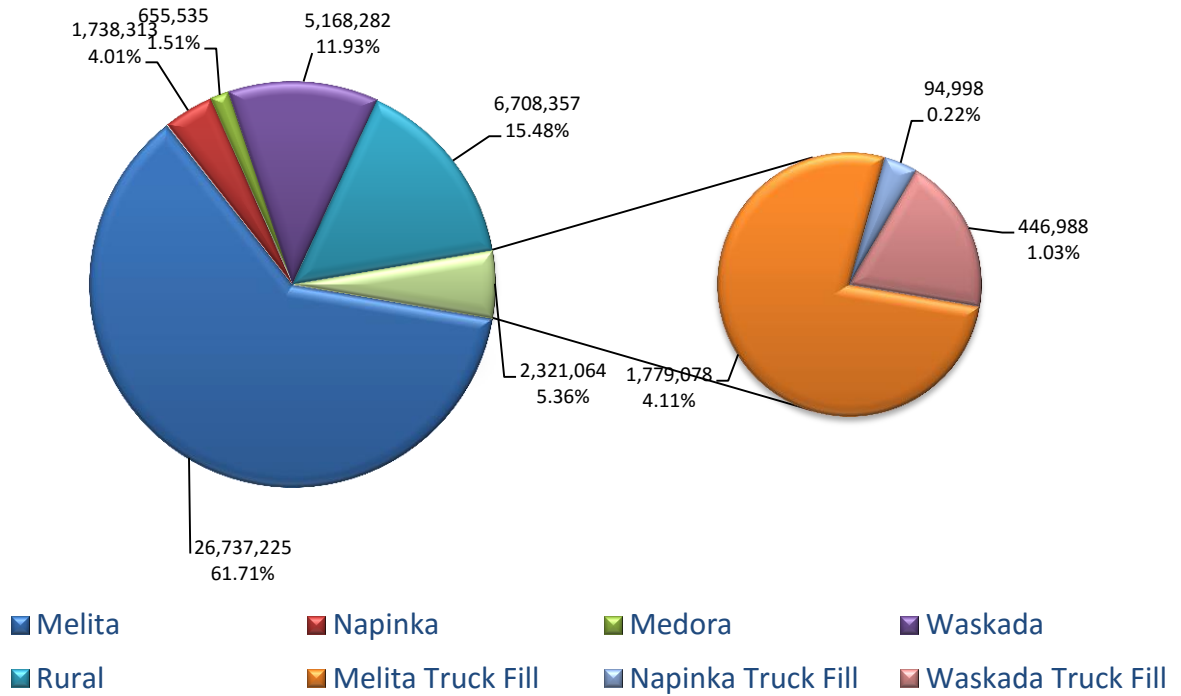
2015 Usage Chart in Imperial Gallons

The treatment system capacity was designed to meet a 20 year future demand for Melita as well as additional capacity for the rural water system. Although that has proven to be incorrect and will be revised accordingly as after only 4 years several upgrades have already taken place and more scheduled in the near future. The water system production and usage are summarized in the following charts in **Appendix “A” – Usage Charts**.
