Public Water System Annual Report

Southwest Regional Water Treatment Plant & Southwest Regional Water Co-op
2016

Date Prepared: 2/16/2017

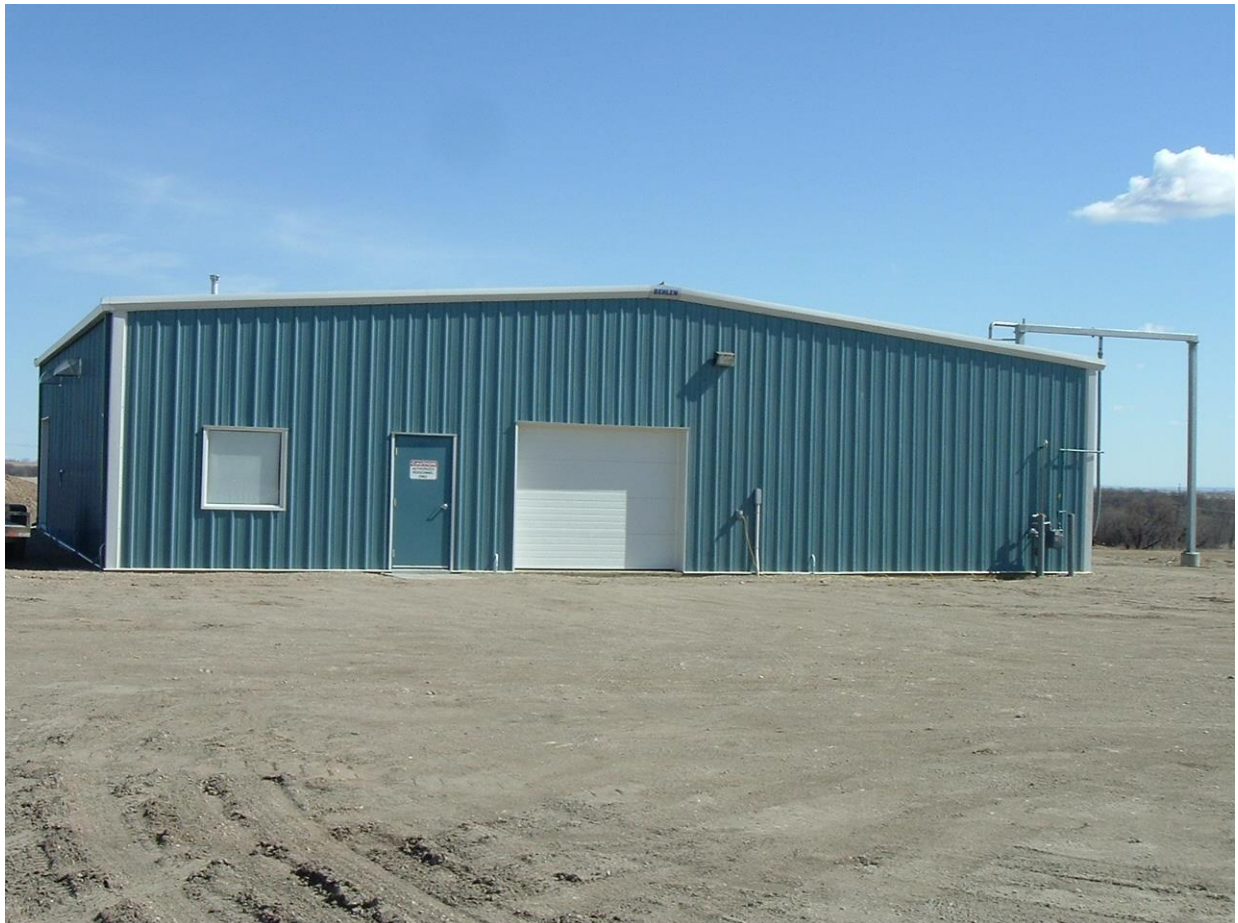
The Melita Water Treatment Plant

The Southwest Regional Water Co-op Public Water System (PWS) provides safe potable drinking water to the residents of Melita, Two Borders, Brenda, Napinka, Medora and Waskada through the distribution systems and to other rural residents by means of the Truck Fill System at the Water Treatment Plant (WTP). Treated water produced from the WTP meets or exceeds all health and aesthetic objectives as stated in the *Guidelines for Canadian Drinking Water Quality*.

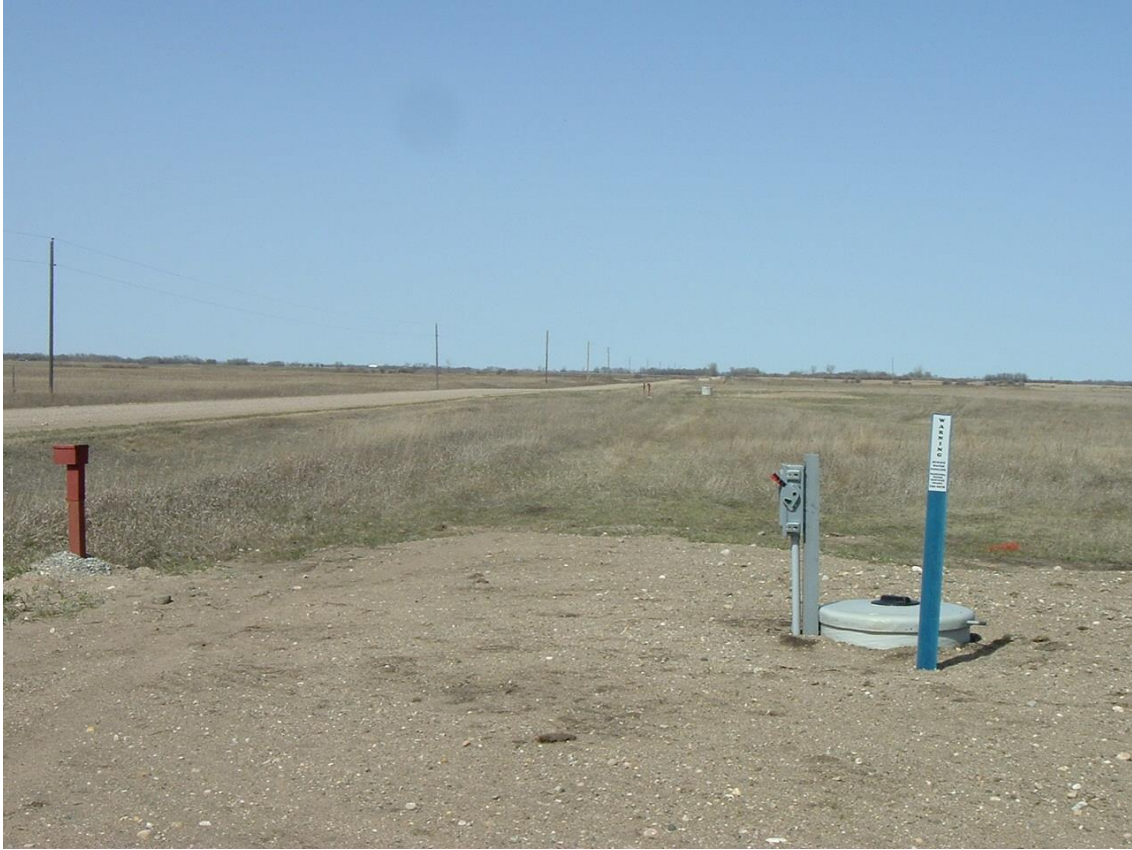
Recharge Wells

Test drilling activities in 2009 revealed at least three separate basins in close proximity to the well field. The basins are referred to as the south, middle, and north basins whereby the production wells are located in the south basin. In addition, the Broomhill truck loader station is also located in the south basin. Due to the water table drop, the pump in the truck fill had to be lowered to maintain its operation. Recharge infrastructure include a 760 mm (30 inch) well was installed in both the middle and north basin. A 75-mm pipe line was installed from the middle basin well to the south production well. This would allow groundwater from the middle basin to be pumped to the production well site and artificially recharge the south basin. However, due to Manitoba Hydro power restrictions, this well can only be pumped while the production well is not in operation. The WTP generally requires water for about 13 hours a day on average for 2012, such that the middle basin is pumping only when needed. When recharging is required the pump is turned on and runs continually until water levels are back up to an acceptable level and then turned off until needed. Pumping groundwater from the middle basin to the south basin commenced on August 26th, 2009 on an as needed basis and wasn't used in 2010 and since then only as needed.

Since the middle basin could only be pumped intermittently, the north basin well was temporarily equipped with a pump, generator, and overland pipeline to speed up the water table recovery. Pumping from this basin occurred from September 3rd to September 21st until water levels significantly recovered and the north basin water table prevented further pumping. The water table in the north basin has since recovered. In 2012 the north basin was converted to a supplemental well to improve operating pressures and flows to the plant when it is in operation.

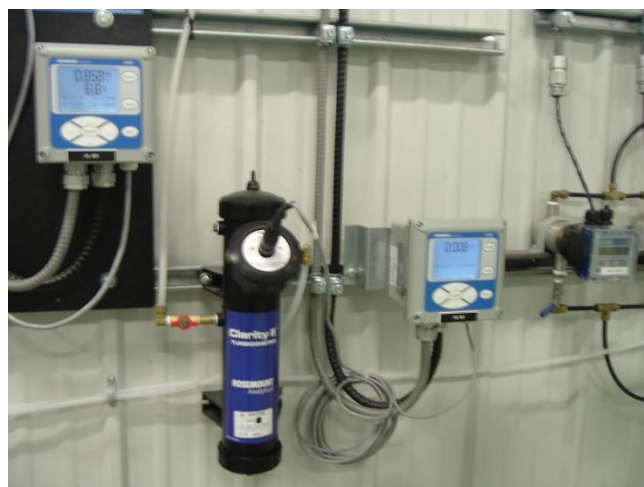
Online Monitoring Equipment

the chlorinators, as well there are two spare chlorinator pumps kept at the plant. Disinfection residuals are monitored continuously by an online monitor that monitors the water continuously as it leaves the WTP. We also monitor the residuals daily at the WTP and in the distribution system; these tests are performed at the WTP after the samples are collected. The results of all tests are recorded on our records at the WTP as well as Monthly Chlorination Report forms which are sent to the regional *Drinking Water Officer* at the end of each month, to check for standard compliance.

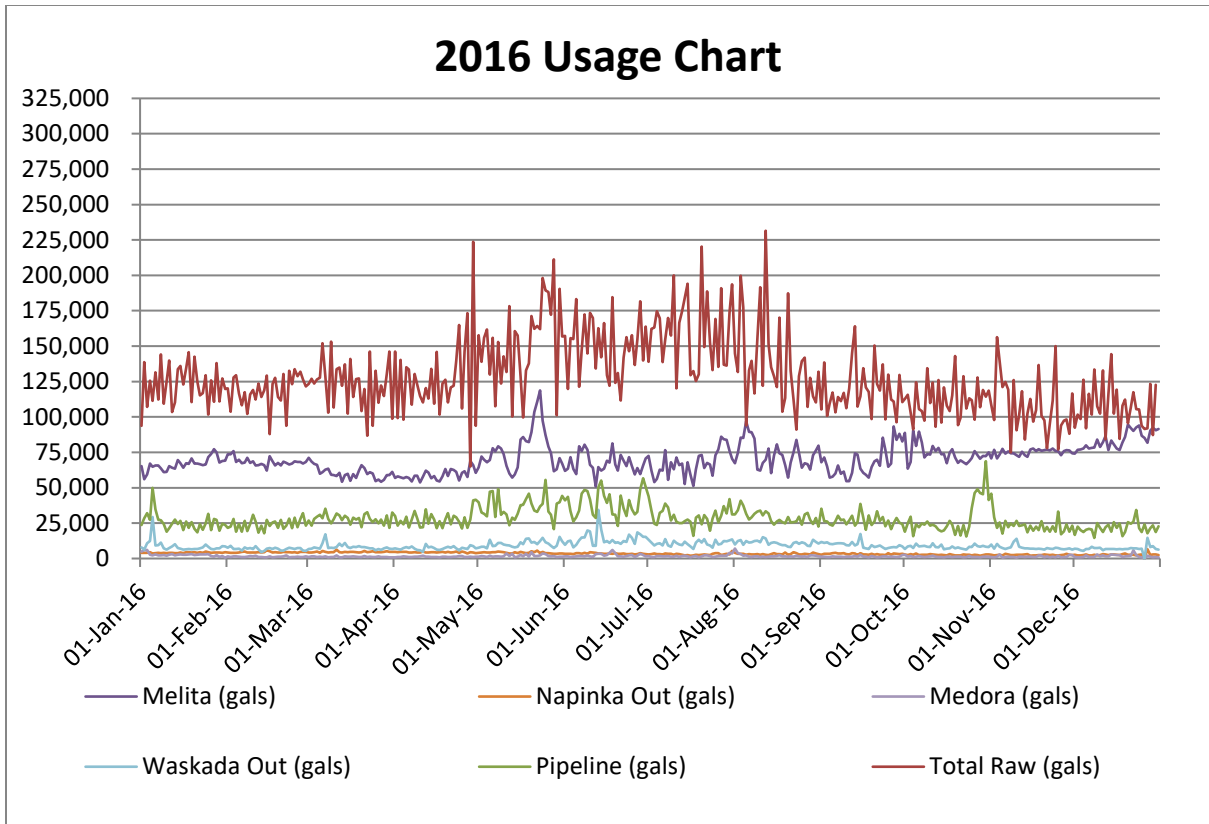
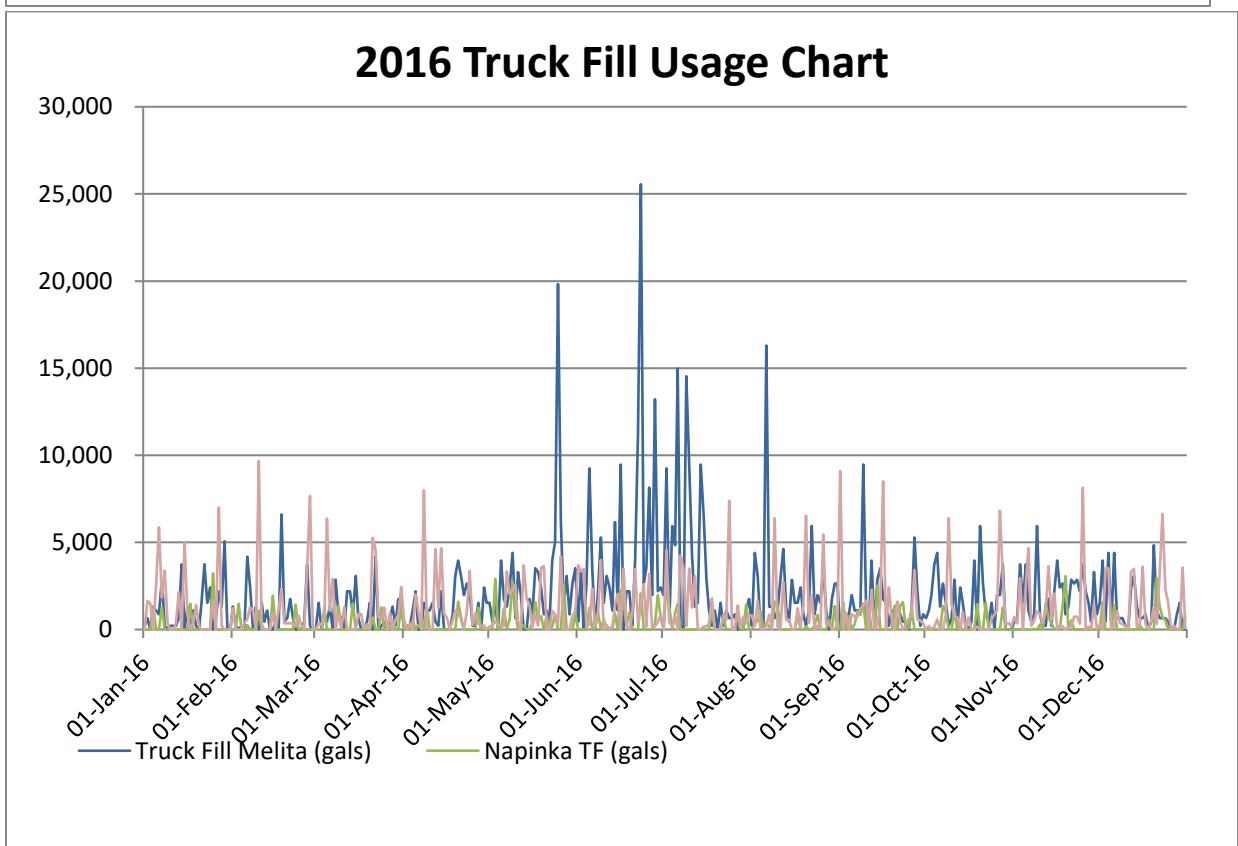
2016 Usage Chart in Imperial Gallons

The treatment system capacity was designed to meet a 20-year future demand for Melita as well as additional capacity for the rural water system. Although that has proven to be incorrect and will be revised accordingly as after only 4 years several upgrades have already taken place and more scheduled in the near future. The water system production and usage are summarized in the following charts in **Appendix “A” – Usage Charts**.
