# Public Water System Annual Report

Southwest Regional Water Treatment Plant & Southwest Regional Water Co-op  
2017

Date Prepared: 3/28/2018

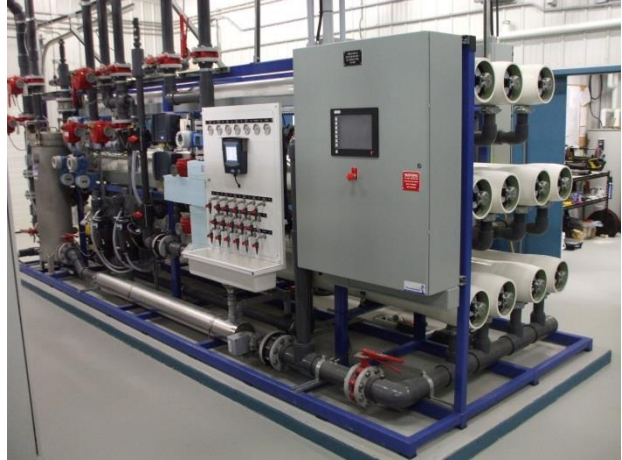
The North RO (new)

Raw water is pumped to the WTP where approximately 90% of the flow is directed through reverse osmosis membranes. The remaining 10% by-passes through a sand-filter with 3 new UV (ultraviolet) units prior to blending with membrane permeate. Blended flow is chlorinated with sodium hypochlorite and then stored in a 1,000,000-litre concrete reservoir for distribution. Since membranes remove most dissolved minerals, blending permeate with filter water allows the operation to produce treated water with a more desirable hardness and PH. Approximately 13% of membrane flow (11% of the raw water) is discharged as membrane concentrate to the Souris River. Treated water is distributed to the Co-op and a bulk water (truck) fill is available for rural usage. In the spring of 2014 the second RO unit and filter came online doubling the production capacity of the plant.

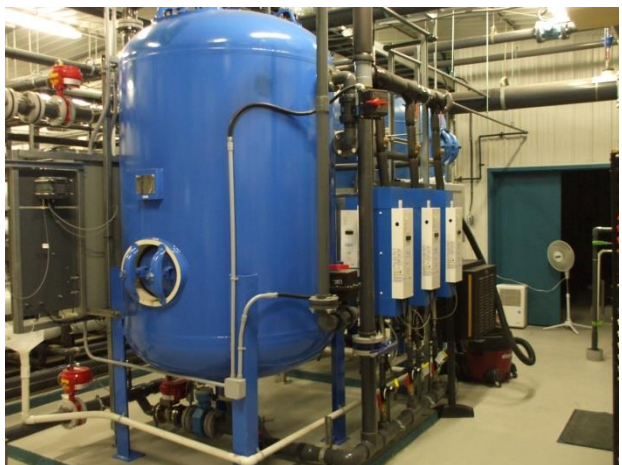
The New Sand Filter with UV

The Melita WTP disinfects by adding a 12% sodium hypochlorite solution to the water via 4 chlorinator pumps. One for the raw water before it enters each sand-filter (pre-treatment) and two for the blended water before it enters the reservoir. In 2012 three UV units were added after the filter. In 2014 three more UV units were added after the second filter.

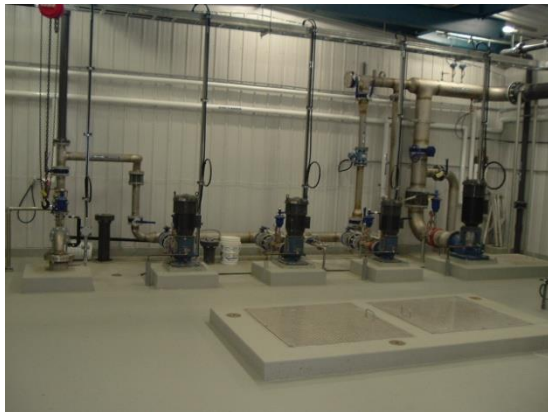
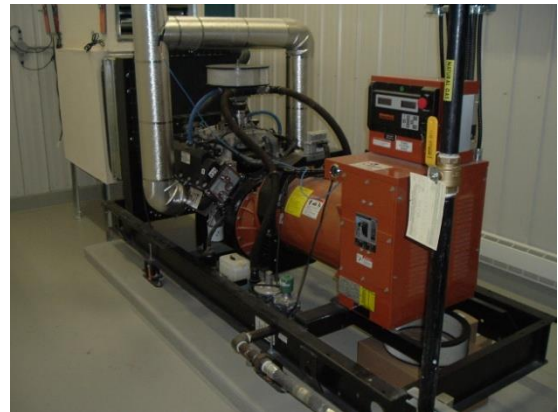
The Generator

Treated water from the reservoir, located underneath the WTP, is pumped throughout the Melita distribution system via two 7.5 horsepower duty pumps, with one 30 horsepower emergency standby pump for firefighting purposes. The SWRWC has one 7.5 horsepower duty pump and a new 2 horsepower jockey pump which was installed in the spring of 2017. The SWRWC distribution system consists primarily of High Density Polyethylene Pipe. In 2017 the rural system was expanded to take in another 71 homes and another 150 km of pipe was installed, the raw, 10" and 8" didn't increase but the rest did. 12 miles of 8" raw water supply line, the distribution consists of the following 11 miles of 10", 5 miles of 8", 19 miles of 6", 30 miles of 4", 68 miles of 3", 49 miles of 2", for a total of 182 miles of pipe in the ground. A map of the distribution system pre-expansion is on the next page, a current map is not yet available. The Waskada Rural Water Co-op already had several miles of pipe in place but is now part of the overall distribution system. The WTP also has a natural gas powered generator located in the building that powers the distribution pumps during times of a power failure.

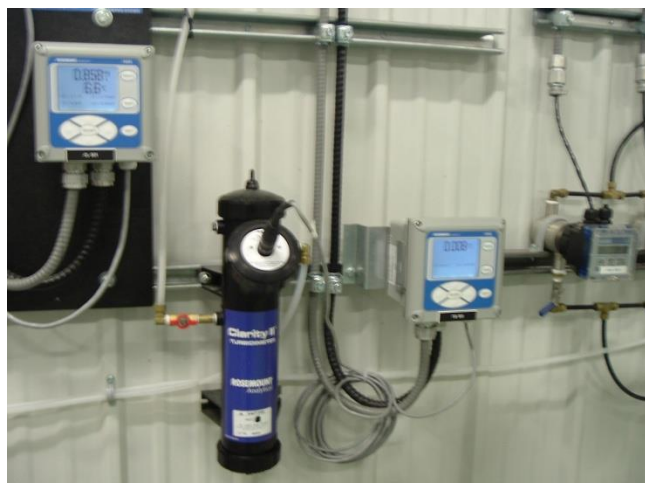
Online Monitoring Equipment

the chlorinators, as well there are two spare chlorinator pumps kept at the plant. Disinfection residuals are monitored continuously by an online monitor that monitors the water continuously as it leaves the WTP. We also monitor the residuals daily at the WTP and in the distribution system; these tests are performed at the WTP after the samples are collected. The results of all tests are recorded on our records at the WTP as well as Monthly Chlorination Report forms which are sent to the regional *Drinking Water Officer* at the end of each month, to check for standard compliance.
