Public Water System Annual Report

Southwest Regional Water Treatment Plant & Southwest Regional Water Co-op
2019

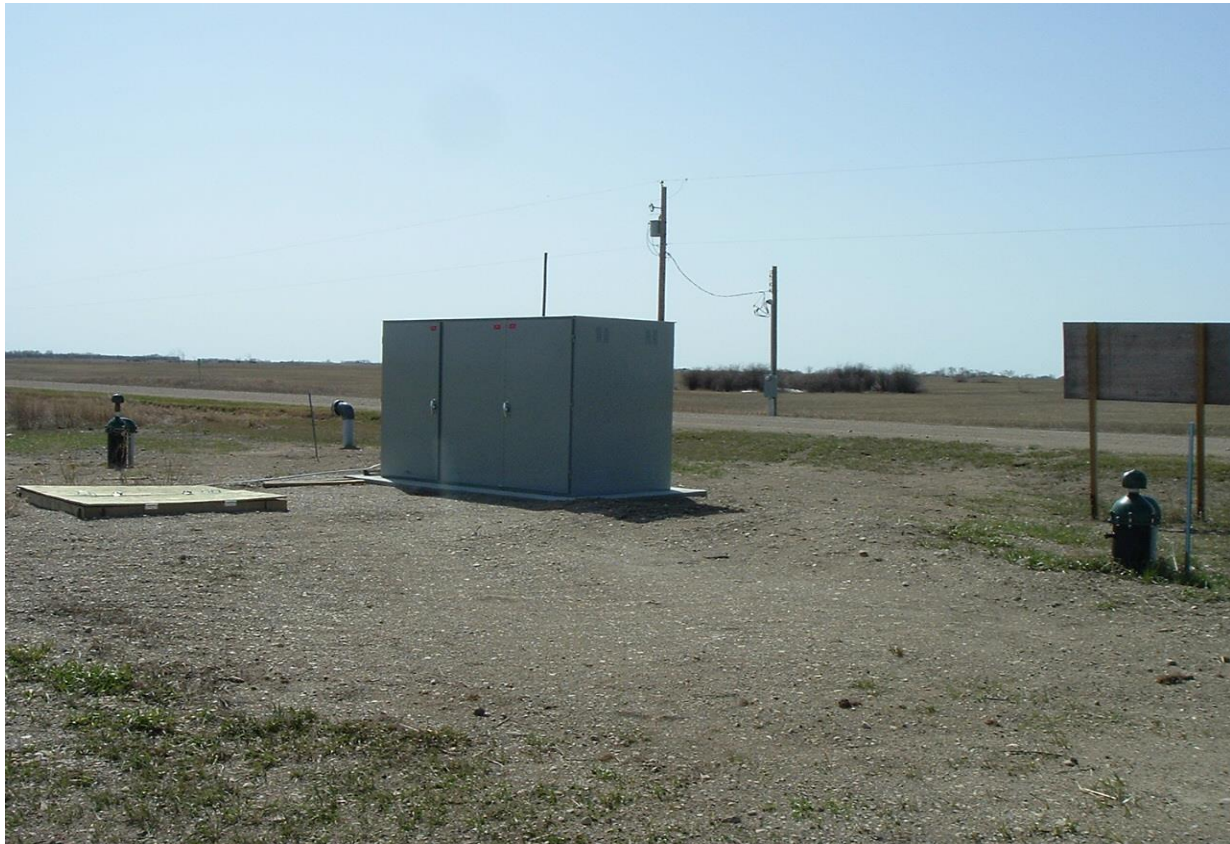
Well Site 1

The WTP receives groundwater from four wells located at 16 km North East of Melita @ NW23-5-27W. The wells draw groundwater from the Oak Lake Aquifer. The wells were drilled to a depth of 33 feet. Raw water pumped from the wells into a 200 mm (8 inch) pipeline where it flows directly into the WTP for processing and treatment.

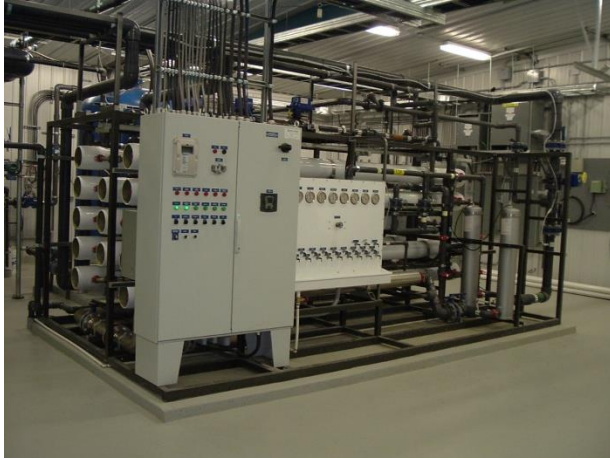
The South RO (original unit)

Raw water is pumped to the WTP where approximately 90% of the flow is directed through reverse osmosis membranes. The remaining 10% by-passes through a sand-filter with 3 new UV (ultraviolet) units prior to blending with membrane permeate. Blended flow is chlorinated with sodium hypochlorite and then stored in a 1,000,000-litre concrete reservoir for distribution. Since membranes remove most dissolved minerals, blending permeate with filter water allows the operation to produce treated water with a more desirable hardness and PH. Approximately 13% of membrane flow (11% of the raw water) is discharged as membrane concentrate to the Souris River. Treated water is distributed to the Co-op and a bulk water (truck) fill is available for rural usage. In the spring of 2014 the second RO unit and filter came online doubling the production capacity of the plant.

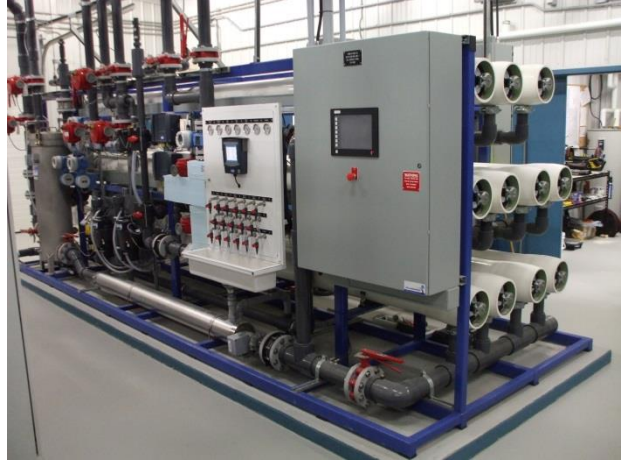
The North RO (new)

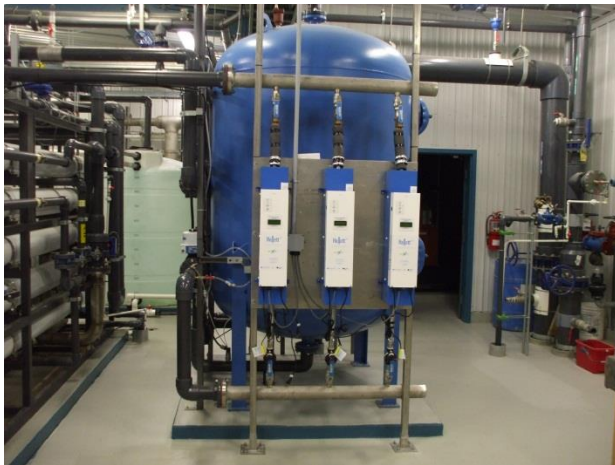
The Original Sand Filter with UV upgrade

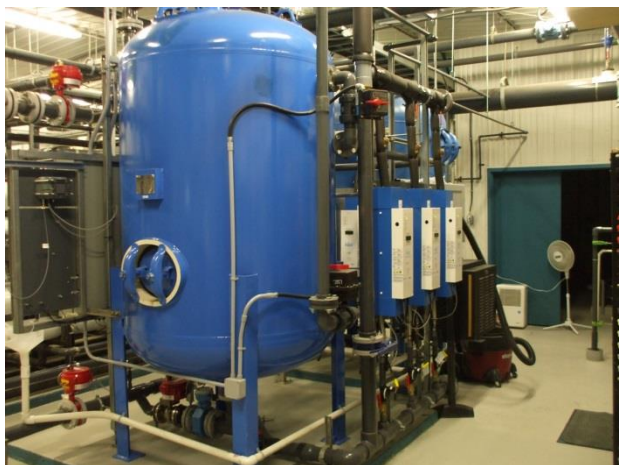
The New Sand Filter with UV

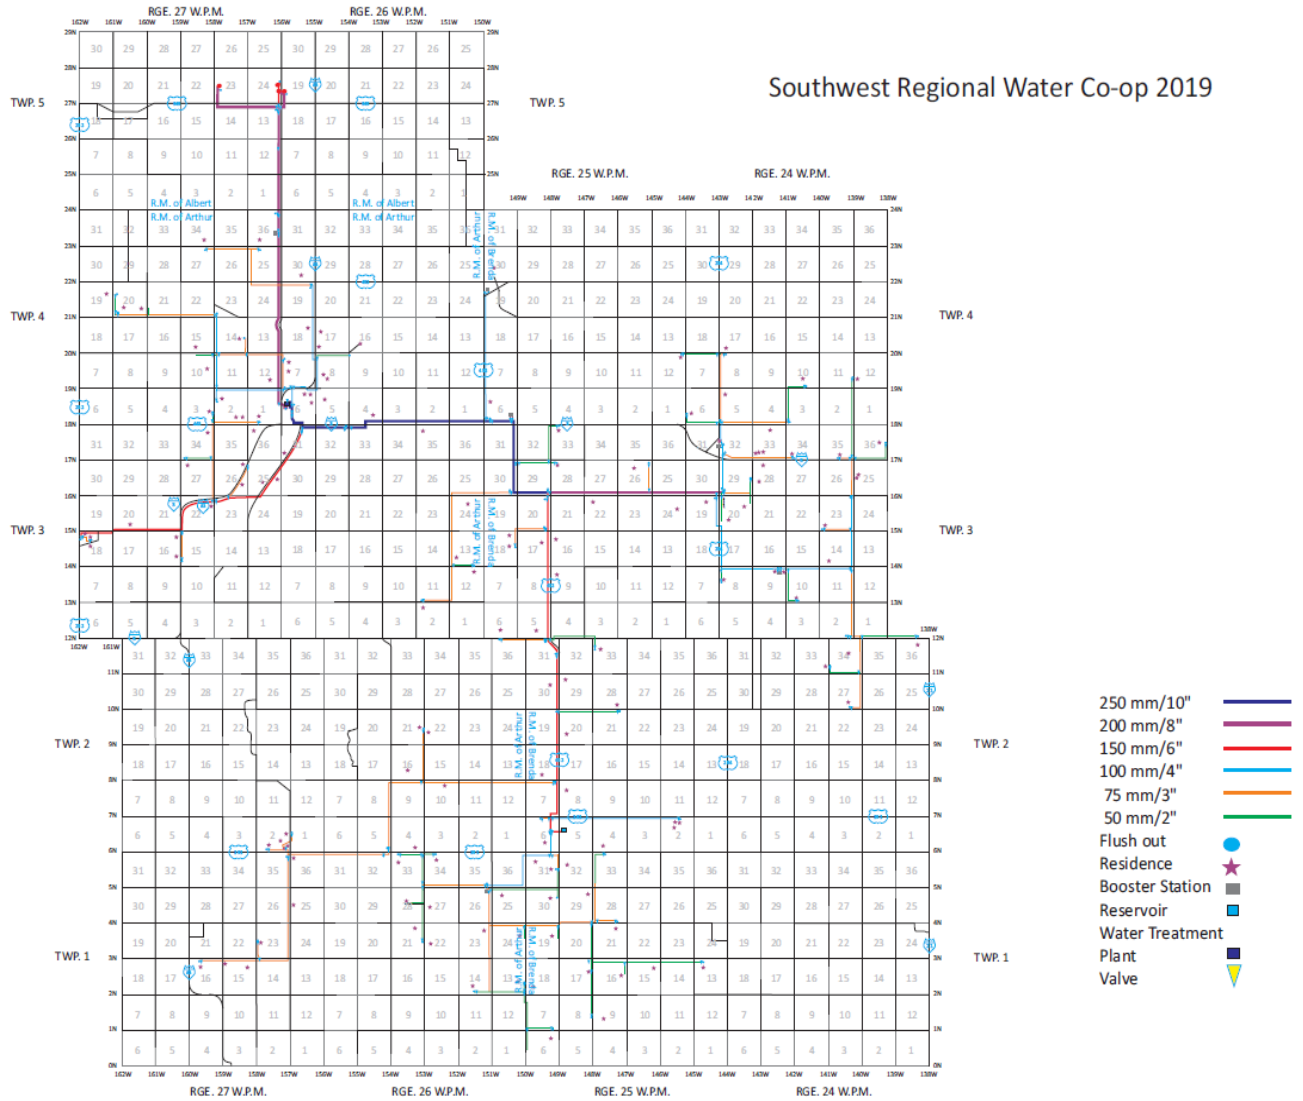
The Distribution Pumps

Treated water from the reservoir, located underneath the WTP, is pumped throughout the Melita distribution system via two 7.5 horsepower duty pumps, with one 30 horsepower emergency standby pump for firefighting purposes. The SWRWC has one 7.5 horsepower duty pump and a new 2 horsepower jockey pump which was installed in the spring of 2017. The SWRWC distribution system consists primarily of High Density Polyethylene Pipe. In 2017 the rural system was expanded to take in another 71 homes and another 150 km of pipe was installed, the raw, 10" and 8" didn't increase but the rest did. 12 miles of 8" raw water supply line, the distribution consists of the following 11 miles of 10", 5 miles of 8", 19 miles of 6", 30 miles of 4", 68 miles of 3", 49 miles of 2", for a total of 182 miles of pipe in the ground. A map of the distribution system pre-expansion is on the next page, a current map is not yet available. The Waskada Rural Water Co-op already had several miles of pipe in place but is now part of the overall distribution system. The WTP also has a natural gas powered generator located in the building that powers the distribution pumps during times of a power failure.

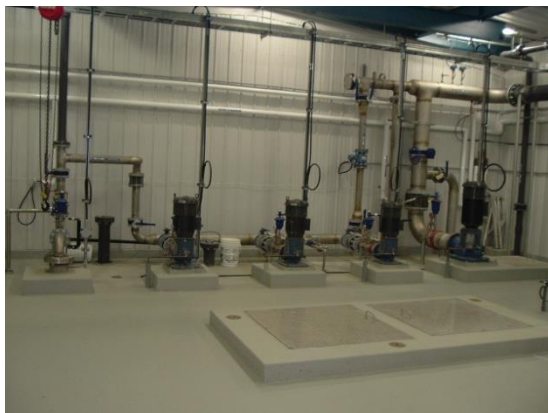
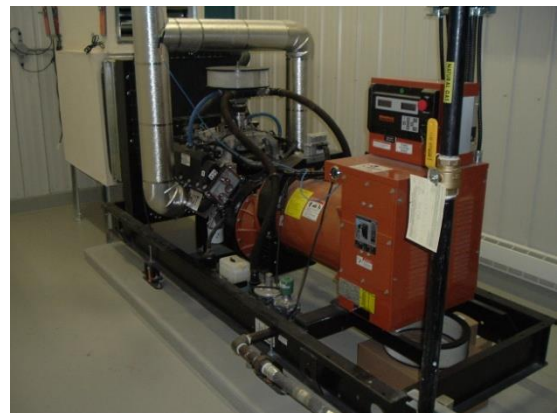
The Generator

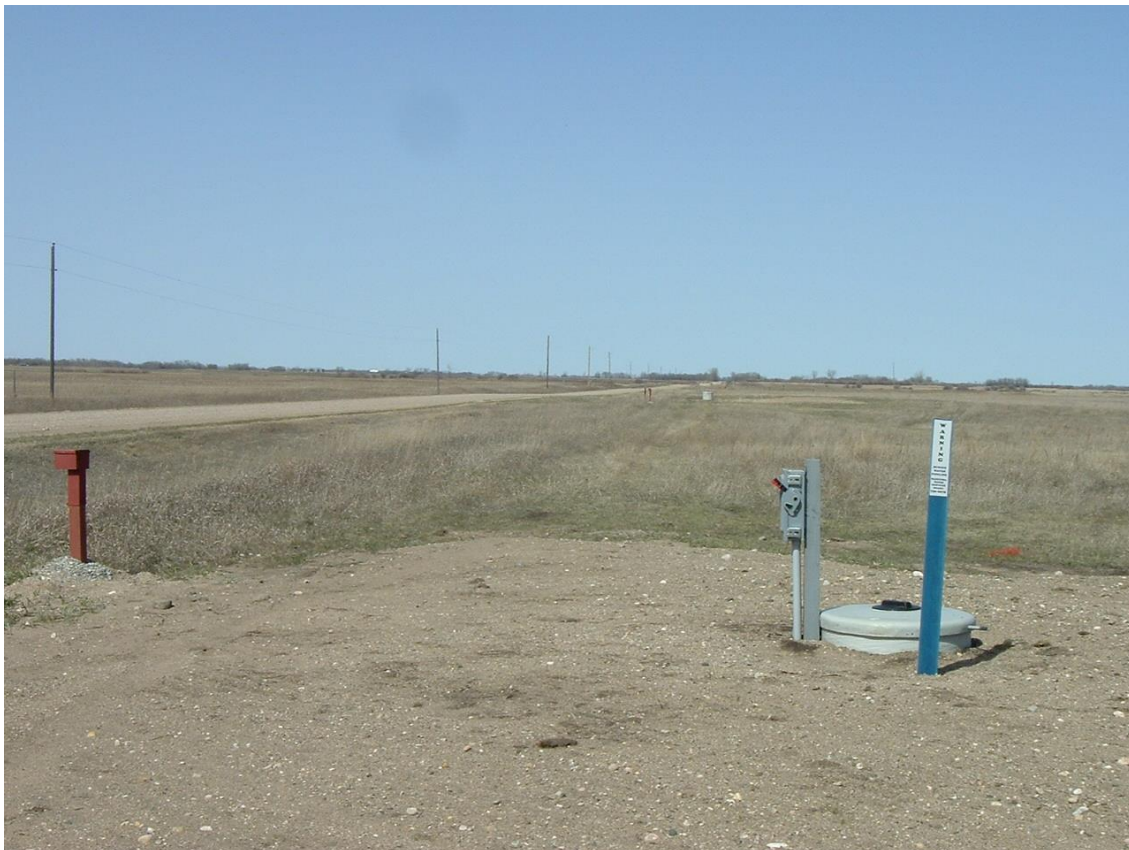
Recharge Wells

Since the middle basin could only be pumped intermittently, the north basin well was temporarily equipped with a pump, generator, and overland pipeline to speed up the water table recovery. Pumping from this basin occurred from September 3rd to September 21st until water levels significantly recovered and the north basin water table prevented further pumping. The water table in the north basin has since recovered. In 2012 the north basin was converted to a supplemental well to improve operating pressures and flows to the plant when it is in operation.

Since fall of 2017 we have not had to recharge the east site because we stopped pulling water from these wells and now only pull from the new ones at the East site.

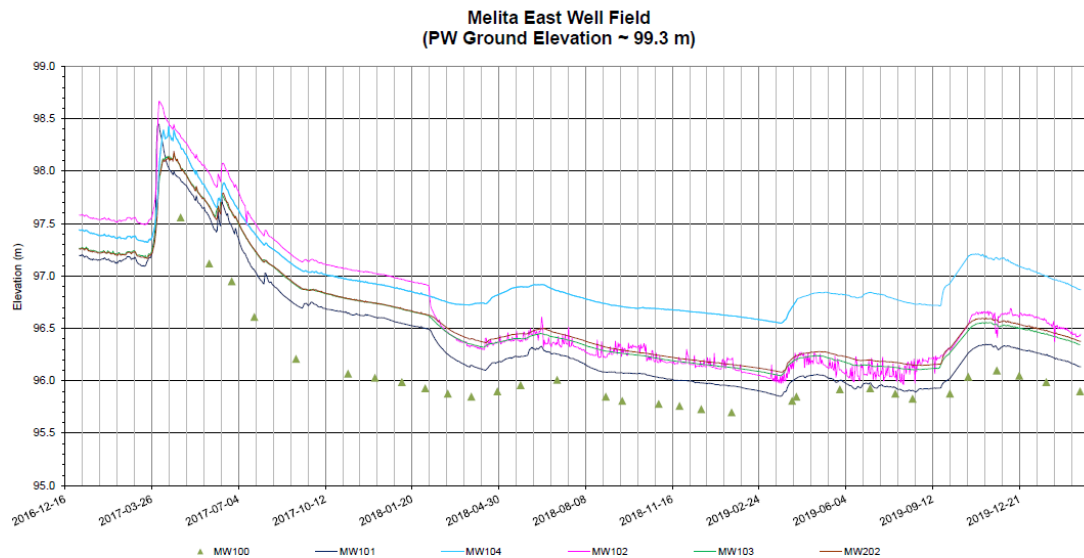
The locations of all monitoring wells are shown in the appendices. 5" MW represents the water table depth near the production well, while MWa and MWb represent the water table depth in the middle and north basins.

The updated graph on page 11 shows ground water levels at various points at and around the new wells.

Groundwater monitoring commenced in July 2009. As many as four pressure transducers were initially set-up and currently three pressure transducers are continuous and manual readings. This graph uses a benchmark of 100.00 m in order to compare levels in each the three basins.

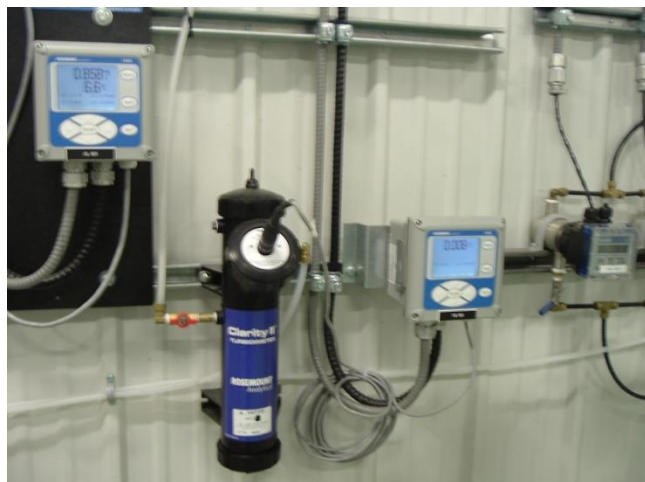
Online Turbidity Monitoring Equipment

As required by the *Drinking Water Safety Act* the Melita PWS ensures continuous disinfection is maintained at the WTP by keeping in stock all spare parts required for the chlorinators, as well there are two spare chlorinator pumps kept at the plant. Disinfection residuals are monitored continuously by an online monitor that monitors the water continuously as it leaves the WTP. We also monitor the residuals daily at the WTP and in the distribution system; these tests are performed at the WTP after the samples are collected. The results of all tests are recorded on our records at the WTP as well as Monthly Chlorination and UV Report forms which are sent to the regional *Drinking Water Officer* at the end of each month, to check for standard compliance.

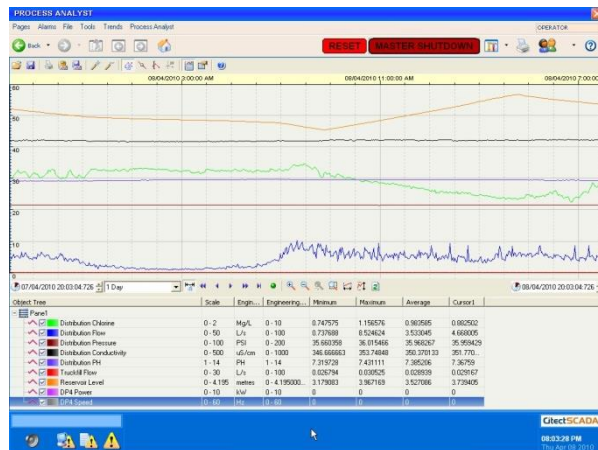
The WTP is monitored continuously by the computer system; it is continuously taking readings from 85 different locations by sensors, probes, and meters. This information is displayed in real-time on a different number of screens (see Figure A, B, C which show three different computer screens) and is also recorded and compiled in the form of a trend. These trends can be accessed at any time and show a history of plant operation in various areas (see Figure D for an example of a trend screen).

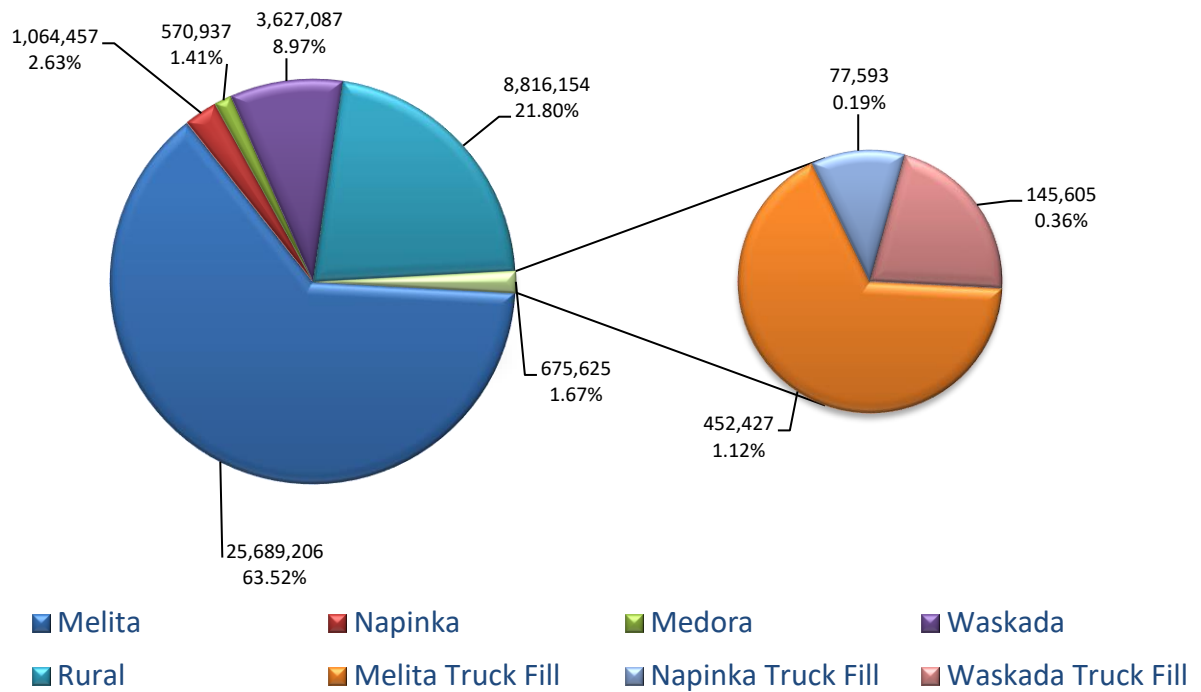
2019 Usage Chart in Imperial Gallons

The treatment system capacity was designed to meet a 20-year future demand for Melita as well as additional capacity for the rural water system. The water system production and usage are summarized in the following charts in ***Appendix "A" – Usage Charts.***

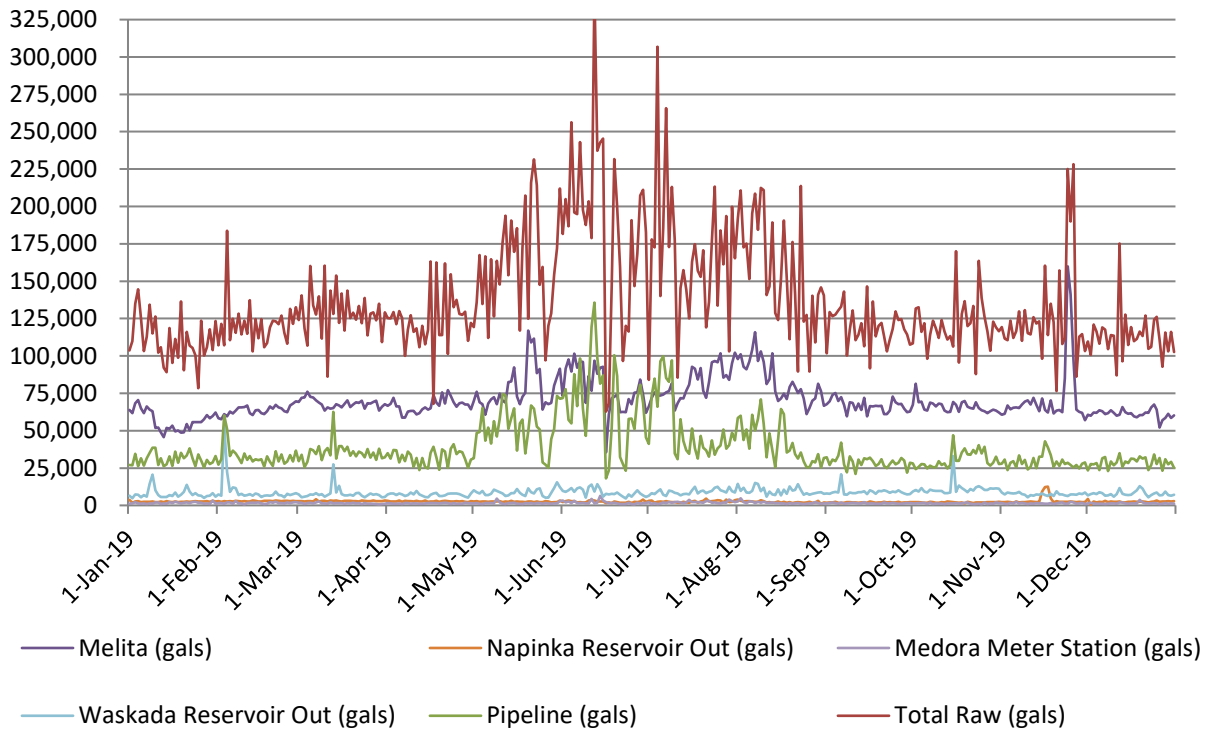
2019 Usage Chart

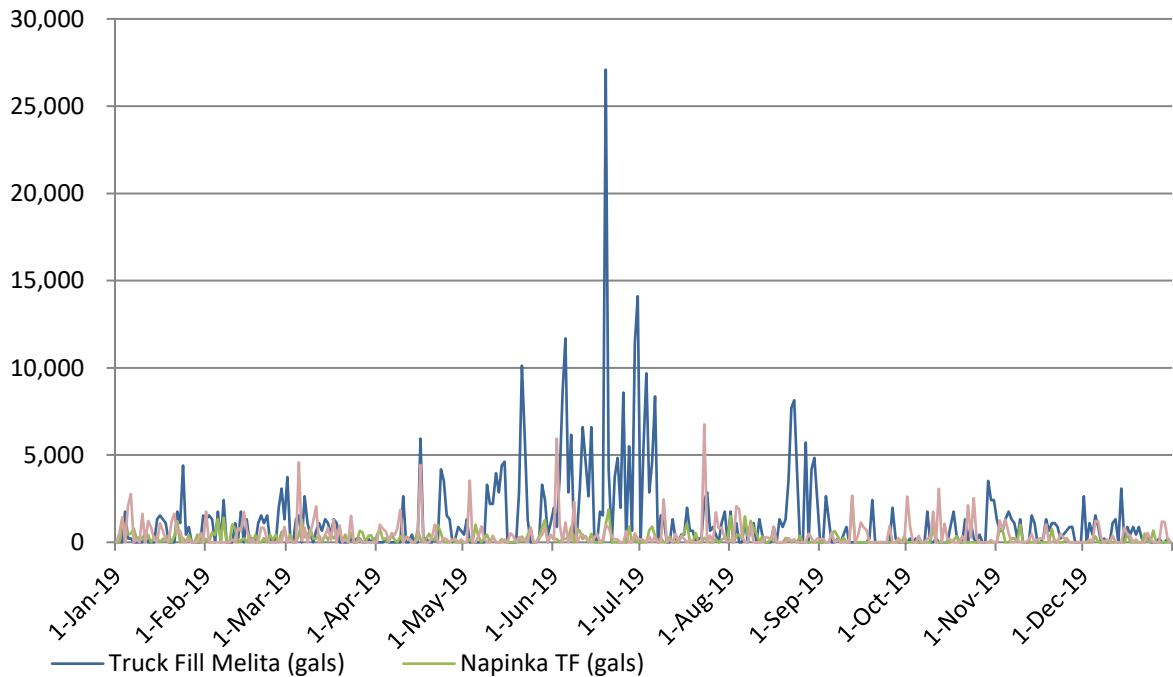
2019 Truck Fill Usage Chart
