California Citrus 2013 Freeze under competitor's wind machines. Notice the upper elevation is green, which means there was warm air above, but lower elevation with a competitors wind machines, the trees are frozen and dead and crispy. Not long after the picture was taken this block was valued at a total loss and removed.

California Citrus Freeze 2013-Chinook wind machines. Across the road from the top pictures where the trees are dead. Crop was harvested and the trees had no damage. ALL GREEN.

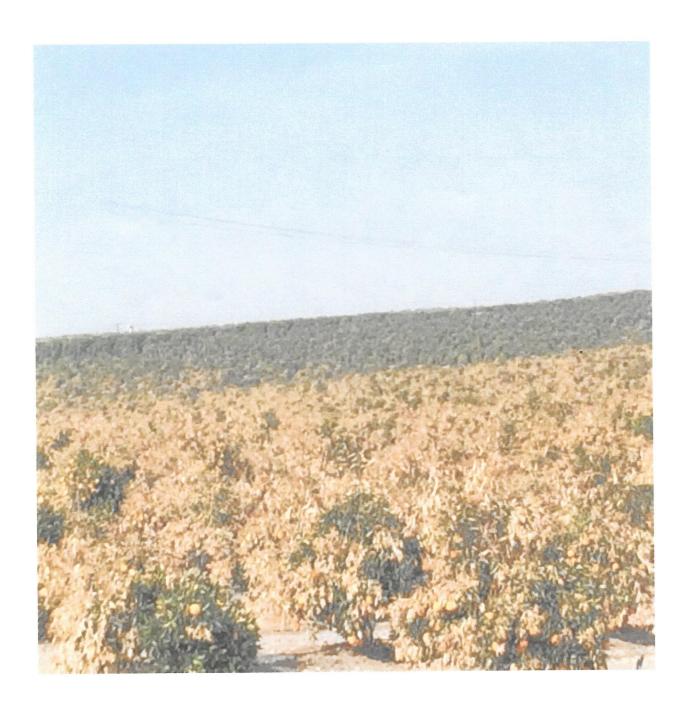
California 2013 freeze, same orchard with another shot of the green trees up the hill and on top where it shows there was warm air and clearly shows dead trees below. Grove was damaged enough that it was removed.

Was covered with competitor wind machines that were not bringing the warm air down and resulted major freeze damage.

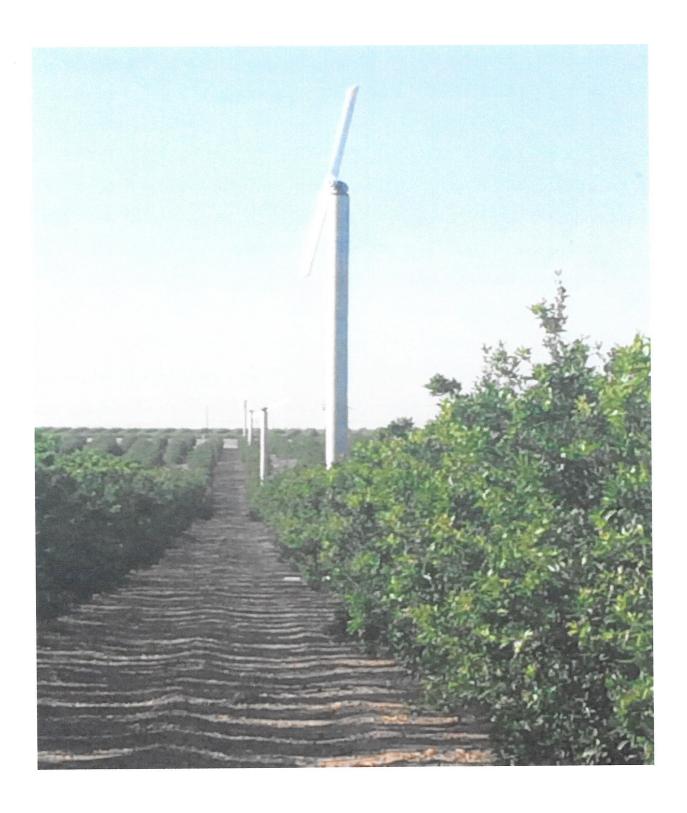
This picture in a different area of the same Citrus Orchard as above. Chinook fans during this major freeze kept the orchards from having freeze damage and green.

Event pulled more air from higher elevation to keep the orchard warmer and green. All blocks in the 2013 freeze with Chinook wind machines survived with green trees and harvested crops.

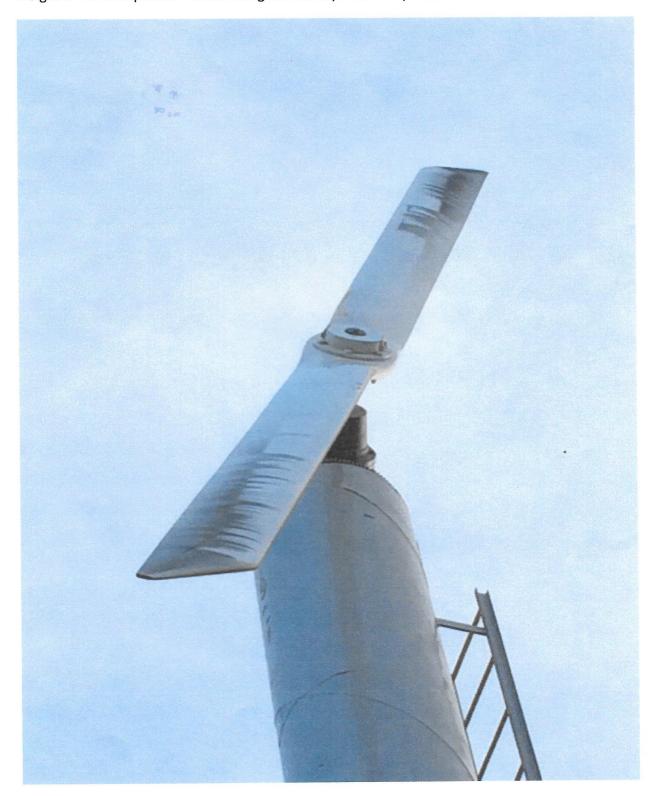
On our Chinook blade you can see that there is marking on the trailing edge marking nearly down to the center of the blade. The whole blade is moving air. Our blade is about ½ the weight of the competitor's blade using less horsepower to operate it.

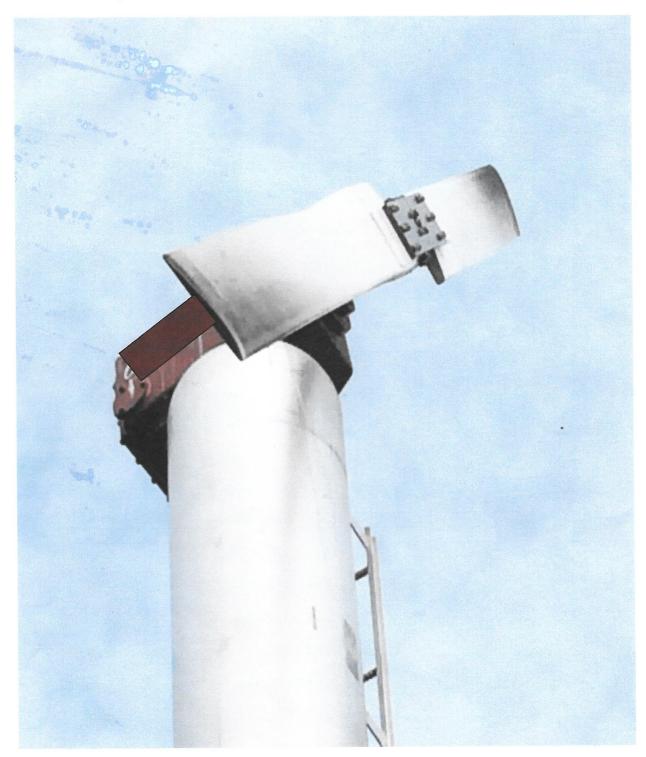
Competitor's Blade is easy to see that there is limited use of the blade. Heavy use on the tip for about 2 feet or so. That means that the rest of the blade is not moving much air or it would have trailing edge marking. No air movement near the towers and these blades are heavy and take extra horsepower to turn them resulting in a lot more fuel burn per hour.
