“ALL THAT HUMANITY COULD DESIRE...”

THOMAS, WEST VIRGINIA

Commerce in Thomas

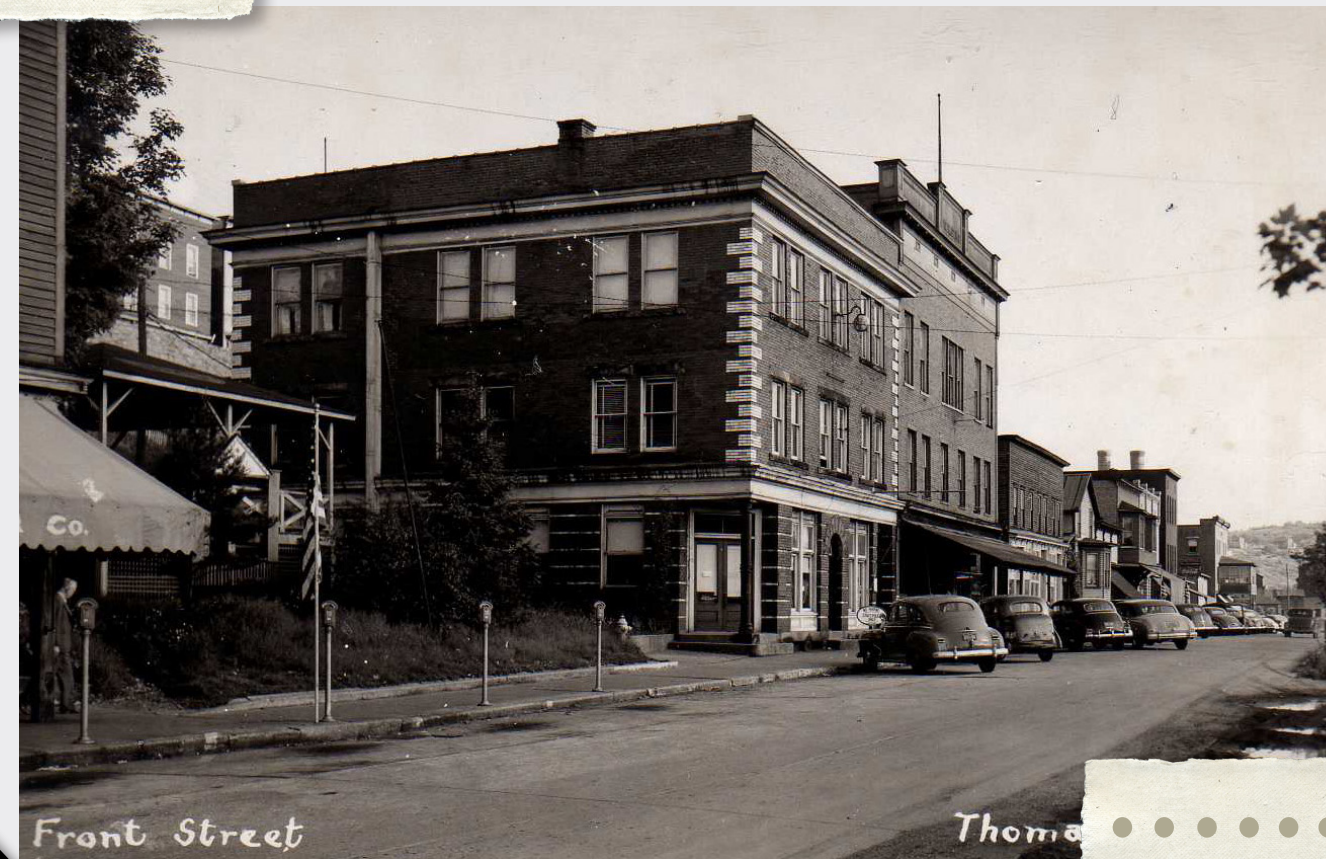
This view of the Miners and Merchants Bank (Tour No. 8) shows the building prior to modern alterations. Customers originally entered through the prominent corner (chamfered) doors. The Cooper Building next door also displays its parapet wall, sign plate and spire. (Courtesy Joseph Sagace)

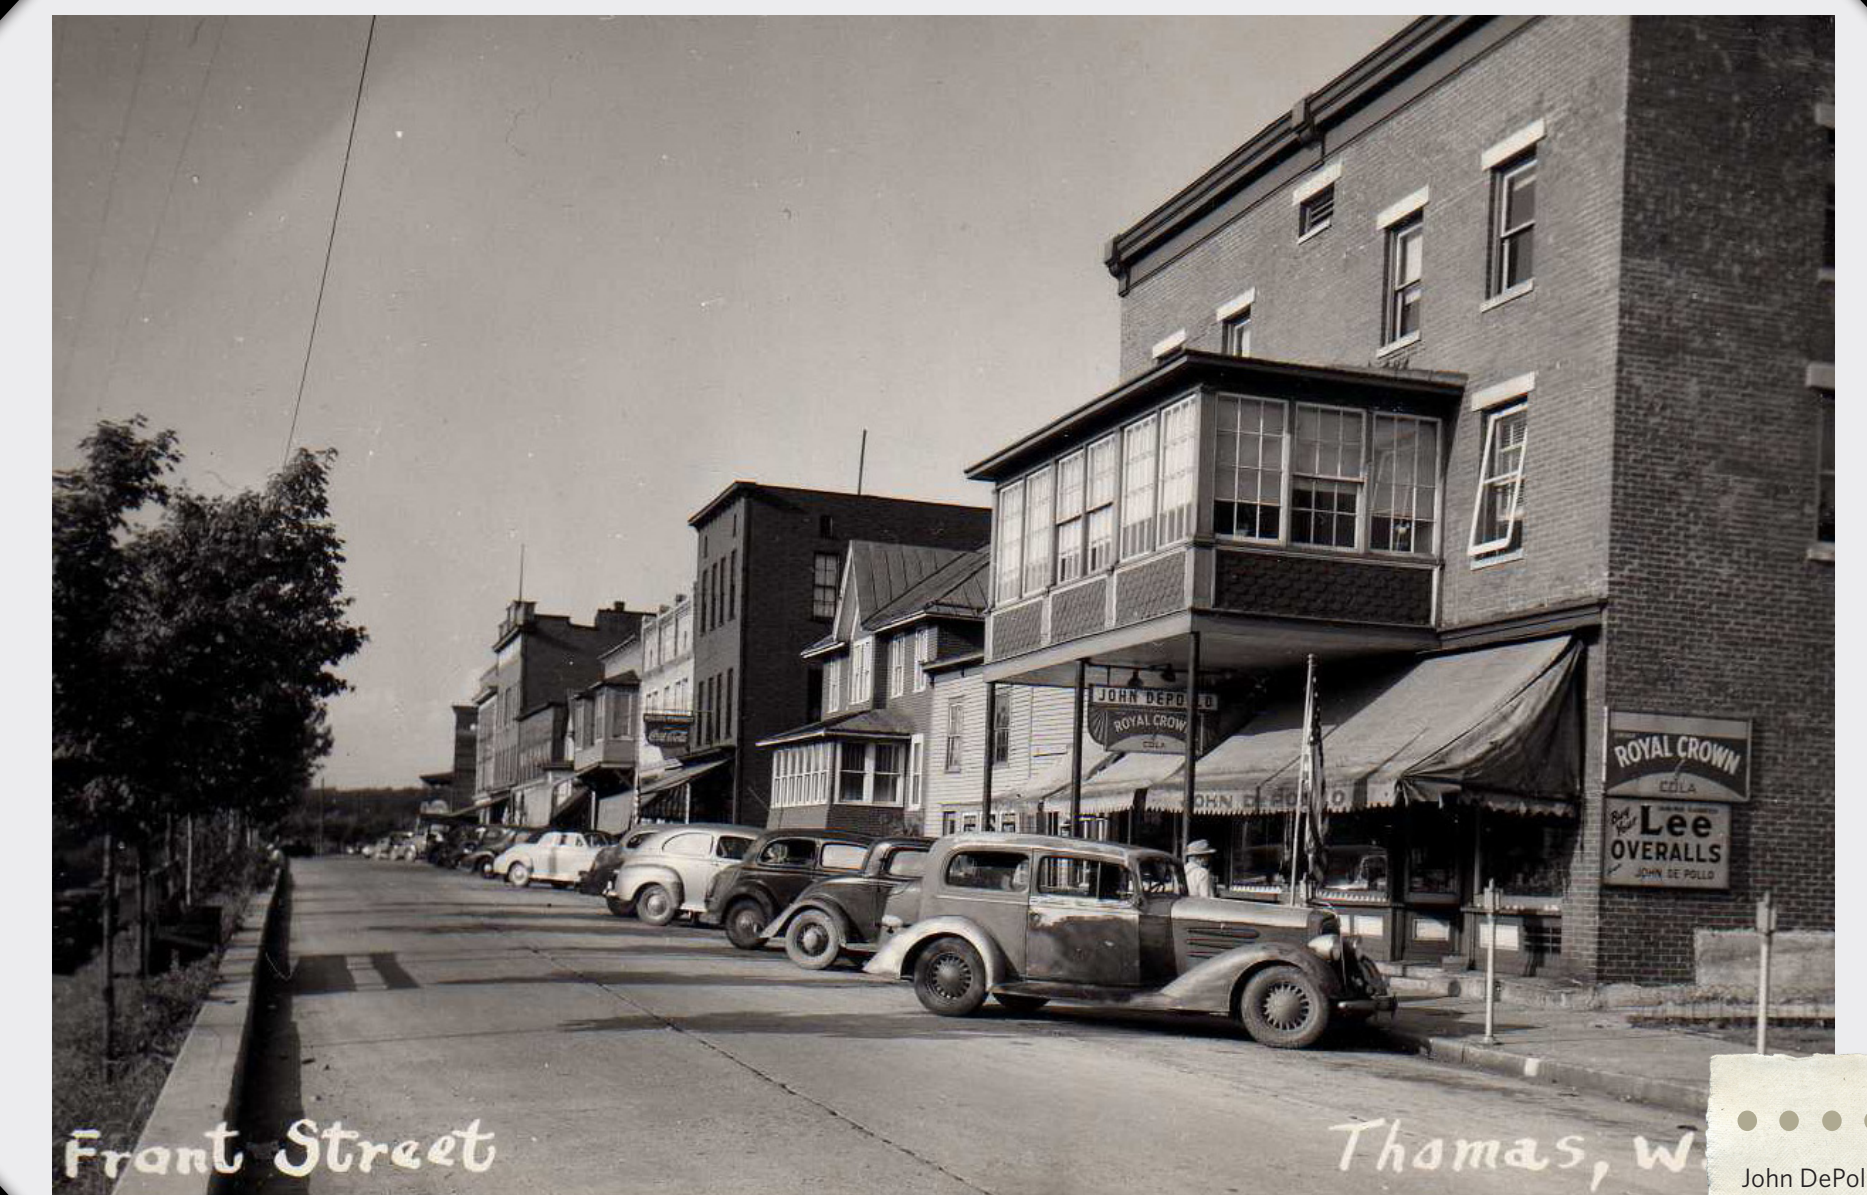
John DePollo's store (Tour No. 15) anchored the southern end of East Avenue, known locally as Front Street. Although ornamentation was kept to a minimum, the symmetry and mass of the building relays a message of organization and substance. For simple brick commercial buildings such as this, attractive and clear signage was key. (Courtesy Joseph Sagace)

Joseph DePollo immigrated to the United States from Italy in 1891. He was recruited in New York to come to Coketon as a worker for the Davis Coal and Coke Company. He visited his wife and 5 children in Italy every year until he could bring them back to Thomas around 1903, the same year he opened his general store on Front Street, which was a small wooden building. The present building (No. 15) was constructed in 1915-16 and the family of 10 lived on the upper floors. Joe's son John began working at age 14 as a delivery boy and went on to help his father manage the store. He became owner when his father died and tended the store for over 50 years, even as the coal industry faltered and the population declined. DePollo's store features expansive glass storefronts and plenty of shelves to display merchandise. The store also served as a kind of clubhouse, where men would gather for a beer and the latest news. The current roof over the sidewalk replaced the original overhanging enclosed porch which was supported on slender metal columns.
