## Replacement of Idler Bearings

## New and Improved Door Lock Control Unit

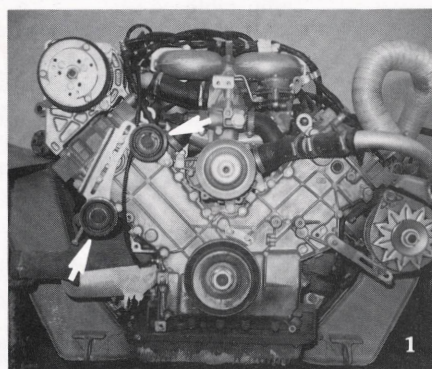
- 1) Access engine compartment.
- 2) Locate idler bearings below air conditioning compressor. (Photo 1)
- 3) Loosen pulley brackets by using ratchet socket and do not remove bracket.
- 4) Remove the air conditioning belt.
- 5) Take the open end 19 mm wrench and remove the nuts on the backside of pulley brackets. (Photo 2)
- 6) Lubricate bearings with penetrating oil to facilitate removal of pins. (Photo 3)

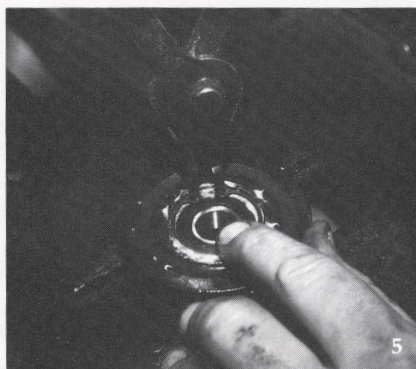
**CAUTION:** Wear protective safety glasses when removing and installing snaprings. Place snapping pliers in carefully with finger over one side and snapping over other, carefully remove snapping on both sides. (Photo 5)

11) Install one snapping to one side. Turn over and install new bearing inside center pulley and drive bearing carefully in with deep socket with same outside diameter as the outside diameter of bearing outer race. (Photos 5 & 9)
