How To: Side Mirror repair - is yours floppy?

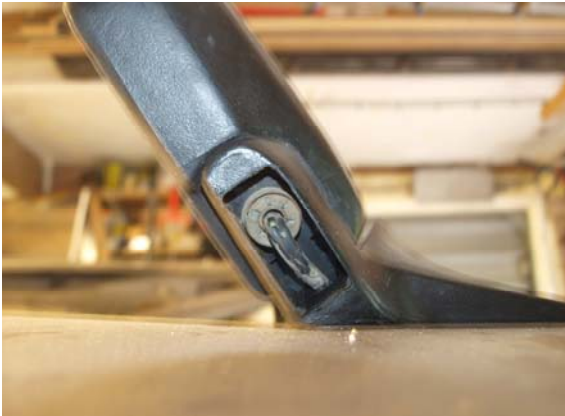
Undeneath the (floppy)mirror, is a plastic panel that I eased out using a blade.

This exposes the wires running through what I will call a "pivot tube".

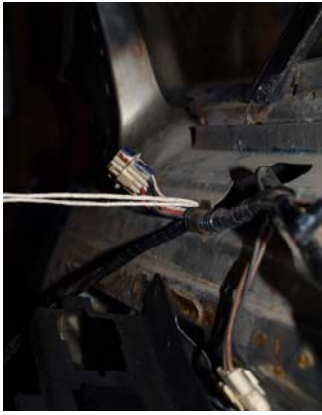
On removing the mirror body, tie some string around the wires going from the harness inside the door to the mirror motor contained in the mirror body. This will enable the wires to be easily pulled **back** through the door when the mirror body is re attached to the door after the repair. (See next picture.)

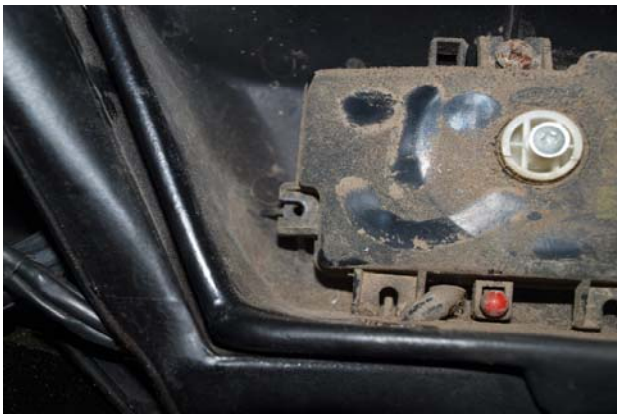
As you can see from the picture below, my mirror body was full of Dubai Sand !!!

The Mirror backing plate is attached to the motor via a central screw that screws into the white flange shown in my earlier "Dubai Sand" photo

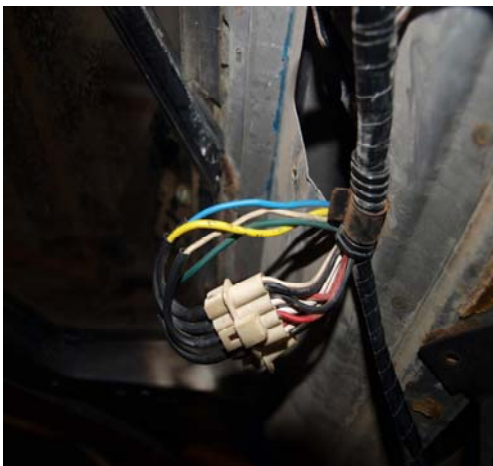
The loom o the mirror (the wires that run through the pivot tube) is uncoupled within the recesses of the

door. Via a male/female multisocket – used in many applications on the DeLorean.

As you can see from the above, quite clearly mine did not have the Male connector, the pins were just pushed into the female socket!!!!

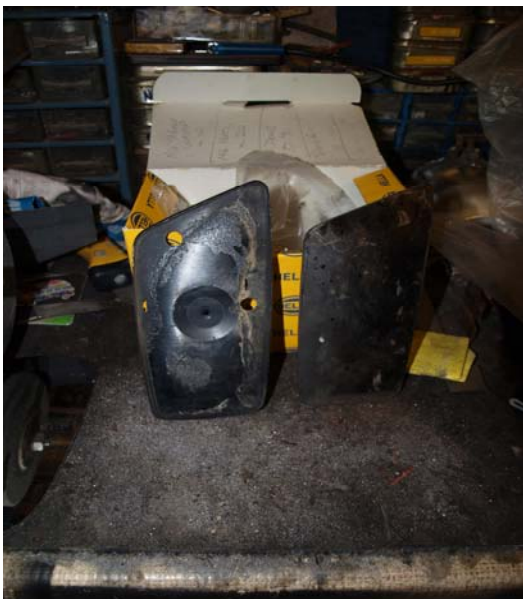
Below is a picture of the glass removed alongside the backing plate.

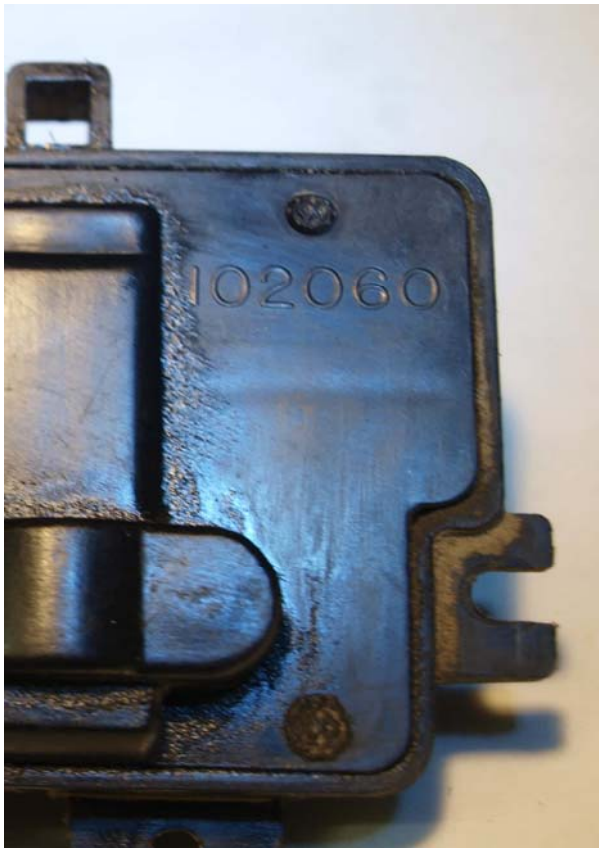
Although not part of the "floppy repair" I would add the motor can be removed from the plastic mirror body, by unscrewing the 3 phillips screws. Interesting enough there are 5 plastic fixing lugs on the motor.

The DeLorean only uses 3 of them ! - So I'm guessing that it's a proprietary part used by other manufacturers?

The motor has the following numbers stamped on it 102060 in one place, and 102063-2 in another location of the motor.

The following pictures show more detail

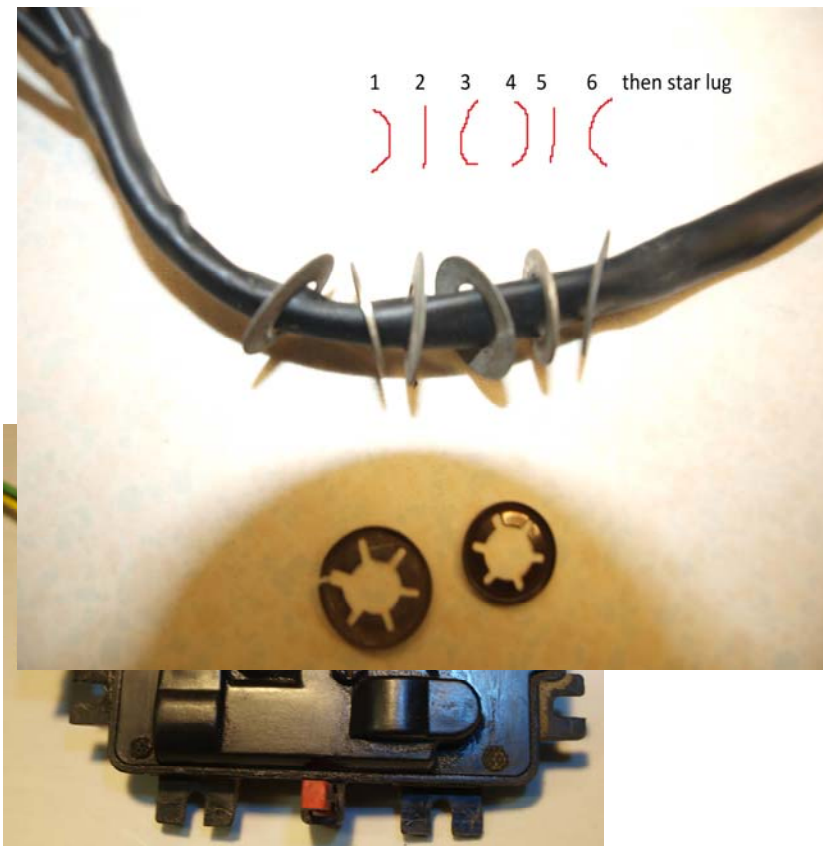
1) Why was my mirror so floppy?

The bottom of the picture shows the culprit !!!... the star lug shown to the left had snapped.

2) There are 7 washers in total that all compress together on the mirror pivot post and they have to go on the pivot post in a particular order.

6 of the washers are shown on the wiring loom that pass through the centre of the mirror pivot tube. The 7th will be the new star lug washer compressing them all together

3) **I've (crudely) show the shape of the washers** in my diagram on the above picture, and their order/orientation which, when compressed, provides the appropriate tension to enable the mirror to move.

I sourced a replacement Star lug (a pack of 10) from a teddy bear materials supplier as shown above.

The internal diameter was 10 mm but I couldn't source one with the correct outside diameter which is 20 mm I think! I even contacted the manufacturers - no dice!

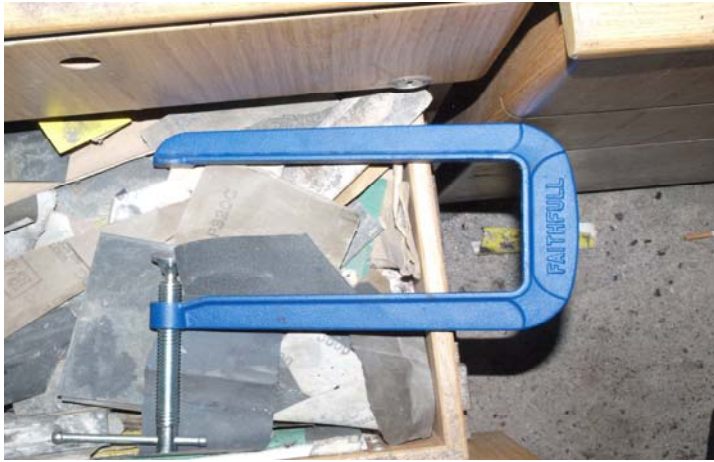
So I came up with the idea of using a G clamp as a press. The above shows "Old Faithfull" - I'd bought this to clamp down the roof box while I bolted it down. The wide mouth of the clamp enabled me to hold the clamp between my knees when I pressed on the Star Lug - otherwise a second pair of hands would probably be required.

So using a socket on the star lugI also used a washer in the mirror plastic body housing to protect it from the forces of the clamp & spread the pressure when using the clamp.

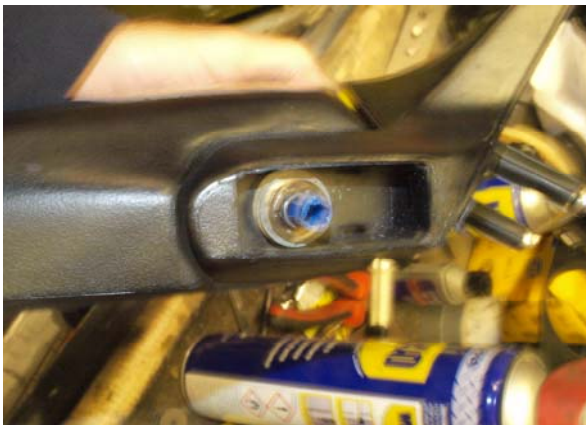
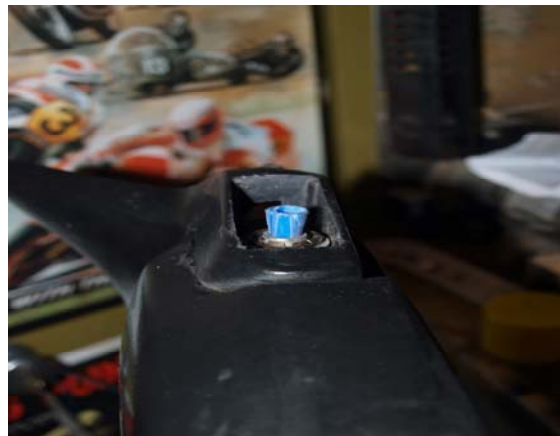
Sooooooooo I cut the top off a biro pen top - slightly conical in shape, inserted that in the pivot post and placed the star lug over that. Shown below is the pen top, that kept the Star lug centred to enable me to

press it on with the "Old Faithfull" clamp.

Compressing the G clamp, on the socket, that sat on the star lug, whilst being centred using a sawn off "blue" pen top, I heard a click!!

S4it I thought something has snapped! - It had ..it was the sound of the star lug snapping into place -
and job's a good un.
