Torsion Bar Roof Support Panel Repair

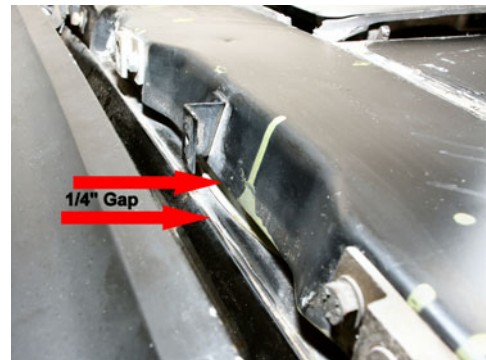
The panel becoming unglued causes several problems. The picture at right shows the original condition of my support panel. It lifted about 1/4" in the center. Note the position of the torsion bar retaining plates. The inside corner of each retaining plate is lifted up and each end of the panel itself is sliding toward the center of the car.

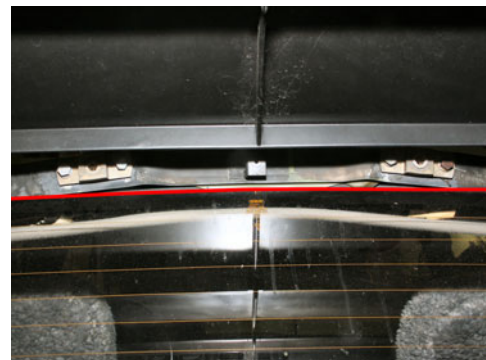
After the plastic finishing piece is removed, one can readily see the torsion bar support panel and the torsion bar retaining brackets. The torsion bar retaining brackets should be relatively horizontal. Also, the gap between the torsion bar retaining plate and the window should be small.

If your panel looks like this, it has become unglued! There should be little space between the bottom of the roof support panel and the top of the rear window (highlighted in red).

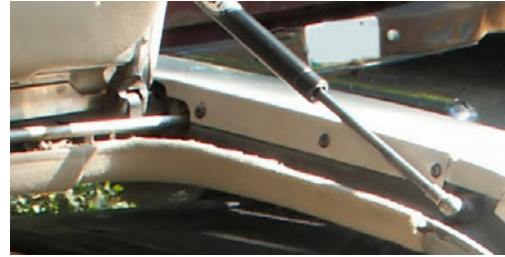
- Open both doors.
- Carefully pull back the weather-strip from the T-roof edge to expose the mounting screws (The picture at right shows the driver's weather-strip removed and the T-roof cleaned of adhesive). There are three (3) screws on each side. Remove these screws and put in a safe place. Close both doors.

- Carefully pull up on the rear of the T-roof. It is likely the T-roof is stuck to the car's fiberglass body—mine was. To unstick it, I carefully took a sturdy yardstick and inserted it between the T-roof and the fiberglass body. By carefully working the yardstick back and forth while slightly lifting the T-roof, I was able to get the T-roof unstuck without damaging its attached insulation. After the T-roof is loose, it simply slides backward to remove (there is a lip on the front of the T-roof that slides under the windshield's upper finishing piece). The key here is to be patient and not force anything. One could easily bend the T-roof if too much pressure is applied. Place the T-roof in a safe place.

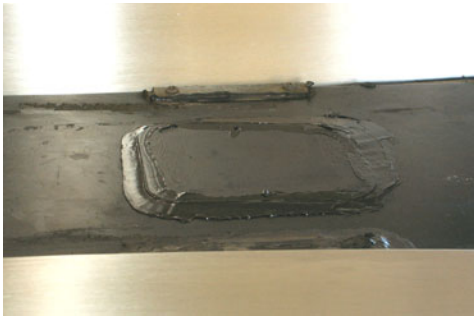
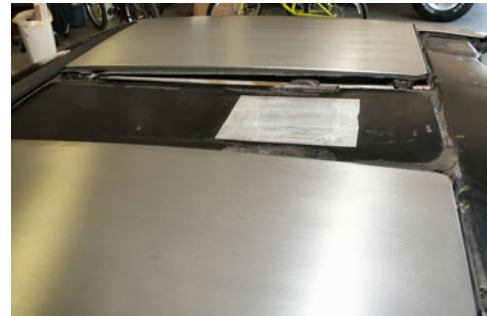
While the T-roof is off, it would be a good time to service the electrical connectors to the doors. There is an access panel on top of the roof. I opened the panel and took the opportunity to clean the contacts to all the electrical connectors (disconnect the battery before doing any electrical work). The pictures below show the plate resealed with RTV and then covered with duct tape.

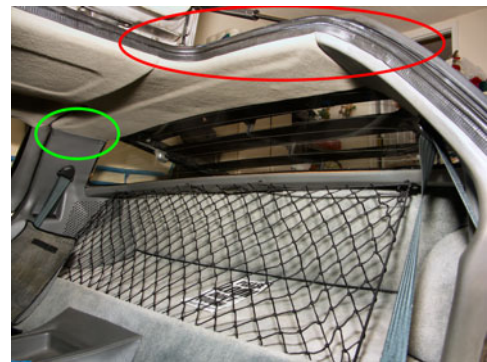
- The rear headliner is held in place by a hidden rear bracket and by glued fabric underneath each door's weather-strip. First step is to remove enough of the weather-strip to get to the glued fabric. Refer to the driver's side area circled in red to the right. The picture at top of the page shows the driver's side weather-strip already removed and gives a good idea of how the fabric from the headliner glues to the car's fiberglass body.

- After enough of the weather-strip is removed from both passenger and driver's side (pulls straight up), carefully separate the fabric on both sides from the car's fiberglass body. Locate the screws holding the headliner to the side upholstery (green circle area in picture at right) and remove them (one per side). The rear headliner can now be carefully slid toward the front of the car to disengage it from the rear bracket.

- After the back is loose, the ends of the headliner (circled in green above) must be released. By moving the headliner to one side and bending the headliner a little, the end will come out. Repeat for the other side.

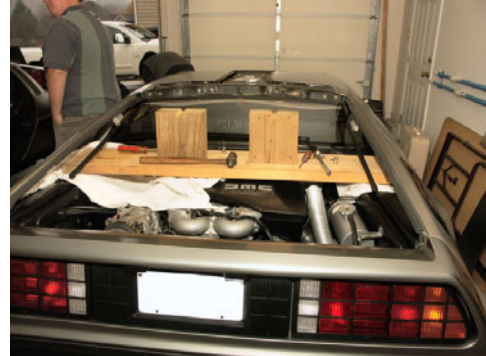
If all is going well to this point, your car should look like the picture on the right. Note I did not remove the torsion bars completely. This is contrary to other posts detailing this procedure. I imagine their idea is torsion bar removal minimizes the risk of damaging them while doing work to secure the support panel. I think if you are careful, this should not be an issue.

My passenger's side torsion bar was loose and could have been removed easily. However, the driver's side torsion bar was stuck tight in the door's front hinge. In helping others with torsion bar work, I have found that unsticking the torsion bar is a rather unnerving task as it tends to pop rather loudly when it releases. Rather than risk fracturing the driver's side bar, I simply left it in. YMMV.

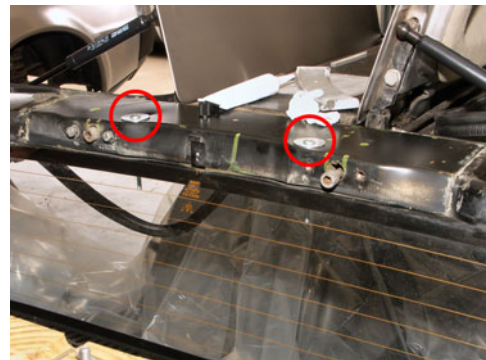
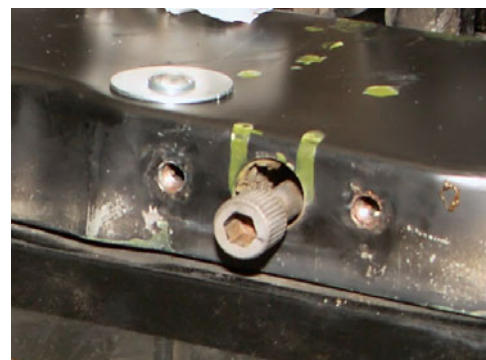
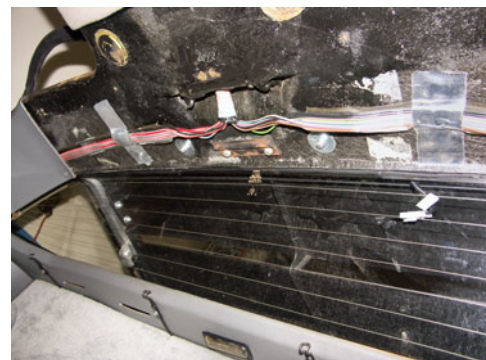
- Refer to the picture at the right. You will notice the carriage bolts with fender washers installed (circled in red). I just used two bolts between the torsion bars because the outside portions of the panel are normally under tension. I suppose one could place another set of bolts on the other side of the torsion bars also, but I did not see a need to do that.

- In the next picture you will see that I located the carriage bolts so that the fender washers are very near the back edge of the panel. They are also located very near to where the panel starts curving inward. This was the point where the panel kinked and looked as if it was the greatest point of stress.

- The bottom picture shows the view from inside the car. The carriage bolts have already been trimmed to fit. Notice the bracket between the carriage bolts. This is what the rear headliner engages to hold it in place. Be careful not to hit the wiring when drilling holes for the carriage bolts!

- After locating and drilling the 1/4" holes through the support panel and the car's fiberglass body, I seated the fender washer onto the bolt. As is, the square portion of the bolt just under the head would not go into the 1/4" round hole of the fender washer. I suppose it would have been easier to buy fender washers with a 3/8" center hole, but I made do with what was on hand.

- Install a carriage bolt with fender washer on top, then install a fender washer on bottom. Tighten with nyloc nuts. I did not get a torque reading on the nuts, but they were tightened down hard using a hand wrench. There was very little deflection in the fiberglass roof inside the car. This area is stronger than one may think.

- After the bolts were in place, I sealed around all edges of the panel with RTV. I also painted the fender washers and bolt heads black to prevent corrosion. There were no signs of water damage or rust in this area, but better safe than sorry.

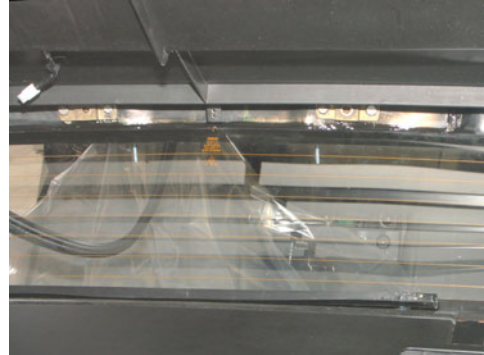
- Reinstall the louver and align it.
- If everything is going well to this point, your car should look like the picture to the right. Note the bottom of the plate now follows the curvature of the rear window and the torsion bar brackets are more horizontal than before. In looking through the window, one can see the weather-strip hanging down as the rear headliner hasn't been installed yet.

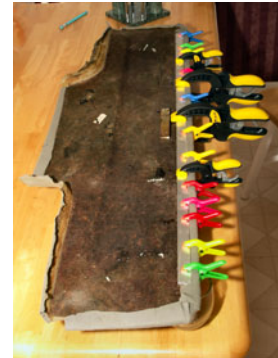
- The plastic retaining piece now needs to be reinstalled. After getting it installed, carefully bend the tabs of the T-roof against the plastic piece. The rear of the T-roof now should be low enough to allow the louver to open without hitting. At no time did the T-roof contact the heads of the carriage bolts.
- Finally comes the rear headliner. My rear headliner was sagging (look at the pictures on the bottom of page 1 and the top of page 4), so while it was out I decided to fix it. Home Depot sells a 3/4" wide X 1/8" thick X 3 foot length piece of aluminum bar that is perfect for the job. This piece was secured to the backside of the headliner using common 2-part epoxy. Please note all those clamps aren't necessary for this job! I got carried away!

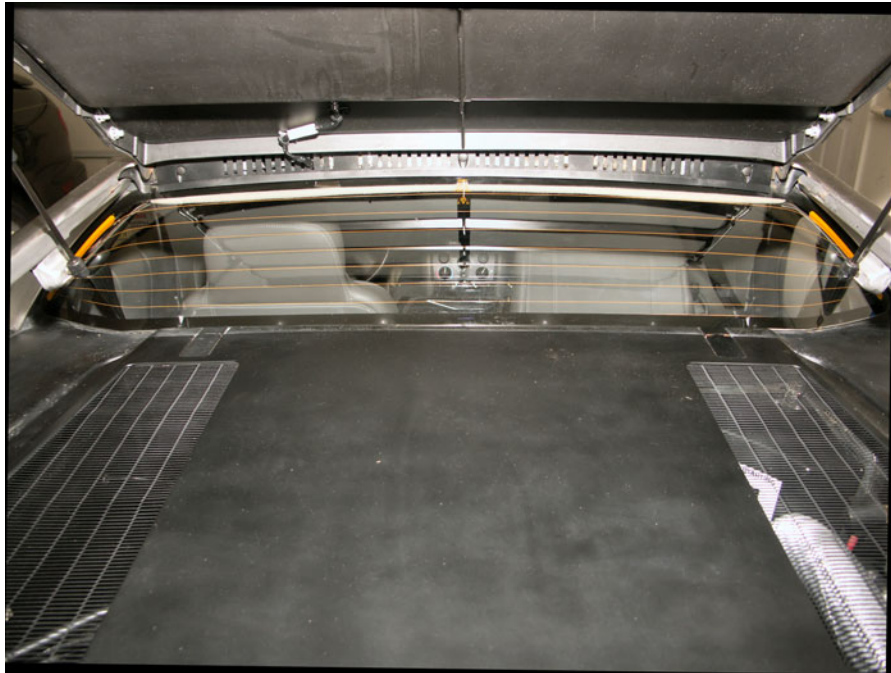
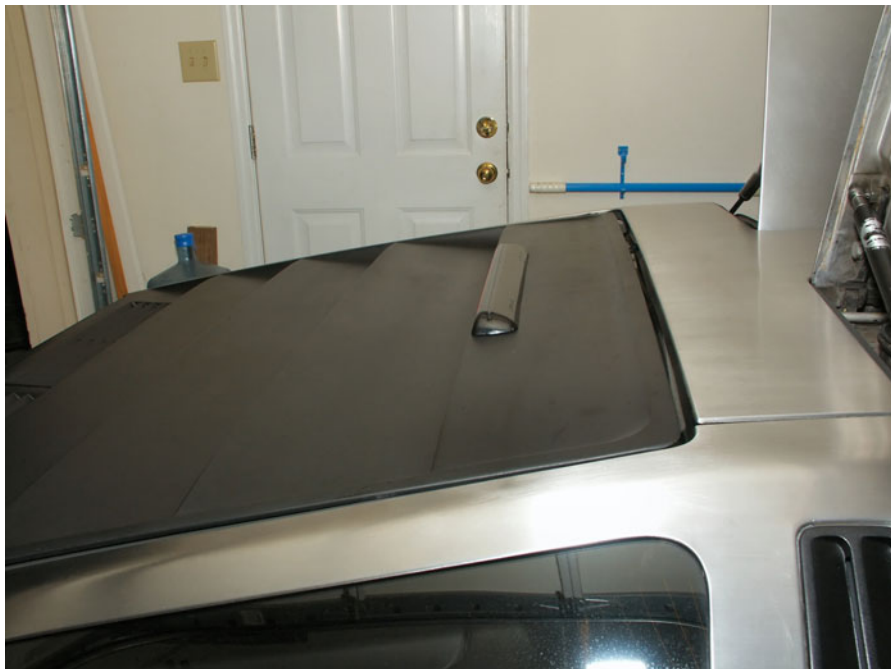
Below is a picture of the finished project. Note the headliner follows the curvature of the roof nicely. Now it doesn't take Superman to close the doors, one doesn't have to quickly get out of the way of the doors as they open, the creaking noises when the doors open or close are gone, the louver clears the T-roof, and I rest a bit easier with the knowledge the torsion bars are no longer rubbing the door hinges.
