### PROJECT NAME: OFFSHORE JACKET REPAIR

**Location:** Offshore Vietnam  
**Client:** Neptune Subsea  
**Product:** ceEntek ce200-140G™

**Product Volume:** 18 m<sup>3</sup> (36 Te)  
**Connection Size:** drilled connections-65mm; grout inlet-50mm  
**Completion Date:** September 2017

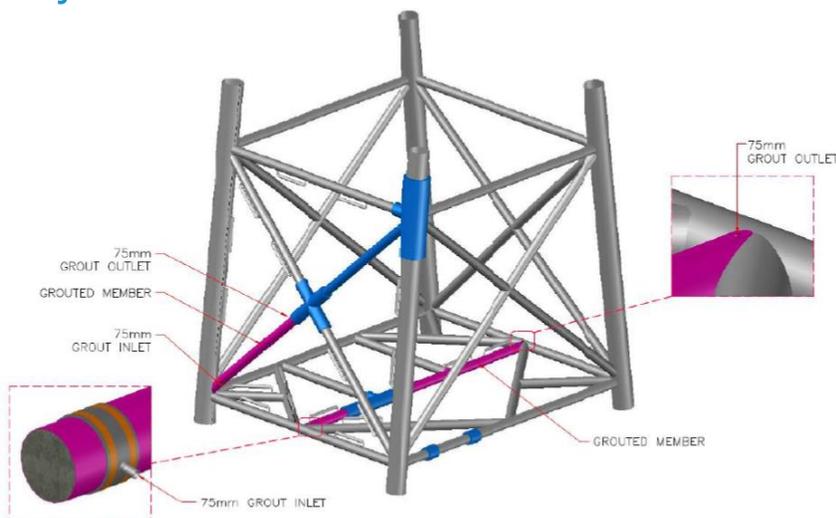
The platform has a 4-legged jacket foundation. The bracings on the jackets had undergone corrosion damage over the years and required structural repair to extend the platform's useful life.

Photo: Technical design of the Offshore Platform highlighting grouted members with ceEntek's ce200-140G™ UHPC grout

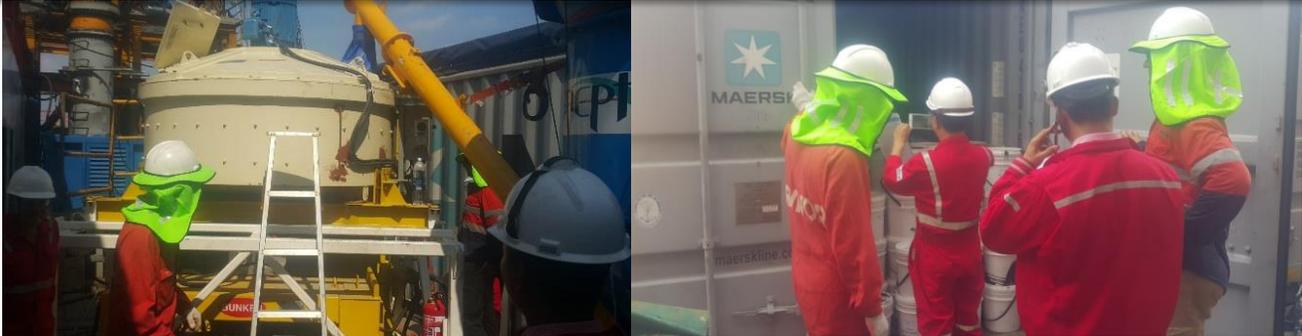
Photo: Neptune Subsea's 0.5 m<sup>3</sup> Pan mixer used to batch ce200-140G<sup>TM</sup> (L); Inspection of ce200-140G<sup>TM</sup> grout delivery (R)

ceEntek's ce200-140G<sup>TM</sup> UHPC grout has been designed for similar structural strengthening in tropical waters. ce200-140G<sup>TM</sup> non-shrink UHPC grout was supplied in 2205lb (1000kg) bulk-bags and batched in the pan mixer located on the offshore vessel. One bulk-bag per batch provided 0.65cy (0.5m<sup>3</sup>) of the UHPC grout. The grout was pumped by Neptune Subsea to 44m (65') depth using 10cm (4") annuli flexible hoses to complete the structural repair grouting of 5 inlet and outlet jacket bracings of the offshore platform. The 50mm cubes were manufactured throughout the operation and taken to the laboratory on-shore for quality reporting services. The laboratory testing was witnessed and endorsed by ABS Consulting to confirm ce200-140G<sup>TM</sup> material performance, certifying the average 1-day compressive strength result at 80MPa (11600 Psi) and 7-day compressive strength result at 120MPa (17400Psi). Due to this rapid strength development and optimized execution, the project was delivered within 6-weeks from start to finish, without compromising the quality.

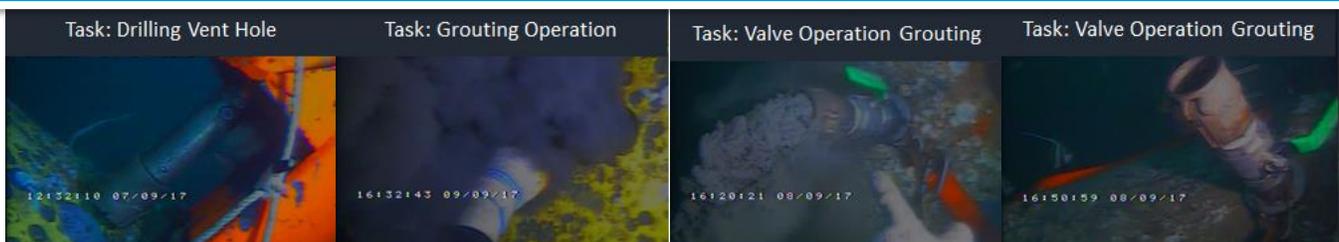
Photo 1: Subsea drilling into member using pneumatic and hydraulic drilling equipment by divers

Photo 2: Flushing of member using die materials to ensure continuity through section for grouting operations

Photo 3: Installation of grout valve and pumping of ce200<sup>TM</sup>-140G UHPC grout material to fill member

Photo 4: Mechanical lock-off at member upon completion of grout installation to complete works operations
