PROJECT NAME: QUAIL-ROOST DR BRIDGE MIAMI, FL

Photo: Longitudinal Connections for the Quail-Roost Drive Bridge over Canal C, Miami-Dade County, Florida

PROJECT PROFILE

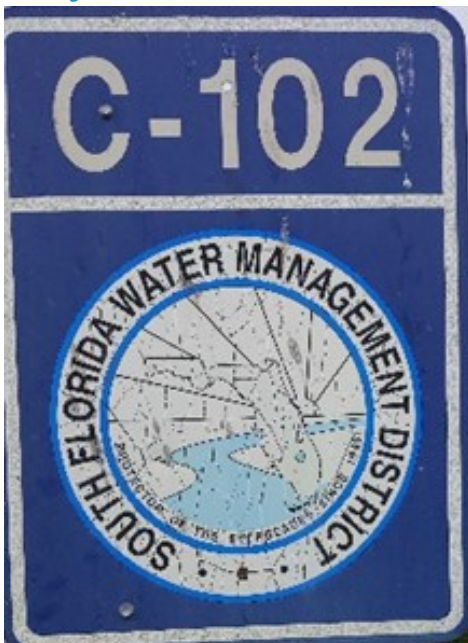
Photo: The bridge is located over the Environmentally sensitive South Florida Water Management's Canal C, Miami-Dade County.

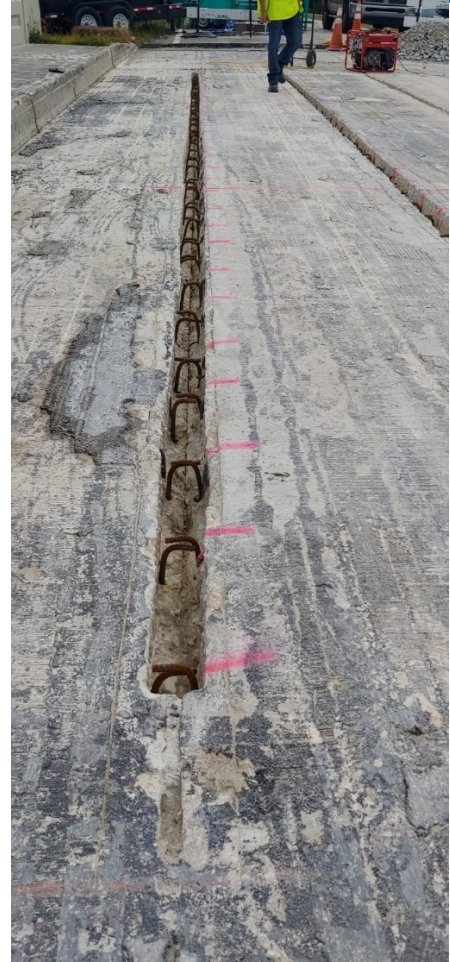
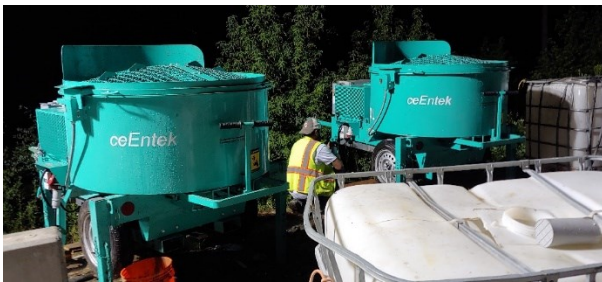
Photos: ceEntek's UHPC Mixers in pairs (L); Connections between the side-by-side Box-girders (R).

The ce200SF-G™ and ce200SF-t™ were batched on site with ceEntek's Variable speed IMER750 Mixers (0.182 cy [0.14 m³] capacity) and supplied on pallets in 20 kg (44 lb) bags, with 0.008" x 0.5" (0.2 mm x 13 mm) steel fibres and ceEntek's CNF enhanced paste. The ce200SF-G™ was used in the connections and the ce200SF-t™ was used for an overlay to repair the damaged area.

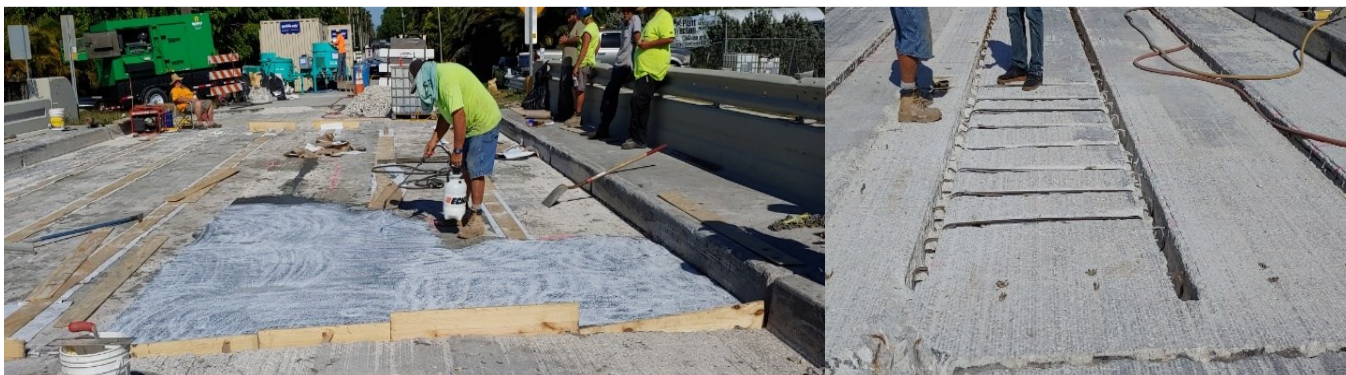
During removal of the old asphalt, the sub-contractor removed a portion of the top concrete cover protecting the steel stirrups in the box girders. An emergency repair using ce200SF-t™ overlay was installed.

Photos: Spraying White Pigmented curing compound on the ce200SF-t™ overlay repair area (L); Close-up of the damaged area before casting the overlay repair (R).
